H. B. NORTON DAM
(PA NO NAME No. 42)
NDI No. PA 00385
PennDER No. 24-35

PHASE I INSPECTION REPORT
NATIONAL DAM INSPECTION PROGRAM

February 1979

H. B. Norton Dam (Pa. No Name No. 42), Elk County, Pennsylvania
NDI No. PA 00385, PennDER No. 24-35
Big Mill Creek
Inspected 13 and 14 November 1978

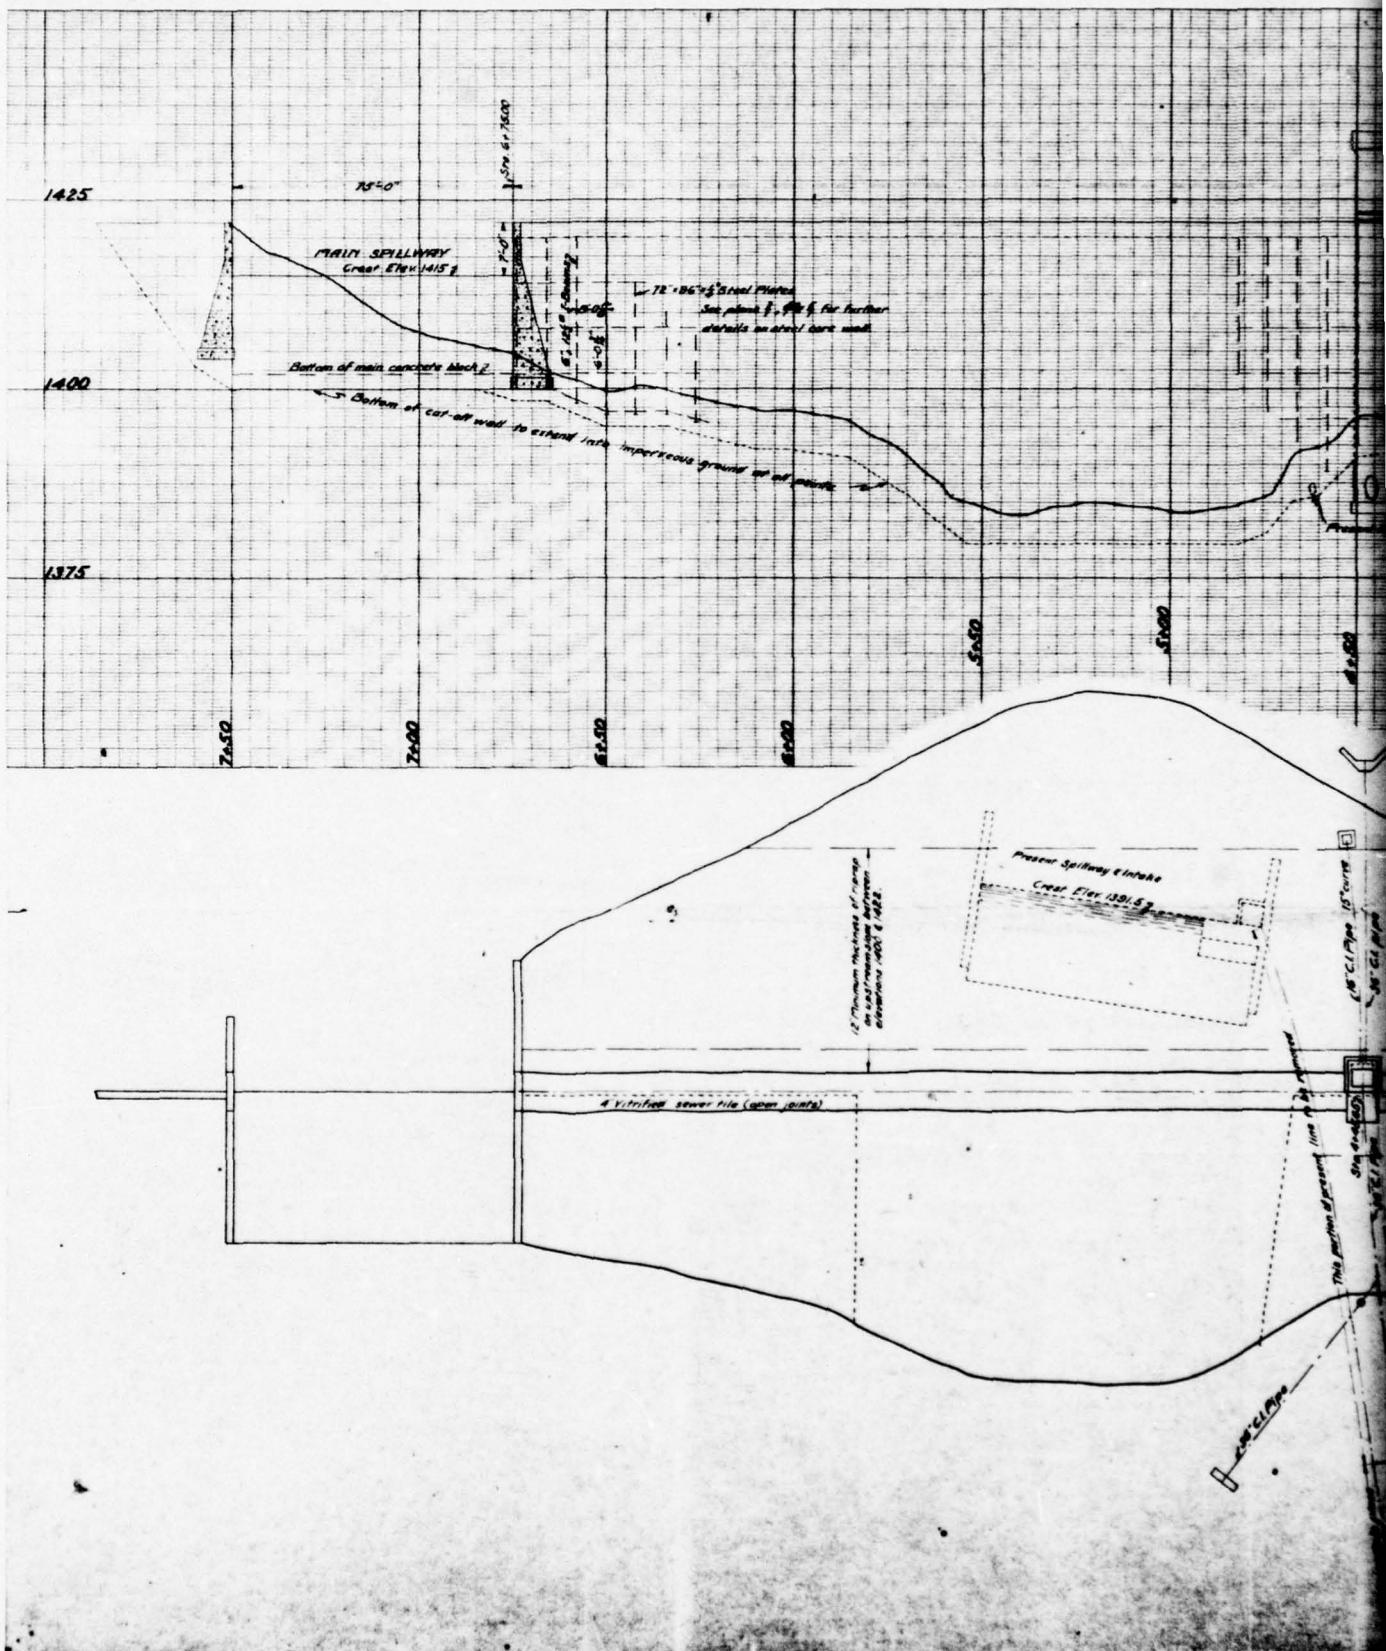
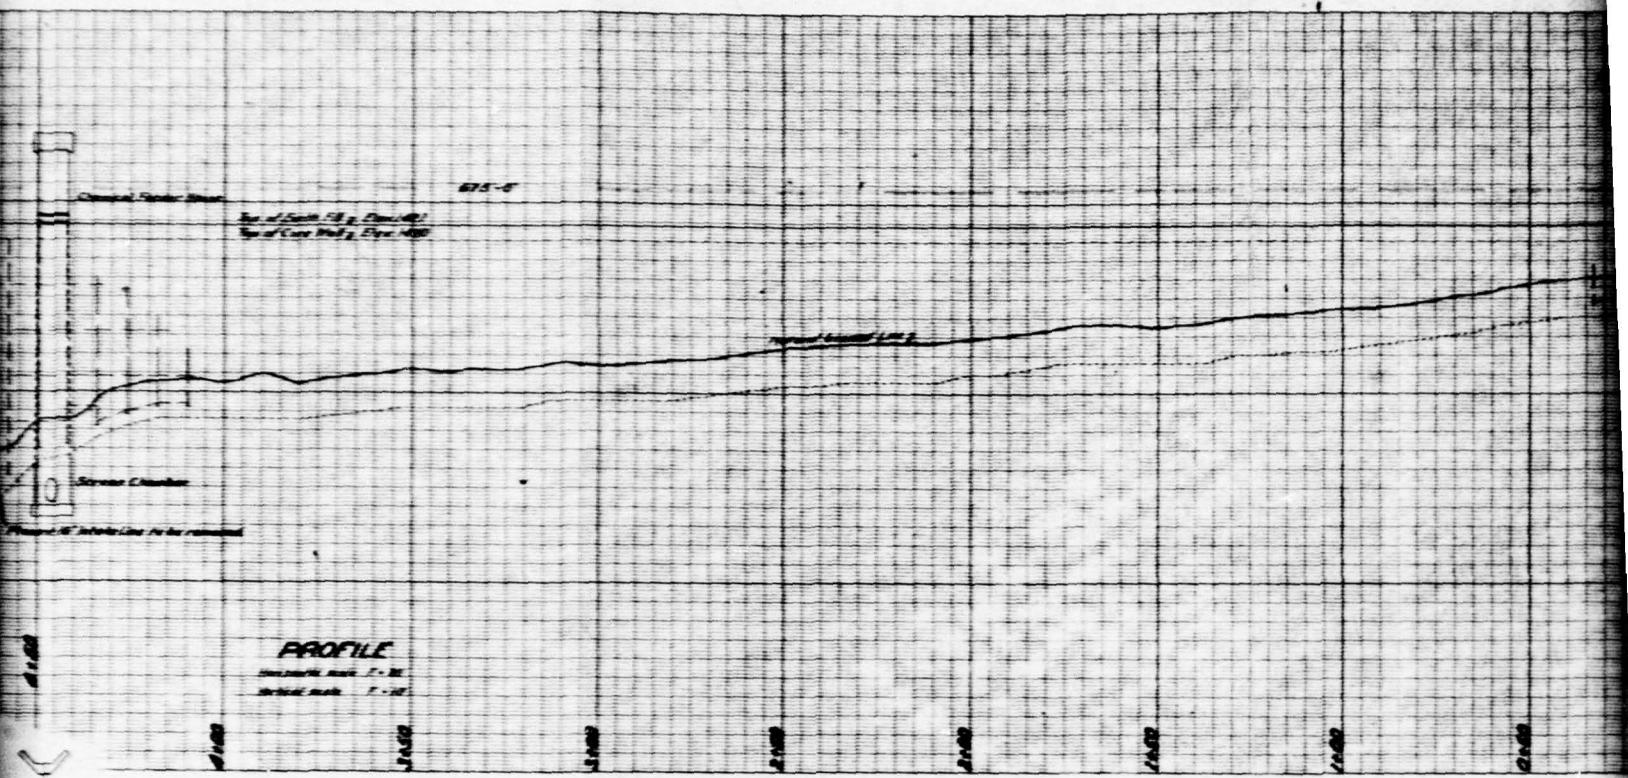
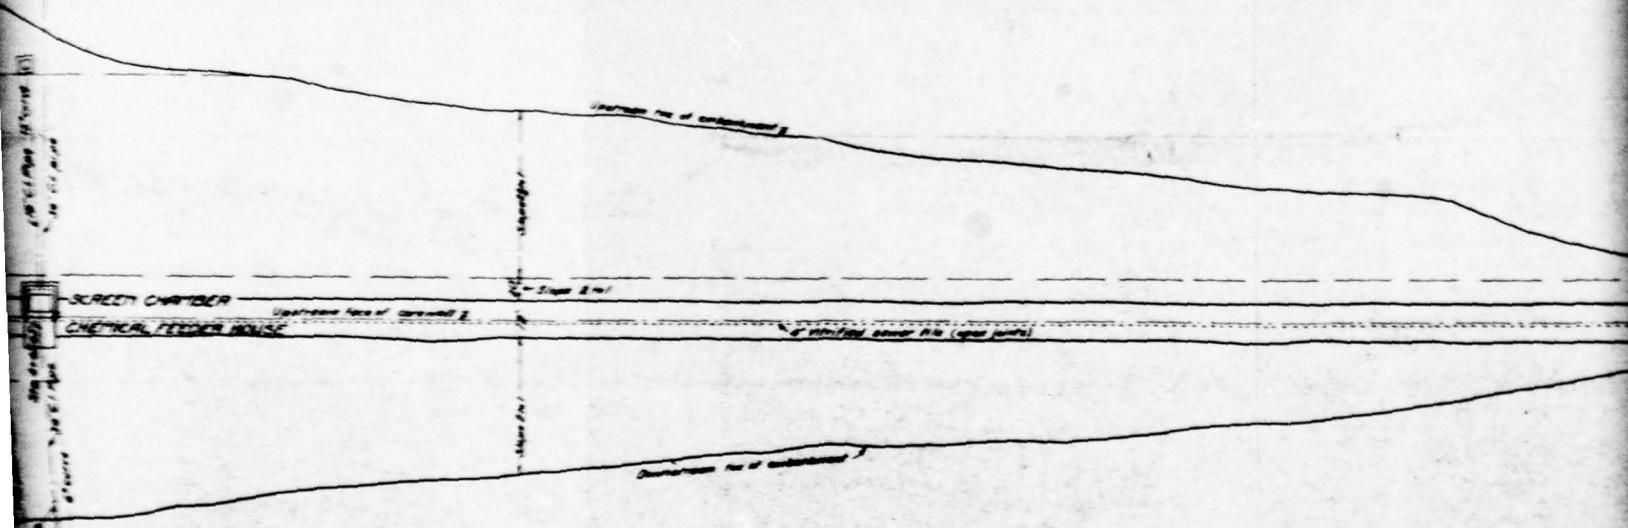
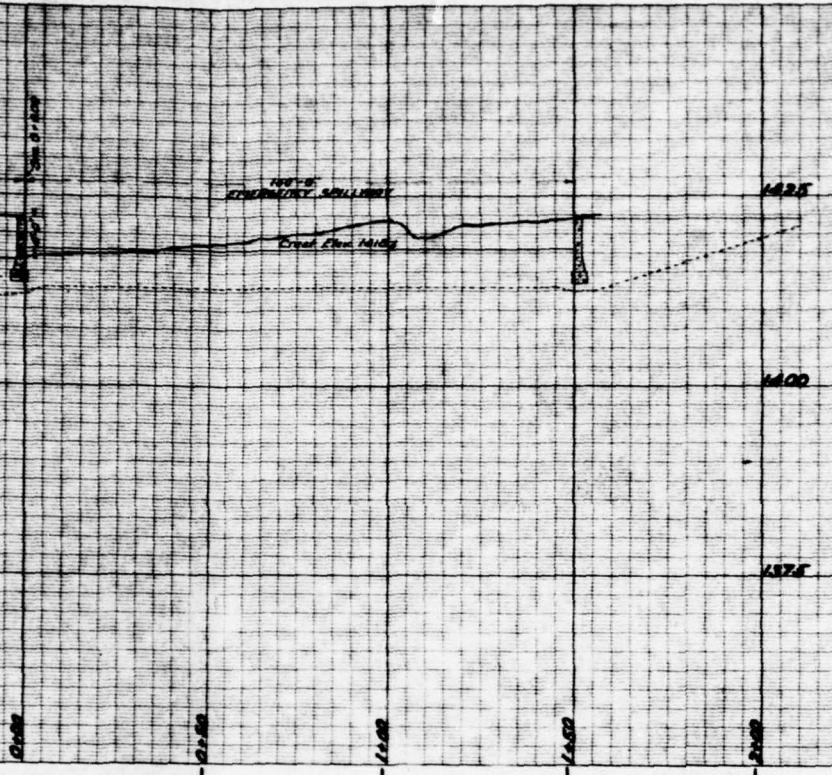
PLATE 3
RIDGWAY BOROUGH WATER WORKS
RIDGWAY, PA.
1931 EXTENSION
DAM
SECTION AND PLAN

According to the plans (see Plate 3), a
4-in. tile drain was to be located behind
the steel sheet core wall. However, no
outlets were found for these drains.
