PENNSYLVANIA
LEVEL
TAMARACK LAKE DAM "A"

NDI No. PA 00181
PenDER No. 20-47A
SCS No. PA 461A

PHASE I INSPECTION REPORT
NATIONAL DAM INSPECTION PROGRAM

TAMARACK LAKE DAM "A"
CRAWFORD COUNTY, COMMONWEALTH OF PENNSYLVANIA
NDI No. PA 00181
PennDER No. 20-47A
SCS No. PA 461A

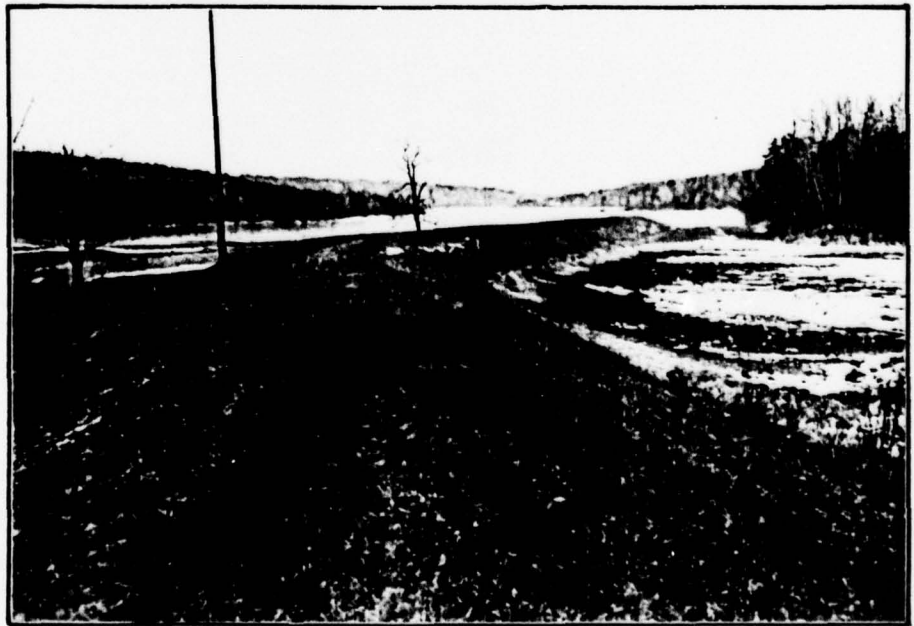
Overall View of Diversion Dam Looking towards Reservoir

- c. Diversion Dam - Some minor erosion was observed on the crest of the dam. No other significant deficiencies were noted. The pond drain was open at the time of inspection and no water was impounded behind the dam.
