NATIONAL DAM INSPECTION PROGRAM. PA-484 DAM (NDI-ID-PA-489) (DE--ETC(U)

PA-484 DAM  
NDI I.D. NO: PA-489  
DER I.D. NO: 63-72

PHASE I INSPECTION REPORT  
NATIONAL DAM INSPECTION PROGRAM

MARCH 1979

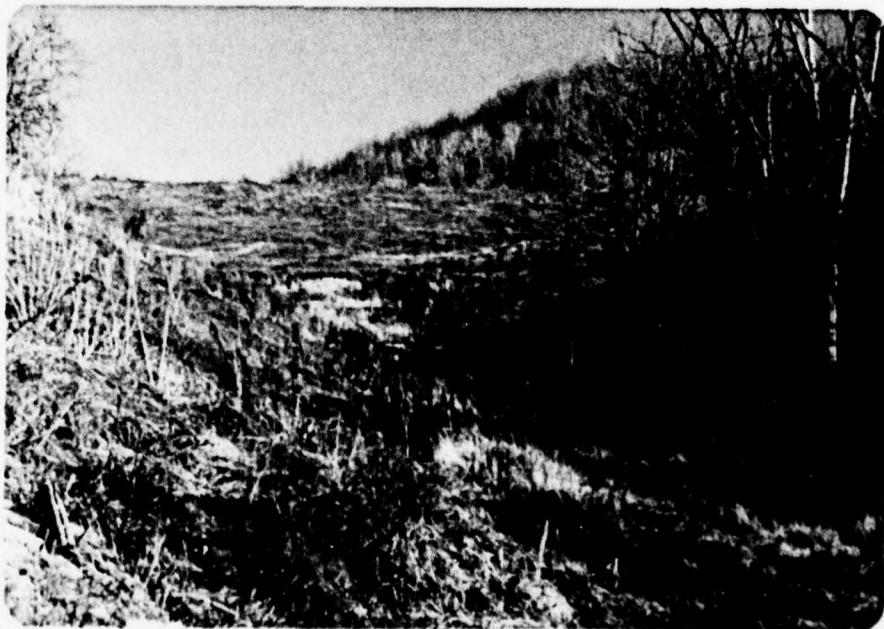
A swampy area with associated seepage exists on the lower one-third of the downstream slope. Although at this time this condition does not appear to pose instability problems, a concern exists as to the continued integrity of the embankment under maximum pool conditions. It is therefore considered advisable that necessary instrumentation, such as piezometers, be installed to monitor the phreatic surface through the embankment and the stability of the embankment be reevaluated based on the results of these observations.

Downstream Face

1. The embankment should be evaluated by a professional engineer experienced in earth dam design and necessary instrumentation installed to monitor the wet area on the downstream slope of the dam. The stability of the embankment should be evaluated based on the results of these observations and necessary remedial work performed, if required.
2. Around-the-clock surveillance should be provided during unusually heavy runoff and a formal warning system developed to alert the downstream residents in the event of an emergency.
