TAMARACK LAKE DAM "B"

NDI No. PA 00746

PHASE I INSPECTION REPORT  
NATIONAL DAM INSPECTION PROGRAM

Tamarack Lake Dam "B", Crawford County, Pennsylvania  
NDI No. PA 00746, PennDER No. 20-47B, SCS No. 461B  
Mud Run  
Inspected 29 November 1978

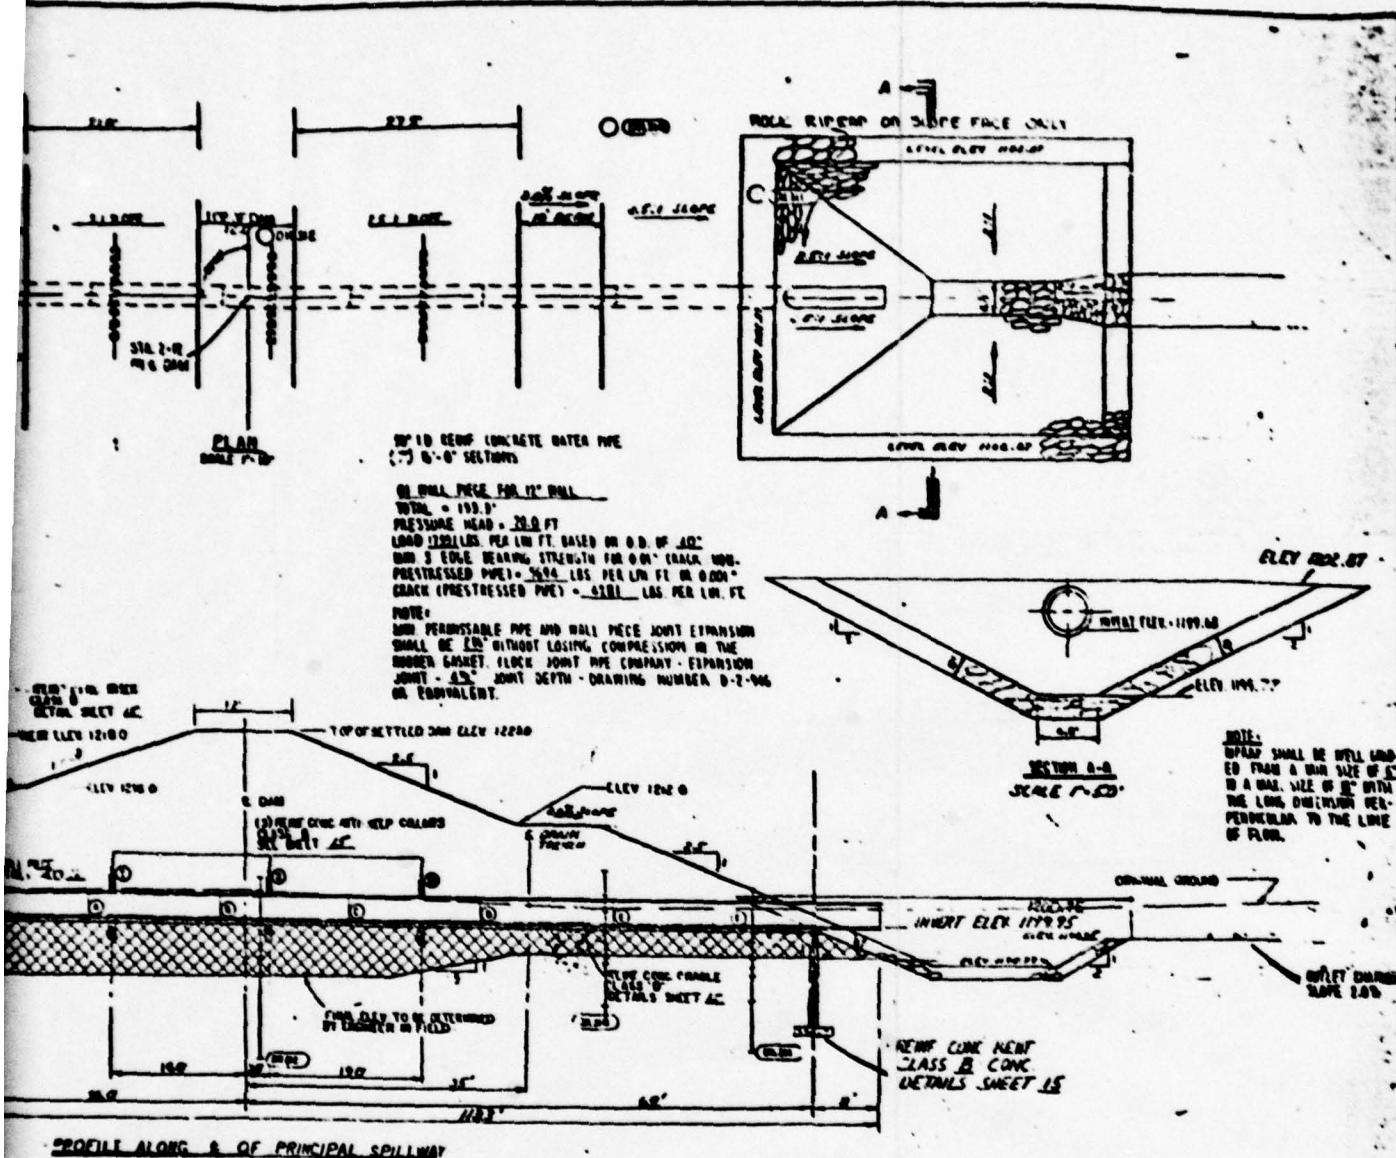
**PLATE 6**

Outlet Pipe - A 30-inch reinforced concrete pipe supported on a concrete cradle. Three reinforced concrete anti-seep collars were provided at non-uniform spacing near the center of the dam (see Plate 6). The remaining sections of outlet pipe were not provided with anti-seep collars. The pipe was installed in 16-foot-long sections for a total length of 113.3 feet (including the wall section at the intake riser).

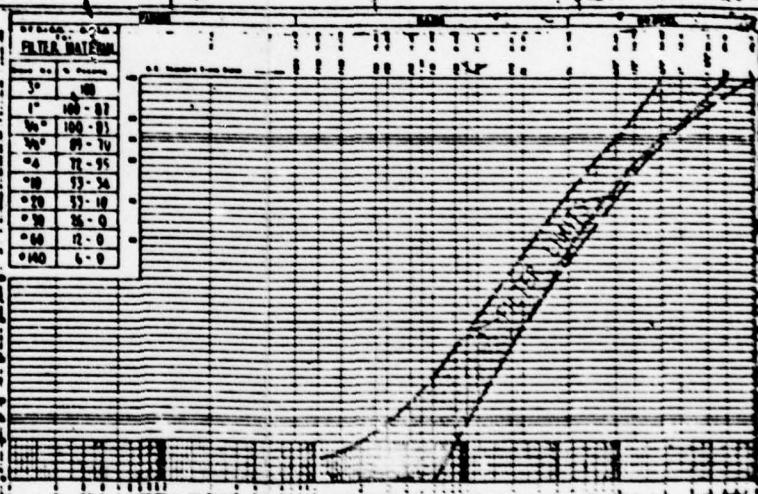
**PLATE 7**

Drains - A filter blanket with two drain outlets is  
located in the downstream portion of the  
embankment (see Plate 7 for location and  
details).
