9  
I.D.  
National Dam Inspection Program, I.D.  
Jeannette Dam (NDS PA-00486),  
(Pennder 65-9), Ohio River Basin,  
Unnamed Tributary to Brush Creek,  
Westmoreland County, Pennsylvania.

PHASE I REPORT  
NATIONAL DAM INSPECTION PROGRAM

Jeannette Dam: NDS I.D. No. PA-00486

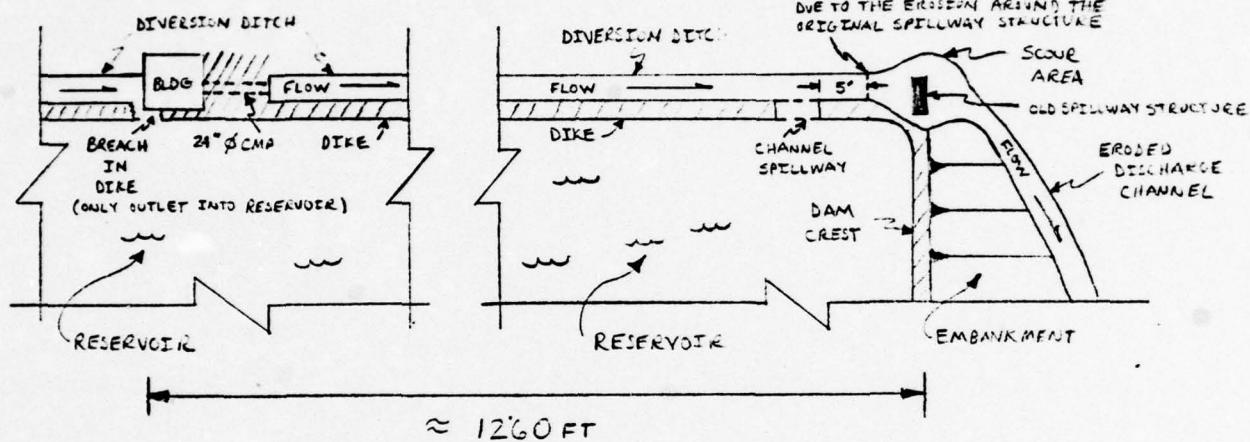
- PLAN VIEW OF SPILLWAY VICINITY : (NOT TO SCALE)  
(SEE APPENDIX F, FIG 1 FOR SKETCH OF ENTIRE RESERVOIR AREA)

THE CONTROL SECTION IS VERY UNSTABLE SINCE IT IS  
FOUNDED IN EARTH AND IS A PRODUCT OF THE EROSION  
AROUND THE ACTUAL SPILLWAY STRUCTURE. HOWEVER, IT WILL  
BE ASSUMED THAT THE SECTION IS STABLE IN THIS ANALYSIS.

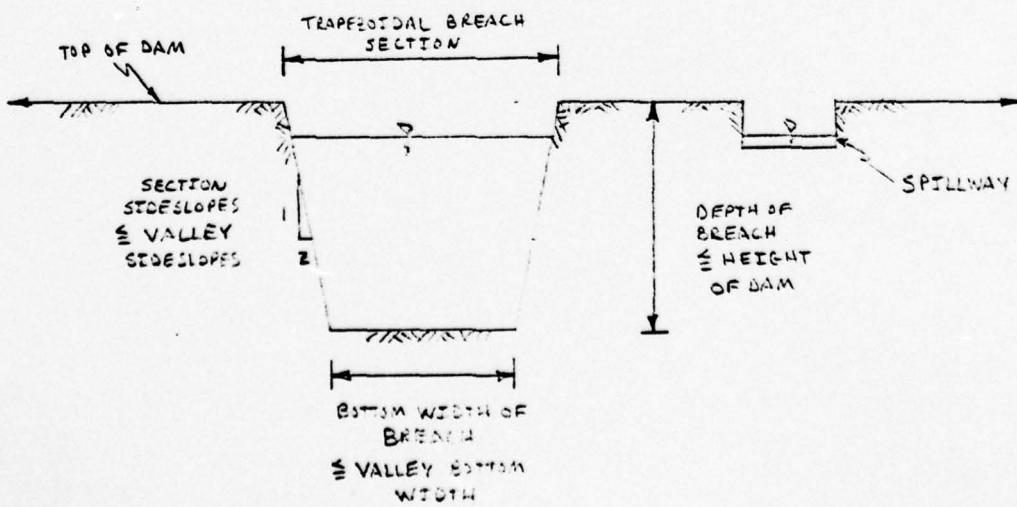
#### - TYPICAL BREACH SECTION :

IN ORDER TO MODEL THIS TYPE OF FAILURE w/ HEC-1, A RELATIVELY SWIFT DOWNCUTTING UNDER  $\frac{1}{2}$  PMF CONDITIONS WILL BE EVALUATED. THE INITIATION OF BREACHING WILL BE AT THE APPROXIMATE RESERVOIR ELEVATION CORRESPONDING TO THE PEAK  $\frac{1}{2}$  PMF DISCHARGE.

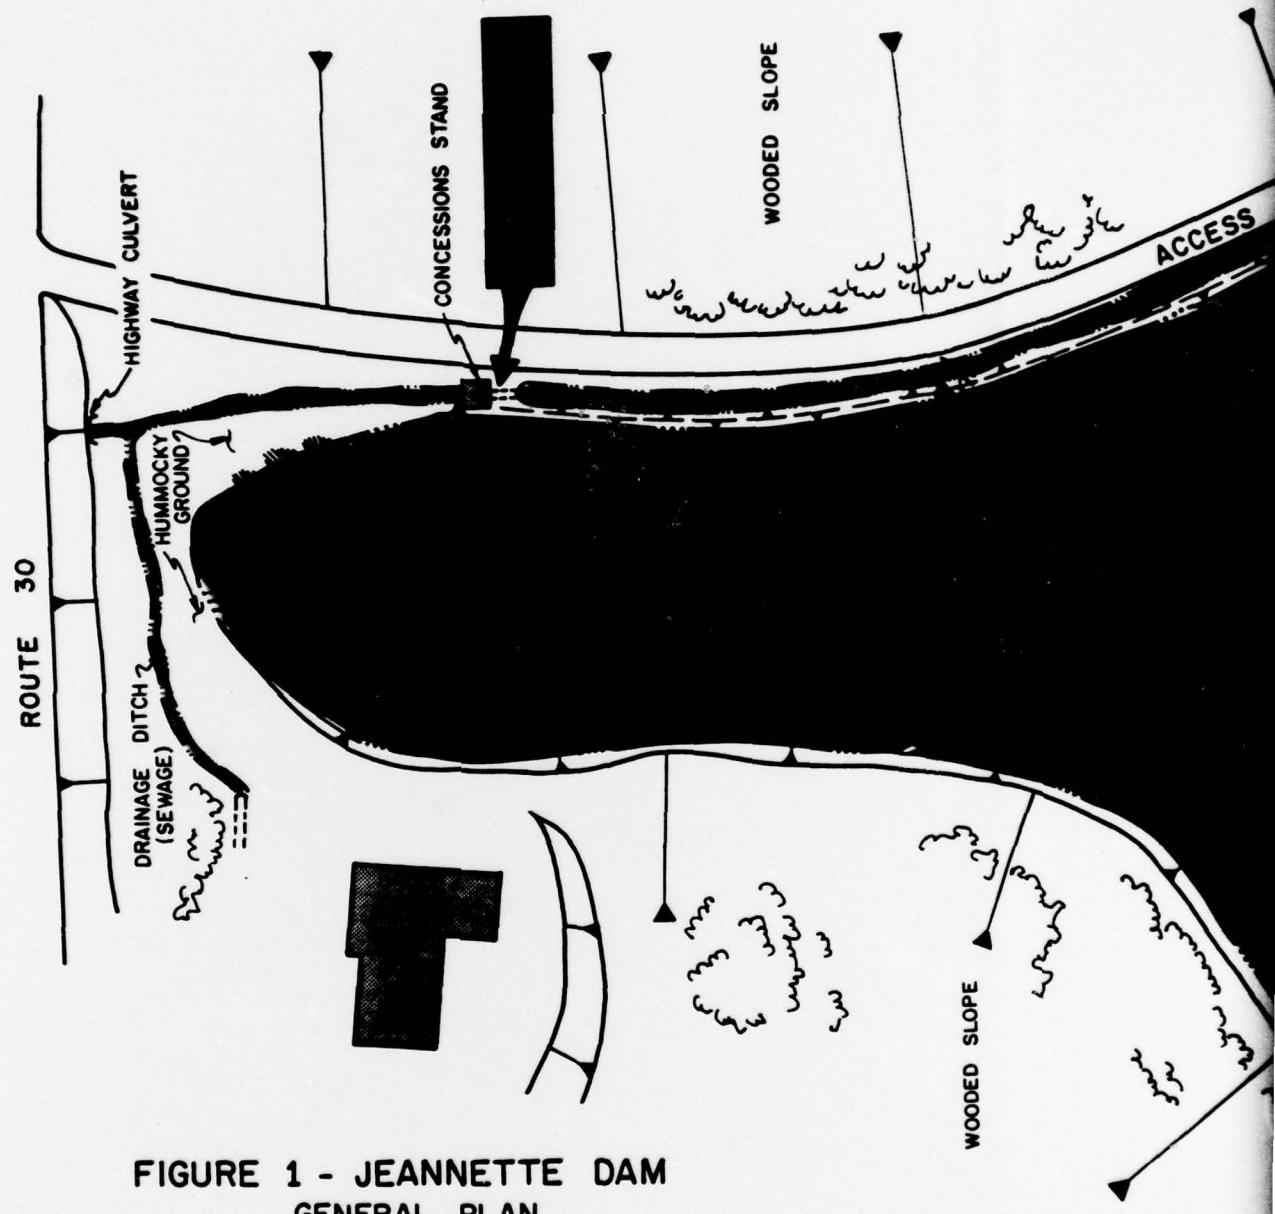
FIGURE 1 - JEANNETTE DAM  
GENERAL PLAN  
FIELD INSPECTION NOTES

Trapezodial-shaped channel constructed parallel to the western shore of the lake extending upstream from the embankment to the culvert passing beneath U. S. Route 30 (total length = 1,500 feet; see Figure 1).
