NRL Memorandum Report 4003

Shock Performance of a Shipboard Electrical Switchgear

EDWARD W. CLEMENTS

June 15, 1979

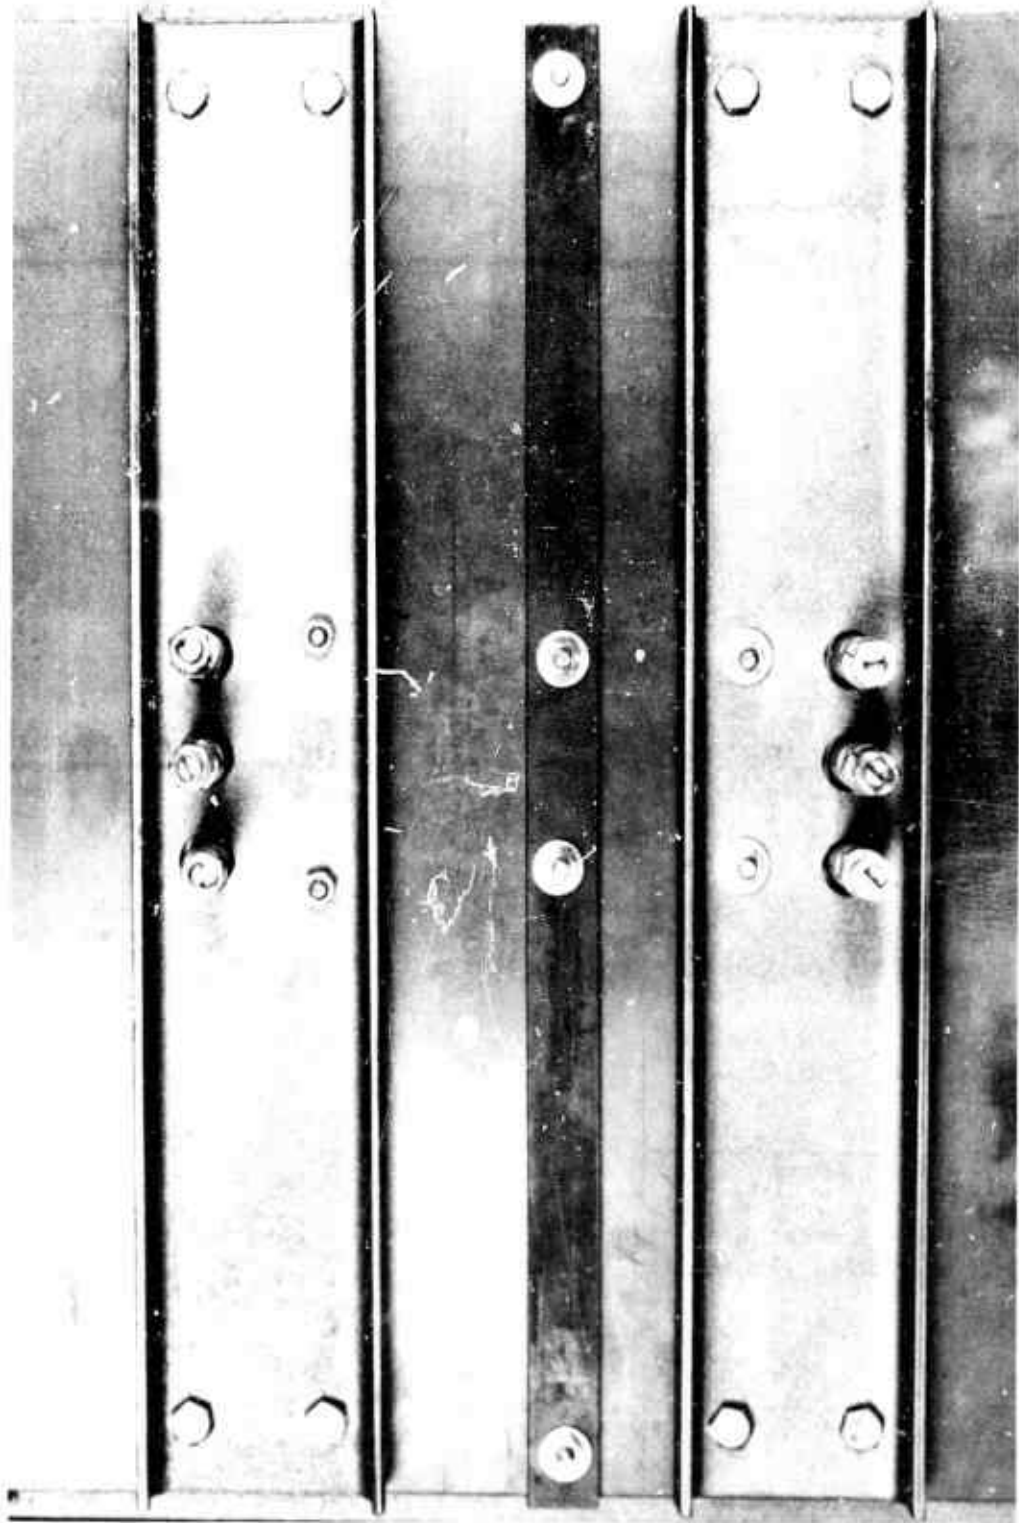
An additional stiffener bar (1 x 1/4 in. steel) (Fig. 9) was added to the back of fixture to see if a more rigid fixture would help. The breaker was then retested with the interlock actuator blocked and free, with the results of Table V.

Fig. 9 - Back view of the LF101 test fixture, showing the extra 1" x 1/4" stiffening bar added at center.

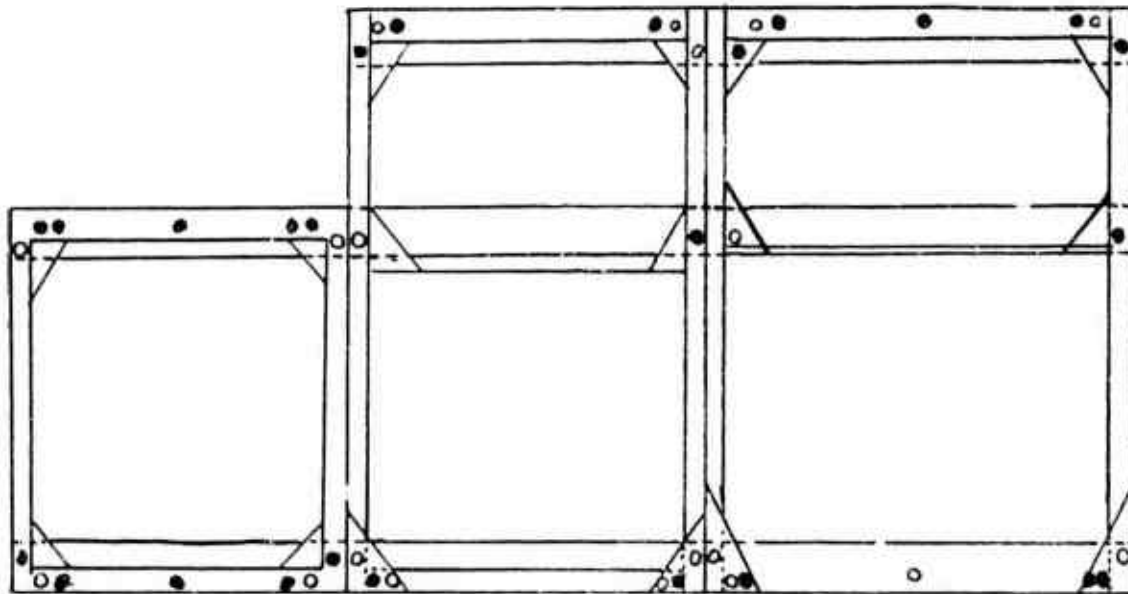
Fig. 24 - Sketch showing locations of switchgear hold-down bolts. Closed circles show bolts actually installed, open circles represent holes in the switchgear base which did not align with those in the channels.

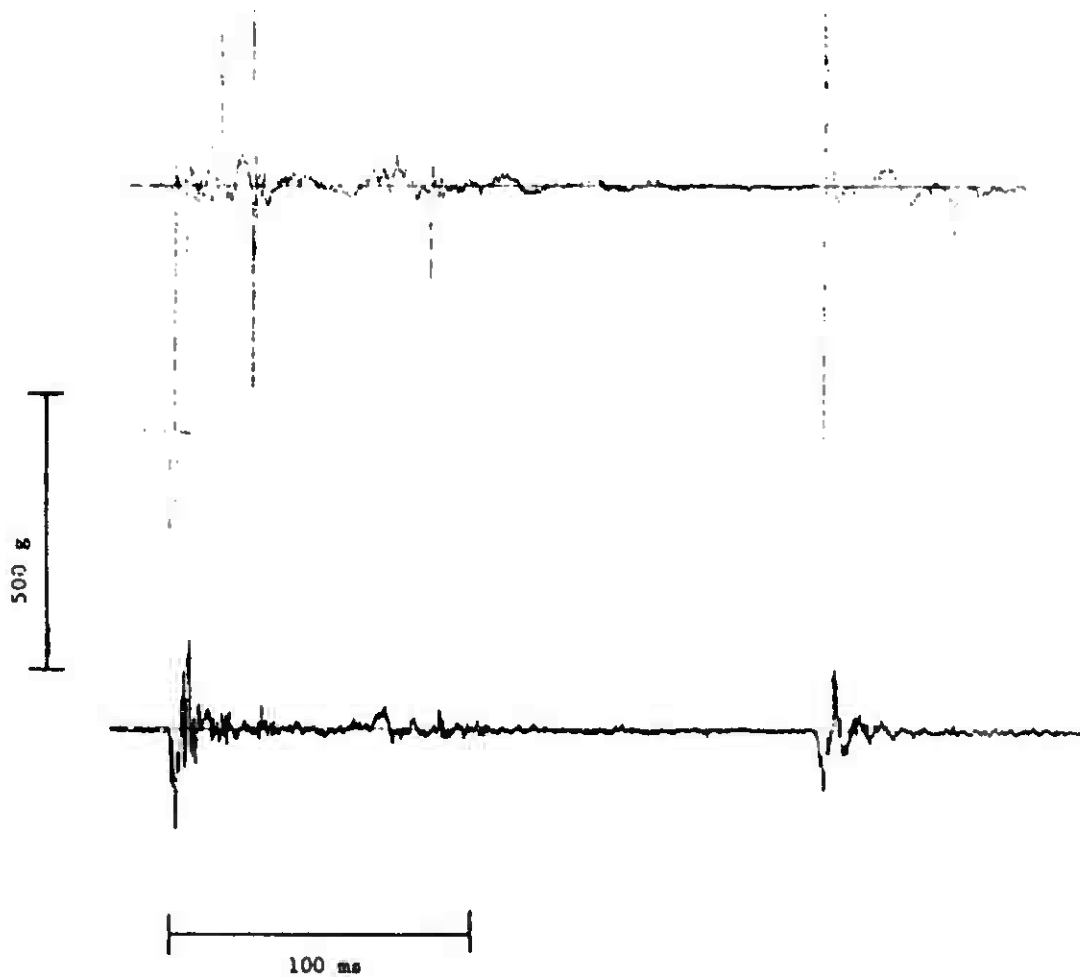
Fig. 65 - Acceleration-time records from the fuse block (upper) and mounting panel (lower) of AQB-LF101 No. 10A during Blow 4 (5-1/2 ft. 3 in.) (Vertical). Note spikes which probably indicate collision of the breaker and the cover panel.

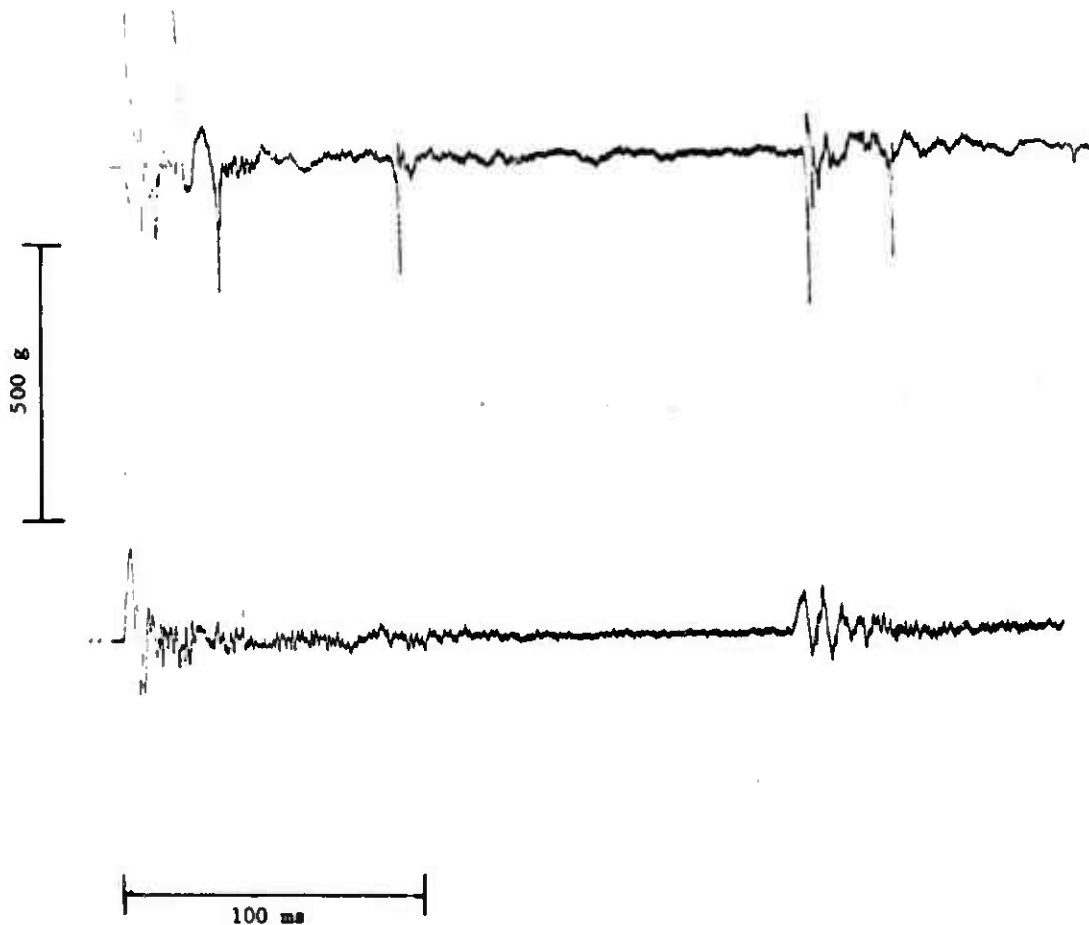
Fig. 67 - Acceleration-time records for the fuse block (upper) and mounting panel (lower) of AQB-LF101 No. 10A during Blow 9 (5-12/ft. 3 in.) (30° - Inclined). Note possible collision spikes.
