NATIONAL DAM INSPECTION PROGRAM. RECREATION DAM (NDS ID NUMBER --ETC(U)  
MAR 79

PHASE I REPORT  
National Dam Inspection Program  
Abstract

Recreation Dam (Cold Stream Dam): NDS I.D. No. PA-00446

Owner: Borough of Philipsburg  
State Located: Pennsylvania (PennDER I.D. No. 14-26)  
County Located: Centre  
Stream: Cold Stream  
Inspection Date: 14 and 22 November 1978  
Inspection Team: GAI Consultants, Inc.  
570 Beatty Road  
Monroeville, Pennsylvania 15146

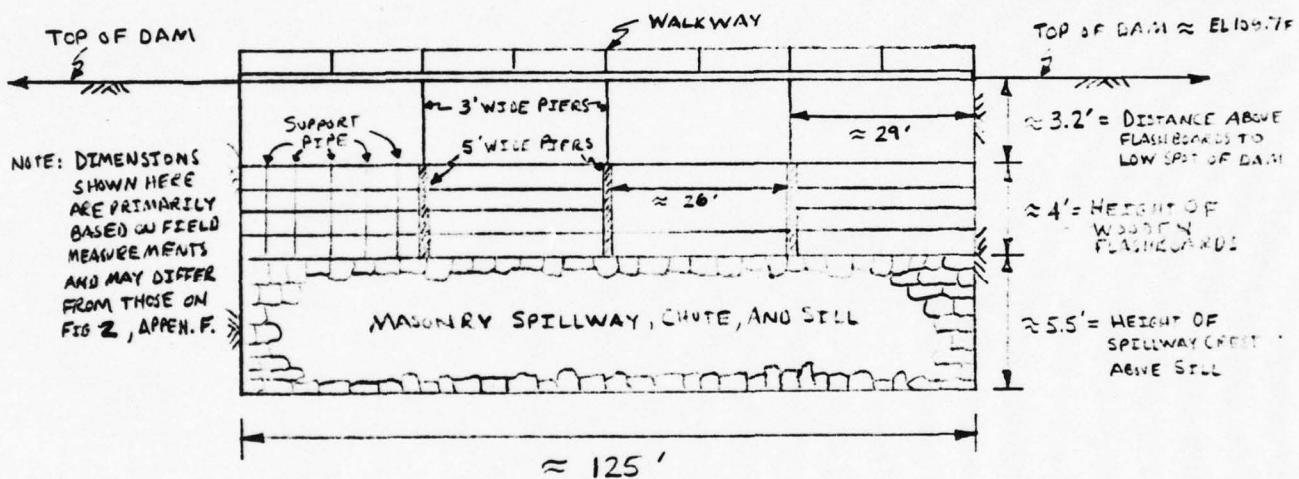
- NORMAL OPERATION IS TO HAVE THE 4 FT HIGH FLASHBOARDS IN PLACE. HOWEVER, FLASHBOARDS ARE DESIGNED TO FAIL, AND THOSE IN THE FAR LEFT AND FAR RIGHT BAYS HAD FAILED PRIOR TO INSPECTION. ACCORDING TO INFORMATION IN THE PENN DER FILES, THE ORIGINAL DESIGN OF THE FLASHBOARDS CALLED FOR FAILURE HEIGHTS OF BETWEEN 2 AND 3 FT ABOVE THE TOPS OF THE FLASHBOARDS. THEREFORE, ASSUMING THAT THE SUPPORT PIPES ARE RELATIVELY NEW (ALTHOUGH AT THE TIME OF INSPECTION THE REMAINING PIPES APPEARED TO BE IN POOR SHAPE), THE FAILURE HEIGHT FOR EACH SET OF FLASHBOARDS WILL BE TAKEN TO BE 2 FT ABOVE THE TOPS OF THE FLASHBOARDS. THUS, THE FLASHBOARDS WILL HAVE FAILED PRIOR TO OVERTOPPING OF THE DAM, AND THE CAPACITY OF THE SPILLWAY IS DEPENDENT ONLY

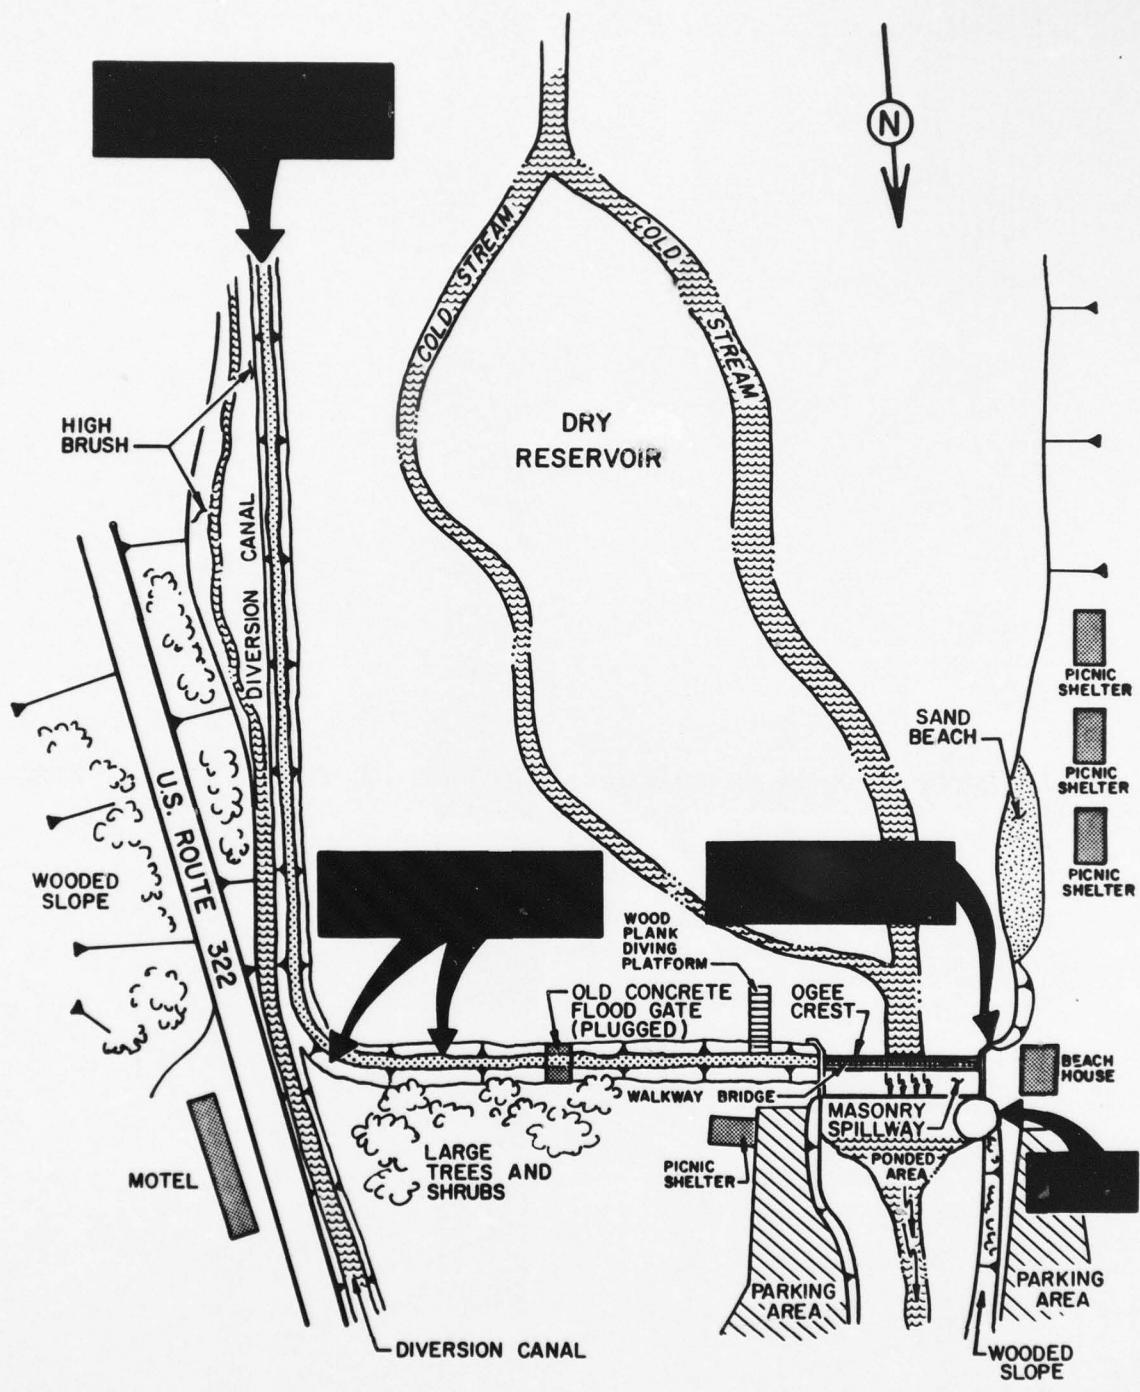
FIGURE 1 - RECREATION DAM  
GENERAL PLAN  
FIELD INSPECTION NOTES

Notes: 1 - Same as  
2 - Ditch dry  
3 - Not dry
