**LEVEL**  
DELAWARE RIVER BASIN  
WRIGHT CREEK, LUZERNE COUNTY

**PENN LAKE DAM**

NDI-PA 00542  
PA DER 40-28

ADA070835  
**PHASE I INSPECTION REPORT**  
**NATIONAL DAM INSPECTION PROGRAM**

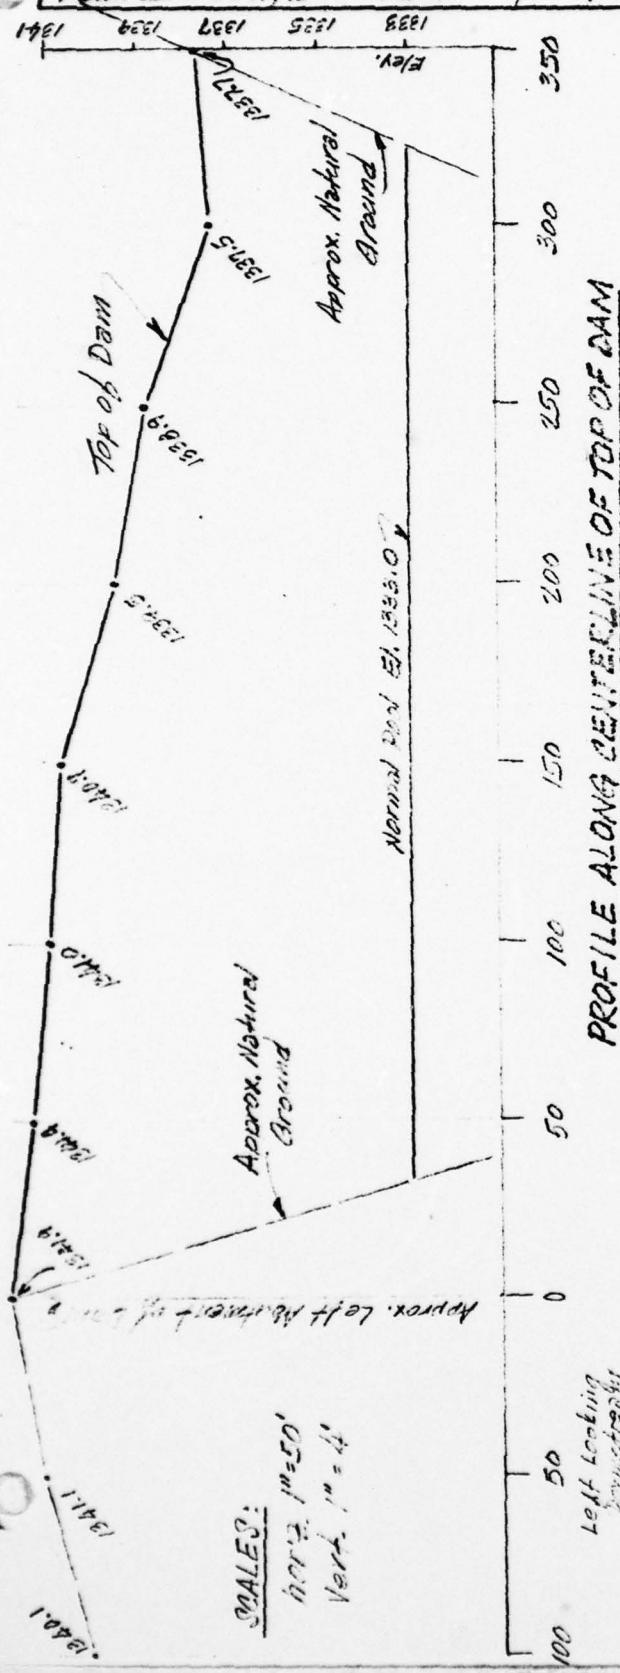
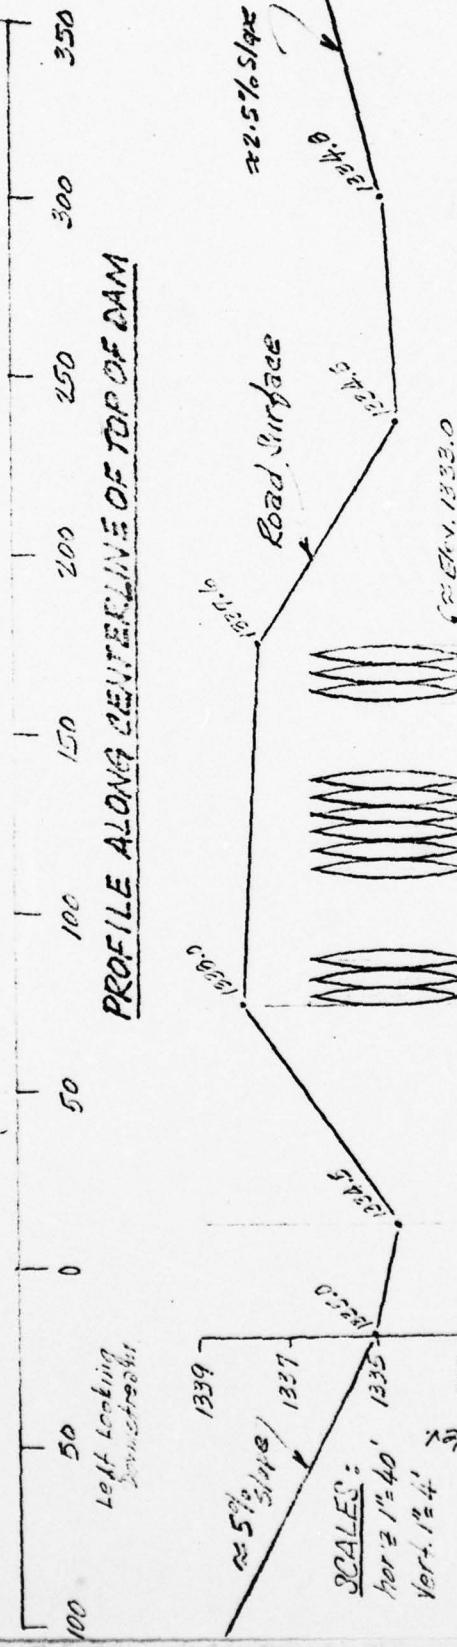
Penn Lake Dam, Plan View of Dam

Based on visual observations made during the date of the inspection, the dam is considered to be in poor condition. There are seeps and rust colored water along the toe of the downstream embankment slope. The entire region immediately downstream of the dam is swampy. Bulges, depressions and embankment sloughing are evident on the downstream slope of the embankment. There are cut brush, stumps, and debris over the entire downstream slope. The upstream slope of the embankment is covered with heavy brush and there is a depression (Plate 4, Appendix E) near the left abutment. The riprap protection on the upstream and downstream slopes of the embankment is poorly graded and sparse in many areas.

4. The area at the downstream end of the reservoir drain system should be cleared of silt and debris. The drain system should then be appraised and repaired as needed. A means of positive closure at the upstream end of the reservoir drain system should be developed.
