TROUT LAKE DAM

NDI - PA 00769
PA DER 45 - 43

PHASE I INSPECTION REPORT
NATIONAL DAM INSPECTION PROGRAM

Name of Dam: Trout Lake Dam
County and State: Monroe County, Pennsylvania
Inventory Number: PA 00769

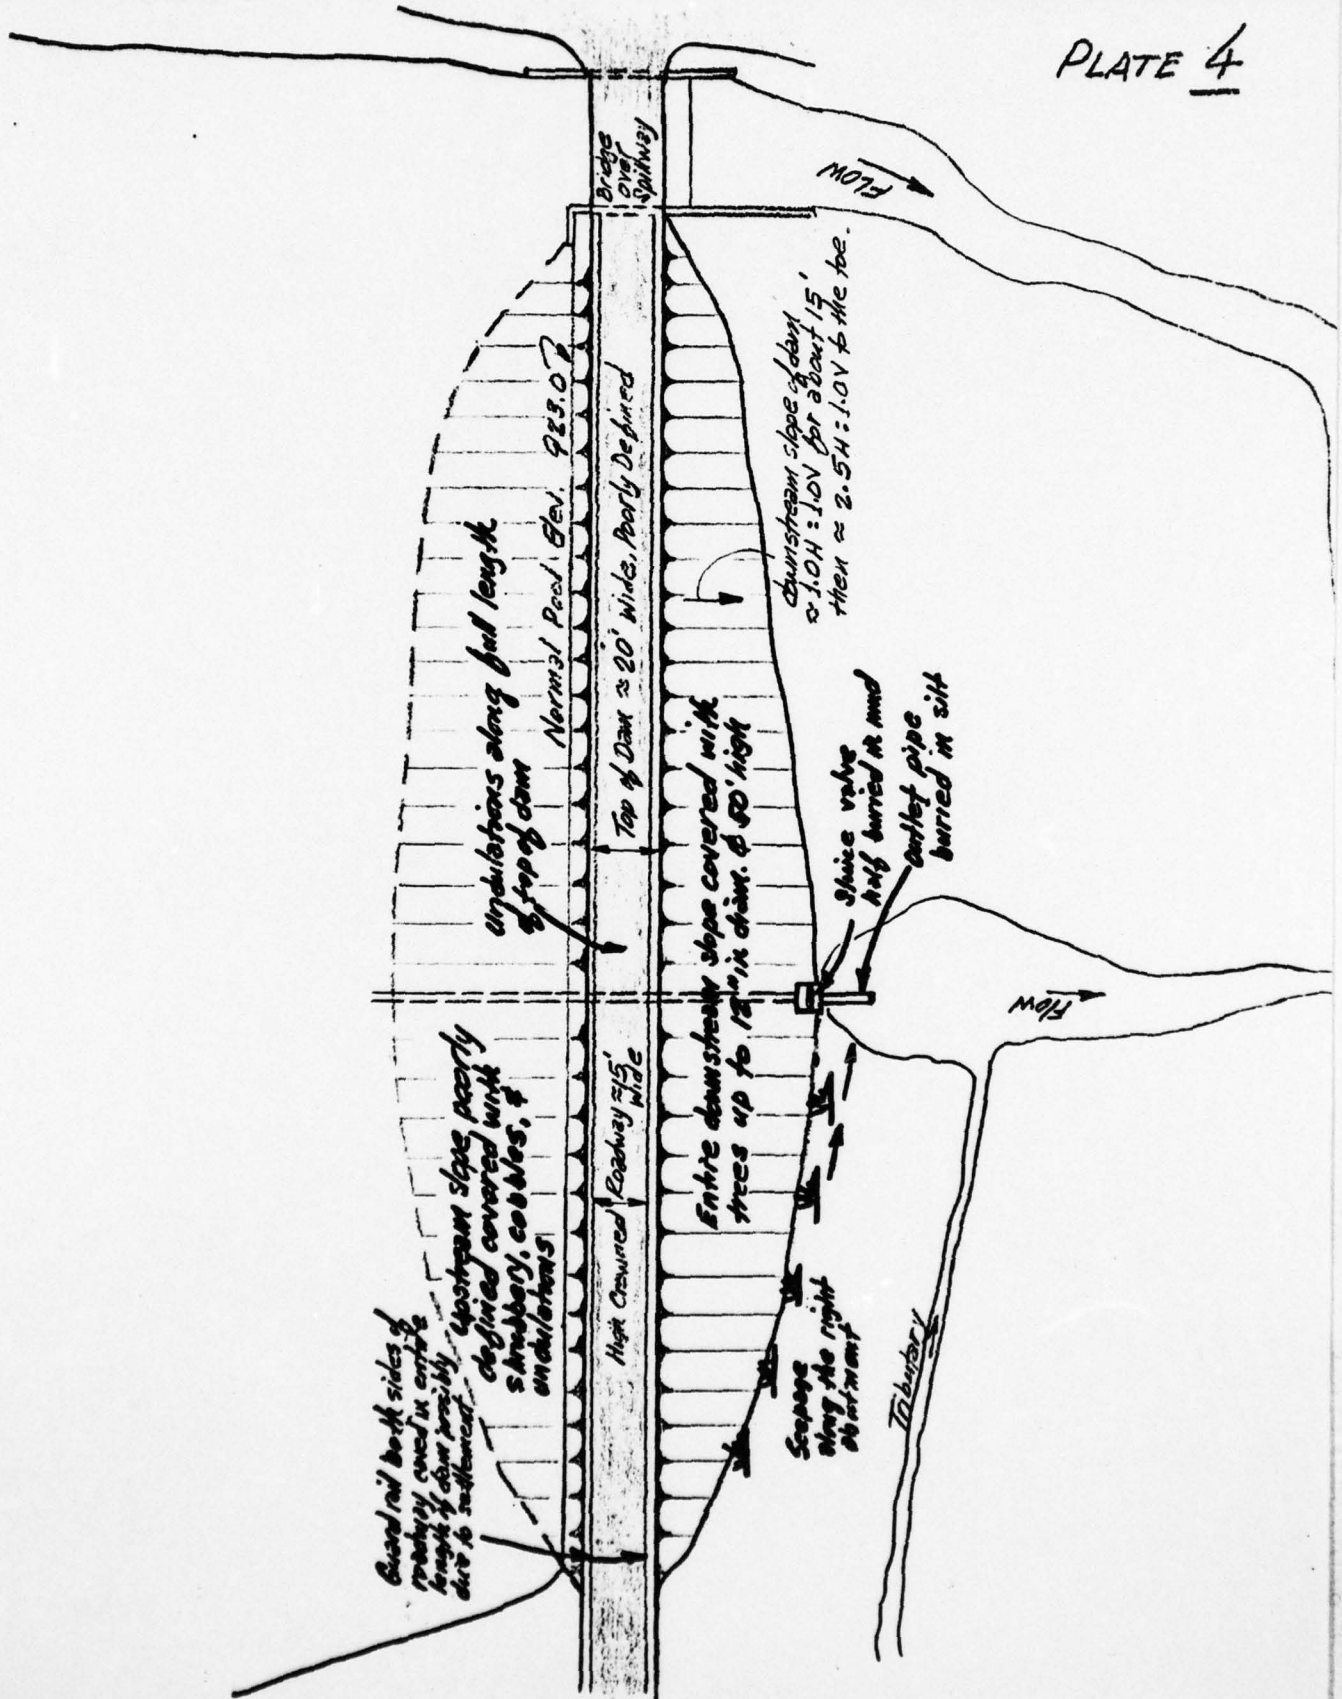
PLATE 4

3. The depressions along the upstream face, the seepage and discolored water at the toe of the earth embankment, and undulations of all of the embankment surfaces may be indicative of the migration of fine material through the embankment or foundation. A subsurface investigation should be initiated at several sections of the dam to include, but not be limited to, soil borings for determination of the composition and in situ properties of the embankment and foundation materials. The investigation should be supervised by a licensed professional engineer with experience in the design and construction of dams. Results of the investigation should be used to establish if the materials are satisfactory for the embankment as designed and constructed; and to detect possible fines migration.

6. The upstream face is not provided with slope protection. Slope protection should be provided to prevent damage from wave action.
7. Portions of the top of the embankment were found to be below design elevation. Areas below design elevation should have additional fill placed and compacted to regrade the embankment to design elevation.

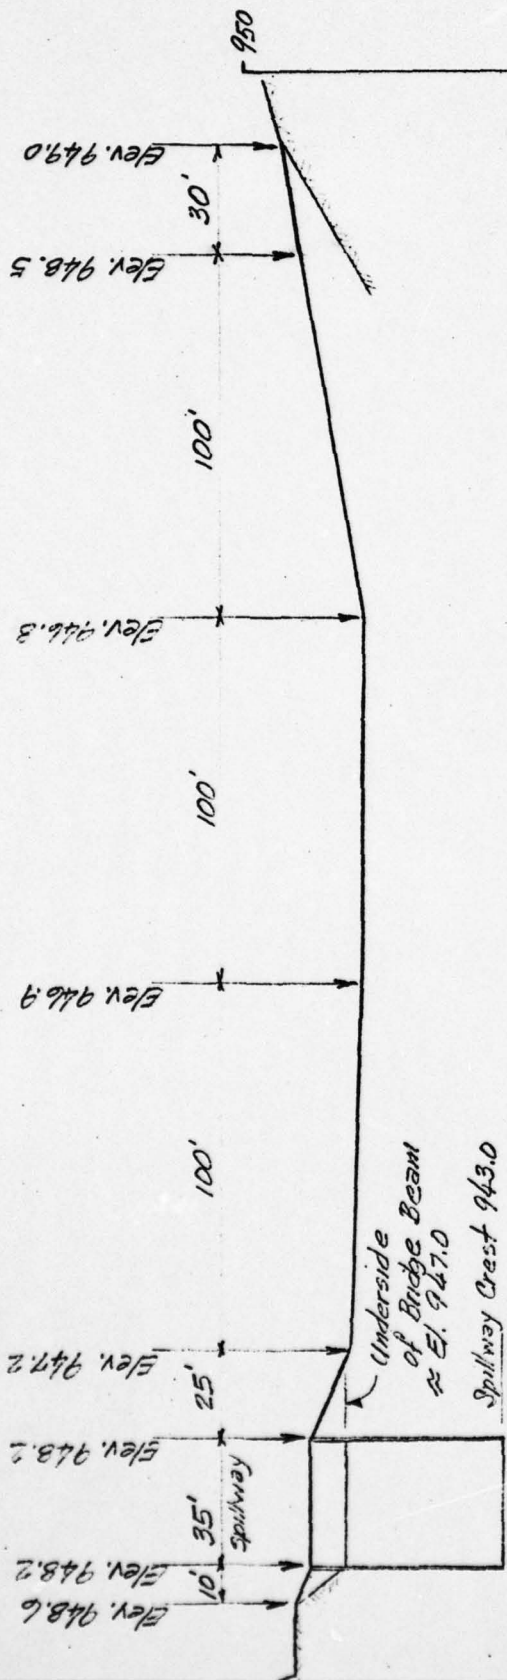
PLATE 5

The field survey of the top of the dam (Plate 5, Appendix E) revealed that the underside of the bridge is above the low spot on the top of the dam. A masonry wall is constructed along the right bank of the spillway discharge channel. The wall extends about 50 feet downstream of the spillway and directs flow in the discharge channel away from the downstream slope.
