National Dam Inspection Program, Colyer  
Lake Dam (NDS ID Number PA-00448,  
PENNDER ID Number 14-112), Susquehanna  
River Basin, Sinking Creek, Centre  
County, Pennsylvania.

Phase I Inspection Report.

COLYER LAKE DAM  
NDS I.D. No. PA-00448  
PENNDER I.D. No. 14-112

PHASE I INSPECTION REPORT  
NATIONAL DAM INSPECTION PROGRAM

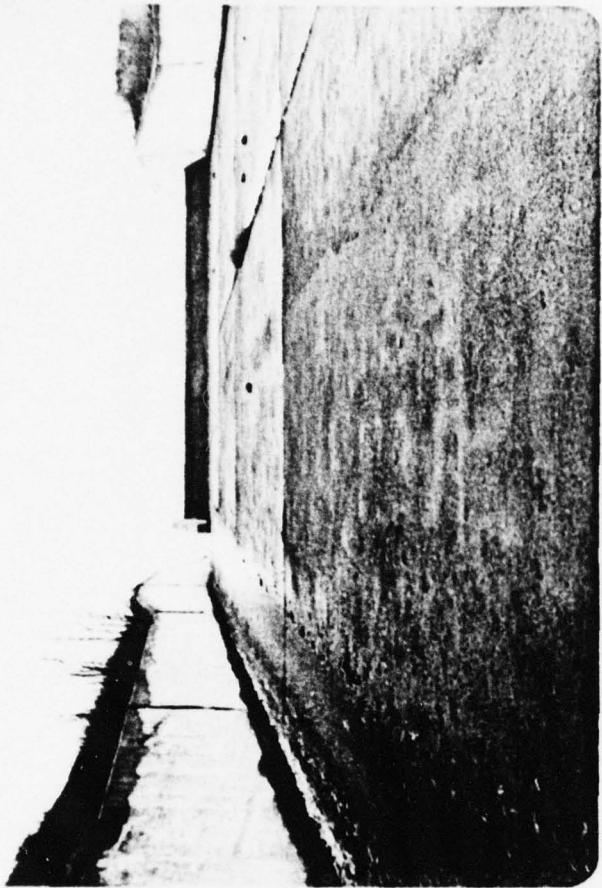
6

The dam is provided with an ungated concrete rectangular spillway and plunge pool located on the right abutment. The spillway consists of a 69-foot wide trapezoidal weir section aside a 10-foot wide rectangular flume section (inside dimensions), separated by a concrete wall (see Figure 10 and Photograph 6). The outlet works consist of a 4-foot square reinforced concrete outlet connected to a rectangular vertical riser. Discharge through the outlet is controlled by stop logs that are set in grooves within the riser.

The spillway is a rectangular concrete chute with a 69-foot wide trapezoidal weir section and a 10-foot wide rectangular flume section (see Figure 10 and Photograph 6) which accepts flow from the by-pass canal. The right retaining wall of the trapezoidal weir section (left wall of flume section) will act as a side channel spillway during flood flows and will discharge flow into the rectangular flume. Ungated discharge from the spillway empties into a stilling basin before entering the original streambed downstream of the dam.

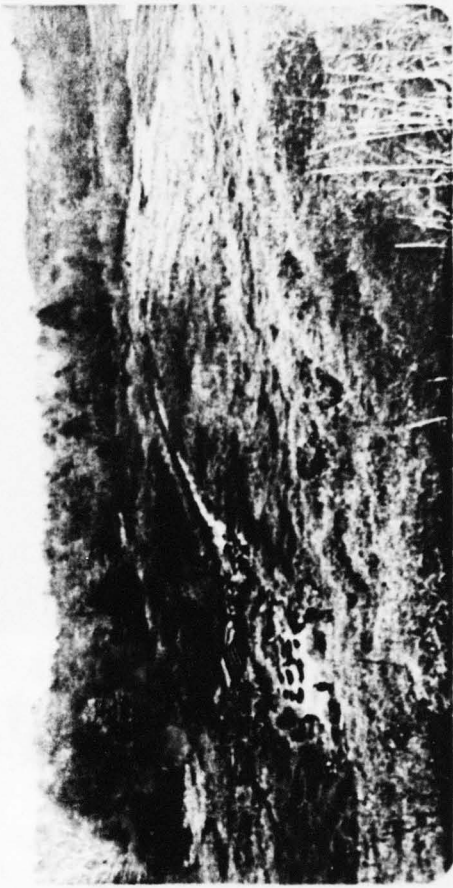
4. Downstream Area. Discharge from Colyer Lake flows through the broad floodplain of Sinking Creek (see Photograph 8) which is surrounded by gently rolling hills used primarily for agriculture. At a point approximately 2,500 feet downstream of the dam, Sinking Creek passes beneath a bridge on a secondary road in the community of Colyer. A home (see Photograph 10) and a church are located in this area with first floor levels less than 10 feet above the stream bottom.

PHOTOGRAPH 8 View looking downstream from the crest of the dam.

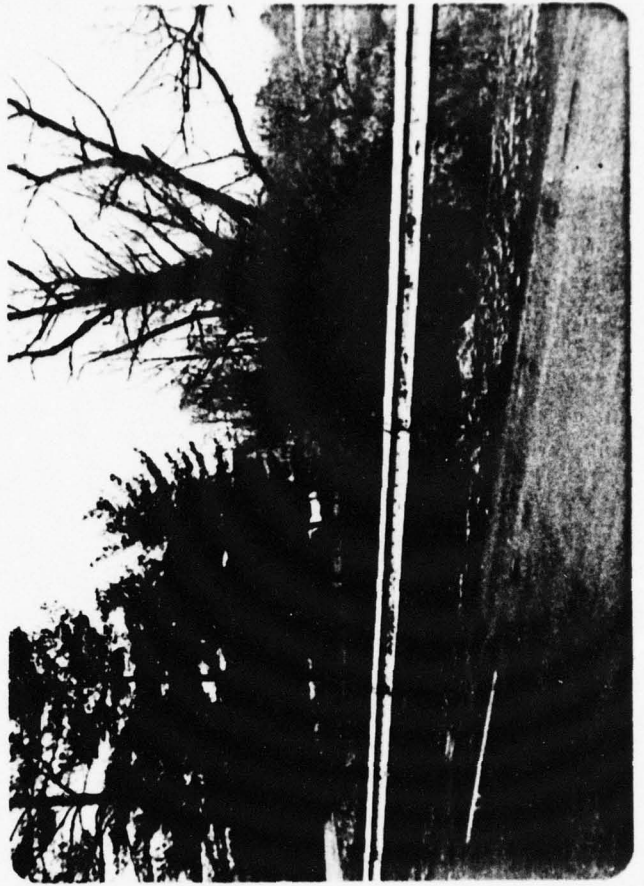
PHOTOGRAPH 10

View of a bridge over Sinking Creek located approximately 2,500 feet downstream of the dam. The bridge represents the first downstream obstruction. Note the home in the left center portion of the photograph.

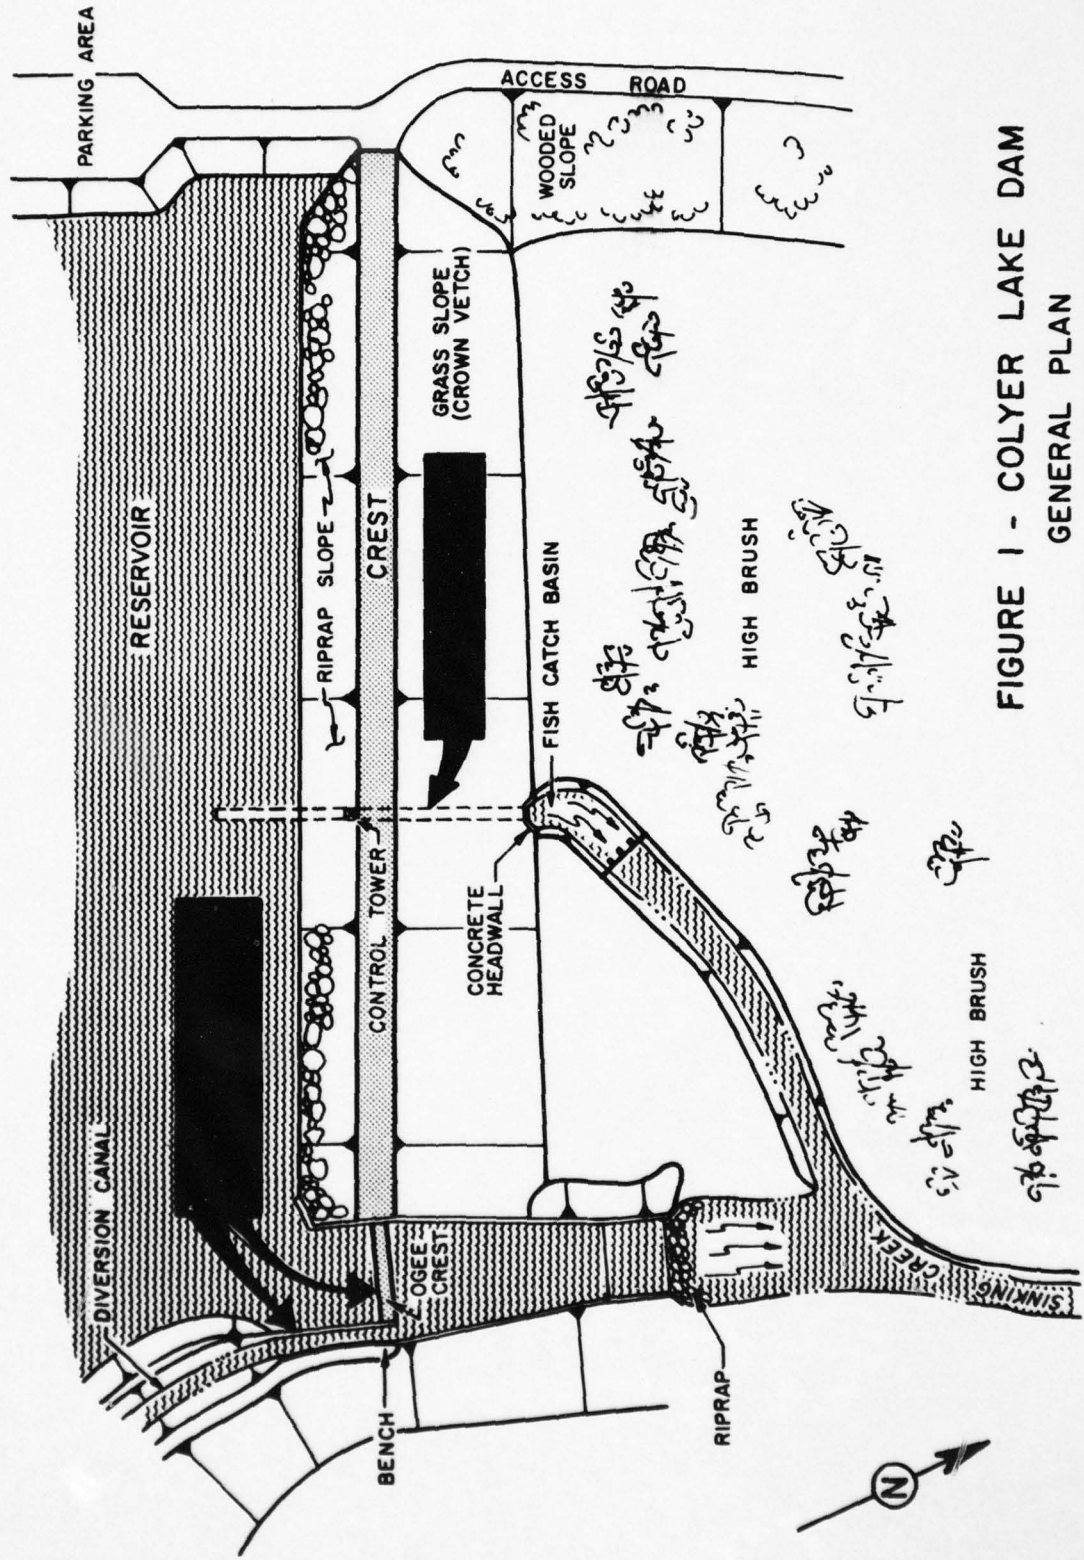
FIGURE 1 - COLYER LAKE DAM  
 GENERAL PLAN  
 FIELD INSPECTION NOTES

a. Dam and Appurtenances. Colyer Lake Dam is a zoned earth embankment approximately 38 feet high and 700 feet long. Including the spillway system, the length of the facility is approximately 780 feet. (see Figure 1).

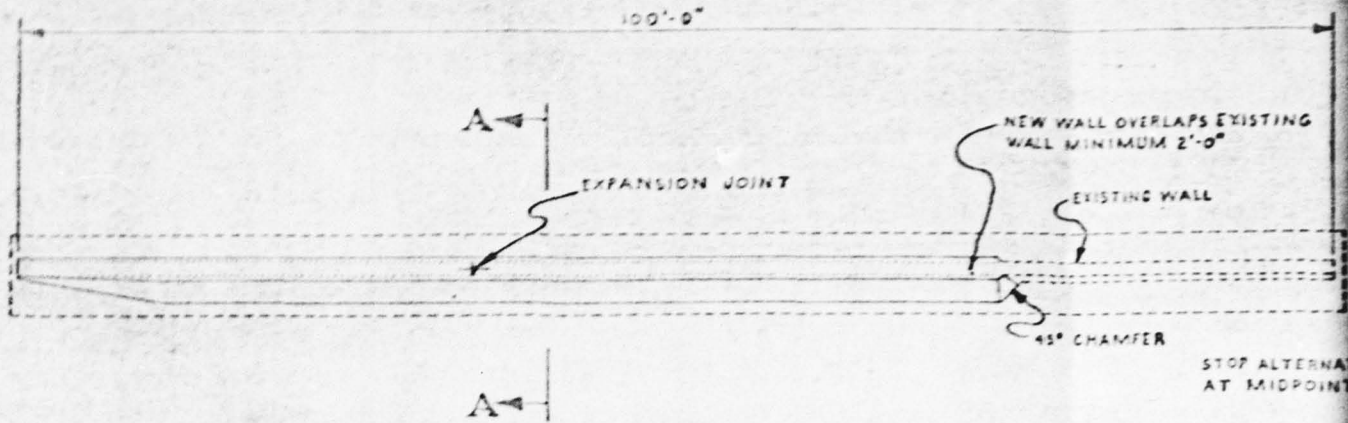
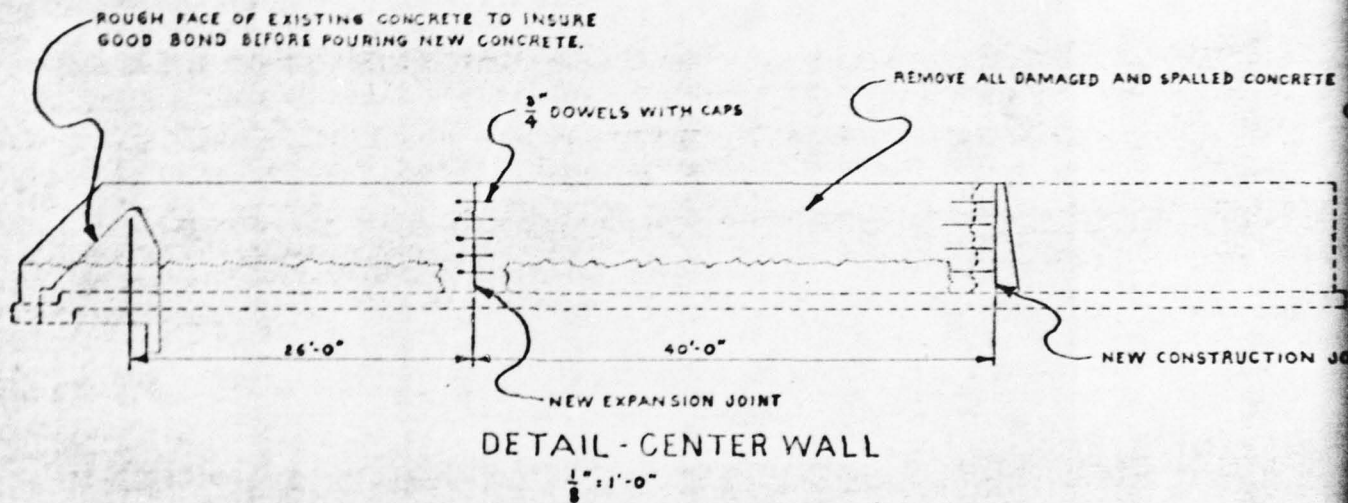
At the time of inspection, the Pennsylvania Fish commission was drawing down the reservoir so as to drain the forebay of the spillway. This is done every winter to reduce ice pressures on the wall separating the trapezoidal weir section and flume section of the spillway. The wall was replaced in 1968 following ice damage (see Figure 11).

ALL DOWELS AND ROBS WERE GROUTED WITH "POR-ROK" A FAST SETTING CEMENT AS MANUFACTURED BY HALLEMITE MANUFACTURING CO. BEFORE NEW CONCRETE WALL WAS POURED.
