FATE OF OIL SPILLED FROM THE
SUPERTANKER METULA

ROY W. HANN, JR.
HARRY N. YOUNG, JR

JANUARY 1979

FINAL REPORT

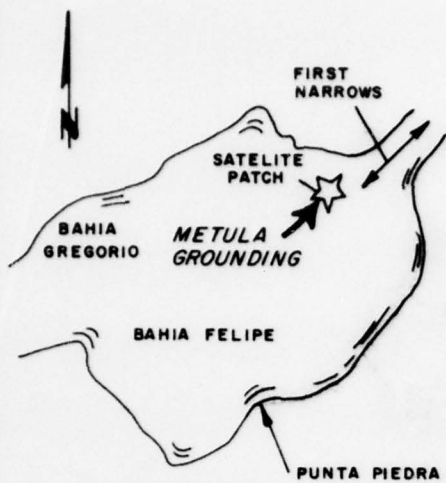
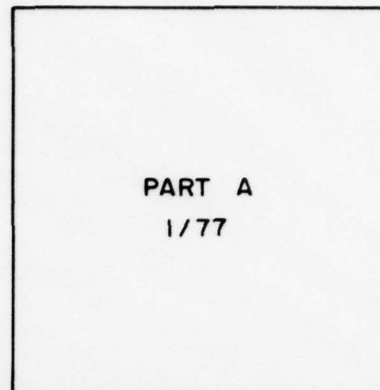
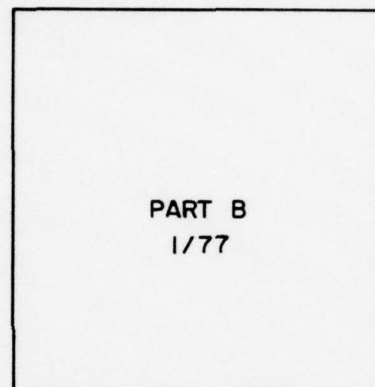
FIGURE 6

- A - View of kelp in Satelite Patch at west end of First Narrows looking east.
- B - Close-up aerial photograph of kelp bed showing flow lines of surface currents at acute angle to channel.

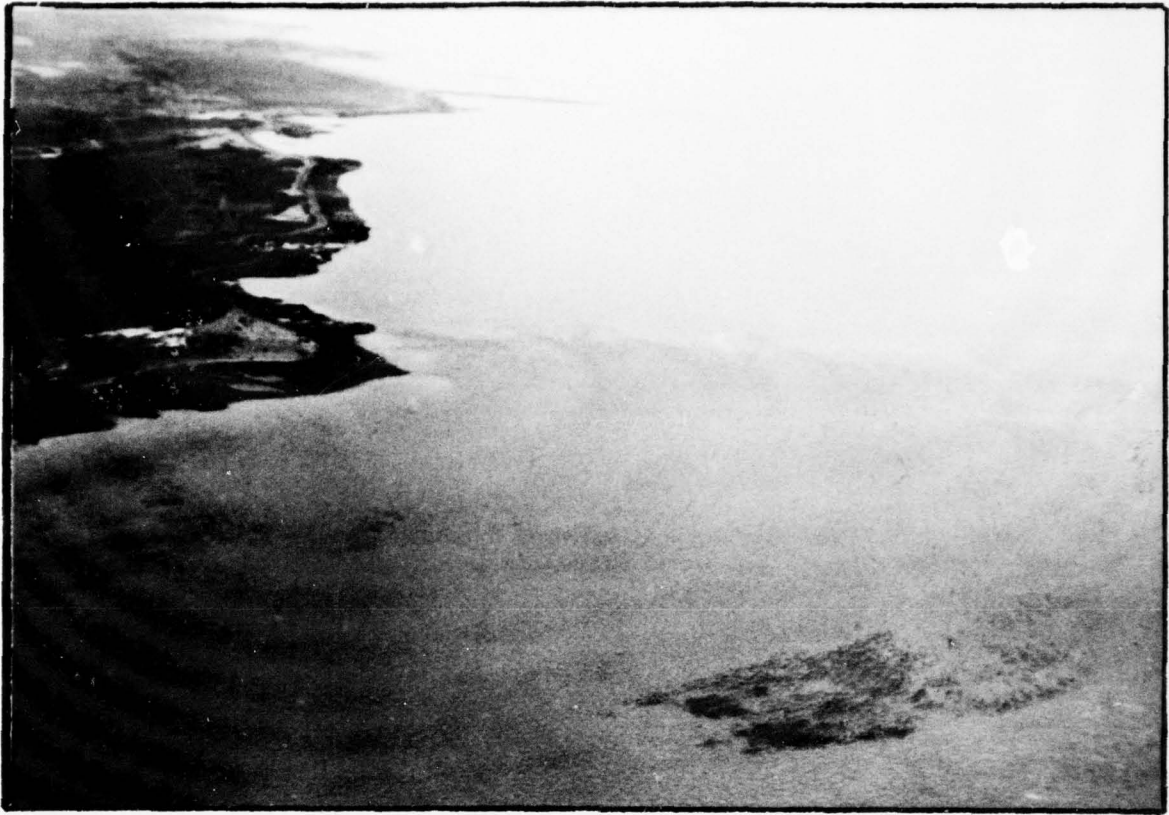
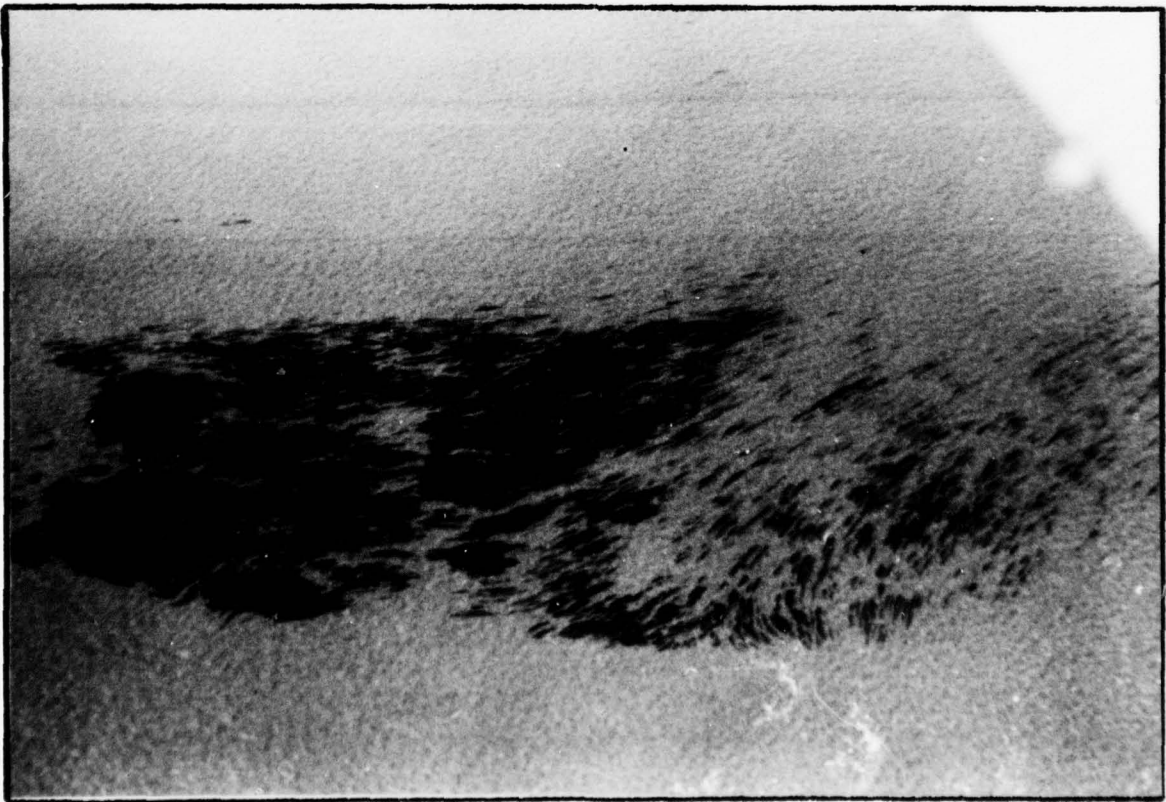
FIGURE 7

pattern to the side of the channel toward the northeast. A theory is that this current acted on the broad side of the ship when it wandered toward the side of the channel and helped push the ship into the side of the shoal. The ship is reported to have struck bottom at nearly her full speed of 14.5 knots, coming to a stop in about 260 feet -- with an action described as "like a shock wave." In the initial impact several forward compartments were breached, including the forepeak, forward deeptanks (containing Bunker C), forward ballast tank, and cargo tanks #1 center and starboard. About 6,000 tons of oil was initially released.

- A - Grounded tanker METULA on Satellite Patch with south shore of South American Continent in the background.
- B - Grounded tanker METULA with lighting tanker HARVELLA alongside. Oil is shown spreading over the water surface.

On August 29, the small Argentinean tanker HARVELLA of 19,000 deadweight tons was brought alongside and the initial pumping of oil from the METULA was carried out as part of the attempt to minimize pollution and to remove sufficient oil to float the ship. In Figure 7 Part B, the tanker HARVELLA is shown alongside the METULA unloading the cargo.

evident in both Bay Felipe and Bay East of the Narrows. The surface slicks, however, were much more evident on the flight on September 5 than they were on the initial flight over on August 28. Views of the surface slicks are evident in Figure 7 Parts A and B.

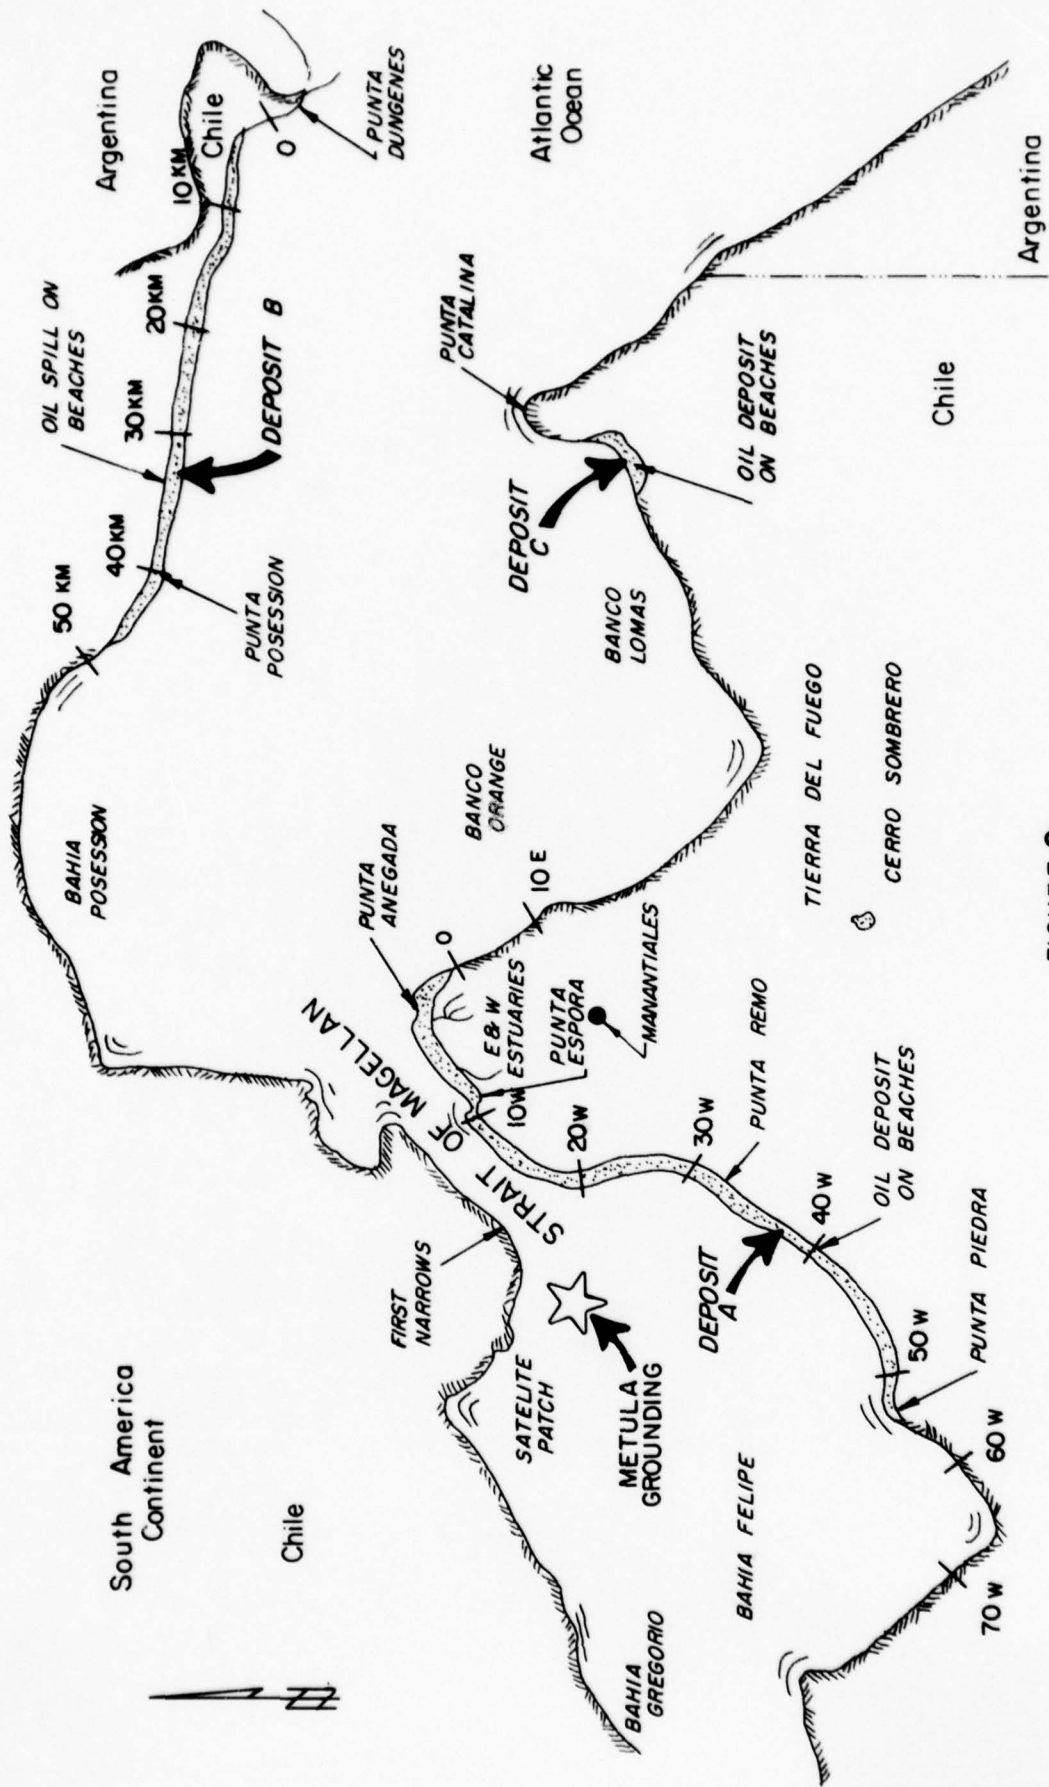
This part of the Strait of Magellan is noted for its exceptional high winds, predominantly from the west, and these winds tended to rapidly drive the oil ashore. Based on an average of 30 knot westerly winds experienced in the area, the oil could expect to travel on the surface at a speed of approximately one knot to impact the shore of Tierra del Fuego within 3 to 4 hours. There it would strand on the shore or be slowly moved along the coastline to the northeast or southwest depending on the wind direction at the time of impact. The winds during August were such that most of the oil that did not volatilize or dissolve into the water column was driven onto the north shore of the Island of Tierra del Fuego as shown as Deposit A in Figure 9. This initial deposition covered between 40 and 50 miles of coastline.

FIGURE 9
 SITE OF GROUNDING AND IMPACTED BEACHES
 (AUGUST- SEPT., 1974)

labeled Deposit B on Figure 9.

During the trip across the channel on September 2 and during the flight on September 4, large patches of darker oil appearing to be spreading faster than the chocolate mousse were observed on the water on the Narrows and to the east of the Narrows. It was later learned that an additional Bunker C tank had been ruptured prior to this period. When the wind shifted from the southwest to the northwest on September 3, some of the darker, fresher oil was swept to the south shore of Bahia Posession of the Narrows and pooled just south of the Point Catalina. This deposit, shown as Deposit C on Figure 9, later proved to be less significant.

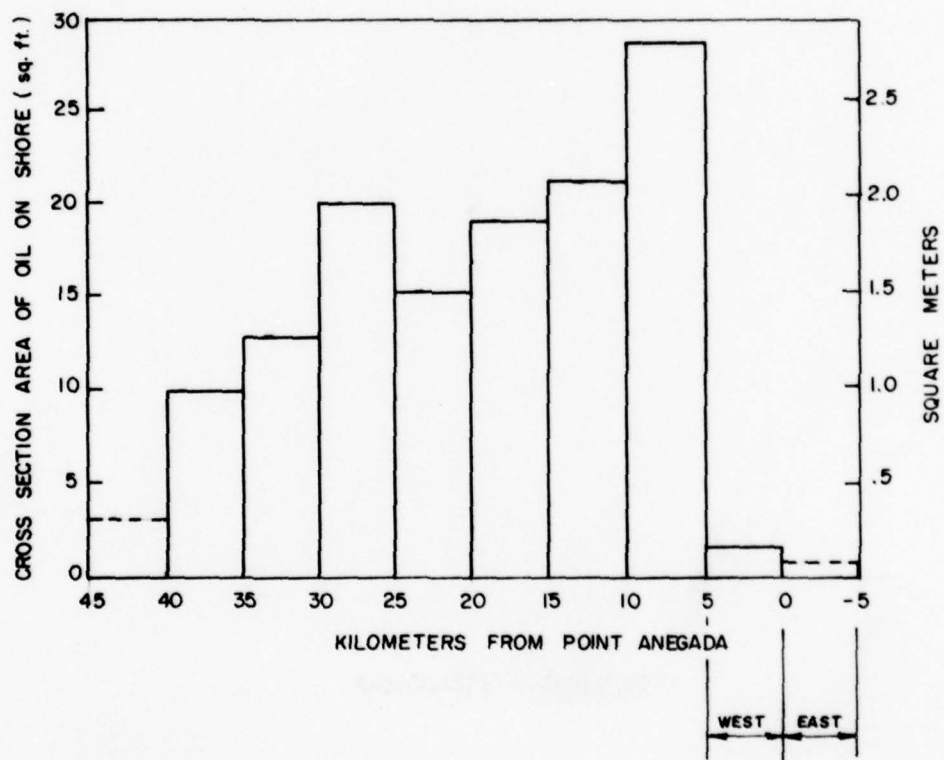
During the field operation in late August and early September, some 25 miles of this beach was walked by teams of the field party and estimates were made of the amount of mousse on the beach. The beach deposits were generally described as being between 15 to 60 meters (50 and 200 ft) wide with a depth of from 2.5 to 10 centimeters (1 to 4 in).

The location in different sectors is shown in Figure 10. Based on these crude estimates some 60,000 cubic meters of mousse was on the coastline at that time. Laboratory analysis of two collected samples led to the belief that the average water concentration of the mousse was 30 percent. This figure is lower than experienced on some later spills which show water

FIGURE 10
ESTIMATE OF OIL ON SHORE
 Aug. 31, 1974 - Sept. 1, 1974

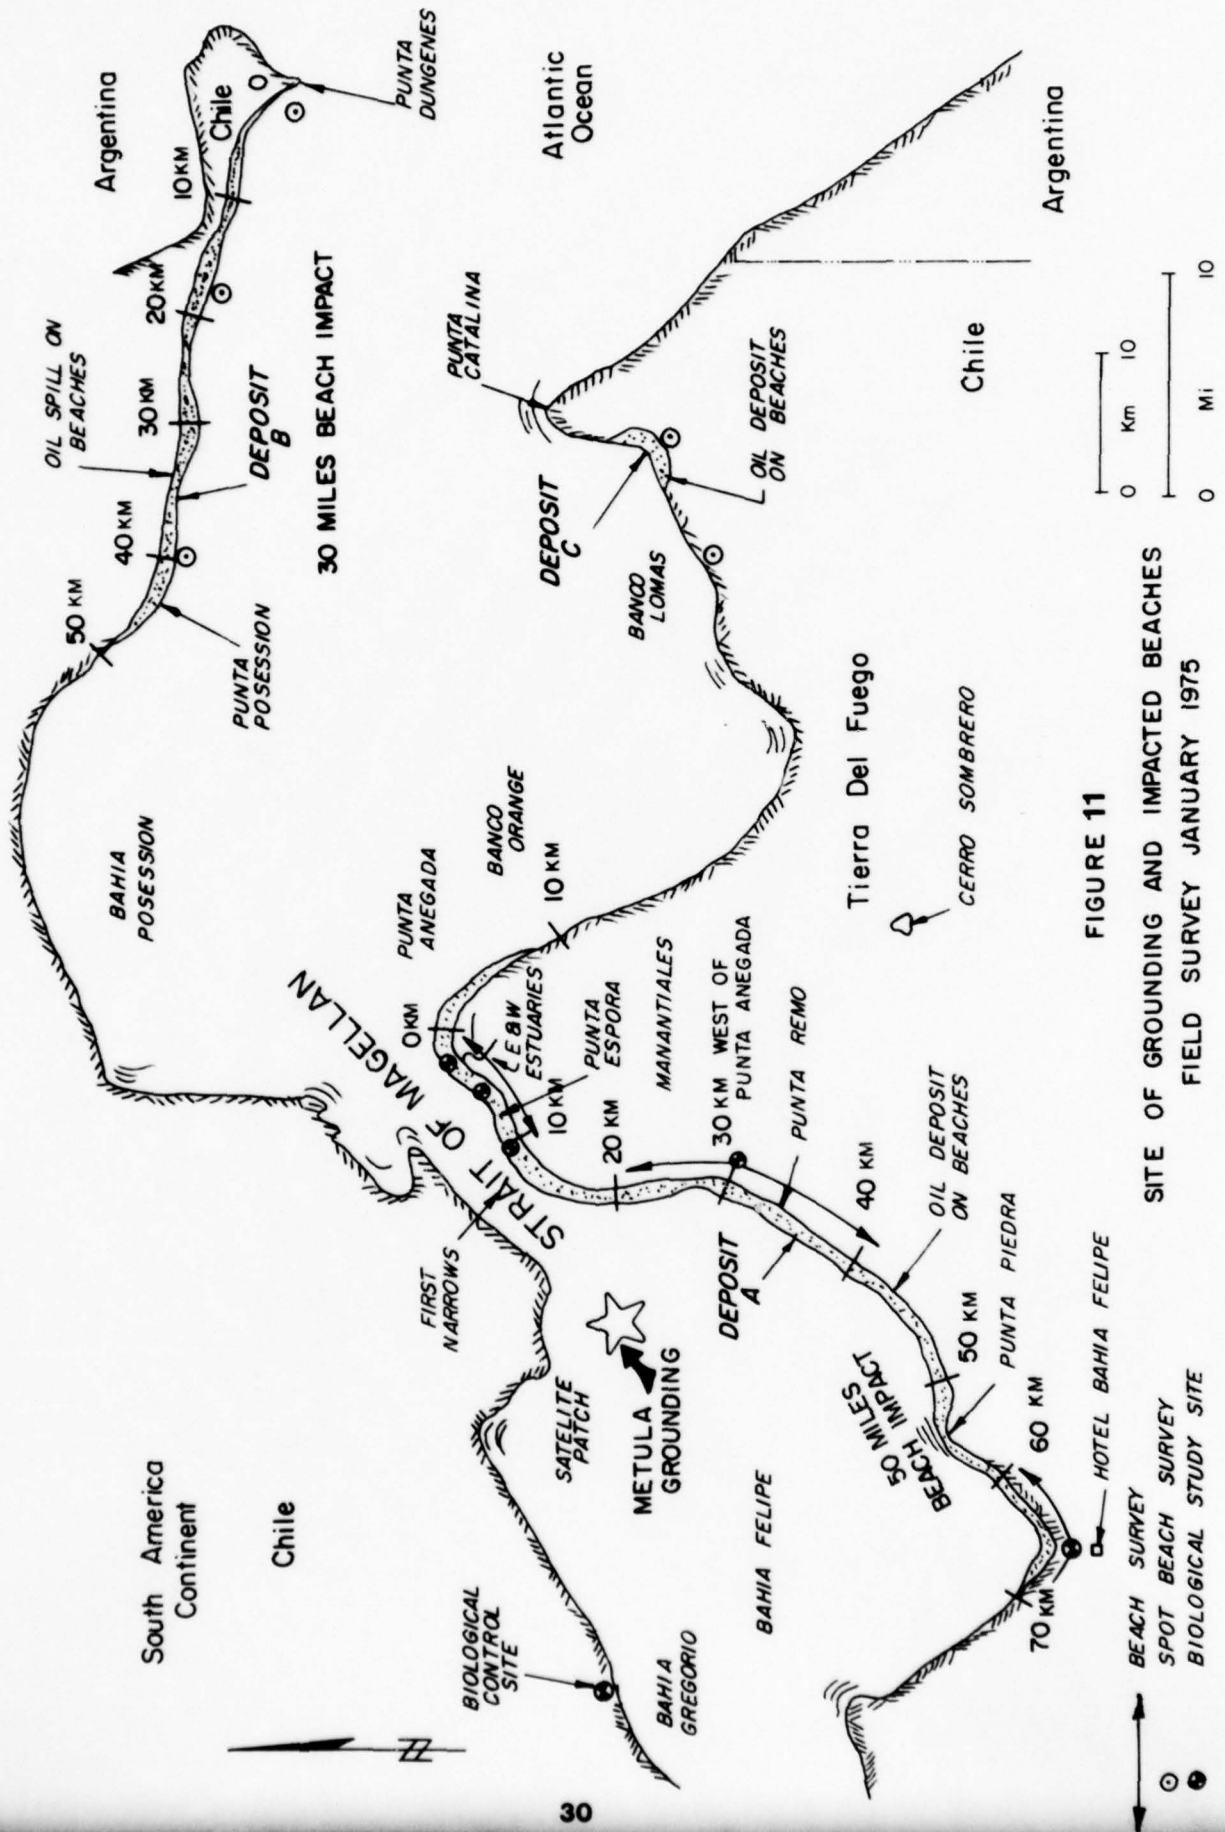
During the following weeks, the mousse continued to spread, be stabilized on the beaches or to be transported to sea. During the following trip in January of 1975, the mousse was observed at more westerly locations on the shore of Bahia Felipe but was generally stabilized in the same areas as observed before. The locations of the deposits in January of 1975 are shown in Figure 11.

FIGURE 11
 SITE OF GROUNDING AND IMPACTED BEACHES
 FIELD SURVEY JANUARY 1975

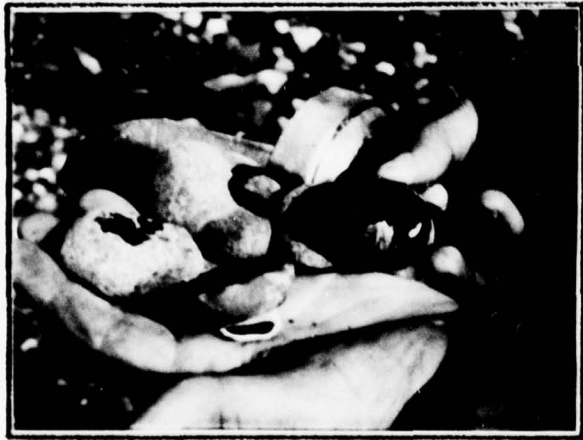
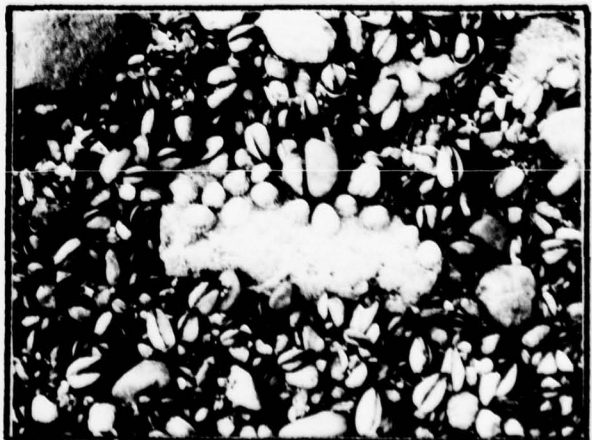
FIGURE 12

Figure 12 Parts A and D show the general area and Parts C and E show closeup of the marine community on, around and under the cobbles. The only oil found in this area has been a tar residue on occasional rocks found at the upper intertidal zone. A handful of rocks gathered over a half-hour period is shown in Figure 12 Part B.

- A - Typical view of uncontaminated beach showing steep sand beach, stranded detritus and near top of beach and cobble area in lower Intertidal Zone.
- B - Tarred rocks found on Gregorio Beach.
- C - Crustacea living under cobbles in lower Intertidal Zone.
- D - Lower Intertidal community with cobbles, algae and marine life.
- E - Close-up of limpets and mussels in lower Intertidal Zone.

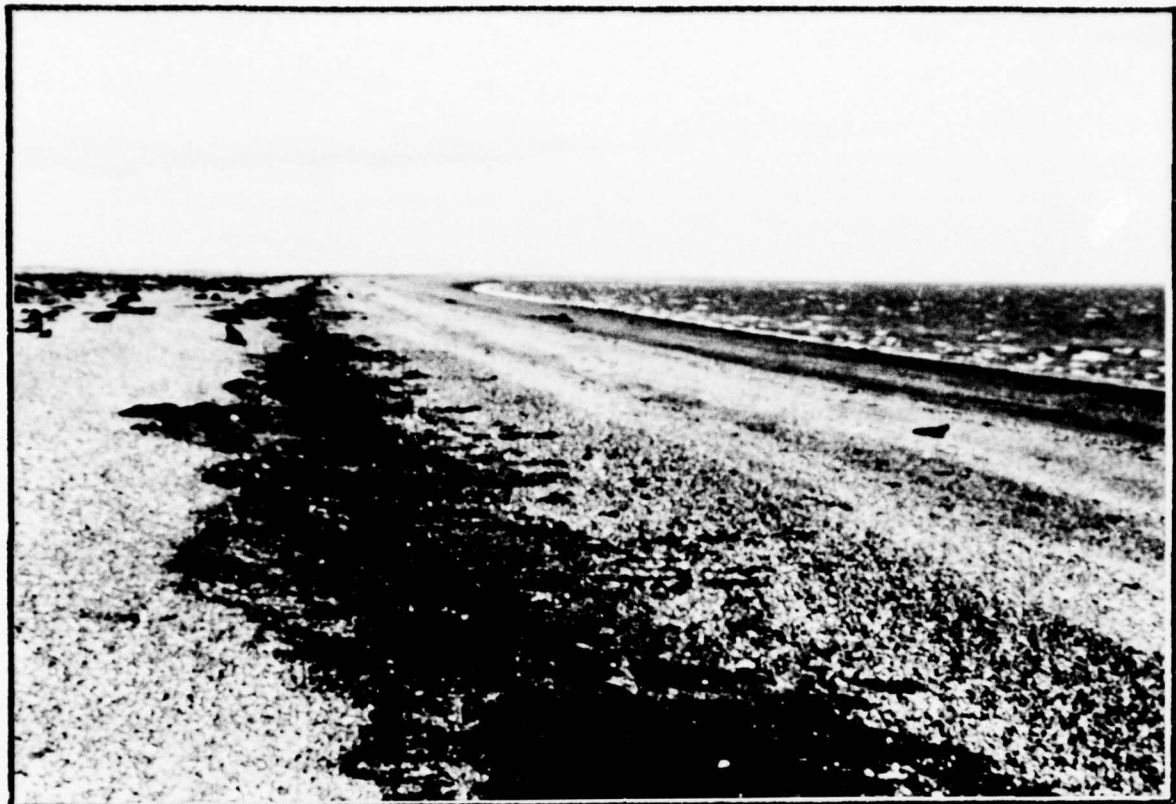
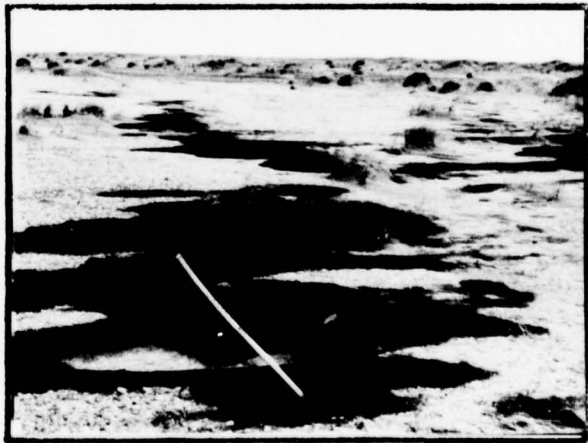
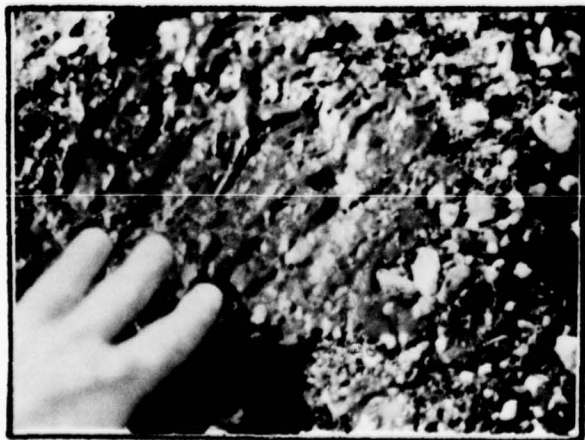
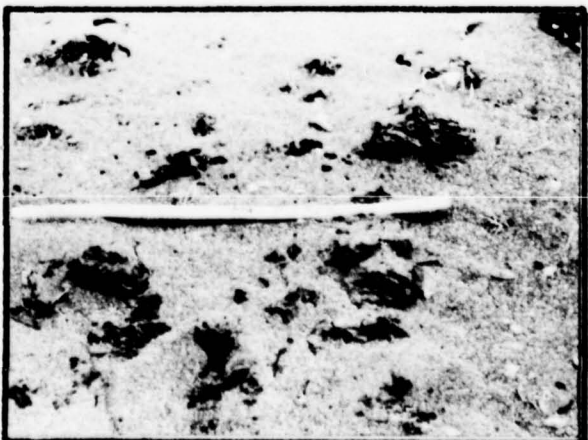
FIGURE 13

Figure 13 shows a series of photographs for this area. Part A and Part B show the deposit at the beach top in January of 1975 and Part C shows the still soft mousse appearance of the deposit at that time. Parts D and E show the same zone two years later. In one case a stretch is shown which has been little changed in coverage whereas in the other only small patches of the oiled crust remain.

- A - Deposition of oil at top of beach near Hotel Bahia Felipe.
- B - Closeup of deposit at top of beach.
- C - Closeup of disturbed surface showing soft mousse which has not yet penetrated into the sand.
- D - Similar area near Punta Piedra two years later.
- E - Area two years later where crust has been eroding away.

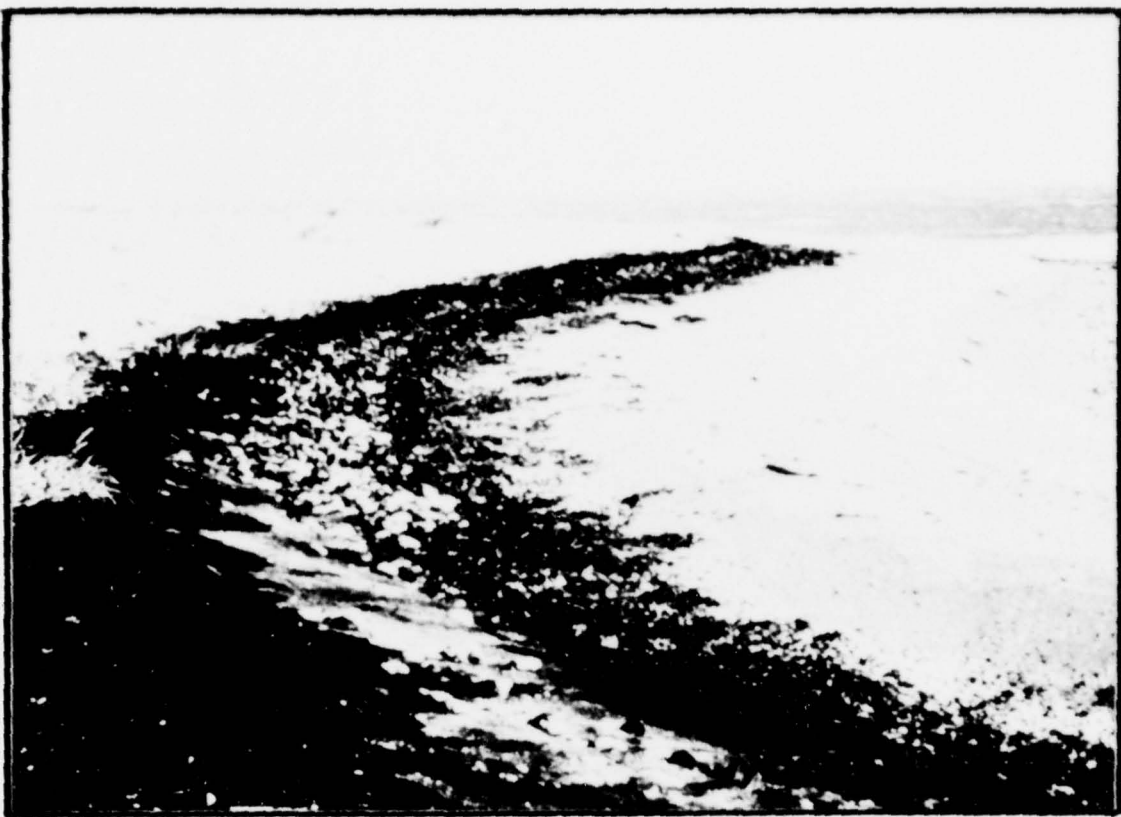
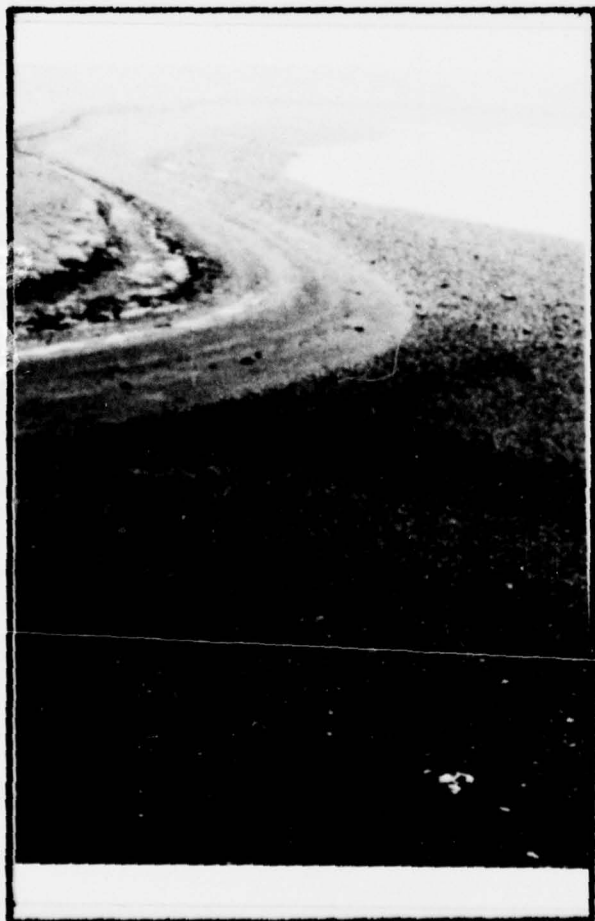
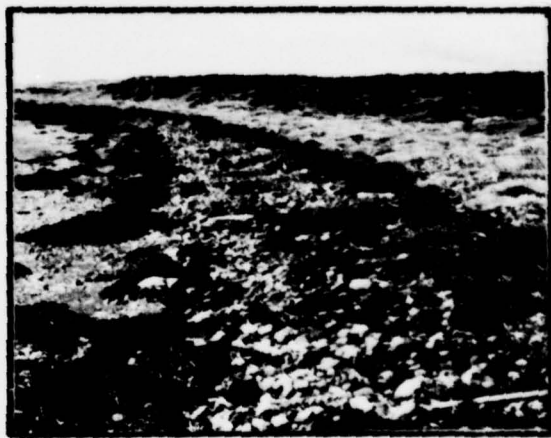
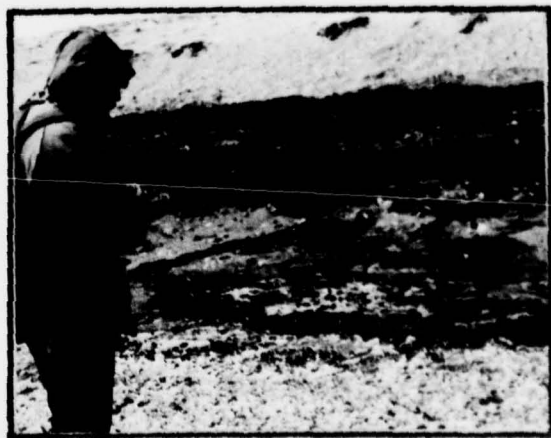
FIGURE 14

On Figure 14 Part A this latter stretch of beach is shown as it appeared in January of 1975. Part B shows an aerial shot of Punta Remo taken in January of 1975. The oiled stretch at the top of the beach and the large cobbled intertidal zone are evident. Part D shows a closeup of the stranded mousse in 1975. Mousse that has been warmed by the sun may be observed oozing down the beach face. Part C of Figure 14 shows the beach top area in 1978. The zone of coverage remains the same. The texture of the oil has changed in that most of the oiled layer now consists of oiled sand rather than mousse. There are, however, some areas where

- A - Oil stranded at the top of the beach in the Punta Remo area.
- B - Aerial photograph showing oiled beach top, sloping beach and wide cobbled zone exposed at low spring tides.
- C - Close-up of oiled beach top near Punta Remo.
- D - Oil leaching from beach top deposits under the heating effect of the summer sun.

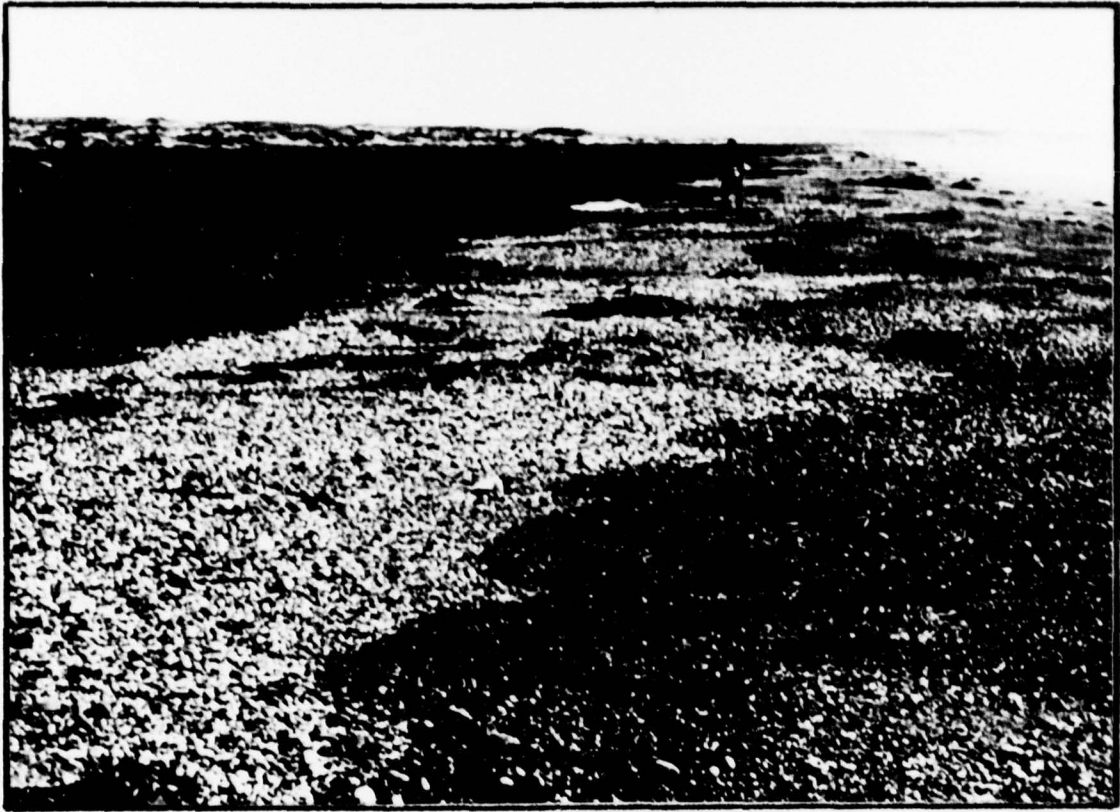
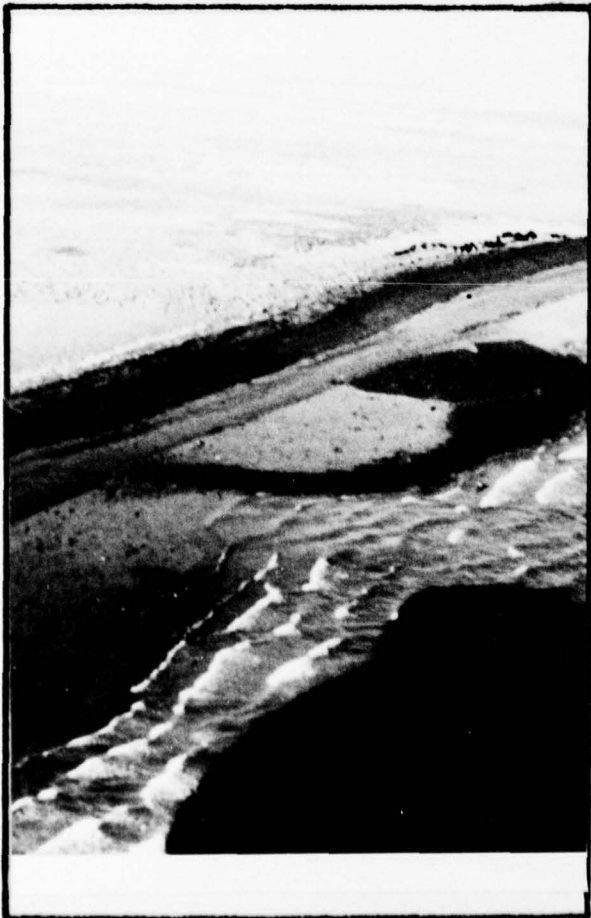
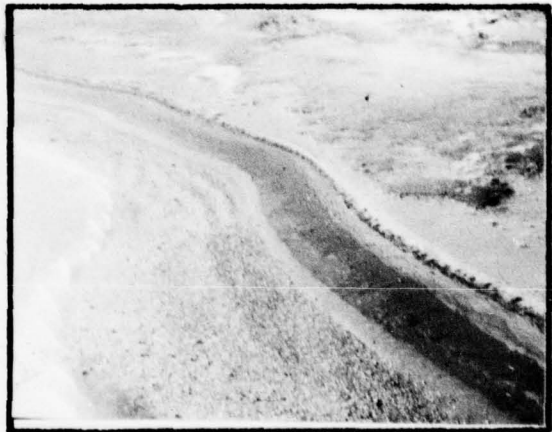
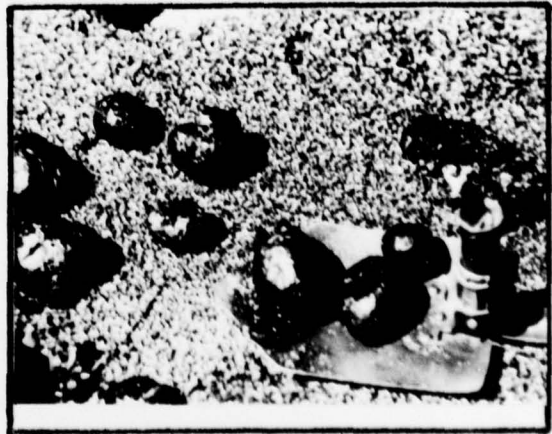
FIGURE 15

The Southeast Arc area of the beach served as the center of a large natural boom to collect the oil driven by the wind across Bahia Felipe. At the time of the spill in August of 1974 the oiled zone on this beach was over 30 meters (approximately 100 ft) wide. Mousse pooled against the shore at that time is shown in Figure 15 Part B.

The wave on the beach in this zone had brown oil stained edges from resuspended oil which would leave random wavy lines in the lower zones of the beach as the tide would come in and go out. Figure 15 Part A shows a typical view of this stretch of beach in January of 1975. Figure 15 Part D shows a group of tarballs found at the base of the beach slope in January 1976.

- A - View of oiled beach top in maximum impact area on Bahia Felipe, exposed oil is to the left of the picture and covered oil under the sand on the right.
- B - Aerial photo of southeast arc area of Bahia Felipe during the time of the spill.
- C - Aerial photo of similar area five months after the start of the spill.
- D - Tar balls found at the base of the beach slope.

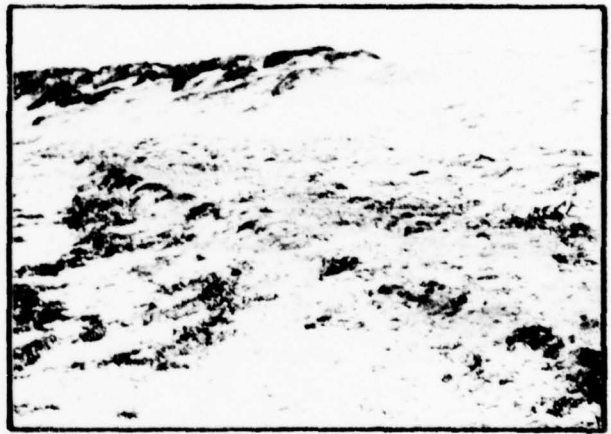
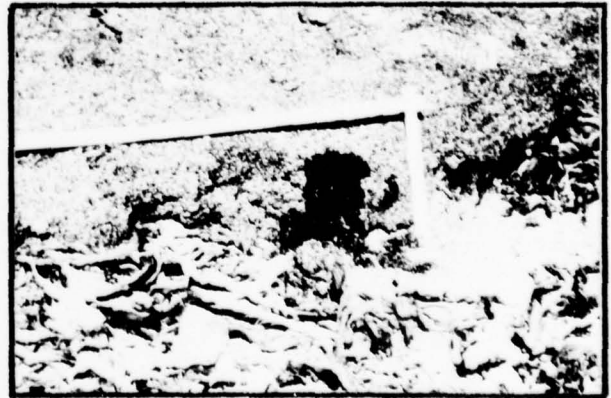
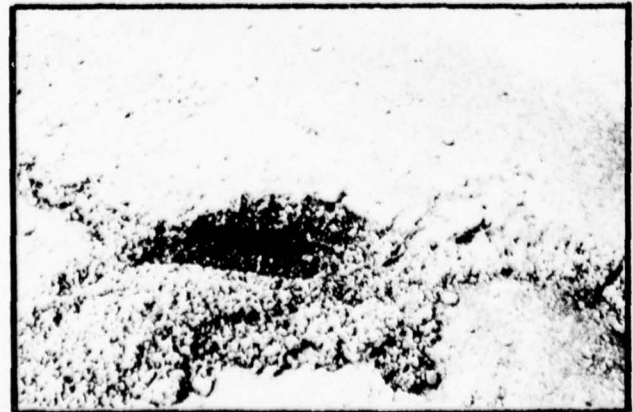
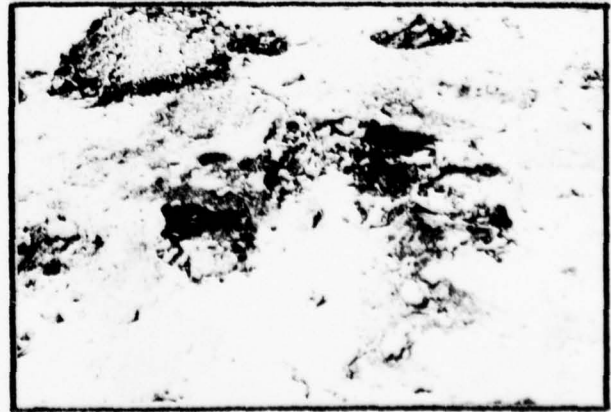
FIGURE 16

Figure 16 Parts A through D show other views taken in this area in January 1975. These may be contrasted with those in Figure 16 Parts E through H which show the same area in January 1977 and 1978.

- A - Oiled beach top southeast arc.
- B - Weathered oil outcropping in beach.
- C - Oil outcropping in beach.
- D - Close-up of oil outcropping in January 1975.
- E - View of oil deposits at top of beach.
- F - View of oiled outcrop 3 1/2 years after the spill.
- G - Close-up of oiled outcrop after 3 1/2 years.
- H - Hole through oiled layer at top of the beach.

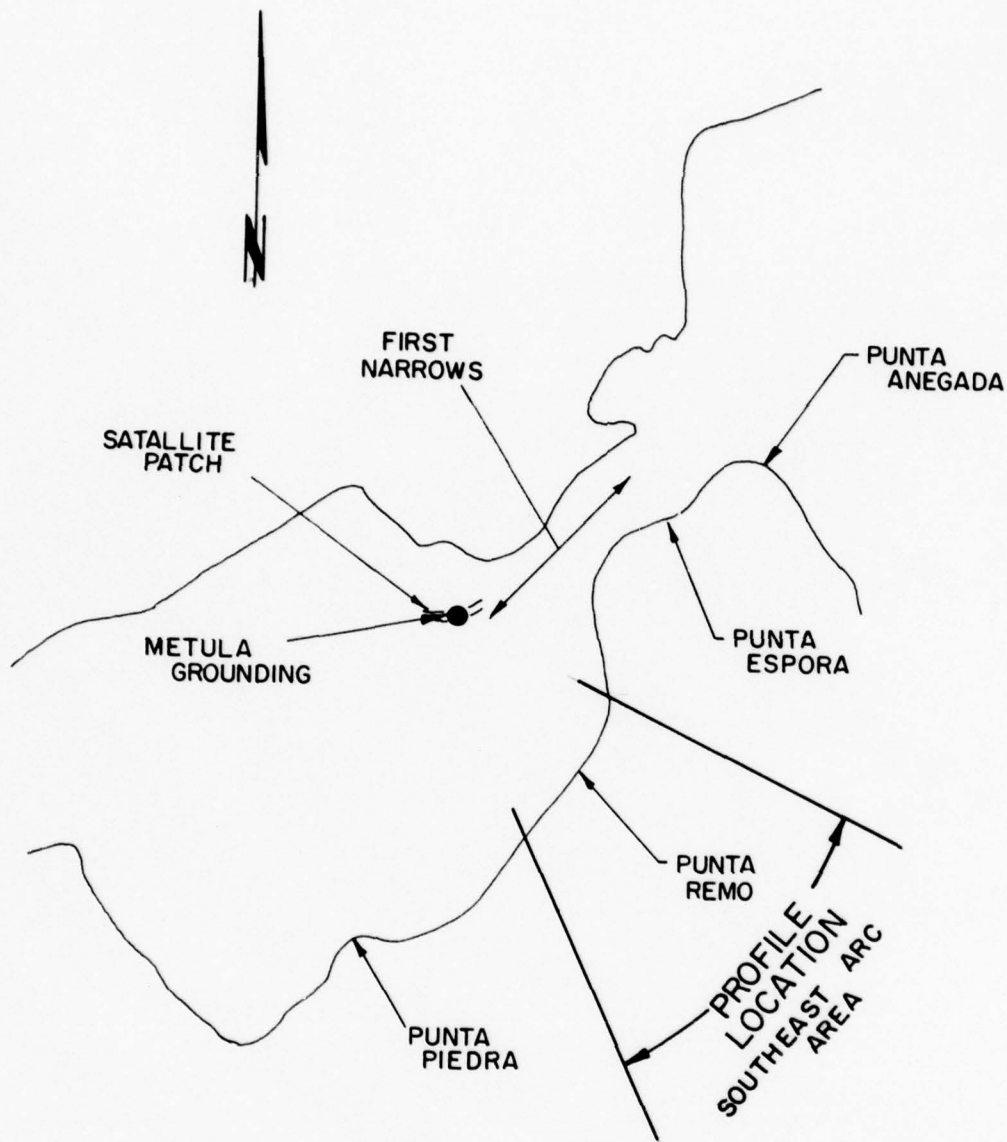
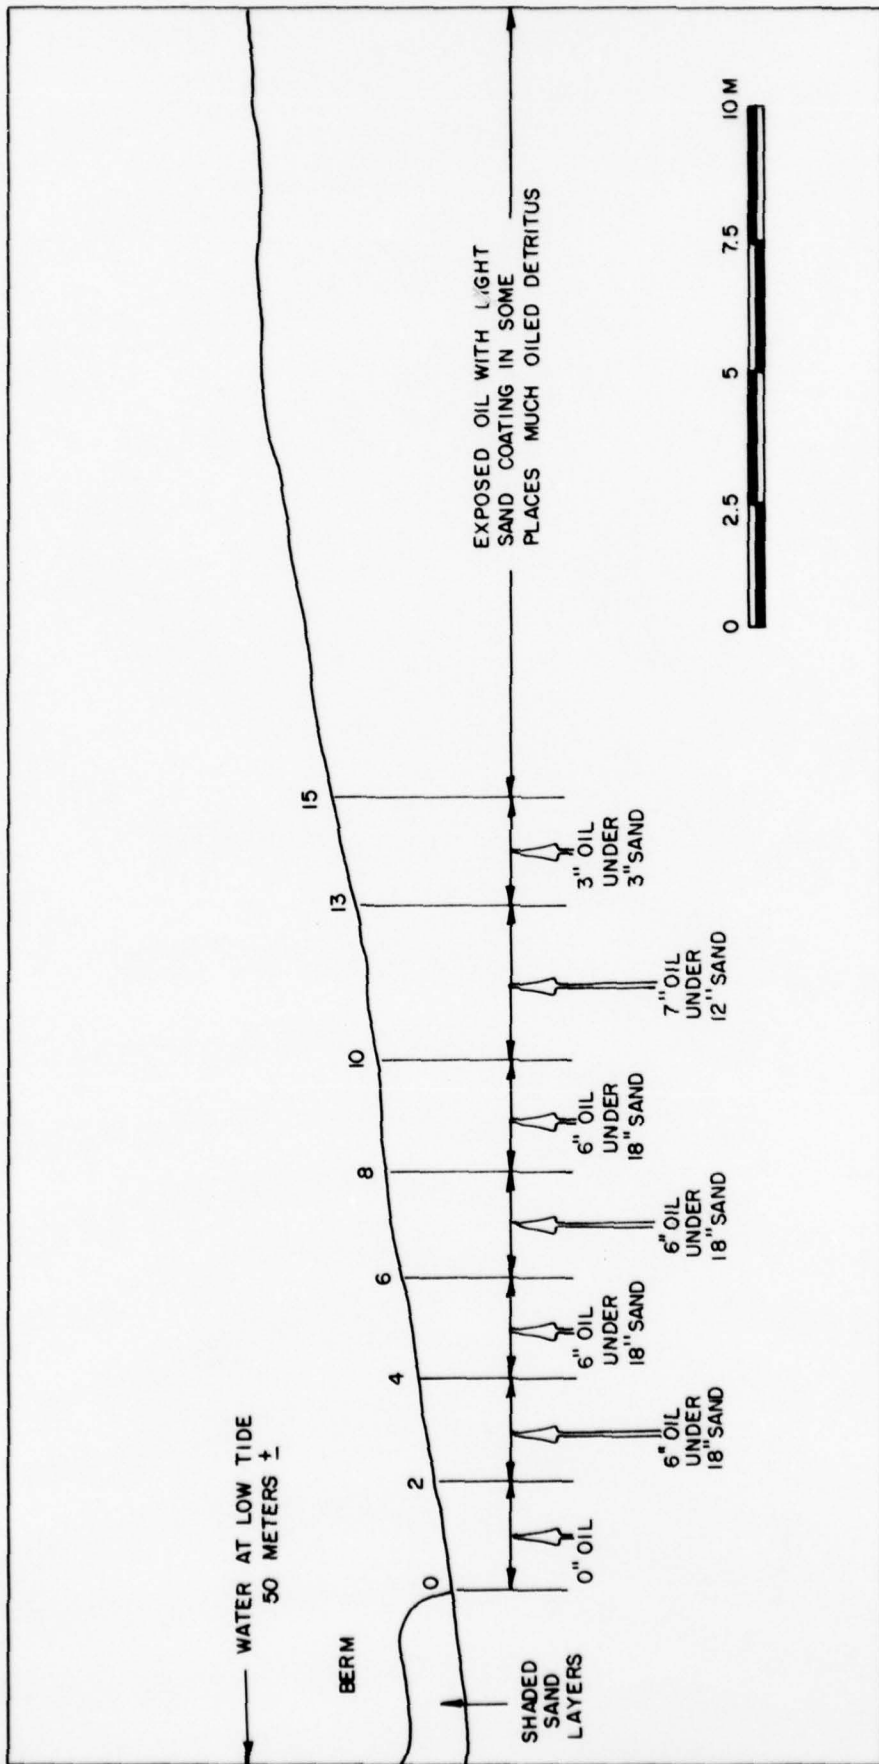
FIGURE 17
 BEACH PROFILE SOUTHEAST ARC AREA BAHIA FELIPE

Figure 17 shows a profile across a typical beach in this area in 1976. At this location oil and mousse was still in evidence over a zone 30 meters (100 ft) wide.

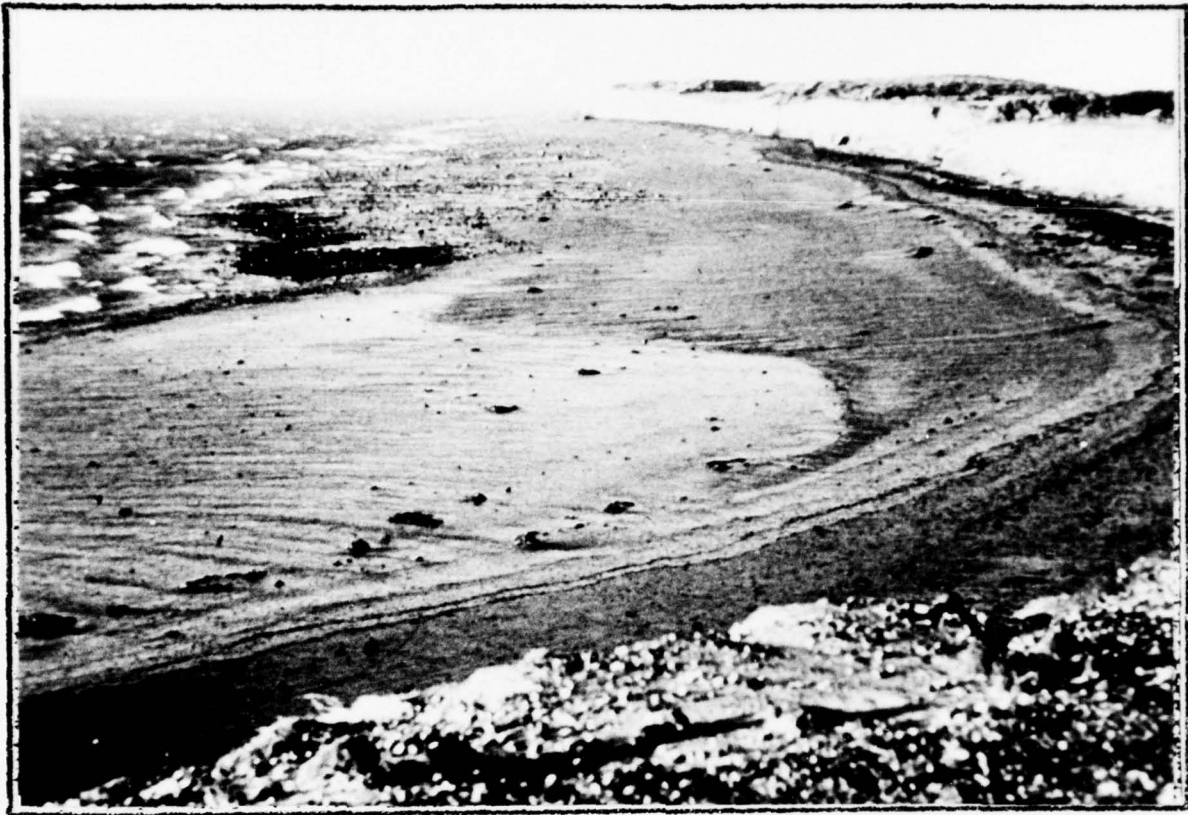
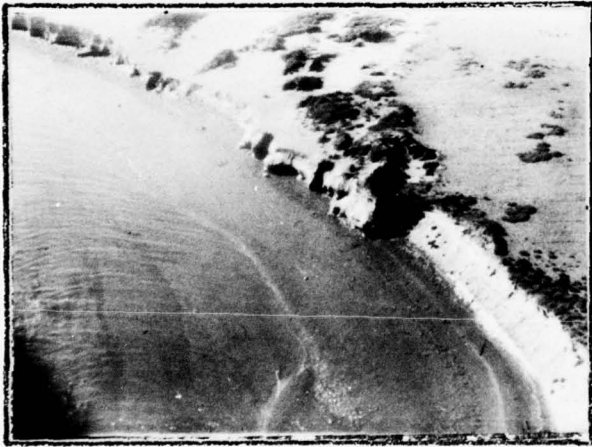
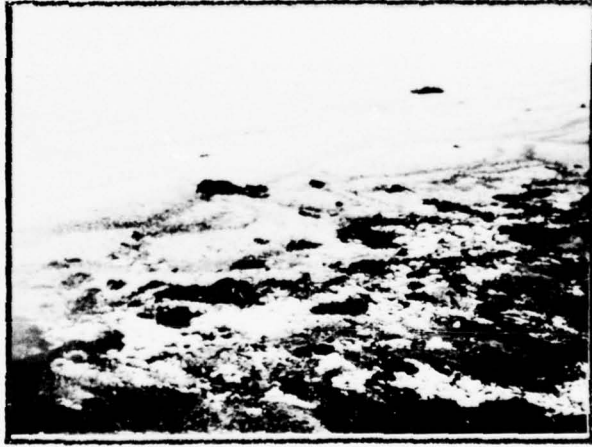
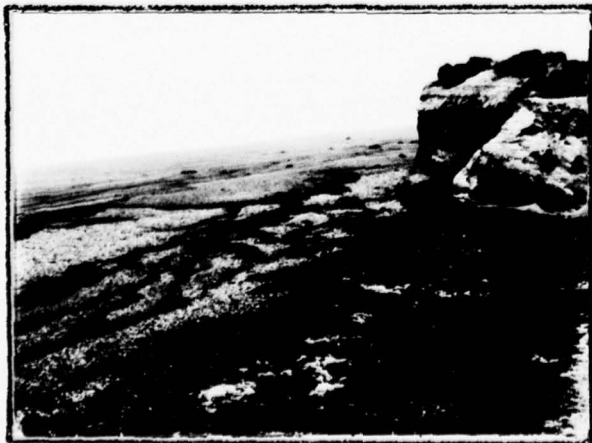
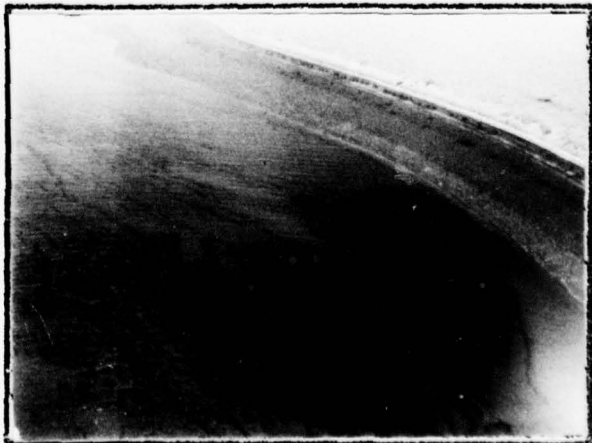
FIGURE 18

The cliff zone which stretches south from Punta Baxa at the entrance to the Narrows to where it intersects the Southeastern Arc was also heavily oiled at the time of the spill. Figure 18 Parts B and E show aerial photographs of this zone at the time of the spill and Figure 18 Part A shows a view from a cliff top of the same general area. This area differs from the Southeast Arc in that cliffs are found at the top of the beach. This resulted in the oil being retained at a zone where future wave action could work on the deposits. At the time of the spill it was noted that the action of the surf against the base of the cliffs had in some places thrown oil on the top of cliffs 8 to 10 meters high. The deposits on the beaches at the time of the spill generally ranged from 30 to 100 meters wide (98 to 328 ft) depending on the beach slope.

Figure 18 Parts C and D show cliff top views of this area in 1975. Selected points in this area have been visited in 1977 and 1978. Figure 19 Parts A, B, D, E and F show views taken in 1978.

- A - Oiled beach zone in Punta Baxa area during the spill period.
- B - Another oiled beach zone during the spill period.
- C - Same beach area observed five months later.
- D - Same beach area with dead horse observed five months later.
- E - Aerial photograph of Punta Baxa beach area.
