FATE OF OIL SPILLED FROM THE
SUPERTANKER METULA

ROY W. HANN, JR.
HARRY N. YOUNG, JR

JANUARY 1979

FINAL REPORT

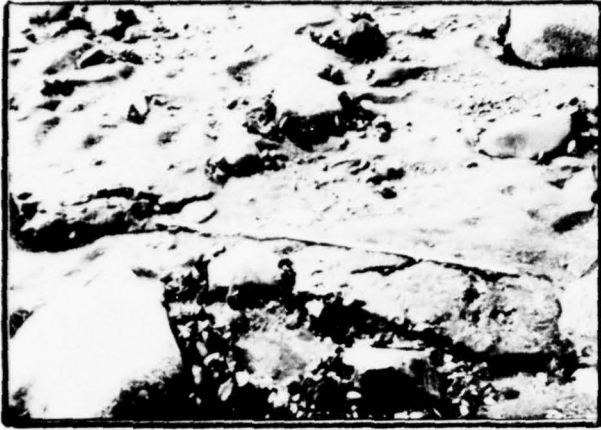
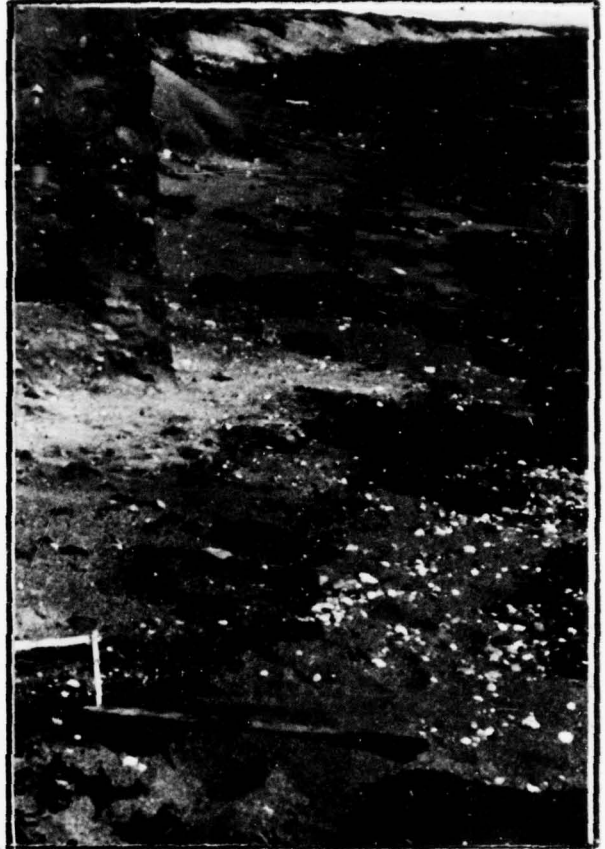
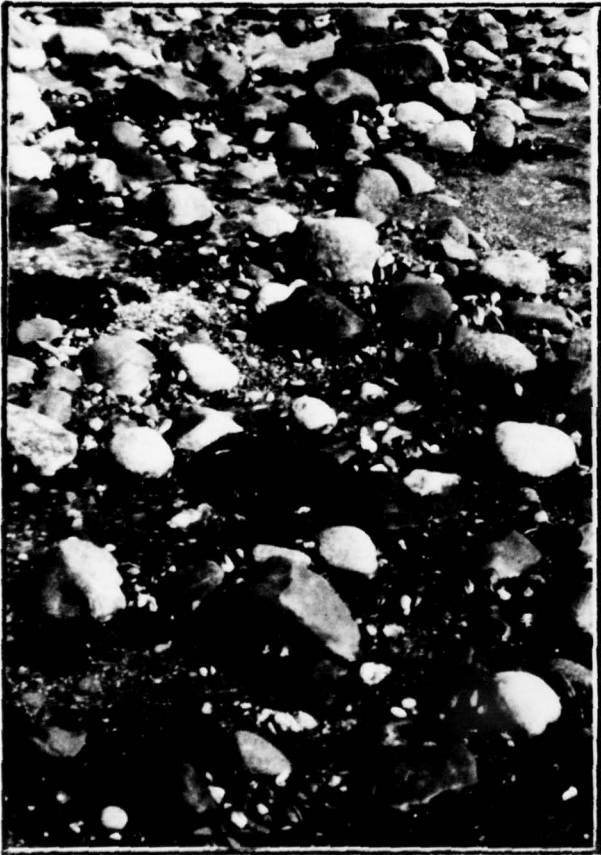
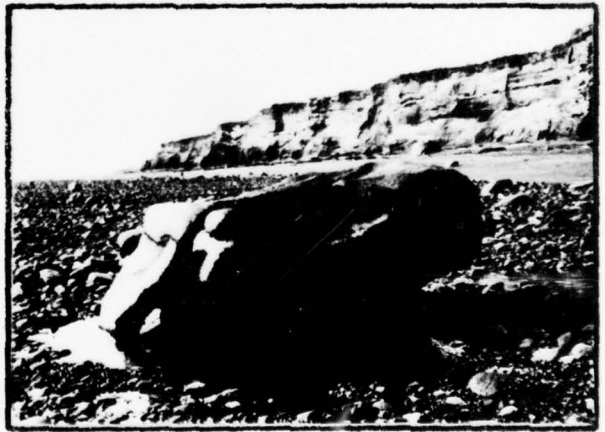
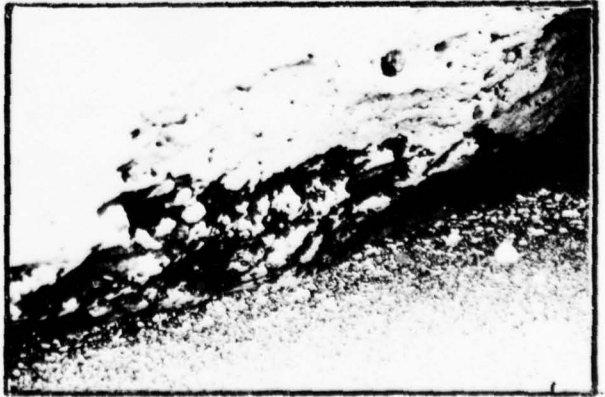
FIGURE 19

There was still evidence in numerous places of a ledge of weathered moussecrete at the top of the beach. This indicates that wave action only occasionally reaches the base of the cliffs. This is further demonstrated in Figure 19 Part F where the oiled top of a small cave is still evident three and a half years after the spill.

Unique in this area are the large number of tar balls and tar slabs found at the base of the beach slope. These are shown in Figure 19 Parts A and B. These may have resulted from the erosion of the oiled zones at the beach top. Since the beach in this area was building at the time the question is raised as to whether there is a large amount of buried oil under the bottom of the beach slope.

From the lighthouse at Punta Baxa to Punta Espora is the exposed south shore of the Narrows. This zone was heavily oiled at the time of the spill but relatively little oil has been observed since. In January 1977 several large rocks such as the one shown in Figure 19 Part C were found to be "painted" with a 1/8 layer of tar. Oil was also found around the edges of the cobbles in the lower intertidal zone.

- A - Tar slabs at bottom of beach face in Punta Baxa area.
- B - Tar balls at bottom of beach face in Punta Baxa area.
- C - Tarred rock face on south shore of First Narrows.
- D - Eroded oil layers at foot of cliffs in Punta Baxa area.
- E - Heavy mussel population on large rock in cobble area near Punta Baxa.
- F - Oil on top of small cave at top of beach near Punta Baxa.

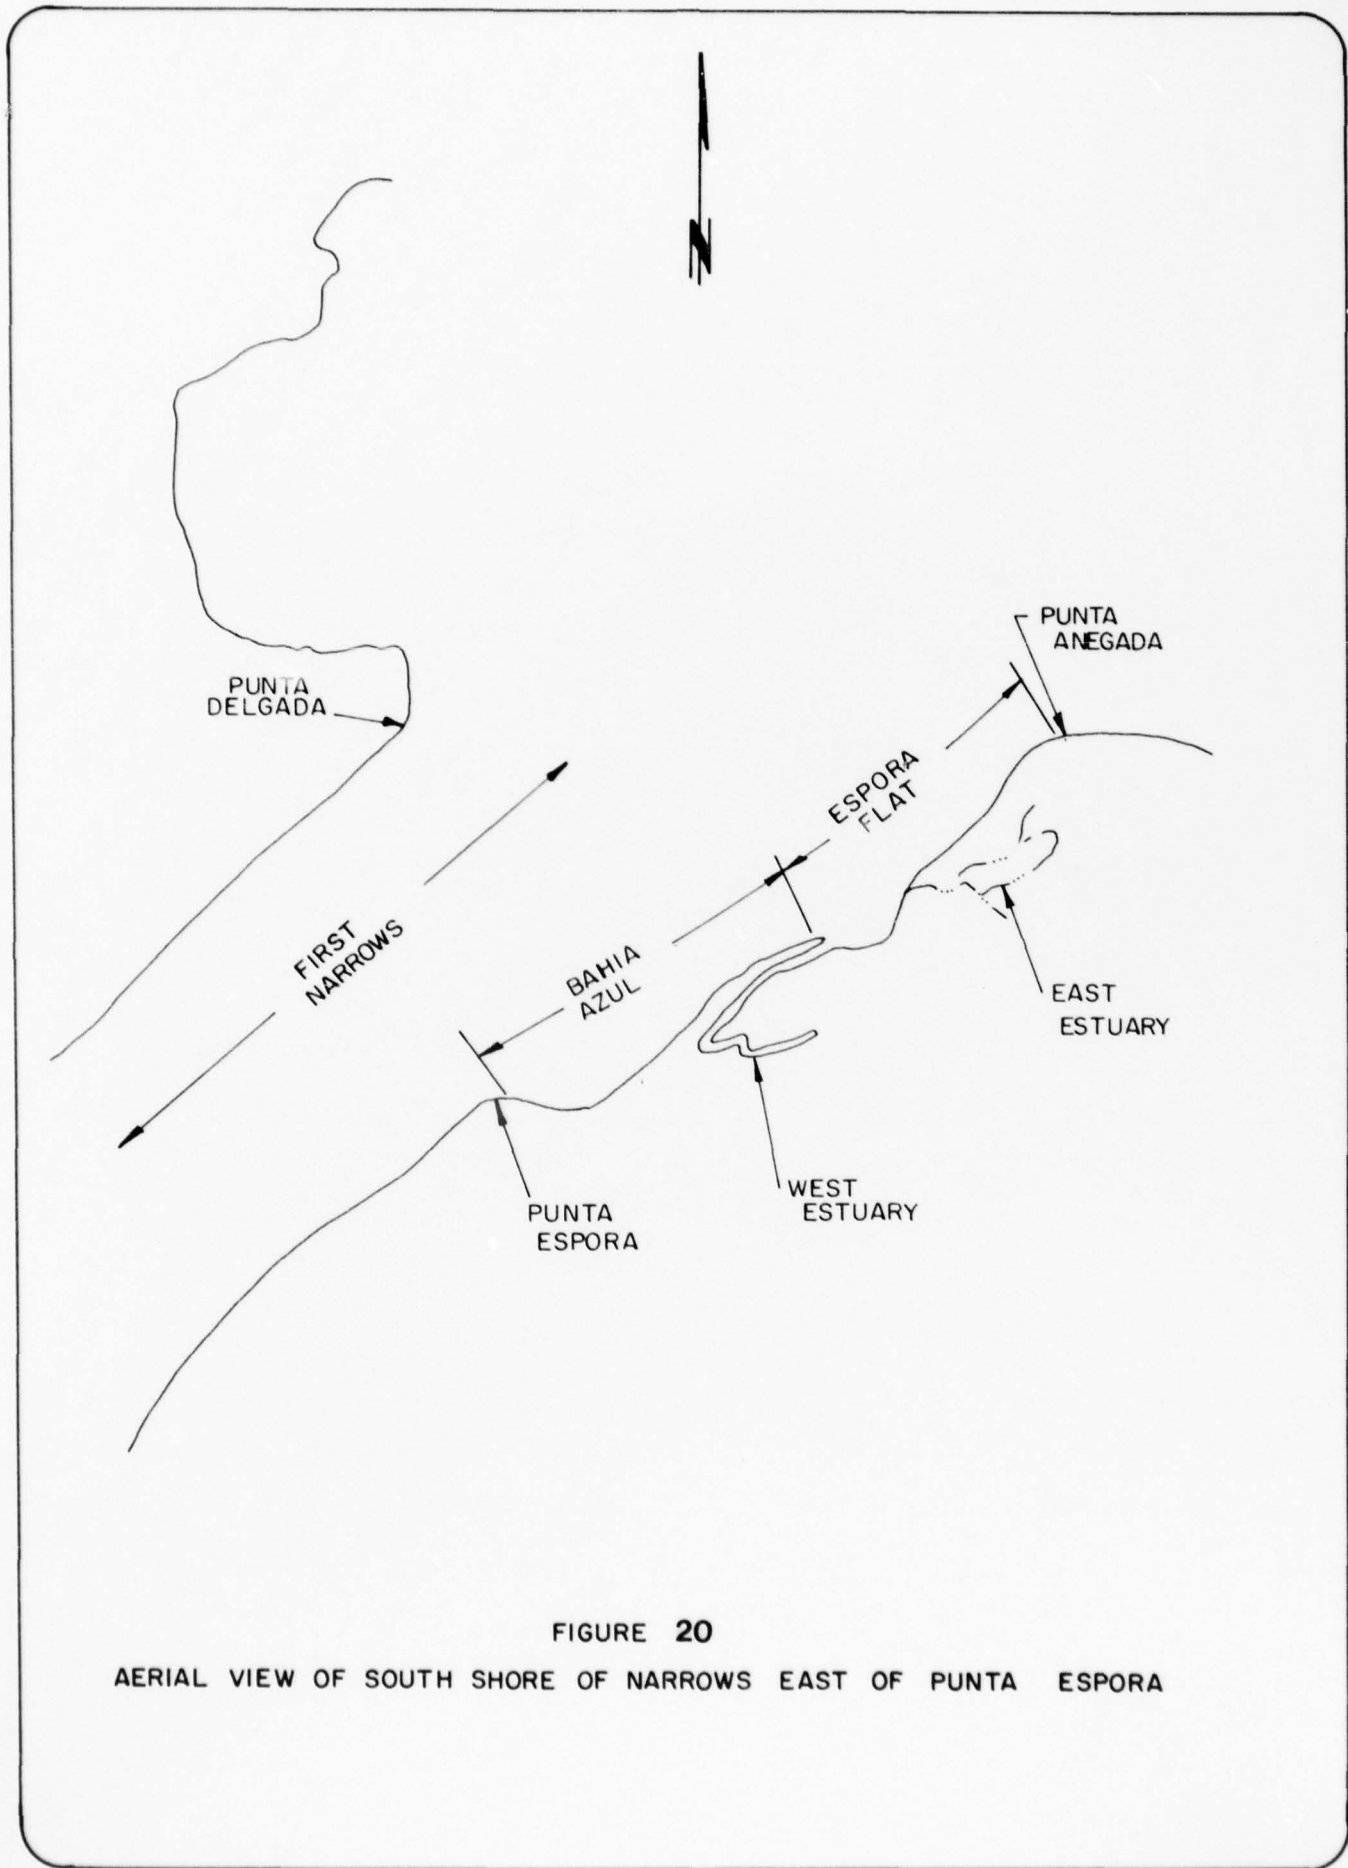
FIGURE 20

AERIAL VIEW OF SOUTH SHORE OF NARROWS EAST OF PUNTA ESPORA

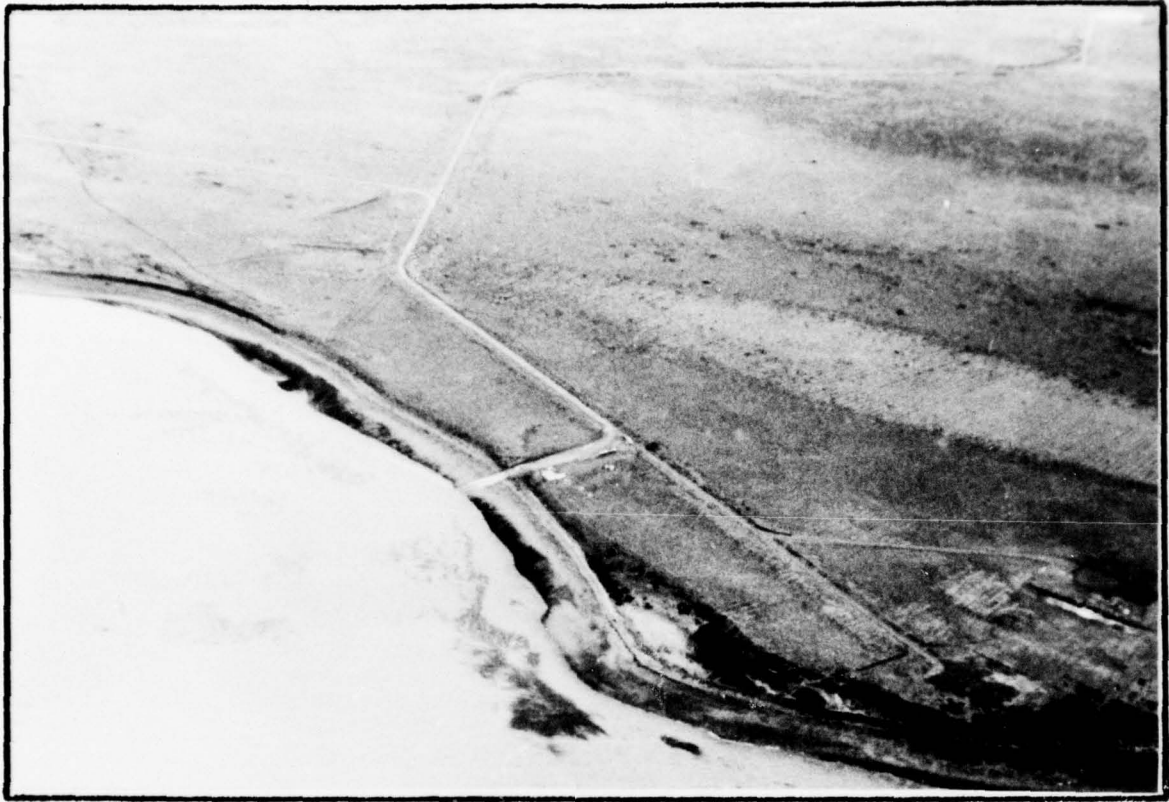
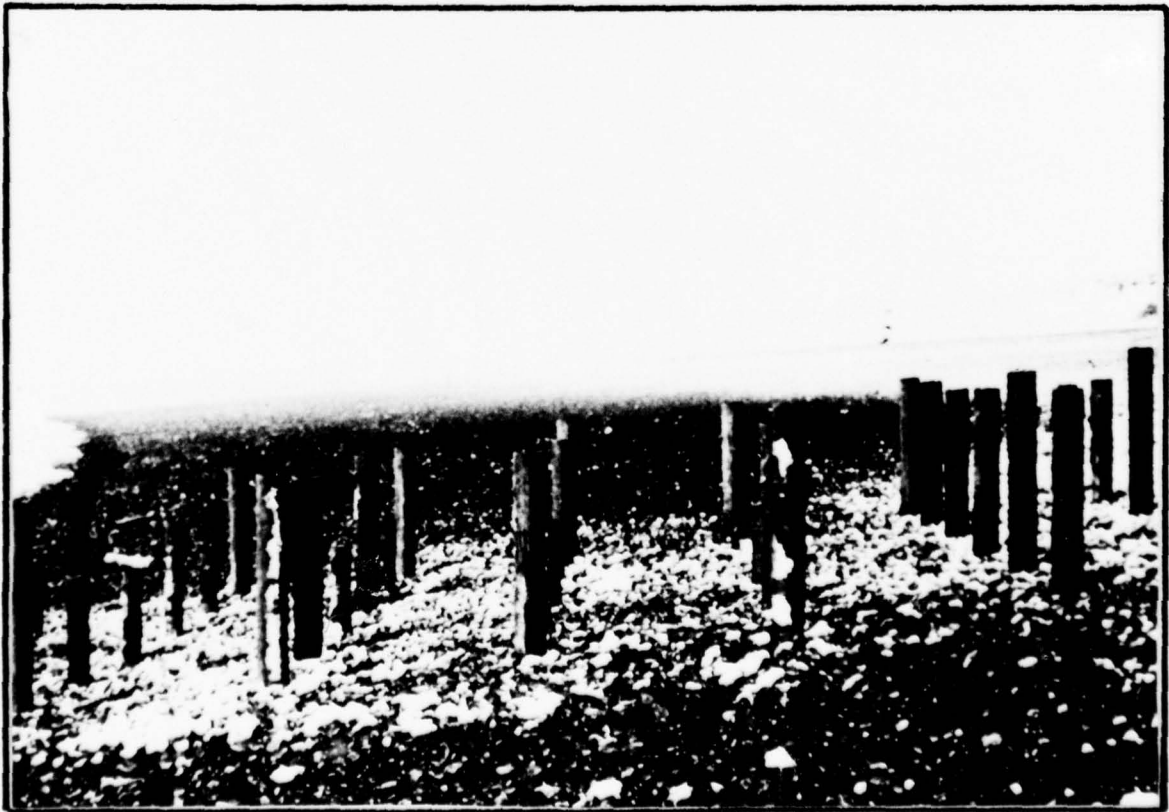
FIGURE 21

The Bahia Azul Beach was not observed at the time of the spill but the construction of the new ferry landing and access road in late 1974 made observation possible in January of 1975. Figure 21 Part B shows the Azul Beach at the new ferry landing. The clean undersides of rocks disturbed by the construction contrasted drastically with the oiled beach face in the foreground and background.

- A - View of Bahia Azul Beach showing new road and ferry loading. Punta Espora is in the lower lefthand corner.
- B - View of oiled beach face on Bahia Azul. New construction has turned over rocks in piling area in contrast to oiled rocks in foreground and background.

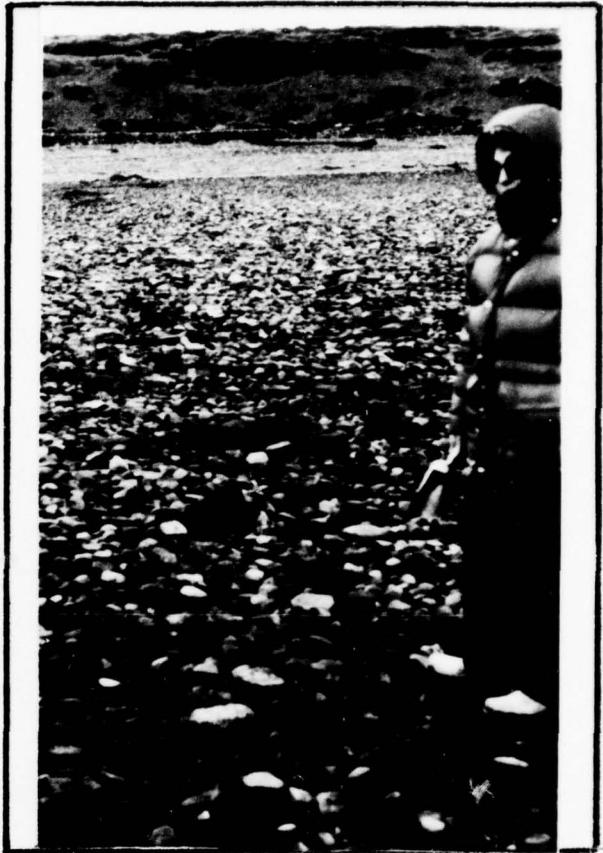
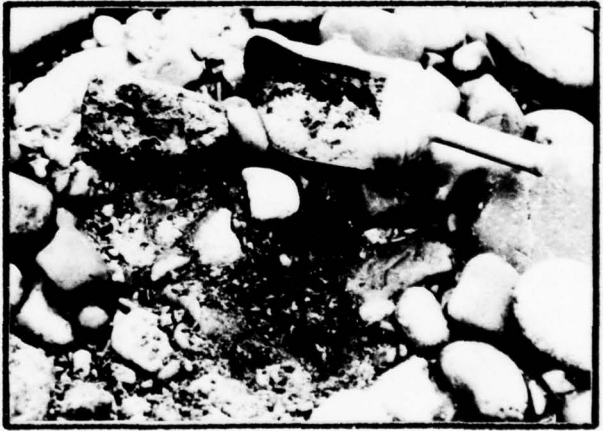
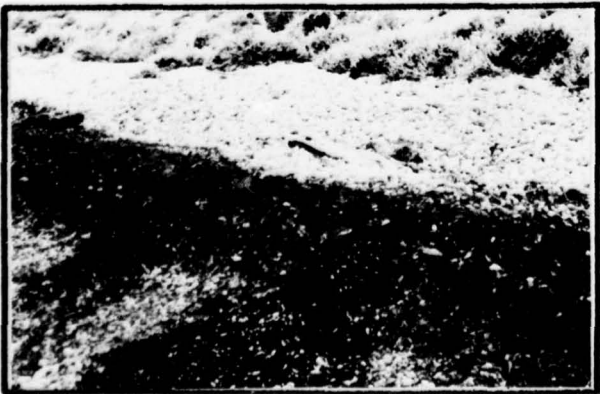
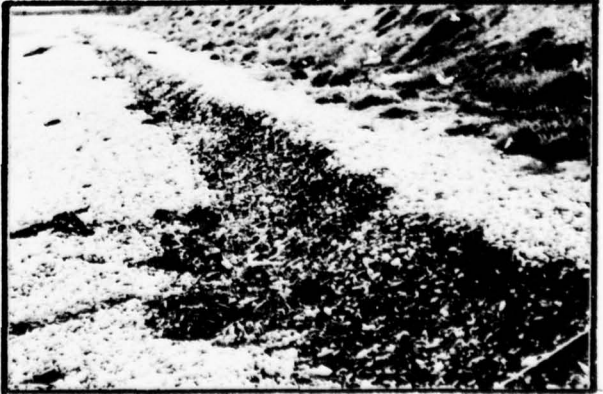
FIGURE 22

The entire beach zone in this area is heavily oiled. Figure 22 Parts A through F shows views of this beach in 1975 and 1978. Figure 23 shows a beach profile made in 1975. Almost an identical profile was observed in 1978 except for the relative absence of oil in the sandy zone between the oiled layer at the top (Figure 22 Parts C and F) and the paved cobble area shown in Figure 22 Parts A, B, D and E.

- A - Paved beach to south of New Ferry landing on Bahia Azul.
- B - Closeup of oiled pavement on Bahia Azul Beach.
- C - Oiled shell and flat stone beach top deposit in January 1975.
- D - Series of sampling pits perpendicular to the beach on Bahia Azul shore.
- E - Closeup of oiled pavement.
- F - Oiled shell and flat stone beach top deposit in January of 1978.

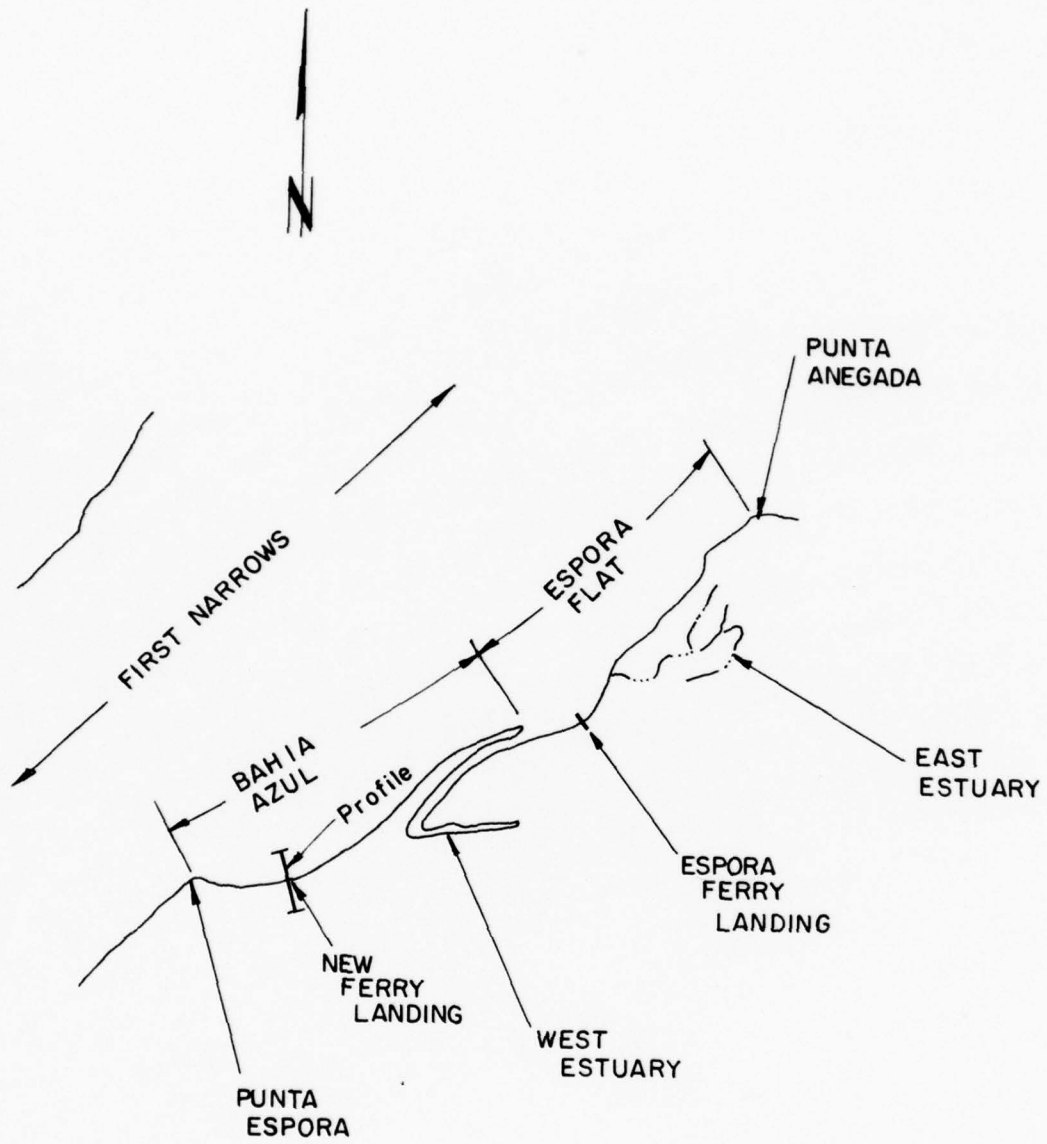
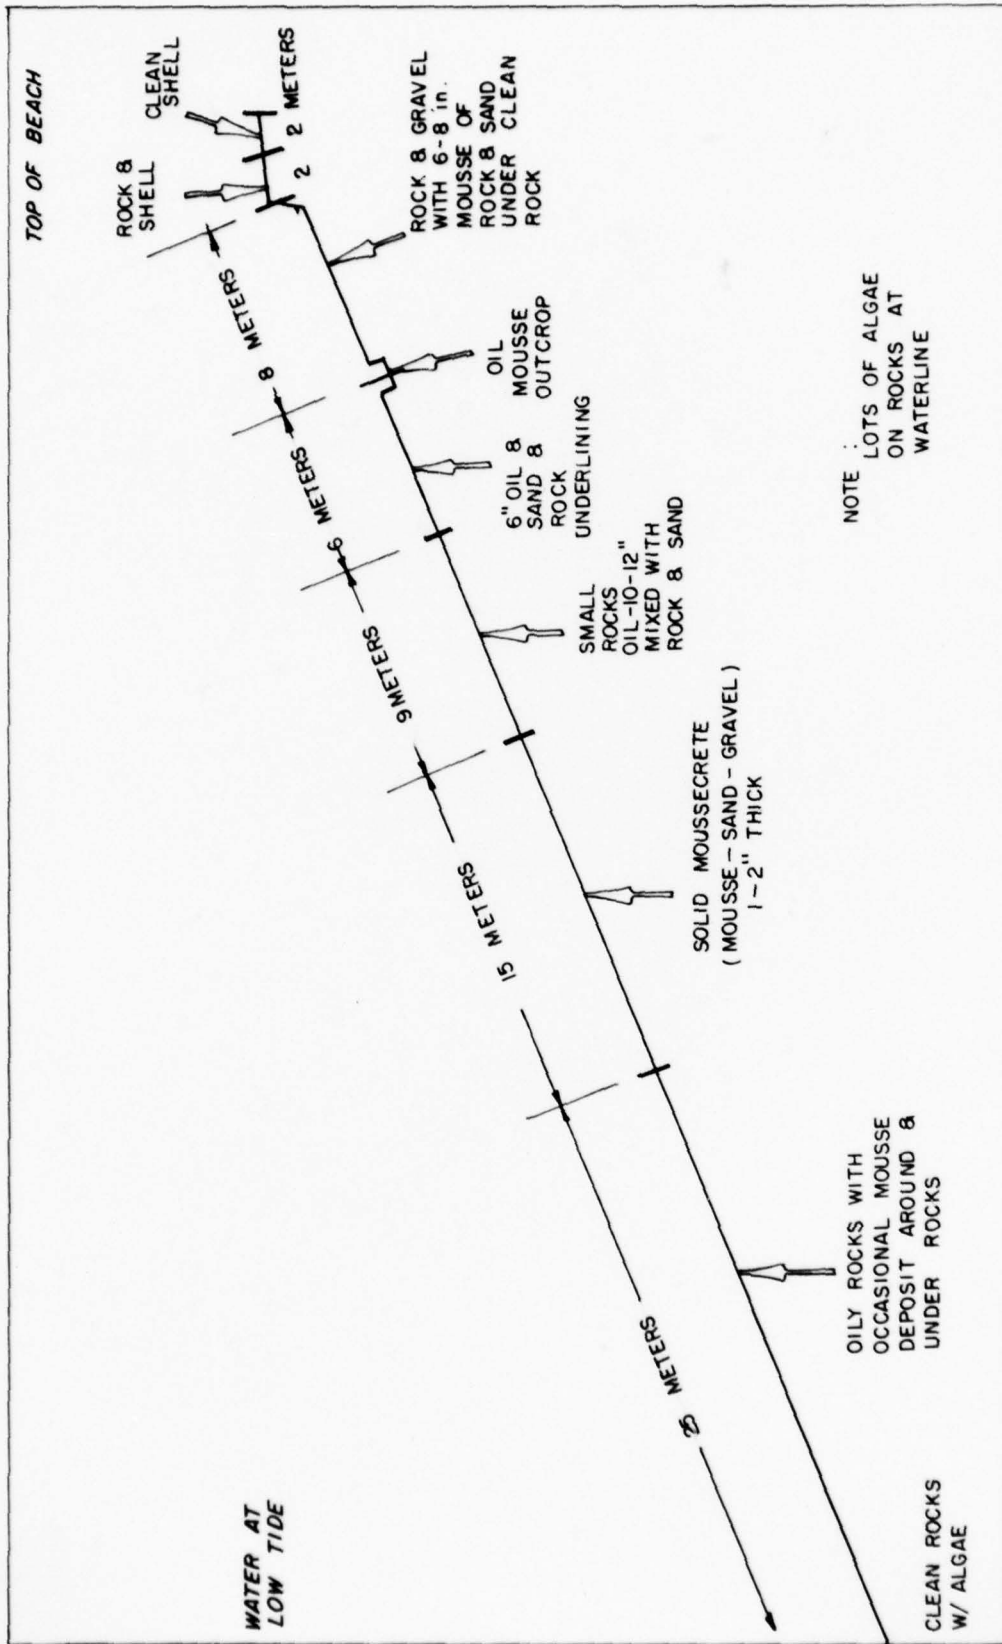
FIGURE 23

BEACH PROFILE BAHIA AZUL BEACH FACE

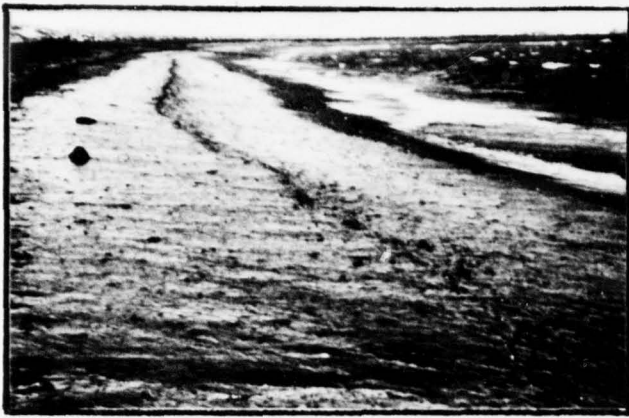
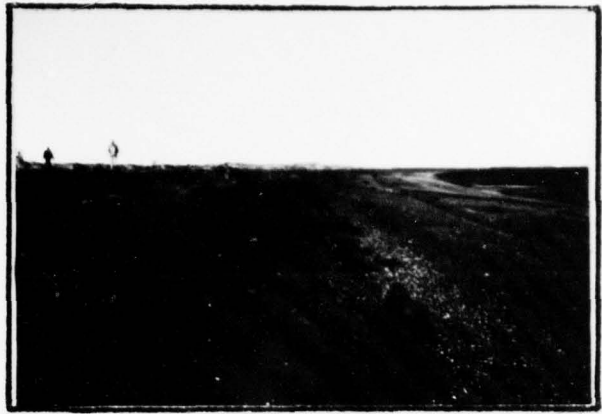
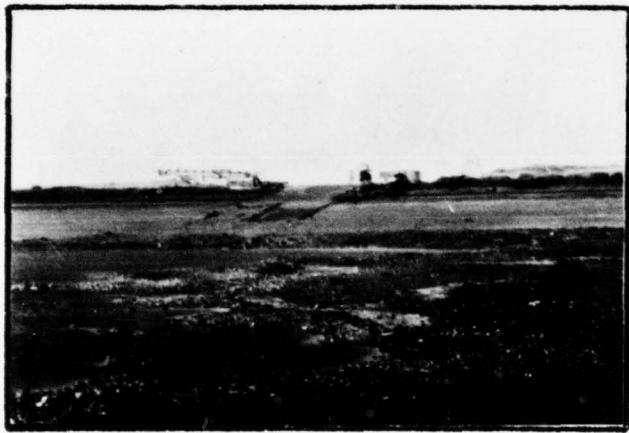
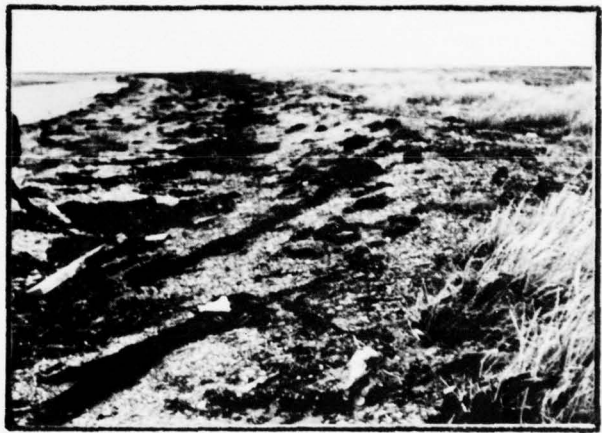
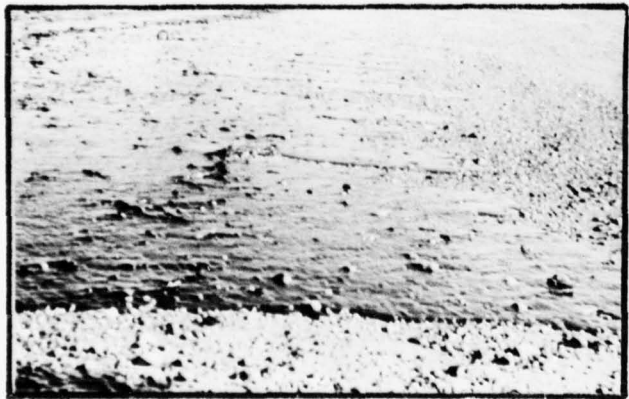
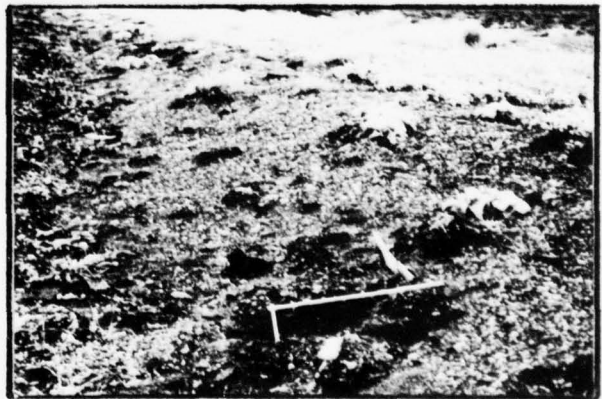
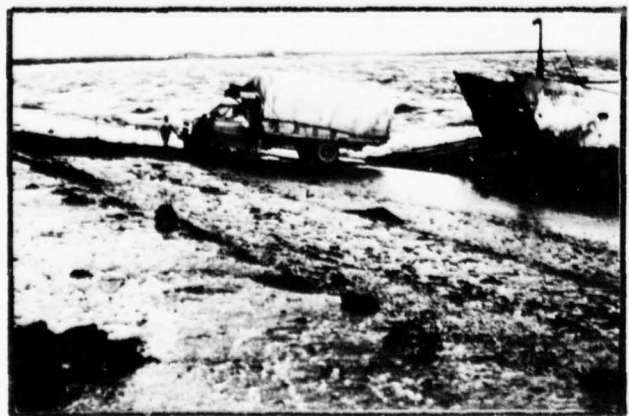
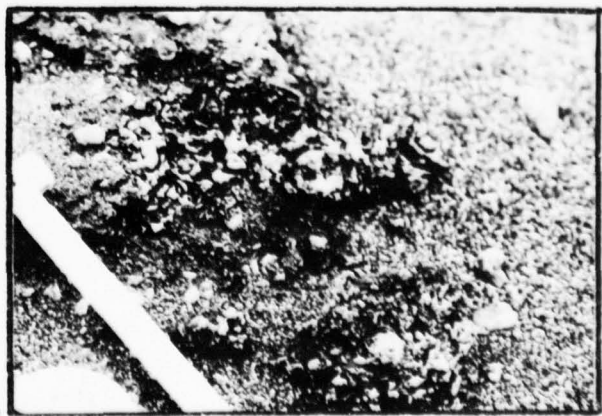
FIGURE 24

The study in January 1975 indicated substantially heavier deposits in the intertidal zone than in September 1974. The initial loading of the Espora beach top in late August and early September 1974 as compared to how it looked in January of 1978 is depicted in Figure 24. In Figure 24 Parts A, B, C and D the loading on the beach at both high and low tide may be noted.

- A - Espora beach top at time of the spill.
- B - Old Ferry Landing at Puerto Espora at low tide during the spill.
- C - Stranded oil draining down beach face during time of the spill.
- D - Ferry Unloading on oiled Espora beach.
- E - Weathered oiled beach top looking west at Espora in January 1978.
- F - Weathered oiled beach top looking east at Espora in January 1978.
- G - Close-up of weathered sediments at top of Espora beach.
- H

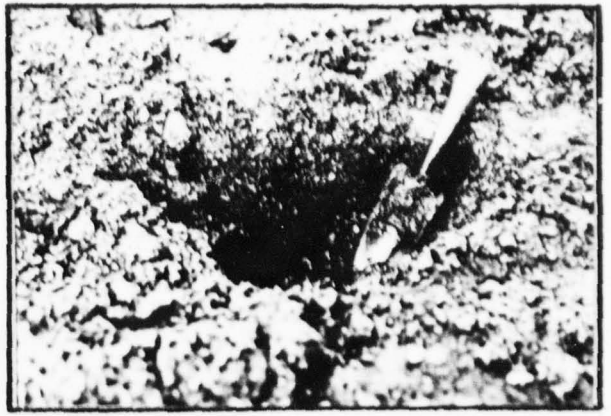
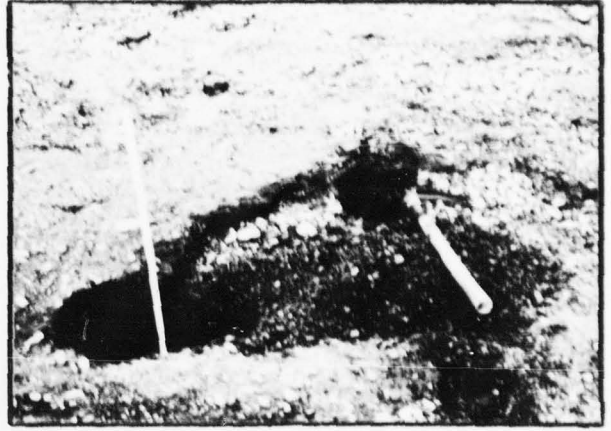
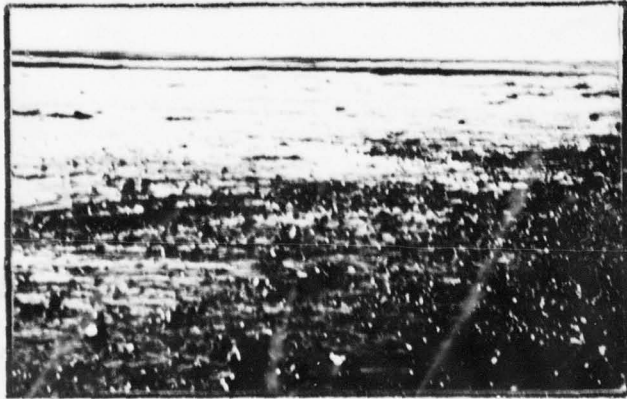
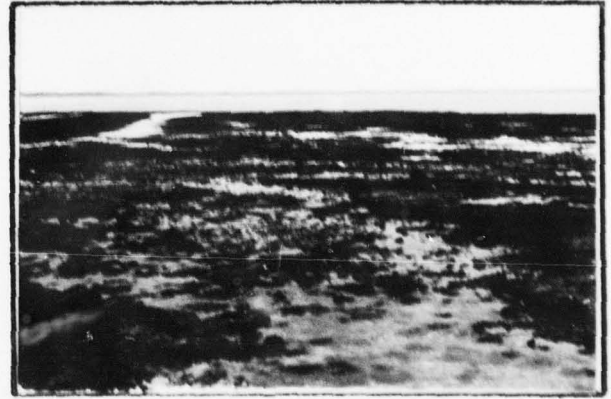
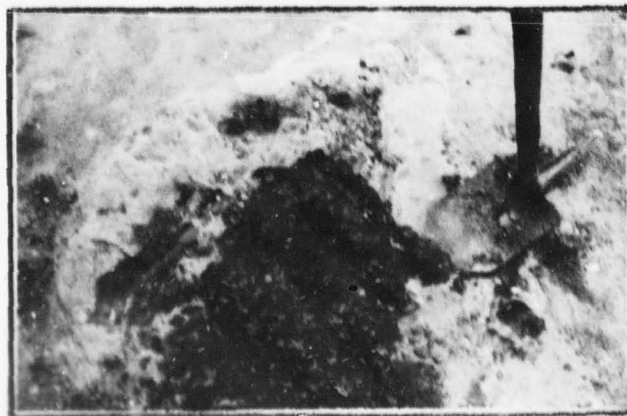
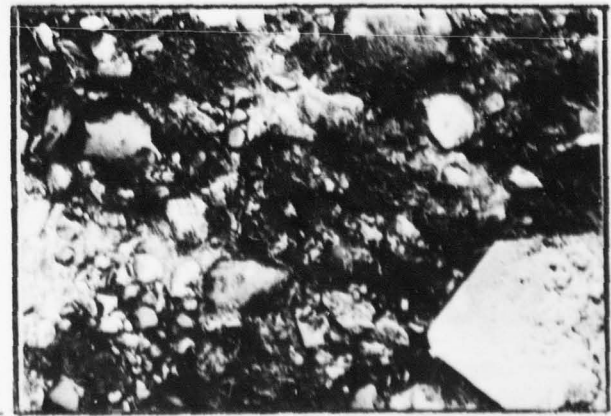
FIGURE 25

It is in the broad flat intertidal zone that the oiling at Espora was so dramatic. The sequence of events that led to this phenomenon are shown in Figure 25 Parts A, B and C.

It is believed that the rapid return of the tide in this area created a hydrostatic head over the stranded oil which forced it into the sediment before it could float or be washed to the surface. Much of the flat had mousse penetrating into the sediments from 5 to 10 centimeters (2 to 4 in) and in places it was over 30 centimeters (12 in) thick. Figure 25 Part E shows a measurement pit in the pavement in 1975 and Figure 25 Part F shows a similar pit in 1978. Since the sediments are covered with cold water much of the time and since the thick mousse contains much water, the oil in the pavements has weathered very little. The new pits yield the same brown mousse observed three years earlier. Figure 25 Parts G and H show additional views taken in 1978. In Part G the algal growth on the oiled sediments may be noted.

- A - Espora flat in late August 1974.
- B - Movement of oil into Espora area on September 2, 1974.
- C - Deposited oil in Espora Flat at low tide on September 2, 1974.
- D - Algae on oil surface and mousse under surface.
- E - Oiled sediment in Espora Flat on January 1975.
- F - Oiled sediment in Espora Flat in January 1978.
- G - Oiled Espora tidal flat looking seaward.
- H - Close-up of algae growing on oiled sediment.

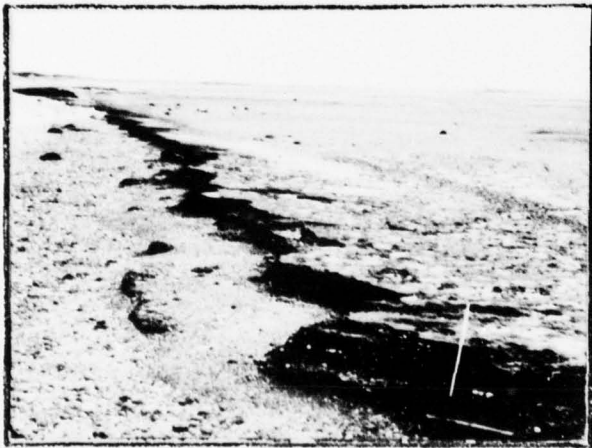
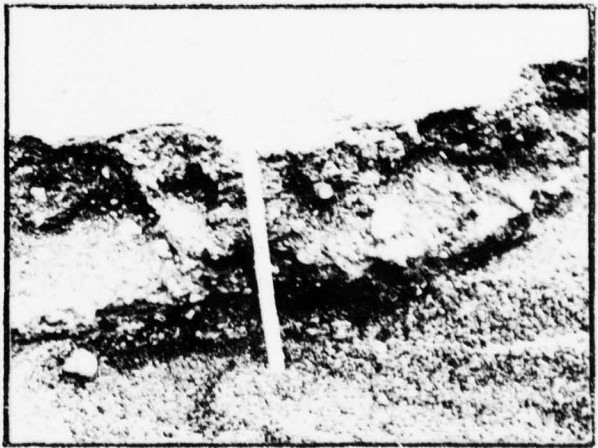
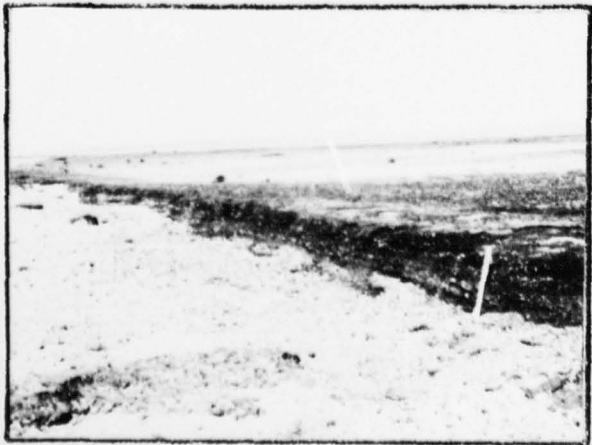
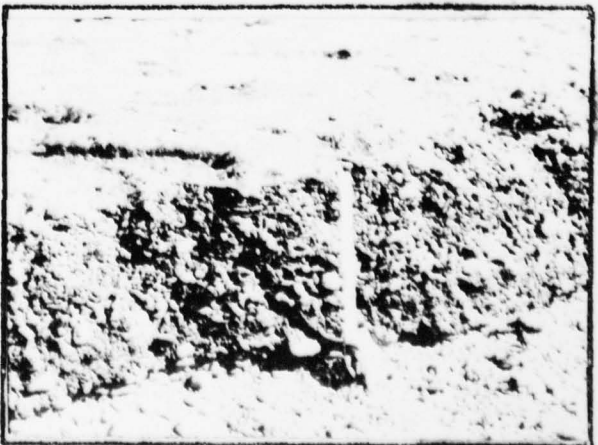
FIGURE 26

The dramatic aerial extent of the deposits may be noted in Figure 26 Part A and the depth of the pavement-like moussecrete may be noted in Figures 26 Parts B, C, D and E. These latter pictures were taken in 1977 and 1978 where the edges of the pavements are eroding.

- A - View along oiled tidal flat toward Old Ferry landing.
- B - Eroded edge of sediment at bottom of beach slope.
- C - Close-up of eroded edge showing 11 inch thickness.
- D - Additional close-up of eroded edge taken in January of 1978.
- E

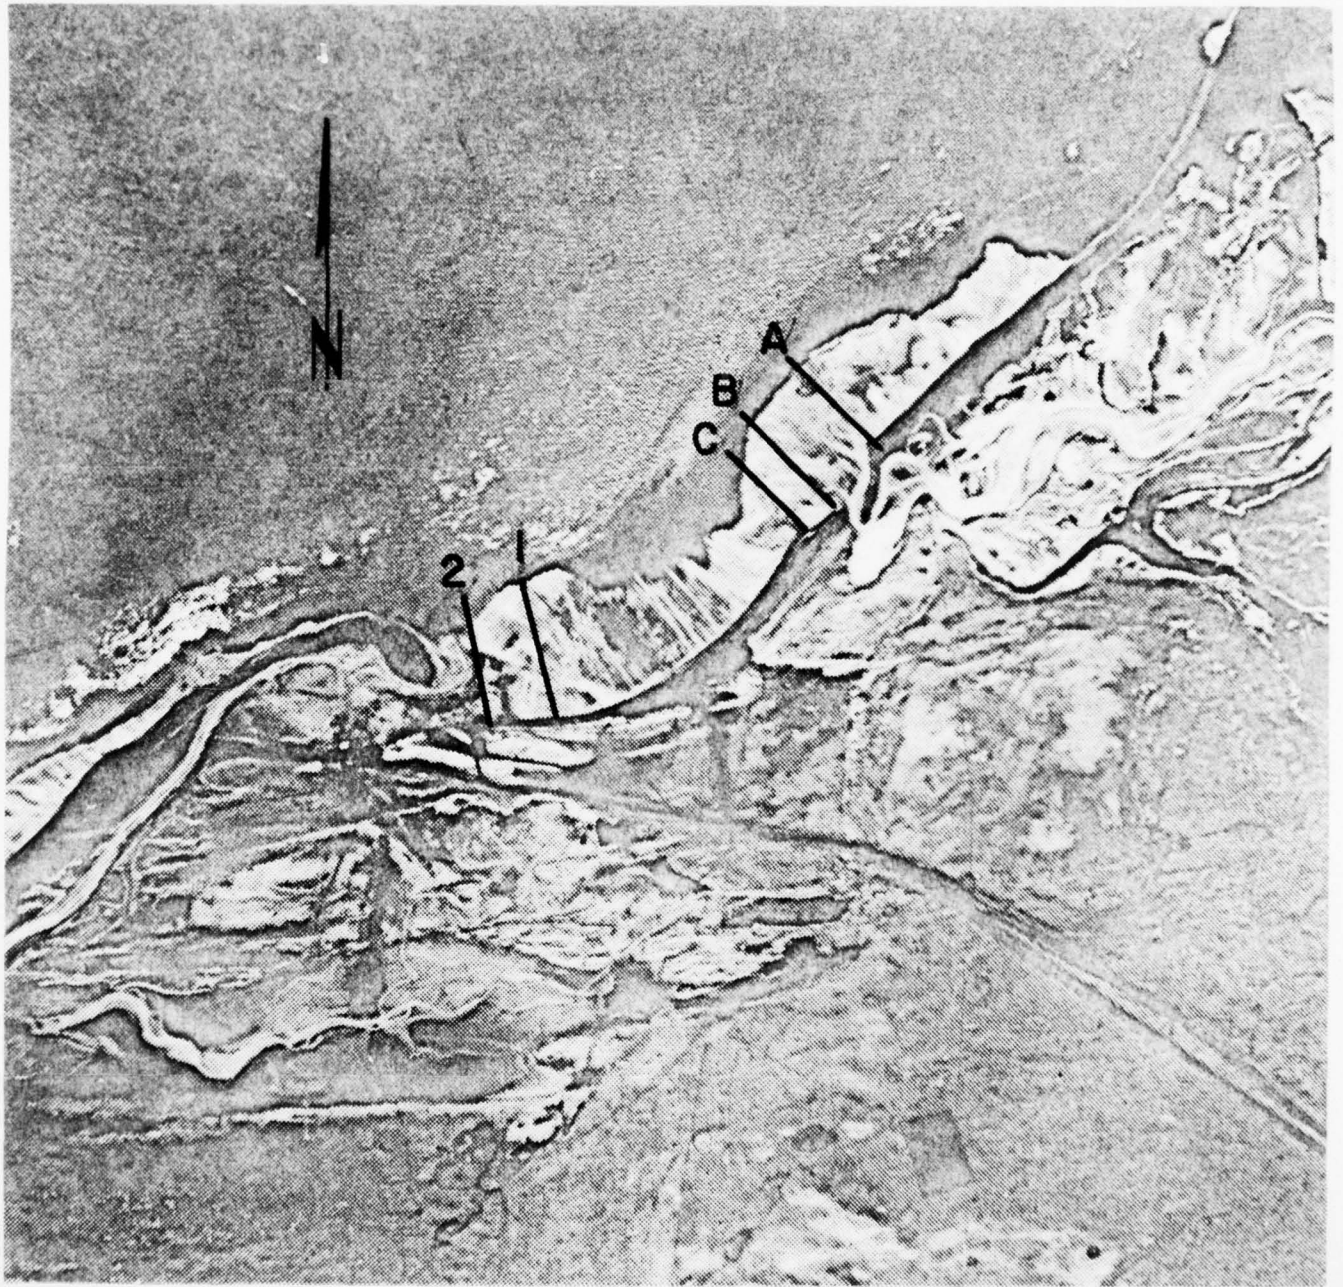
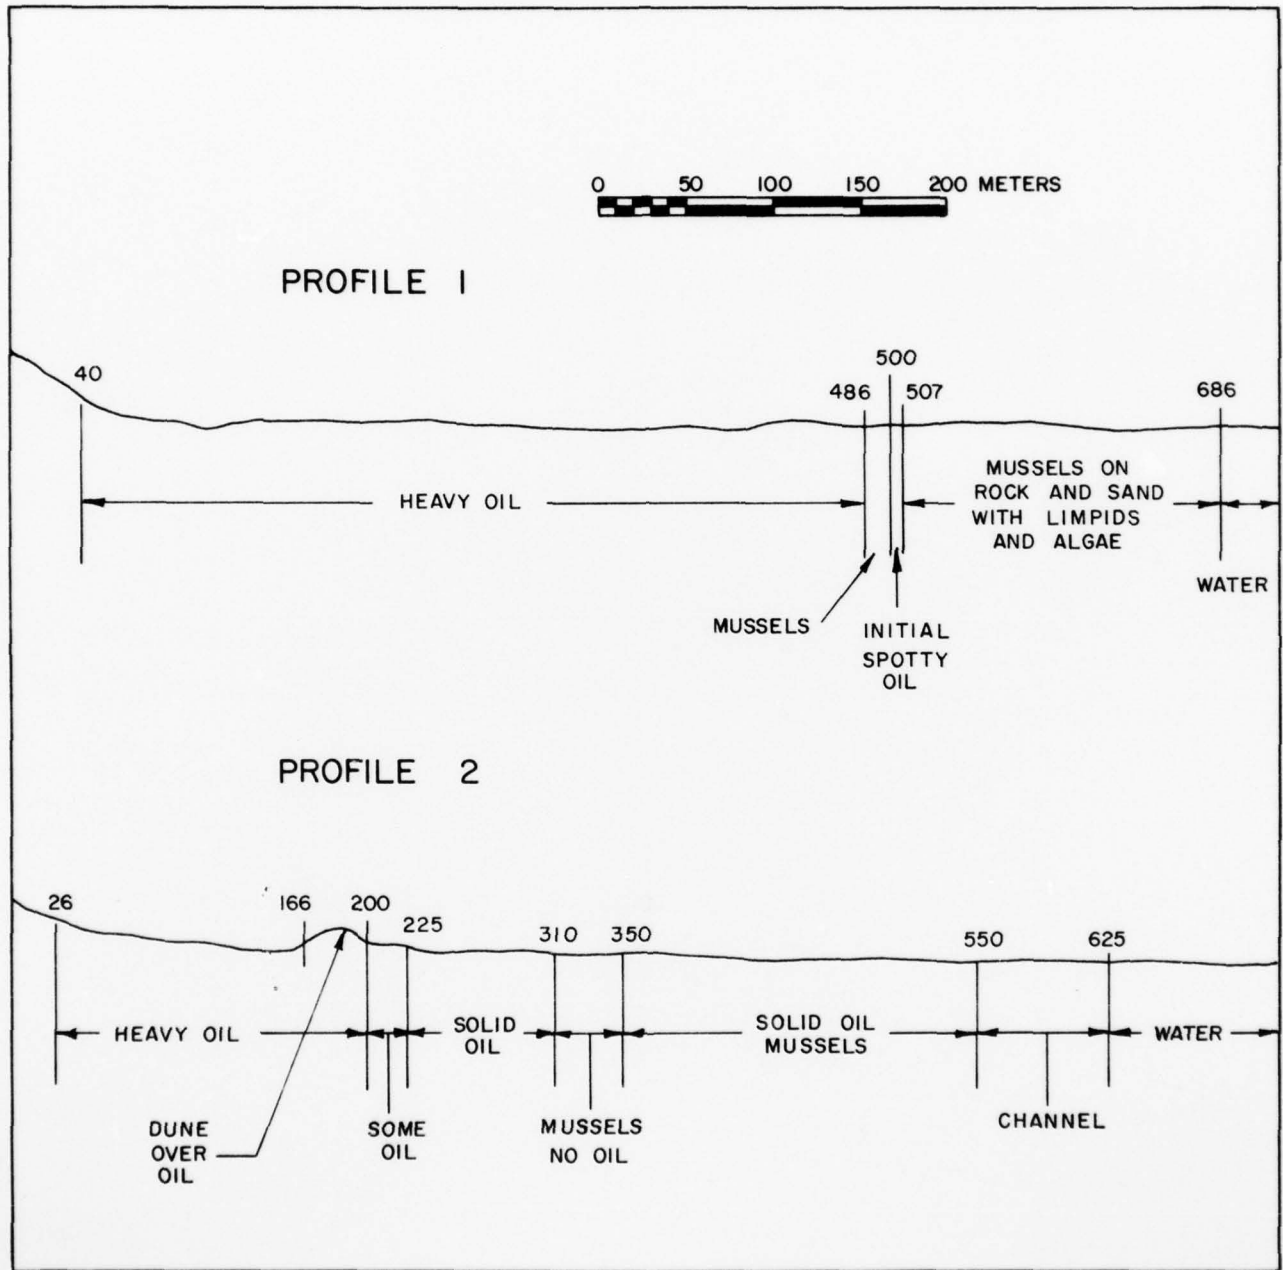
FIGURE 27
BEACH PROFILE ESPORA FLAT NEAR ENTRANCE OF WEST ESTUARY

Figures 27 and 28 show five profiles made across the Espora Flat in 1977. It may be noted that the oiled zone ranged from over 300 meters to 600 meters (110-220 ft) wide.

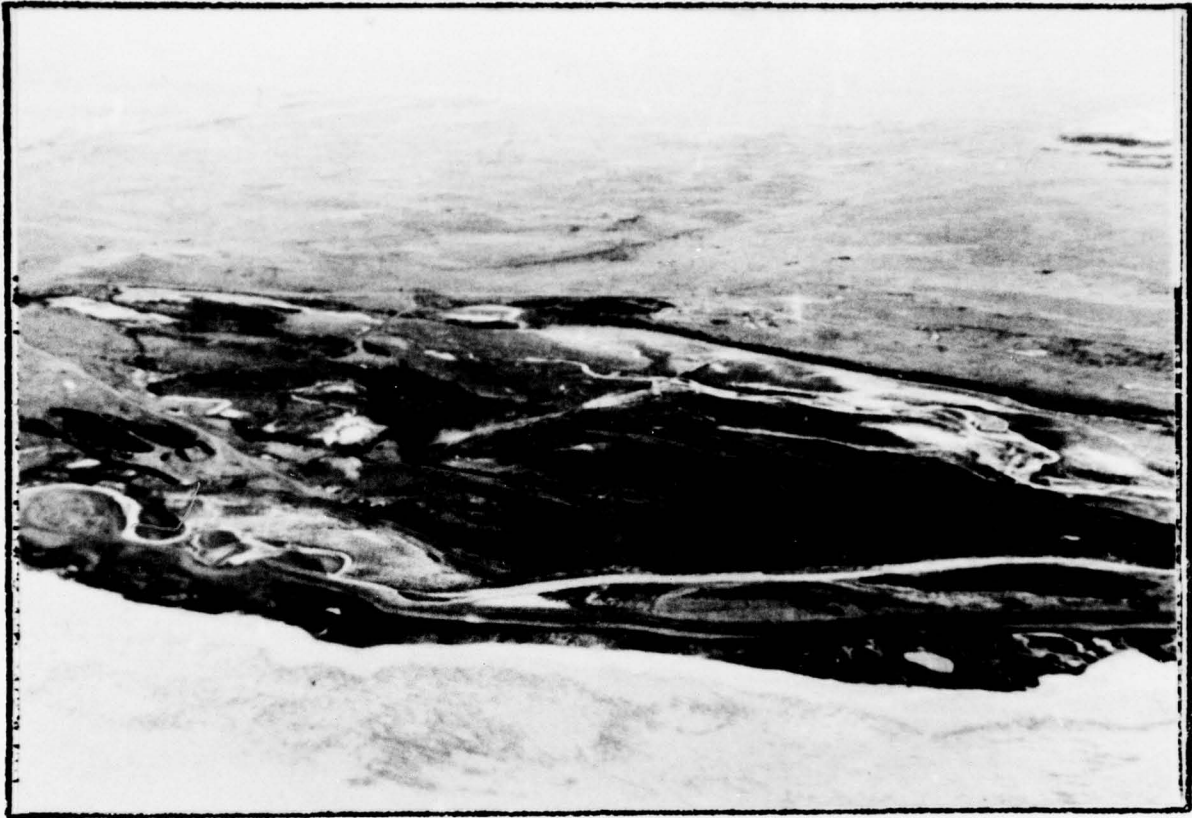
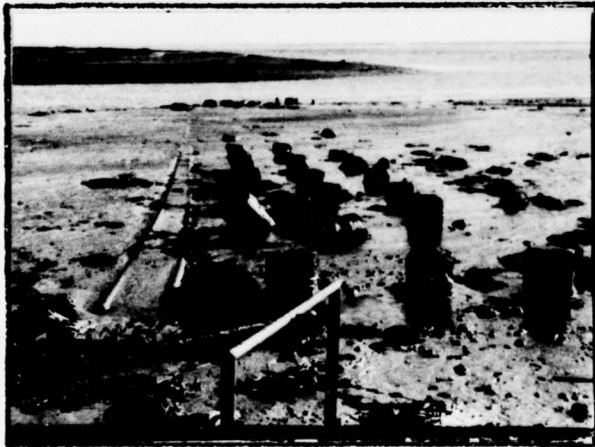
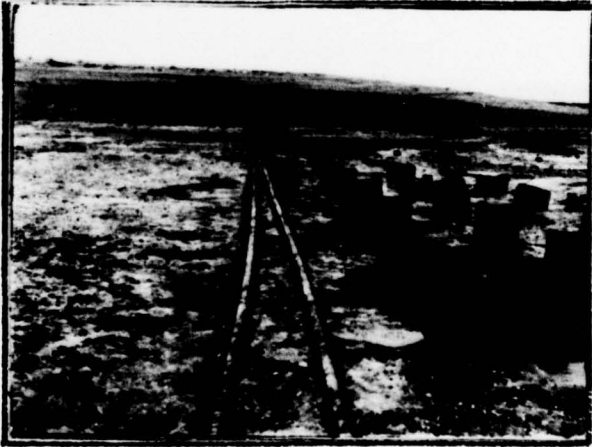
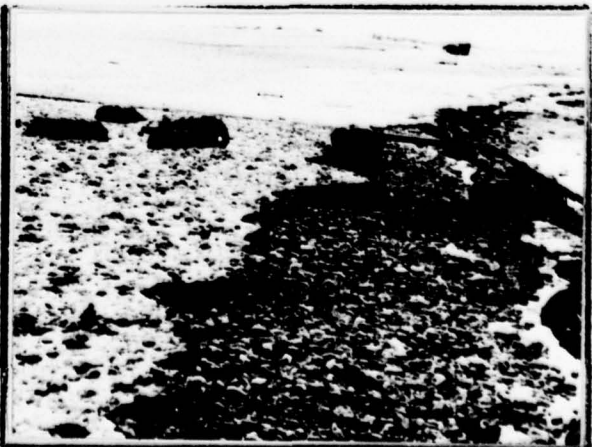
FIGURE 30

An oblique aerial view of the entrance area is shown in Figure 30 Part A. Figure 30 Parts B, C, D and E show views of an old pipeline and dock area at the West Estuary entrance. It is of interest to compare the depth of coverage in 1974 versus 1978. In 1978 the entire area along the pipe is still mousse covered, but the thickness has been reduced by weather and loss of water.

Figure 30 Part E shows the eroding lower edge of this deposit. It has only moved a few meters in the three and a half year period but does continually back oil into the West Estuary waters. The banks along the West Estuary were essentially paved with mousse in 1974. Figure 31 Part A shows an Environmental Protection Agency scientist viewing the paved north bank in January 1975.

- A - Aerial photograph of entrance to West Estuary at low tide.
- B - Oil drum area near mouth of West Estuary in August 1974.
- C - Aerial view of oil drum area in January of 1975.
- D - Oil drum area near mouth of West Estuary in January 1978.
- E - Eroding lower edge of oiled layer at oil drum area.
