FATE OF OIL SPILLED FROM THE
SUPERTANKER METULA

ROY W. HANN, JR.
HARRY N. YOUNG, JR

JANUARY 1979

FINAL REPORT

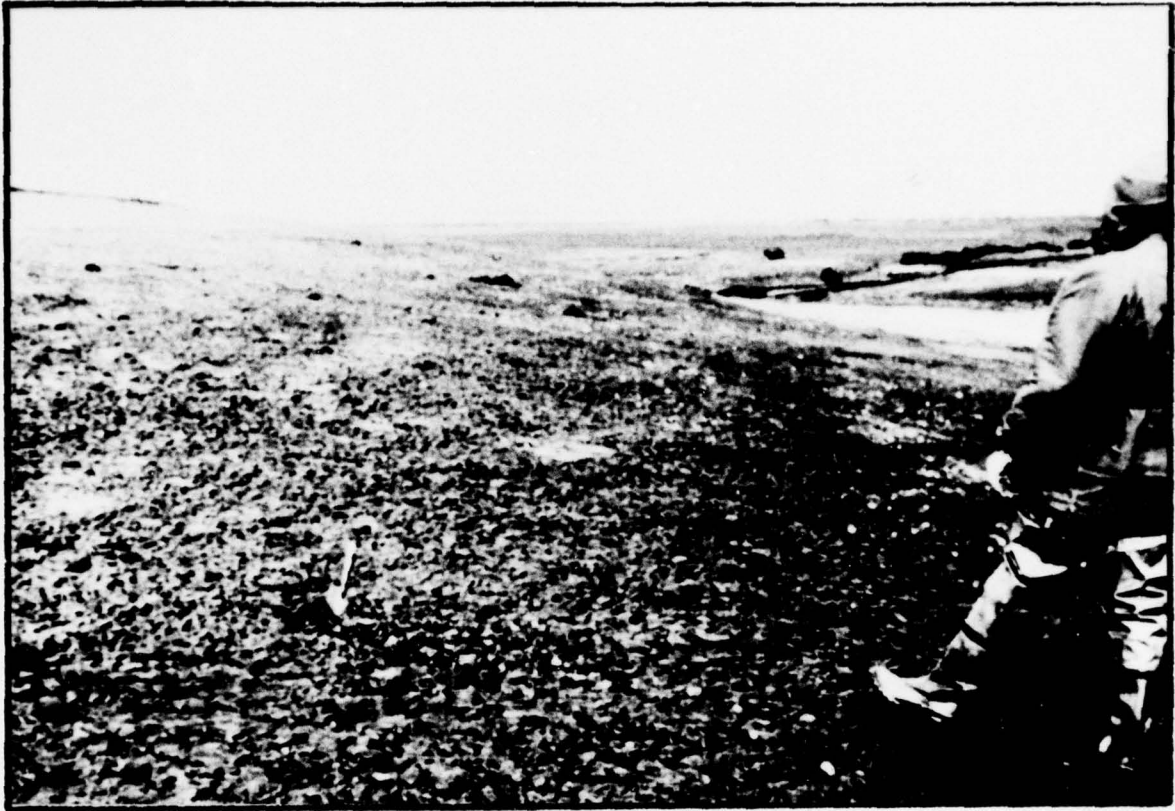
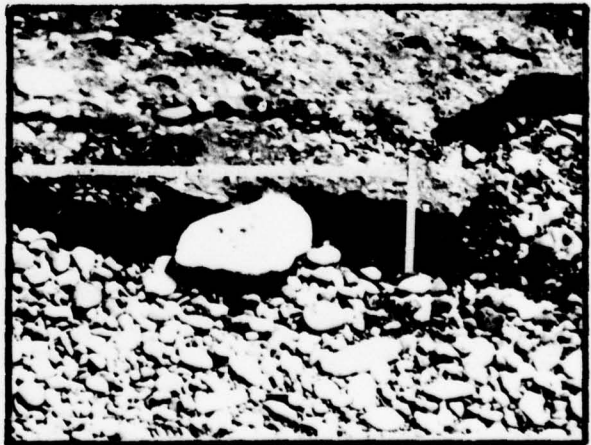
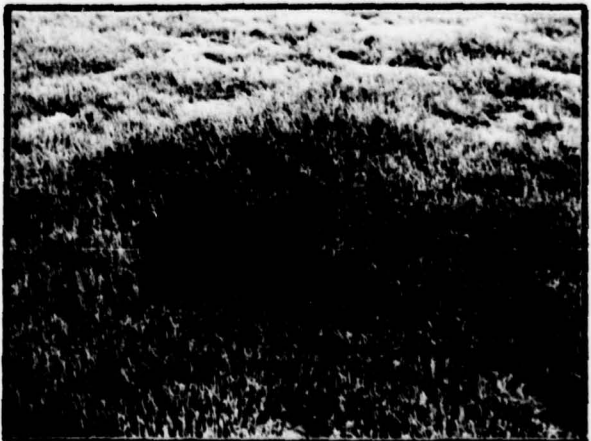
FIGURE 31

Figure 30 Part E shows the eroding lower edge of this deposit. It has only moved a few meters in the three and a half year period but does continually back oil into the West Estuary waters. The banks along the West Estuary were essentially paved with mousse in 1974. Figure 31 Part A shows an Environmental Protection Agency scientist viewing the paved north bank in January 1975.

Figure 31 Parts B through D show views of the eroded and non-eroded areas in 1978 and a closeup of an eroding edge at the spring high tide level near the mouth where the limited erosion is taking place.

Figure 31 Part E shows a newly oiled area in a salicornia patch in 1978. This oil had leached from a patch of older oil under the influence of summer sun and high tide and been deposited in a heretofore uncovered area. Figure 32 Parts A, B, C and D show various views of stranded mousse on the salt marsh and mud flats of the West Estuary in 1974 and January 1975.

- A - Oiled north bank of West Estuary in January of 1975.
- B - Eroding upper edge of paved bank on South Shore.
- C - Another view of eroding upper edge.
- D - Close-up of eroding edge.
- E - Patch of Salicornia newly oiled by oil washed from previously oiled area on a warm day.

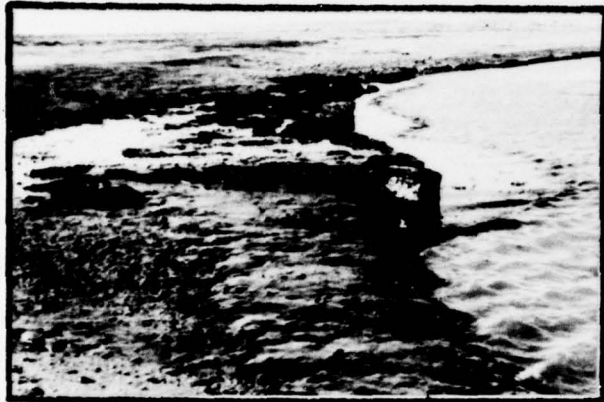
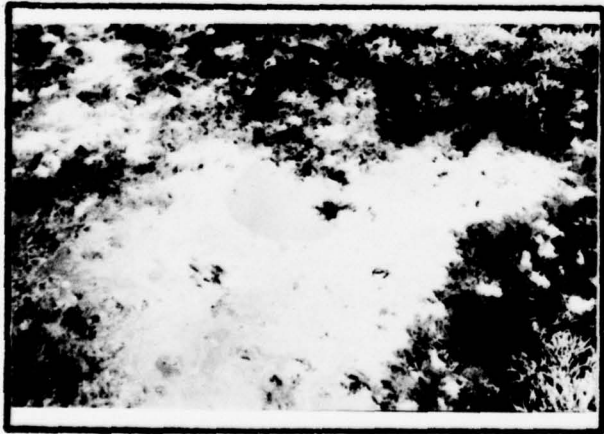
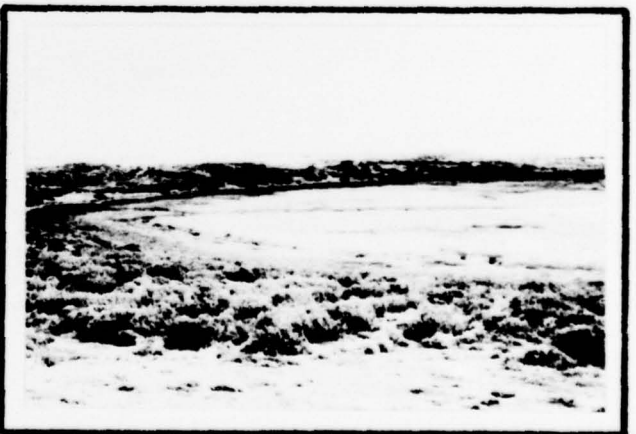
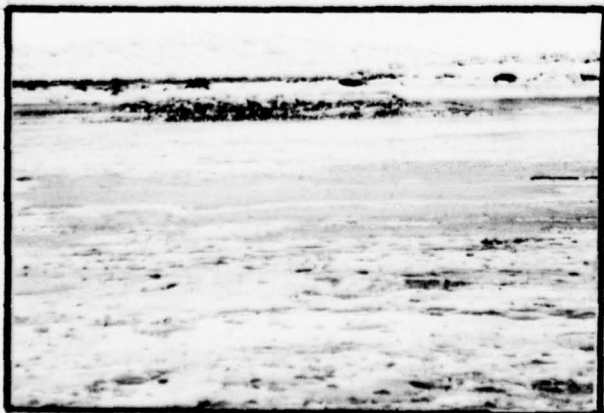
FIGURE 32

Further inland in the West Estuary are tidal flat areas originally covered with salicornia and large barren sand flats. Figure 32 Parts E, F, G, and H shows a sequence of photographs of one of these areas taken from 1974 through 1978.

It may be noted that the same oiled areas are evident in each of the photographs. The texture and sheen of the oiled areas have dulled from

- A - Oiled Salicornia area in tidal marsh.
- B - Oil stranded on mud flat inside West Estuary bend.
- C - Oiled Salicornia and pool of oil.
- D - Oil stranded on mud flat.
- E - West Estuary Marsh 8/74
- F - West Estuary Marsh 1/75
- G - West Estuary Marsh 1/77
- H - West Estuary Marsh 1/78

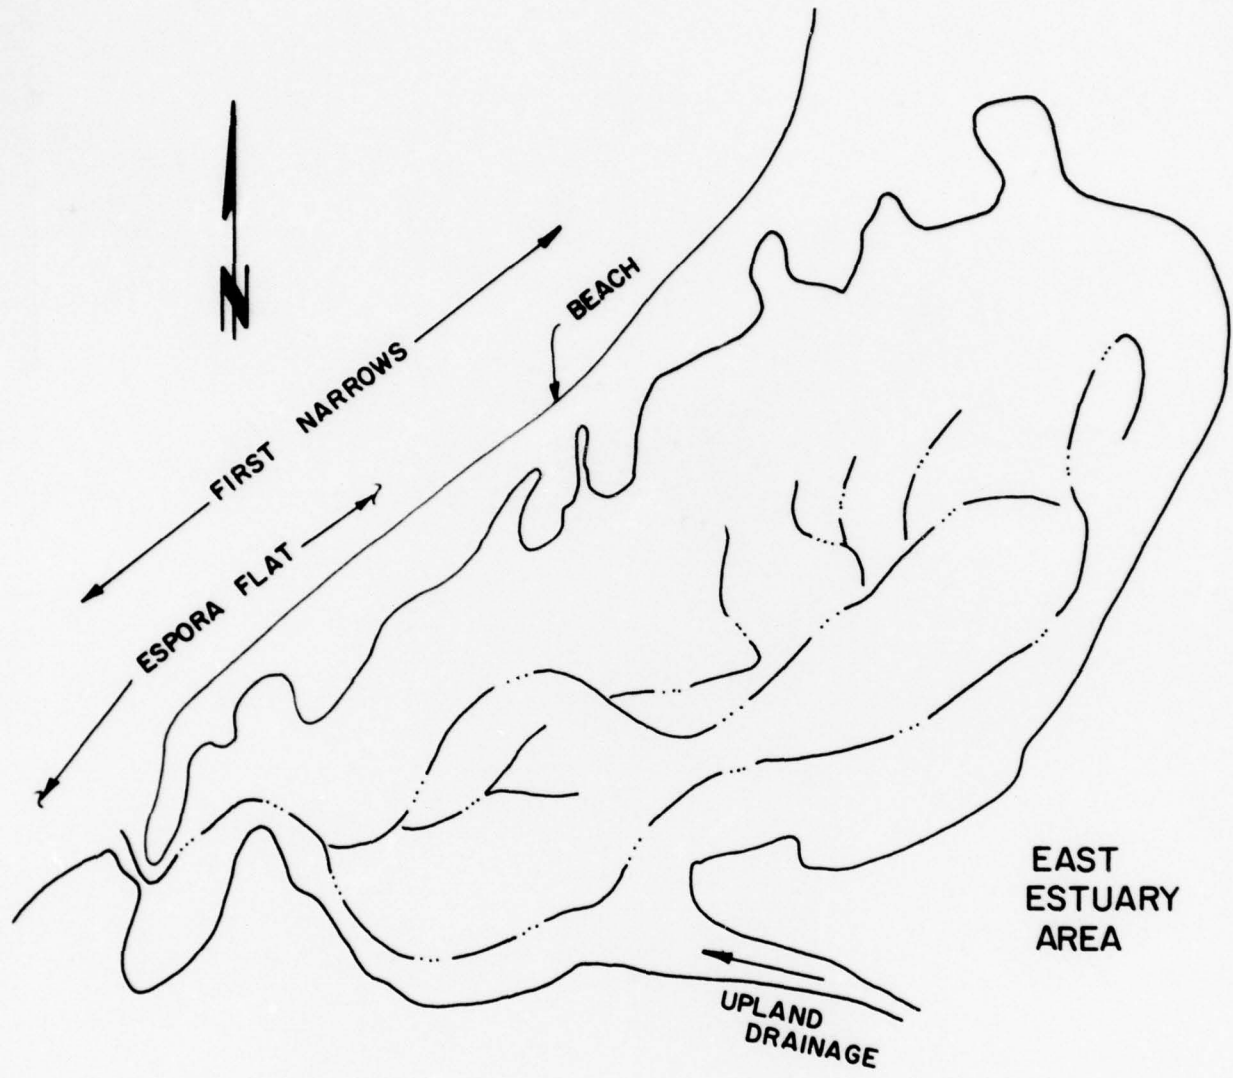
The East Estuary is a winding, twisting estuary which splits into several channels. The estuary drains a flat basin covered with grass and salicornia. Figure 33 shows an aerial photograph of the East Estuary and the Espora Flat over which the estuary drains. Figure 34 shows oblique aerial photographs of the estuary. Part A is taken from the Narrows looking shoreward and Part B from the back of the estuary looking toward the First Narrows.

FIGURE 33
AERIAL VIEW OF THE EAST ESTUARY FIRST NARROWS

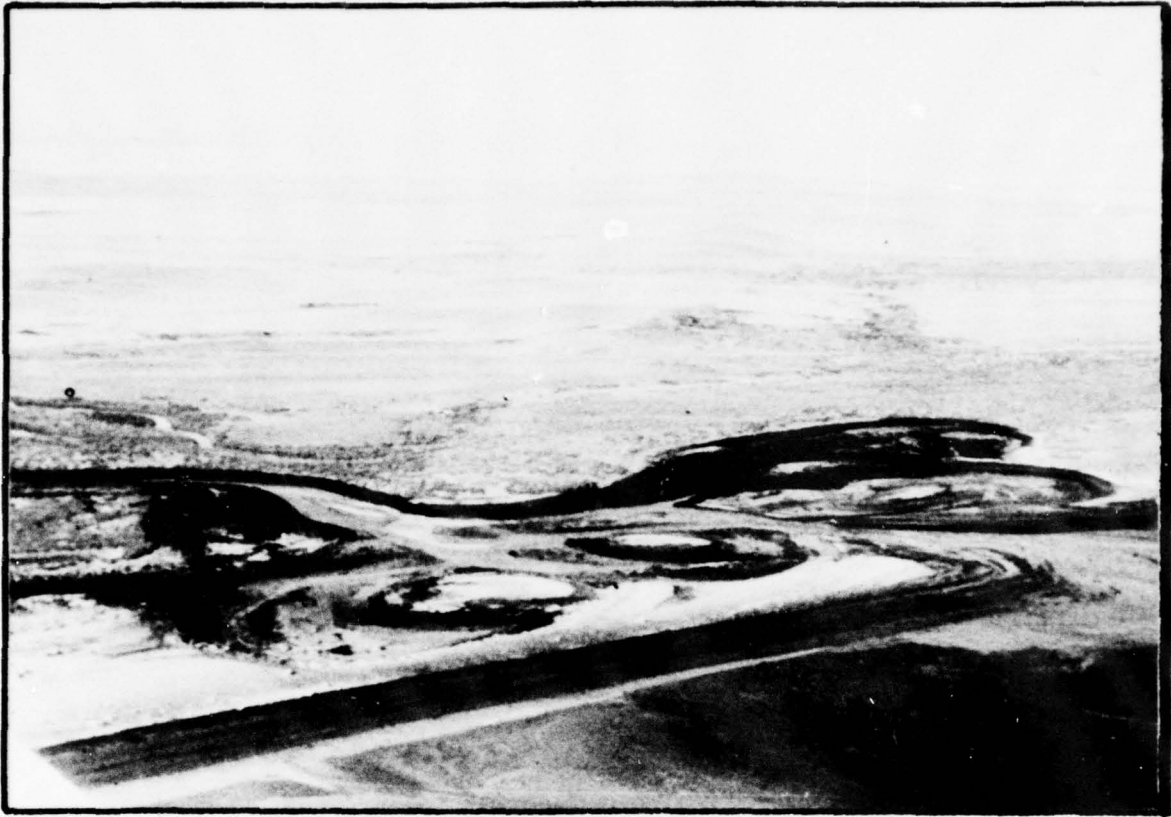
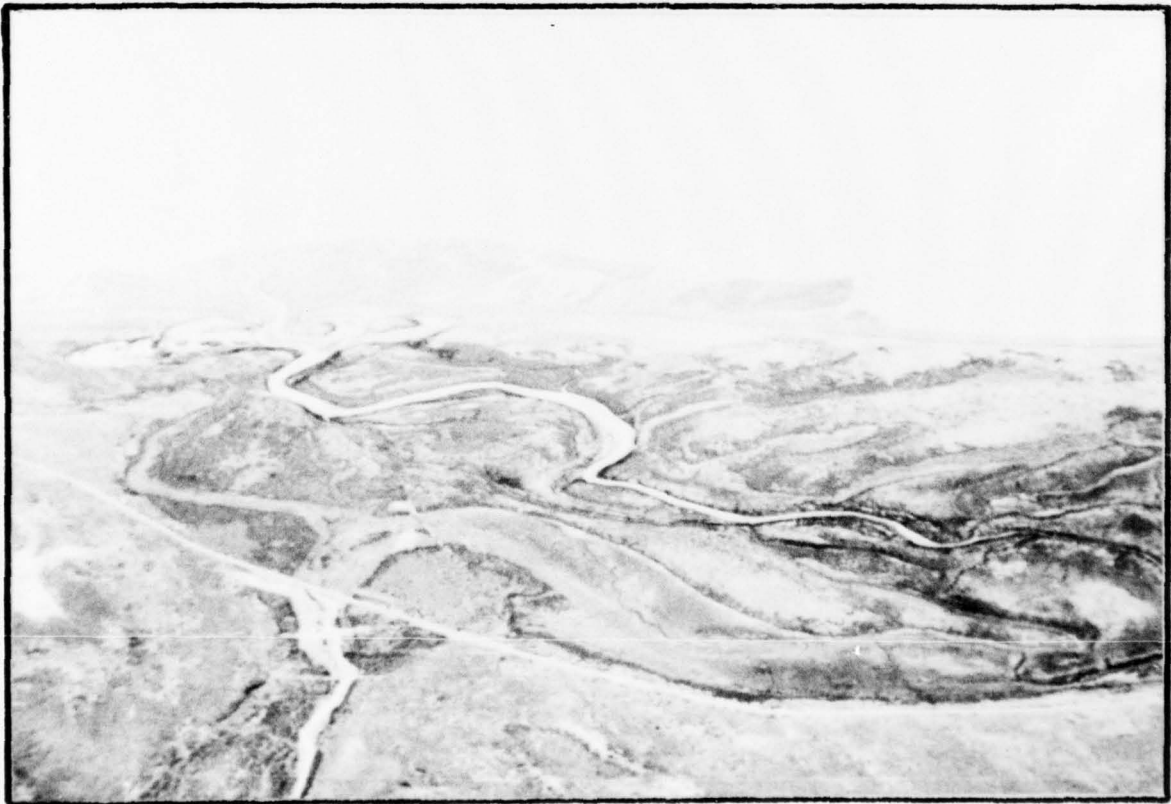
FIGURE 34

- A - Aerial view of East Estuary looking south.
- B - Aerial view of East Estuary looking northwest.

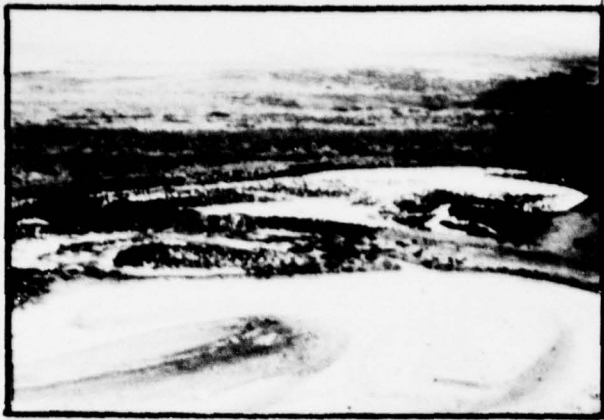
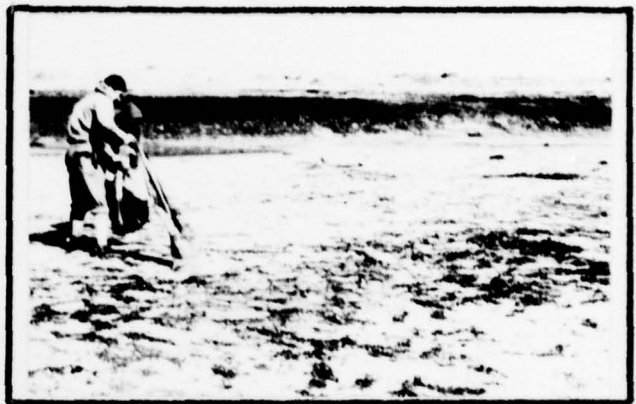
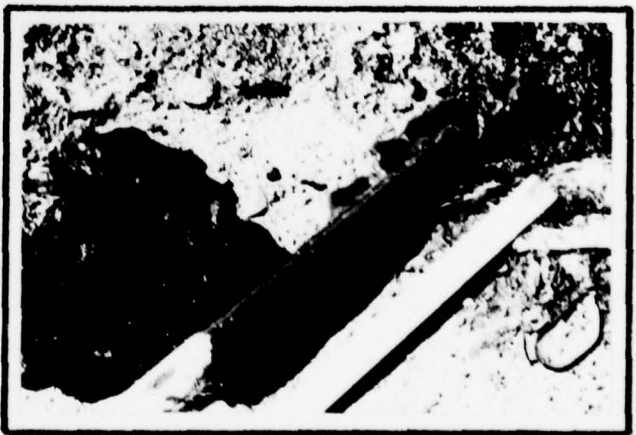
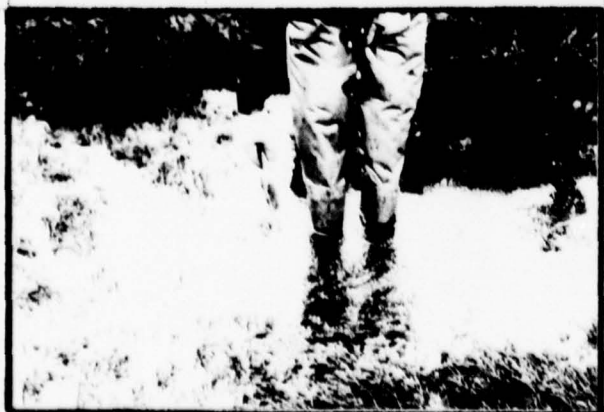
FIGURE 35

Figure 35 Parts A, B, C and D show views of the entrance area of the estuary in January 1975. In this area depressions and secondary channels were filled with mousse from a few centimeters to over 25 centimeters deep. The sediments of the channels and the channel banks were covered with mousse and mousse up to several centimeters thick. Figure 35 Parts E, F, G and H show views of this area in 1977. The area has changed very little since originally oiled. Entire areas are grotesquely black with no vegetation recovering. Liquid mousse remains in depressions and the channel bottoms are paved with moussecrete from 8 to 15 centimeters

The surface of the oil has blackened and in some cases algae and sediment form a thin film on the surface which dulls the appearance. Underneath, however, soft mousse is found everywhere.

- A - Aerial photograph of entrance area.
- B - Bank of East Estuary near mouth.
- C - Pooled oil near the entrance.
- D - Oil in shallow depression near entrance.
- E - Oiled basin near the entrance channel.
- F - Oiled bottom of a bend in the East Estuary.
- G - Close-up of oiled surface.
- H - Eroding edge of oiled sediments.

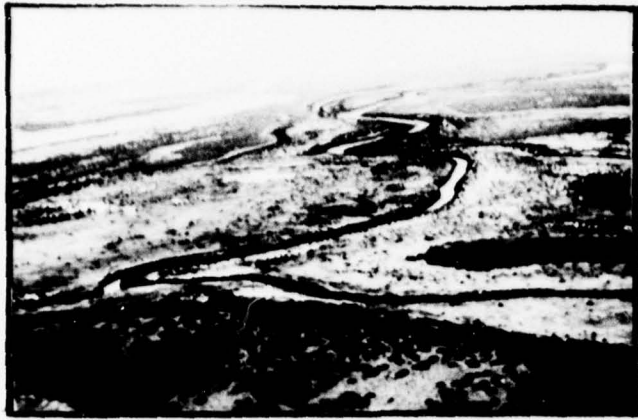
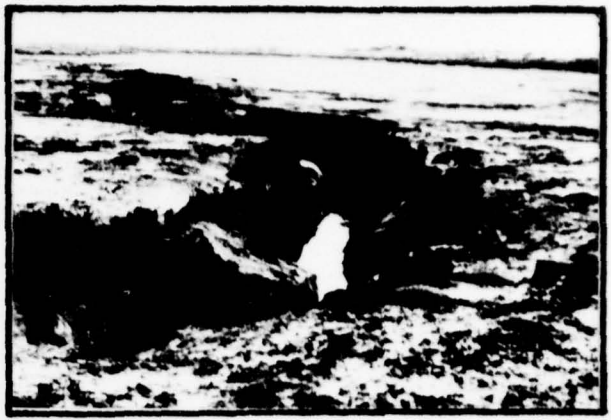
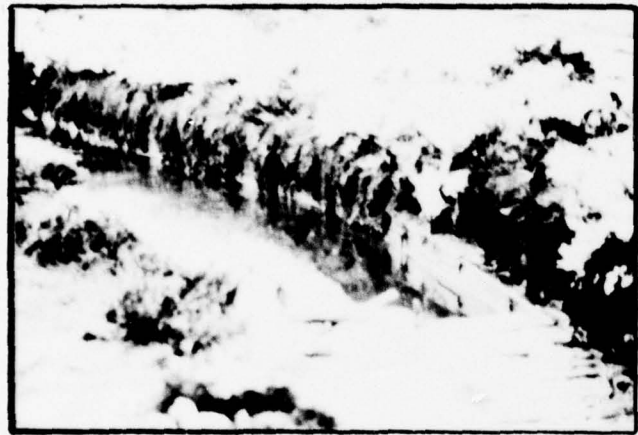
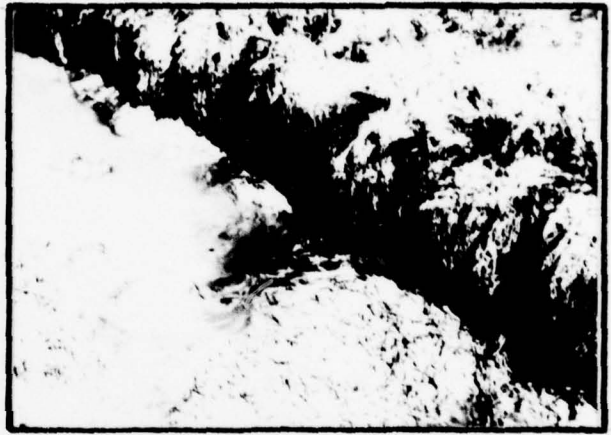
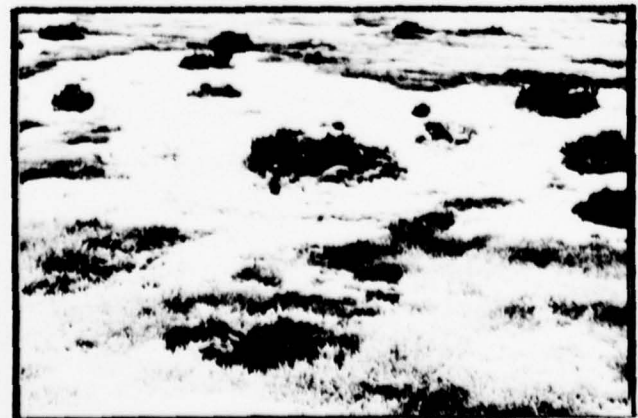
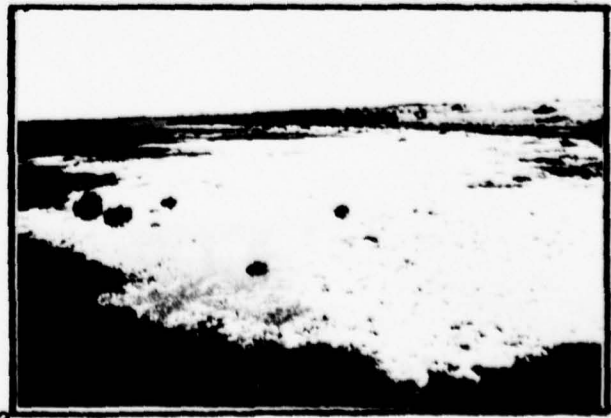
FIGURE 36

The estuary channels from about one kilometer inland were reported completely filled with floating mousse to the ends of the smallest channels in the system in January 1975. The channels were estimated at that time to have from 20 to 30 centimeters (8 to 12 in) or more of floating mousse trapped in it. The mousse would rise and fall with high spring tides and recoat the channel walls and vegetation. These channels are shown in Figure 36 Parts A, B and C.

The mousse had been flushed from the channels by January of 1976, but the flat areas between channels and the channel bank as shown in Figure 36 Part D in 1975 and Parts E, F, G and H in 1977 and 1978 remained heavily oiled. This liquid mousse or oil on the surface remains in a soupy liquid form which has changed little in the three and a half years since the spill. Only in the areas where the mousse was not thick has the deposit thickened and hardened. This area will probably have evidence of the METULA spill for 15 to 20 years unless it is ultimately cleaned up.

- A - Aerial view of inland channels showing oil on channel banks.
- B - Close-up of channel edges showing oiled vegetation.
- C - Thick pool of oil remaining in channel five months after the spill.
- D - Isolated oiled vegetation on tidal grass flat.
- E - Oiled channel at later date.
- F - Oiled vegetation on banks 3 1/2 years after the spill.
- G - Oiled channel 3 1/2 years after the spill.
- H - Oiled pool on tidal grass flat 3 1/2 years after the spill.

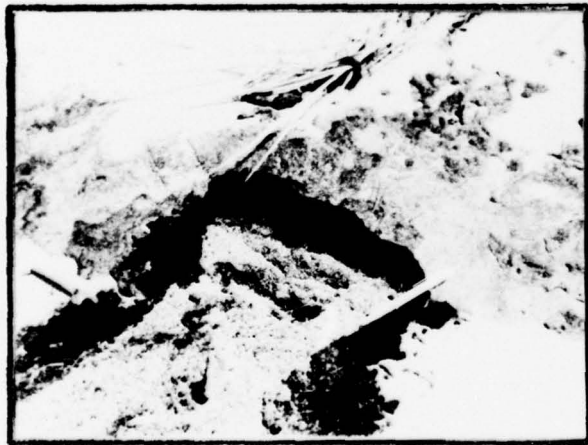
The intertidal zone in Punta Anegada is identically the same as the Puerto Espora area. The amount of oil on the shore fell off rapidly as one proceeds several kilometers east of Punta Anegada at the time of the spill. Figure 37 Part A shows a typical section of this beach line in January of 1975. At that time a 2-to 4-meter (6-12 ft) zone of exposed mousse was observed on the surface and an area of covered mousse and oiled rocks was observed down the beach slope. As shown in Figure 37 Part B and D by 1977 this had eroded to an occasional crust of weathered oil and sand mixture at the top of the beach line.

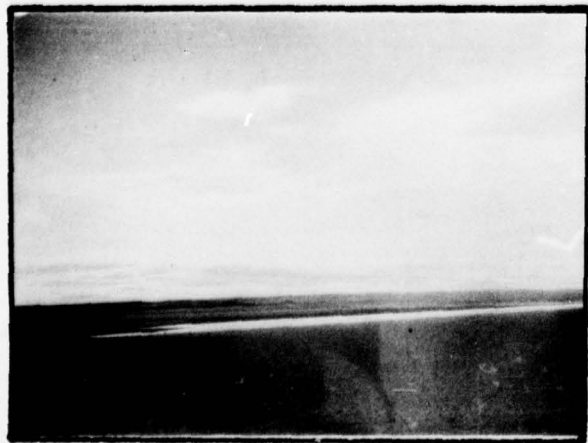
Further east is a broad flat intertidal area west of Punta Catalina. This run appeared to have a heavy oil coating from the air at the time of the spill as shown by the aerial photograph in Figure 37 Part C but only this was probably a wide sheen of fresh oil that was photographed.

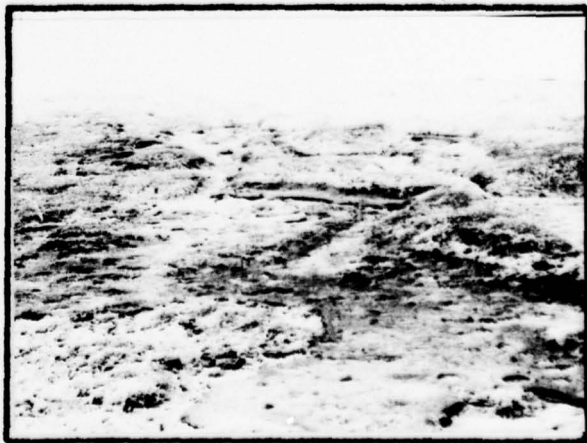
Investigation in January of 1975 showed only occasional oiled areas at the high tide zone as shown in Figure 37 Part D.

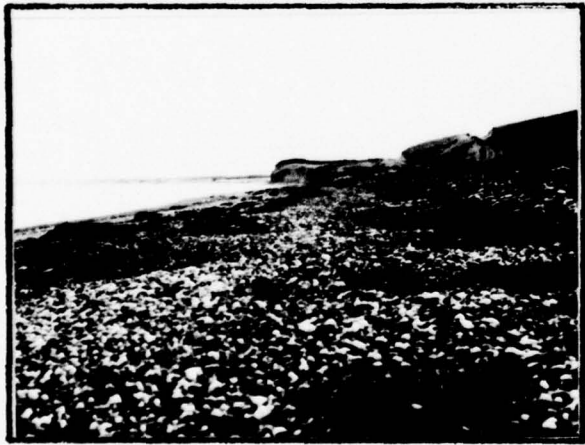
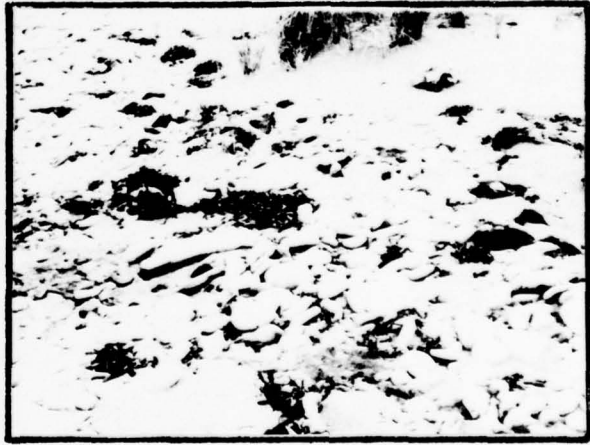
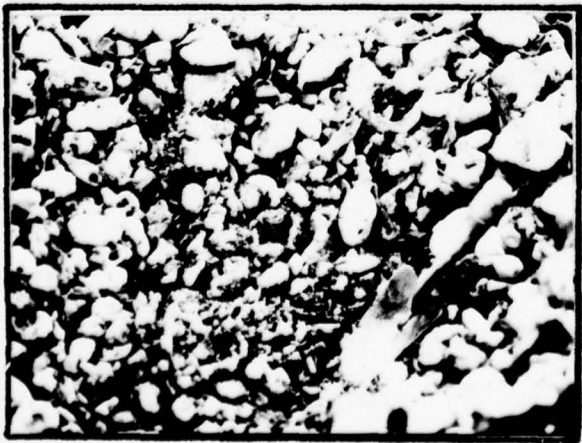
The south shore of the continent to the east of the First Narrows between Punta Dungenes and Punta Posession was observed by air to be banded with mousse of varying widths in early September of 1974. The mousse in this area was deposited by the southwesterly wind of September 1, 1974 which stripped much oil from the south shore of the First Narrows. An aerial view of this deposit at that time is shown in Figure 38 Part A. The zone of the beach was first visited in January of 1975. At that time it was reported at a location 5 kilometers (3.11 mi) east of Pt. Posession, an 8-meter (26 ft) wide band of mousse mixed with sand ranging from a one-centimeter ($3/8$ in) outcrop on one side to a 3 centimeter ($1\frac{1}{4}$ in) on the other was observed. Occasional patches of mousse and slightly oiled rocks were observed outside this band.

Near an ENAP oil facility, approximately 18 kilometers (11.18 mi) west of Punta Dungenes, a layer of mousse mixed with gravel and rock was found which was approximately 6 meters (20 ft) wide and from 5 to 10 centimeters (2 to 4 in) in depth. The layer was covered with approximately 15 centimeters (6 in) of cobbles which were 25 percent covered with light oil.

- A - Stranded mousse at top of beach east of Punta Posession.
- B - View of oil spotted rocks on the beach east of Punta Posession.
- C - Closeup of oiled area on beach east of Punta Posession.
- D - Oil patches of questionable origin east of Punta Posession.
- E - New oil from non-METULA source near Punta Dungenese.

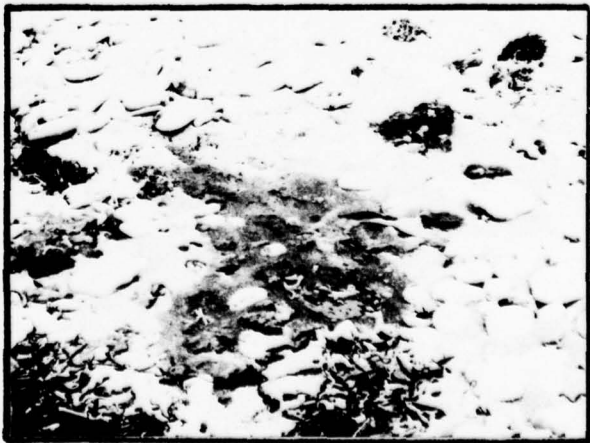
In 1978 extensive oiling was found on this shore near an ENAP sludge spill point and near Punta Dungenes where a recent ENAP oil spill took

place. Figure 38 Parts D and E show examples of these later spills. No oil was found, however, that appeared to be METULA oil. It is believed the location of these beaches so as to receive heavy surf from the strong westerly winds caused the oil to quickly dissipate into the water column.

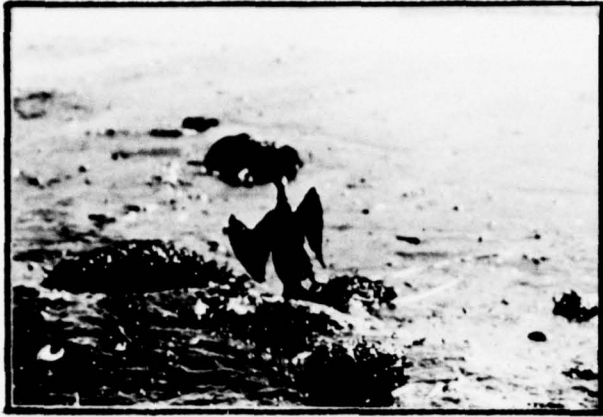
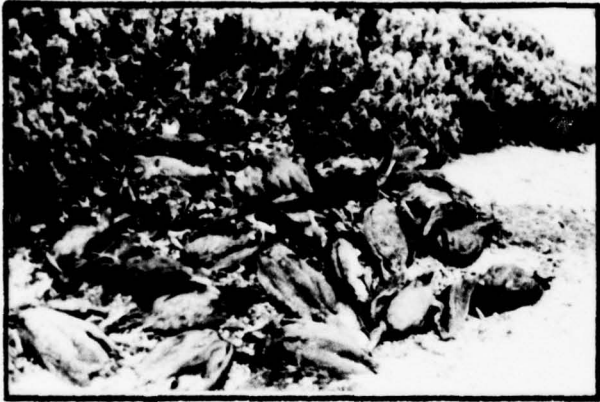
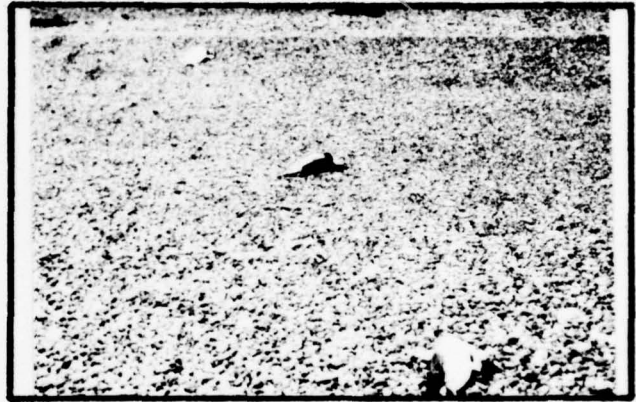
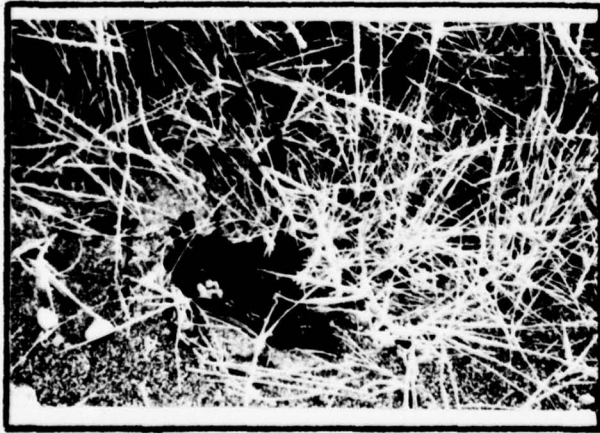
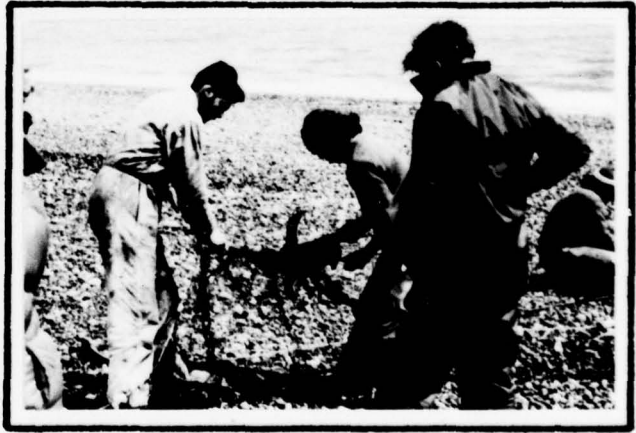
The significant impact of the spill on waterfowl was reported in detail in the initial METULA report by the author. The greatest impact was on the cormorant and penguin communities. Figure 42 Parts A through D show oiled and dead cormorants and penguins at the time of the spill and in January 1975. Mummified oiled birds could still be seen in 1978 as shown in Part E of Figure 42.

- A - Oiled Cormorant near Punta Espora.
- B - Group of 22 dead cormorants found within a 15 meter radius east of Punta Anegada.
- C - Oiled dead Penguin.
- D - Oiled Penguin.
- E - Oiled dead Penguin.
- F - Oiled dead Penguins near Punta Dungenes.
- G - Penguins trapped in fish nets near Punta Dungenes.
- H - Close-up of oiled dead Penguins killed in nets.

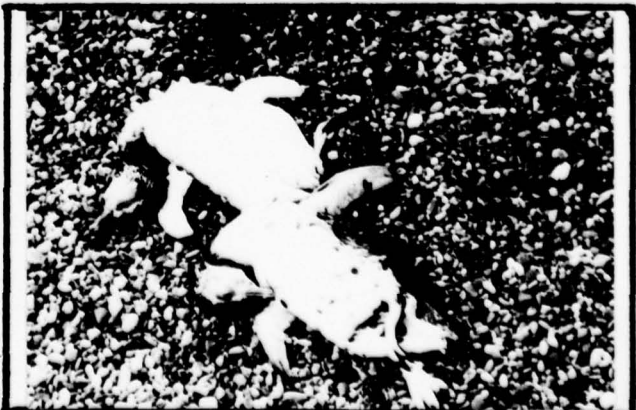
The mystery as to the cause of death of over a hundred oiled and dead penguins observed in January of 1978 was solved when it was found that local fishermen were catching migrating penguins in their nets and wringing their necks to remove them. The bodies were then floating in the intertidal zone and coming in contact with oil spilled in November 1977 from an ENAP facility.

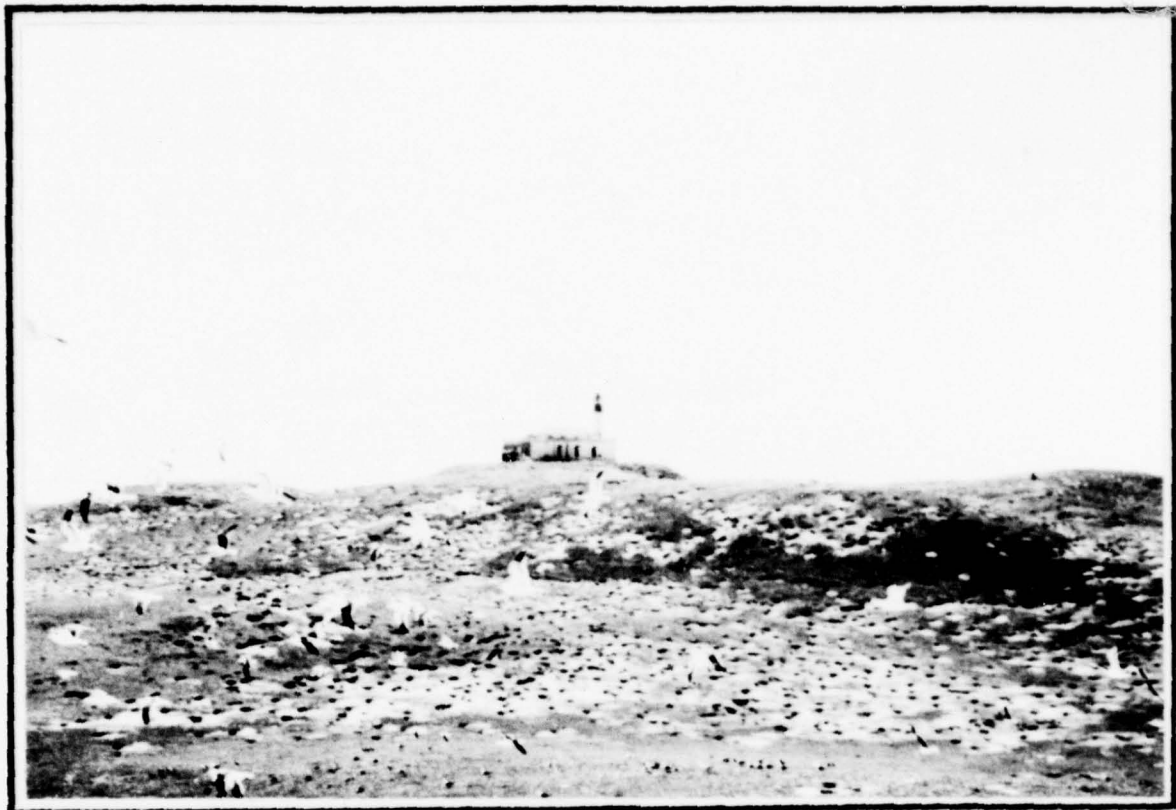
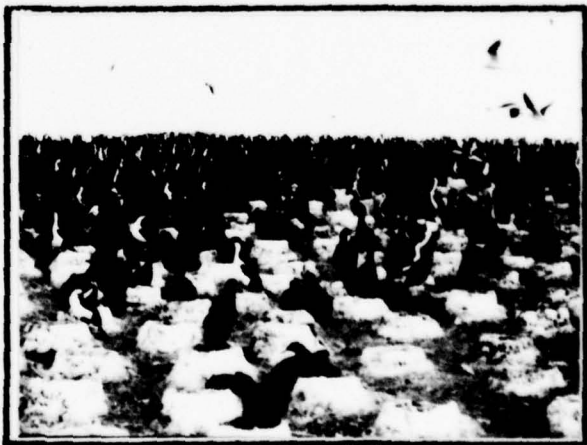
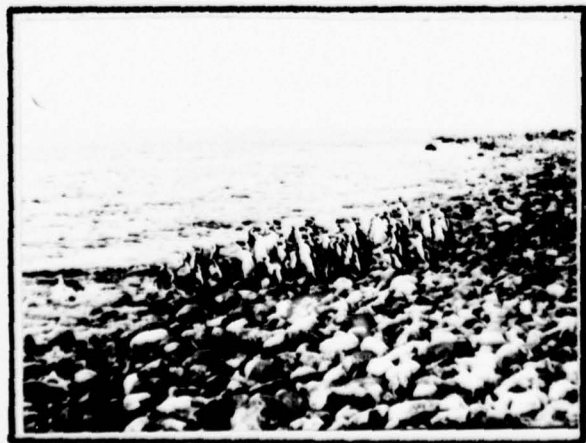
FIGURE 43

- A - Deserted lighthouse and occupied penguin burrows on Isla Magdalena.
- B - Aerial photograph of Isla Magdalena.
- C - Penguin welcoming committee on Isla Magdalena.
- D - Cormorant colony on Isla Magdalena.
- E - Typical penguin home and family on Isla Magdalena.
