HARRY DIAMOND LABS ADELPHI MD
STRUCTURAL FIRING TESTS OF THE M735 PROXIMITY FUZE.(U)
MAY 79 J M MILLER, S A BORING

HDL-TM-79-6

REPORT DOCUMENTATION PAGE		READ INSTRUCTIONS BEFORE COMPLETING FORM
1. REPORT NUMBER 14 HDL-TM-79-6	2. GOVT ACCESSION NO.	3. RECIPIENT'S CATALOG NUMBER
4. TITLE (and Subtitle) 6 Structural Firing Tests of the M735 Proximity Fuze	5. TYPE OF REPORT & PERIOD COVERED Technical Memorandum

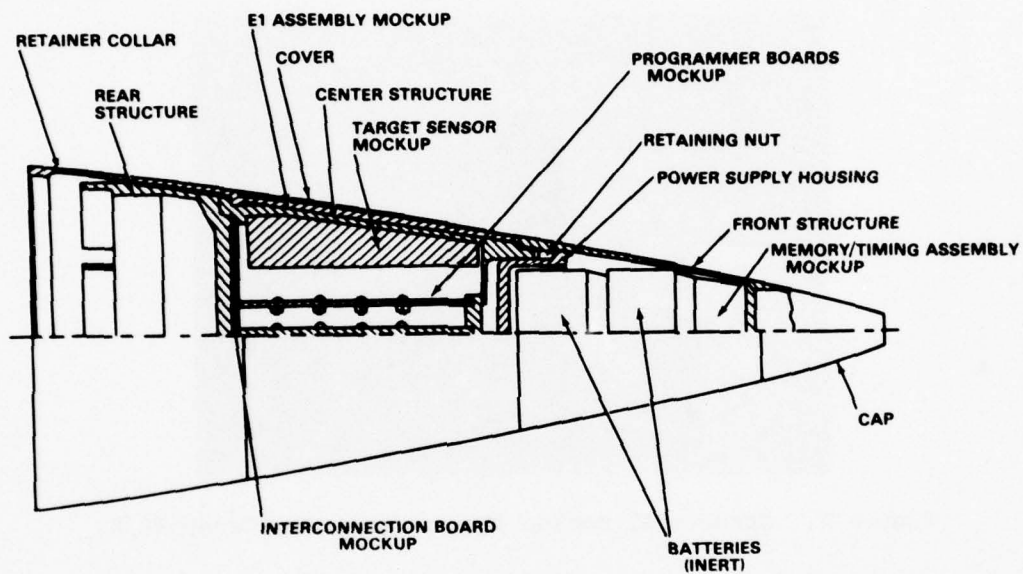
Figure 8. Structural mockup fuze, Group 4A/B.

Referring to figure 8, the test specimens were assembled with the following fuze parts: cap, forward structure, power supply housing (with potting), retaining nut, center structure, retainer collar, rear structure, cover, and miscellaneous brackets and fasteners. The PS416 batteries were replaced with inert batteries (electrolyte not included). The memory/timing assembly was replaced with a solid metal disk. The mass of this component was adjusted for different load factors by using different density materials. The E1 assembly was replaced with a blank mockup bonded to the center structure. The target sensor assemblies were replaced with blank rf housings. Brass plates were attached to the

housings to adjust the mass of these assemblies for different load factors. The interconnect assembly consisted of an insulator, spacer, and bare multilayer interconnect board. The programmer assembly consisted of bare multilayer programmer boards and all associated mounting hardware. Nuts and bolts were attached to the boards to adjust the mass of this assembly for various load factors. Connectors and wire harnesses were not included in any of the above assemblies. A set of structural fuze components is shown in figure 9.

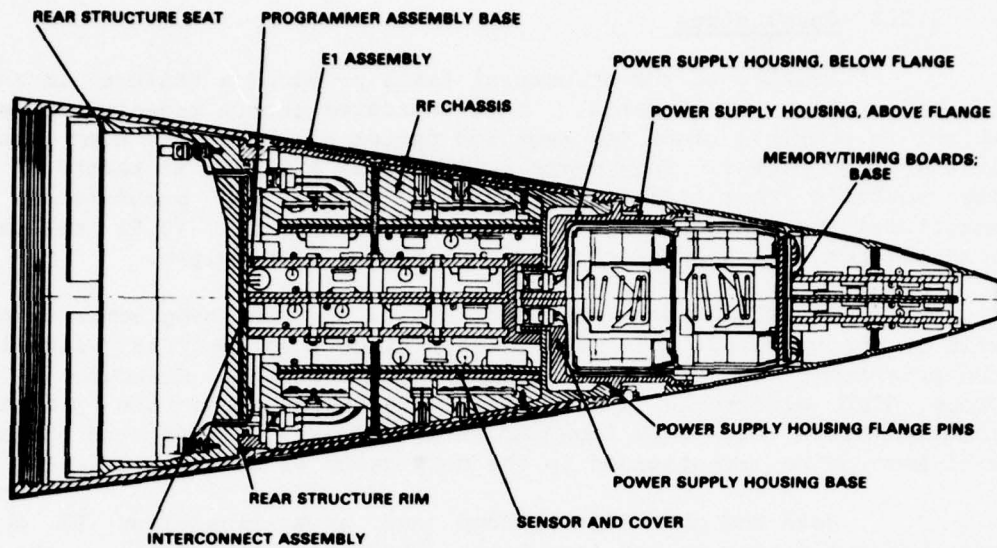
Figure 12. M735 load locations.

Three structural fuzes were assembled, all having the same internal load factors. Figure 12 shows the location of the loads of interest, and table 9 gives the design weights at these locations. The mockup assemblies were designed to 1.25 times the weight of the electronic subassemblies they were replacing. However, when combining subassemblies in the fuze, load factors vary. The actual fuze parts used were the forward structure, forward retainer collar, a potted power supply housing without the wiring harness, center structure, rf chassis, rear structure, retainer collar, and all assembly fasteners. A weight

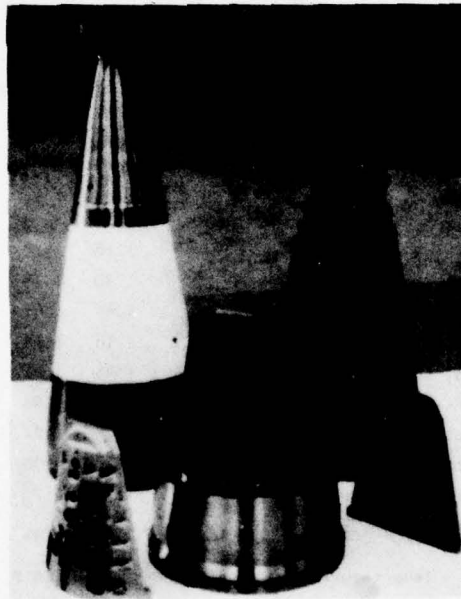
Figure 13. Group 5 structural fuze.

was bolted to the nose of the forward structure to produce an overload on the fuze outer shell. The E1 assemblies were replaced with modified blank mockups. Copper tape was wrapped on these to bring them up to actual weight. The vertical memory/timing boards were weighted with brass plates mounted with nuts and bolts. The interconnect and sensor spacers and insulators were replaced with brass plates. The programmer boards were weighted with nuts and bolts. All electronic boards in the first test were solid G-10 fiberglass boards. These were replaced with actual multilayer circuit boards in the last two tests. The PS416 assembly was replaced with an inert power supply and a machined steel mockup. The rf chassis was weighted with both internal and external brass plates. Programmer mounting-block studs of varying diameters and materials were used in these tests in order to find a stud of adequate strength. Figure 13 shows a Group 5 structural fuze and components.
