ARMY ENGINEER DISTRICT NEW YORK  
NATIONAL DAM SAFETY PROGRAM. SALISBURY MILLS DAM, INVENTORY NUM--ETC(U)  
APR 78 C H BENN

REPORT DOCUMENTATION PAGE		READ INSTRUCTIONS BEFORE COMPLETING FORM
1. REPORT NUMBER	2. GOVT ACCESSION NO.	3. RECIPIENT'S CATALOG NUMBER
4. TITLE (and Subtitle) Phase I Inspection Report Salisbury Mills Dam Moodna Creek Basin, Orange County, New York Inventory No. N.Y. #4		5. TYPE OF REPORT & PERIOD COVERED Phase I Inspection Report National Dam Safety Program

INVENTORY NO. 4

DATE: 19 April 1978

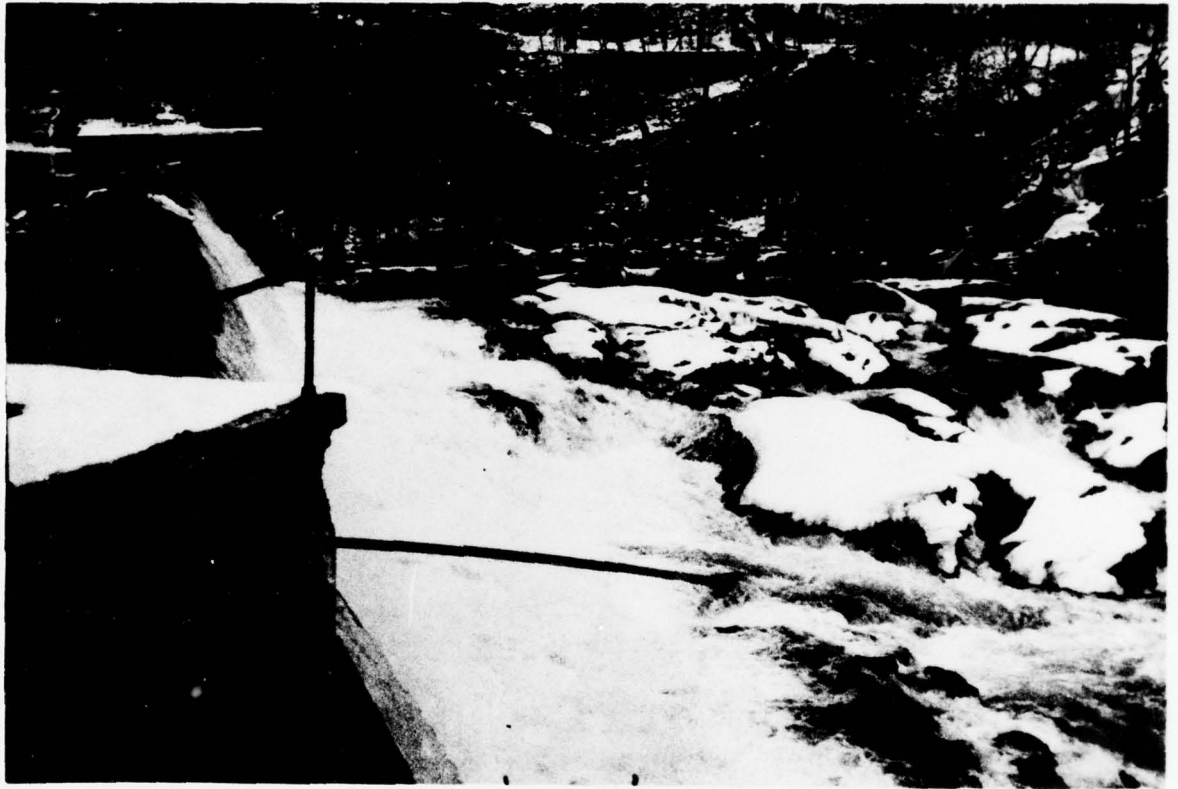
OVERVIEW PHOTO  
SALISBURY MILLS DAM

The Salisbury Mills Dam exhibits serious loss of supportive stone and leakage at the left masonry abutment tie-in wall and serious maintenance deficiencies which render the dam unsafe. The dam will be over-topped by the probable maximum flood or the standard project flood. Although the dam is founded on ledge rock and designed for over-topping the deteriorated condition at the left abutment would cause failure during over-topping. In addition, check of original stability computations indicates instability under conditions of the PMF or SPF. Although flood wave analysis indicates present downstream development would not be affected by a break in the dam, the possibility of serious injury or death to individuals in the downstream flood plain at the time of a break, exists. For this reason it is recommended that the impoundment be lowered immediately and a program of around the clock surveillance be initiated during periods of heavy flow. In addition missing manhole covers and deteriorated timbers on the intake structure should be replaced immediately. If the dam is not repaired, future development in the downstream area should be carefully monitored to assure that it does not fall within the flood plain.
