PRINCETON UNIV N J DEPT OF ELECTRICAL ENGINEERING F/G 19/1
THE INFLUENCE OF CONTACT AND INTERFACE EFFECTS OF THE ELECTRONI--ETC(U)
JUL 79 P MARK DAAG29-76-G-0017

FINAL TECHNICAL REPORT:

SCANNING AUGER MICROSCOPY (SAM) STUDIES OF WORN BORE SURFACES*

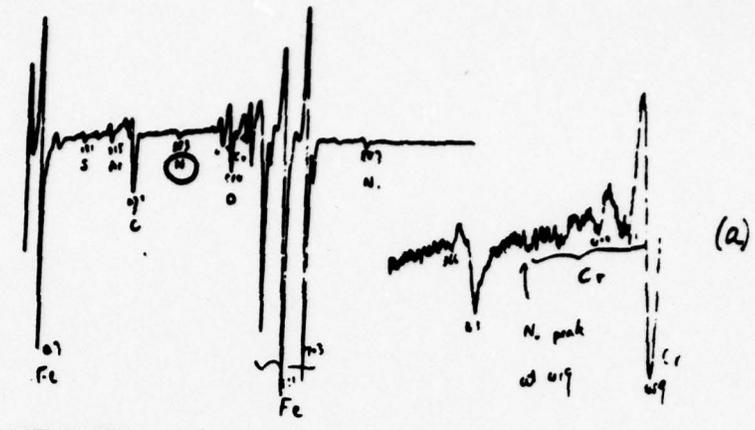
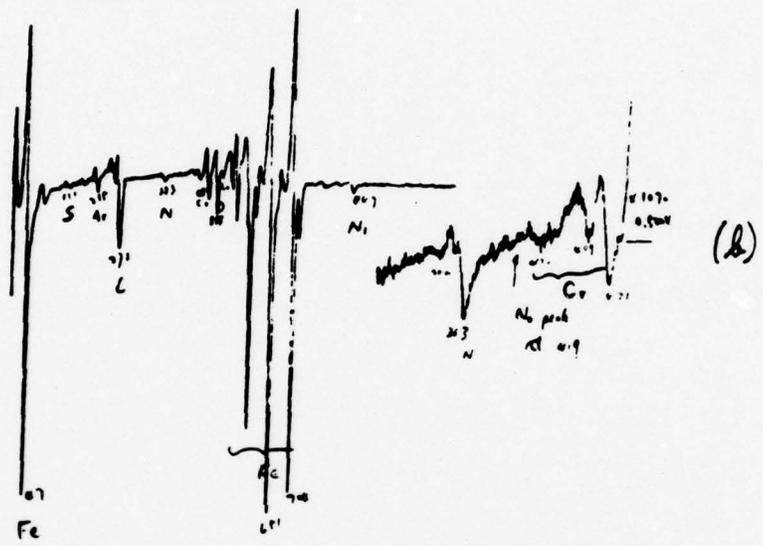
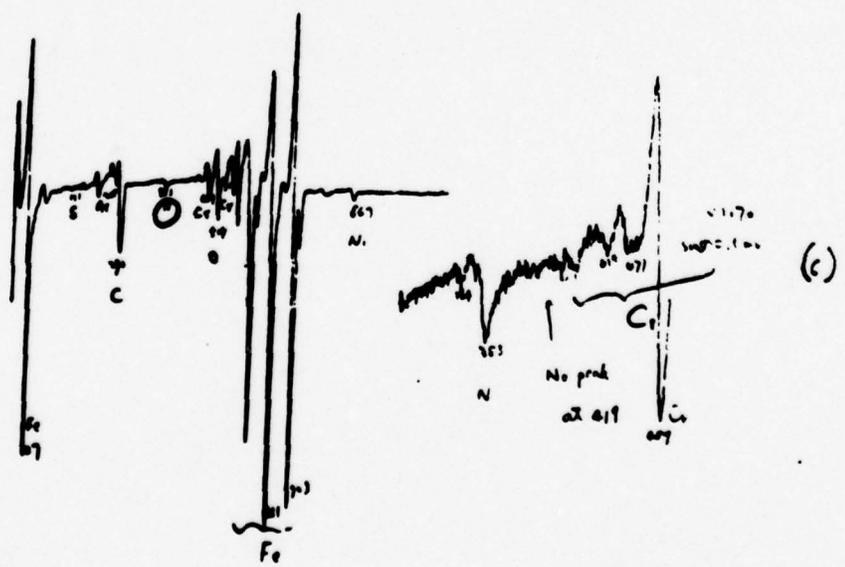
Figure 5

Although there are clear differences in the elemental distributions in these cracks, there are also some common features. For example, the C-images all show that carbon is distributed along the entire length of each crack. The C-signals of AES traces of Fig. 5 are clearly carbide signatures indicating that the carbon in the cracks are most likely metal carbides that have segregated there during the embrittlement of the steel. On the other hand, the N-images all show nitrogen distributions that tend to aggregate at the middle of each crack. The nitrogen is probably in the form of metal nitrides which were formed by reactions between the metal on the crack surfaces and the nitrogenous constituents of the hot propellant gases under pressure during the firings. The absence of nitrogen at the open end of the cracks can be attributed to competing reactions with oxygen to form volatile components. This is suggested by the fact that the O-images show the oxygen more or less concentrated at the open ends of the cracks, in part bonded to carbon (because of the partial correlation with the C-images) and in part as iron oxides because of the correlation with the iron images. No Ti was detected in the cracks. At this point in our work it is not clear why. It may have to do with the fact that the cracks were not clearly correlated with the austenitic grain boundaries of the pebbled surface.

Pebbled Surface: AES traces from surface cracks
 sputter-cleaned surface
 (a)-point A (b)-point B (c)-point C

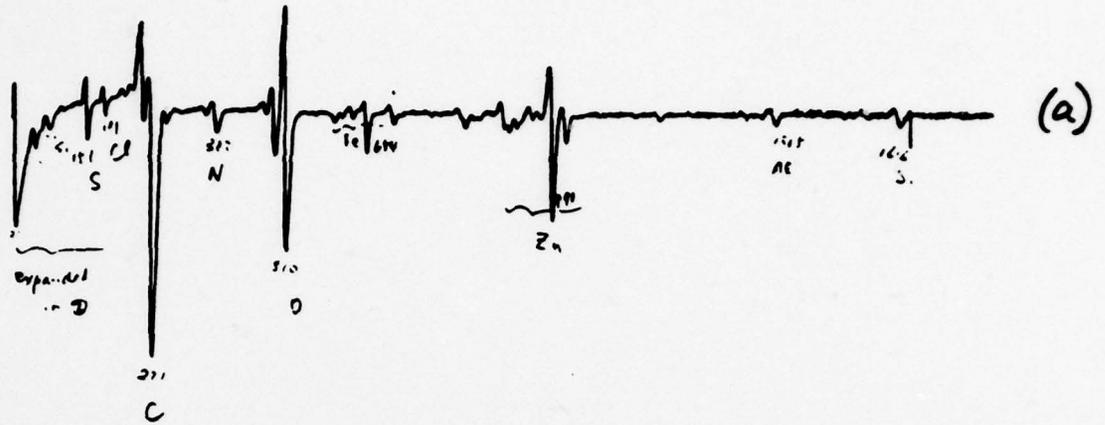
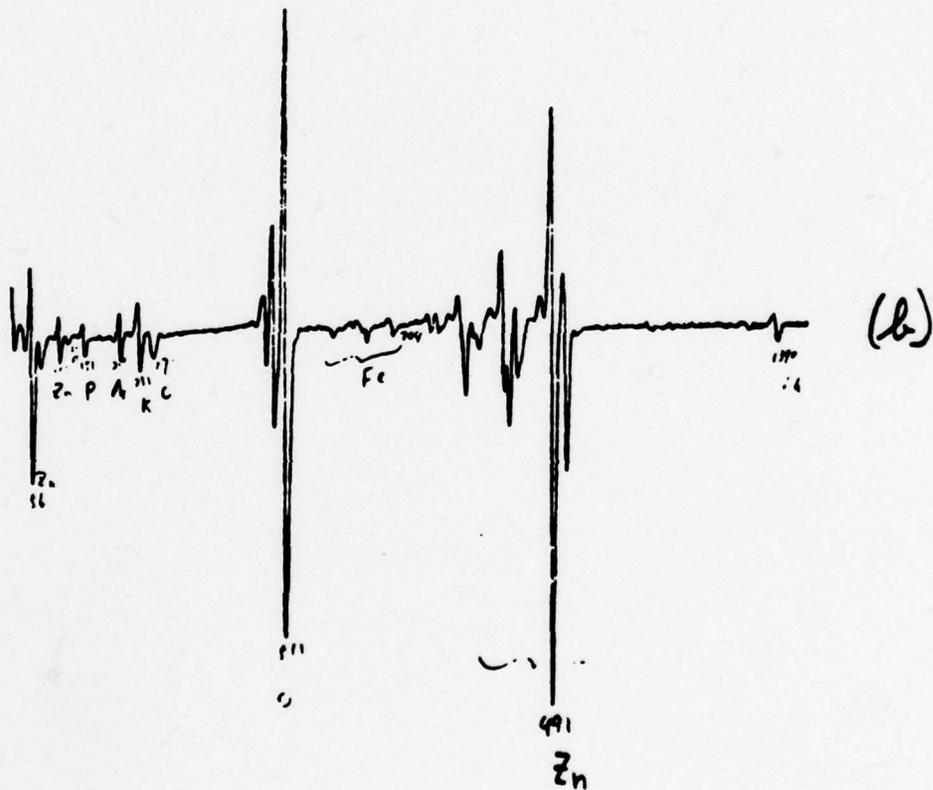
Figure 9

A section from a Cr-coated 105 mm M-68 barrel was also subjected to normal incidence SEM/SAM analysis. A low magnification SEM secondary emission image is shown in the photograph of Fig. 10, panel a. The AES trace from point B of the virgin surface is shown by trace a of Fig. 9. The AES trace of the sputter-cleaned surface is shown by trace b. Trace a shows the typical strong C- and O-signals of environmentally contaminated surfaces.
