ESD-TR-79-142

POST-TEST ANALYSIS OF BRUNSWICK MOD SHELTER TESTED IN DICE THROW

JULY 1979

MTR-3761

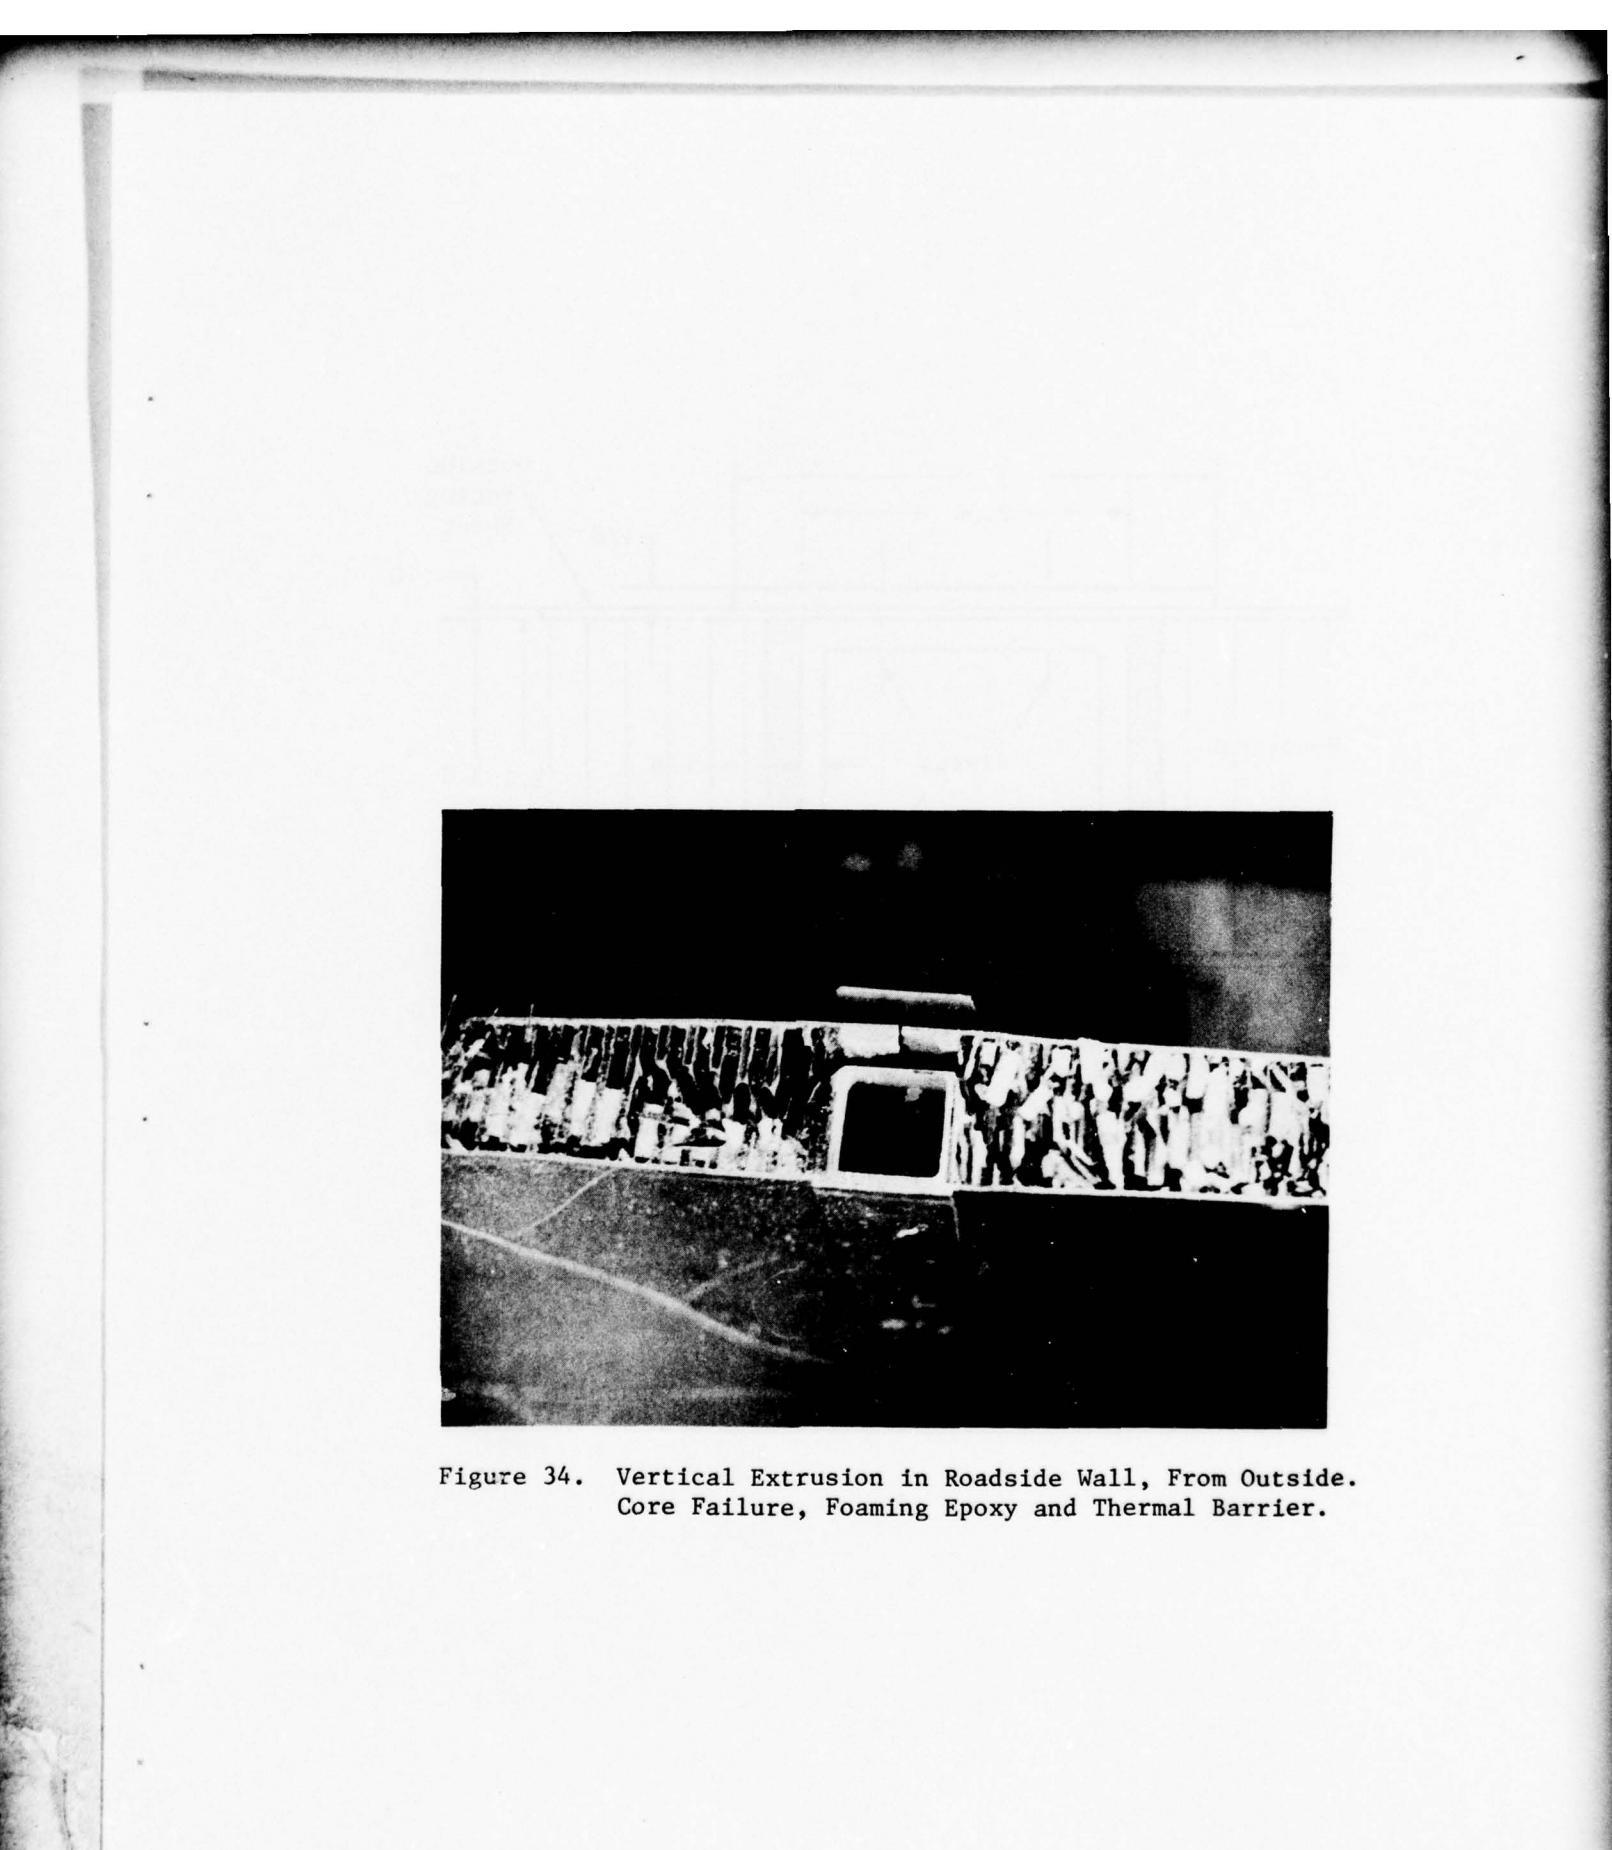
Figure 35. Vertical Extrusion Assembly in Roadside Wall

roadside wall is apparent in Figure 29. Delamination is seen in Figure 30, indicating the extent of this type of failure towards the center of the wall. This cut also confirmed the presence of the vertical extrusions (Figures 33 and 34). These extrusions were connected to the outside and inside facing sheets by rivets through the joint splices. In addition, one side of the extrusion was bonded to the outside facing sheets and the opposite side was bonded to a thermal barrier which, in turn, was bonded to the inside facing sheets. Foaming adhesive was inserted on the other two sides in contact with the honeycomb material. Figure 35 illustrates the cross-section of the extrusion installation.

Considerable internal damage resulted at the vertical extrusion (Figures 33 and 34). There was complete failure of the thermal barrier and the foaming adhesive, and extensive shear failure of the honeycomb core. The extrusion was also bent along its axis.
