SIXTH LAKE DAM
HAMILTON COUNTY, NEW YORK

NY 318
PHASE I INSPECTION REPORT
NATIONAL DAM SAFETY PROGRAM

CONVERSE WARD DAVIS DIXON
CONSULTING ENGINEERS
91 ROSELAND AVENUE, P.O. BOX 91
CALDWELL, NEW JERSEY 07006

11. CONTROLLING OFFICE NAME AND ADDRESS New York State Department of Environmental Conservation/ 50 Wolf Road Albany, New York 12233				12. REPORT DATE 21 September 1978

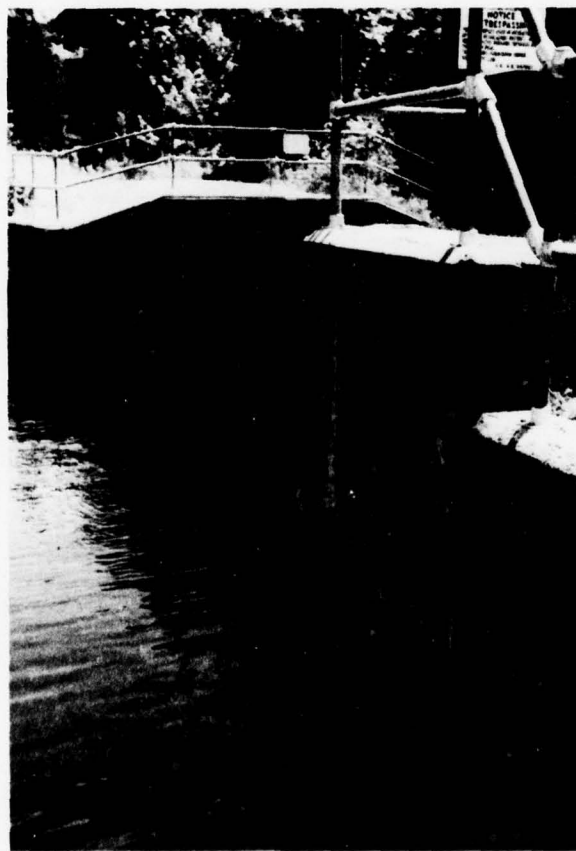
The pool elevation is monitored 6 days a week by a local gatetender of HRBRRD. There is a staff gage to the right of the gate house on the upstream wing wall for this purpose (Fig. 2, Appendix D). The normal operating procedure is to keep the water level of the pool 2 feet below spillway crest elevation during the winter months between November and April, to minimize the effect of ice thrust and to obtain storage capacity for the spring floods. The gates are operated periodically through the winter to keep them from freezing shut.

FIGURE 2. STAFF GAGE

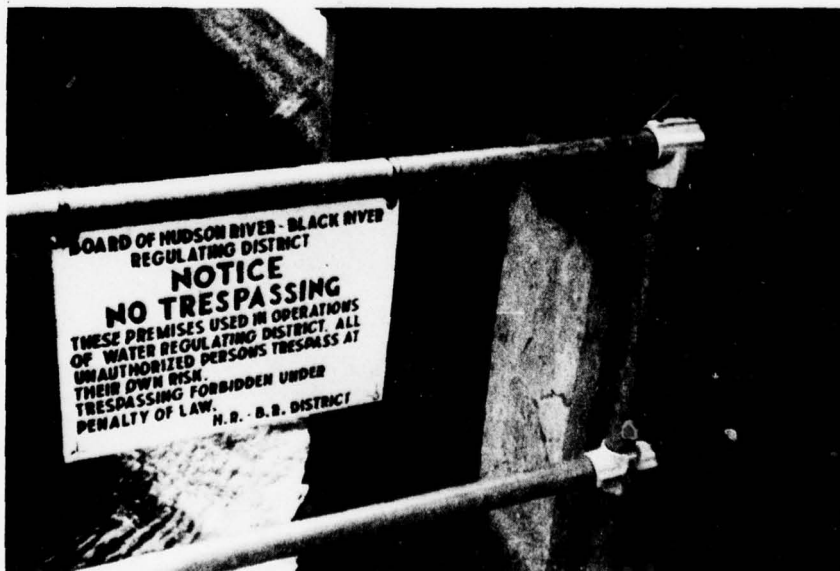
The gate house superstructure is in generally good condition. It is a wood frame structure and has been recently painted. The area around the structure is well maintained and guard rails protect the public from accidentally falling off the retaining walls. No-trespassing signs are clearly displayed (Fig. 12, Appendix D). The interior of the gate house is well lighted and clean. The gate stands are readily accessible and appear to be well maintained (Fig. 13, Appendix D).

FIGURE 12. GUARD RAIL AND SIGN AT GATE HOUSE

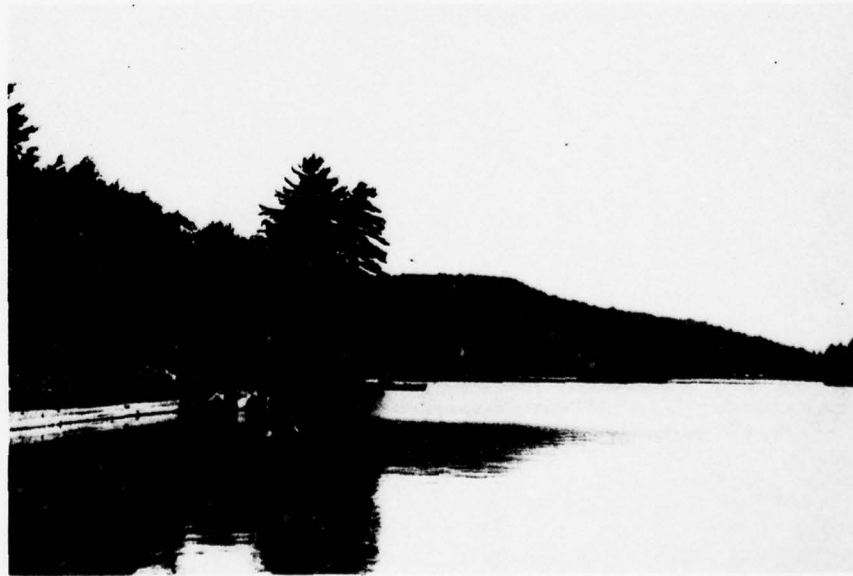
The reservoir area is heavily wooded. Slopes average approximately 1 vertical to 6 horizontal along the immediate shoreline (Fig. 14, Appendix D). They become steeper (about 1 vertical to 3 horizontal) farther inland, especially along the right shoreline. There is no evidence that sedimentation is a problem. The land surrounding both Sixth and Seventh Lakes is zoned primarily for recreational use with some commercial lots. The area is not developing rapidly and the current land usage is not expected to change.

FIGURE 14. RESERVOIR AREA - RIGHT SHORELINE

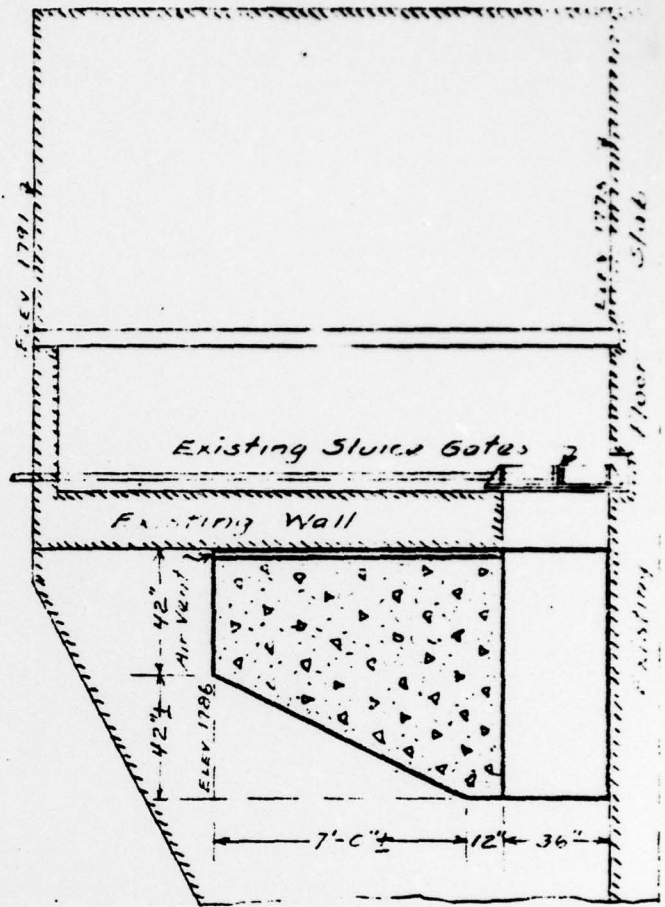
PLAN

The work herein contemplated consists solely of the repair of the gate wall by placing a block of mass concrete on the downstream side of said wall as shown on Plan, Aec 7252, attached hereto

NOTES:-
 All concrete 1:2:4
 Air Vents to be 3" G.I. Gutter pipe
 or other material suitable to Engineer
 Drains to be placed as directed by
 Engineer and to be of material
 acceptable to Engineer
 All surfaces of old concrete before
 covered with new concrete to be
 bushhammered or cleaned and
 roughened as directed by Engineer.
 Disintegrated concrete on face of gate
 bulkhead wall to be removed and grouted
 as directed by Engineer.
