DIVERTING RESERVOIR DAM

PHASE I INSPECTION REPORT

NY 00056

Prepared by: O'Brien and Gere Engineers, Inc.

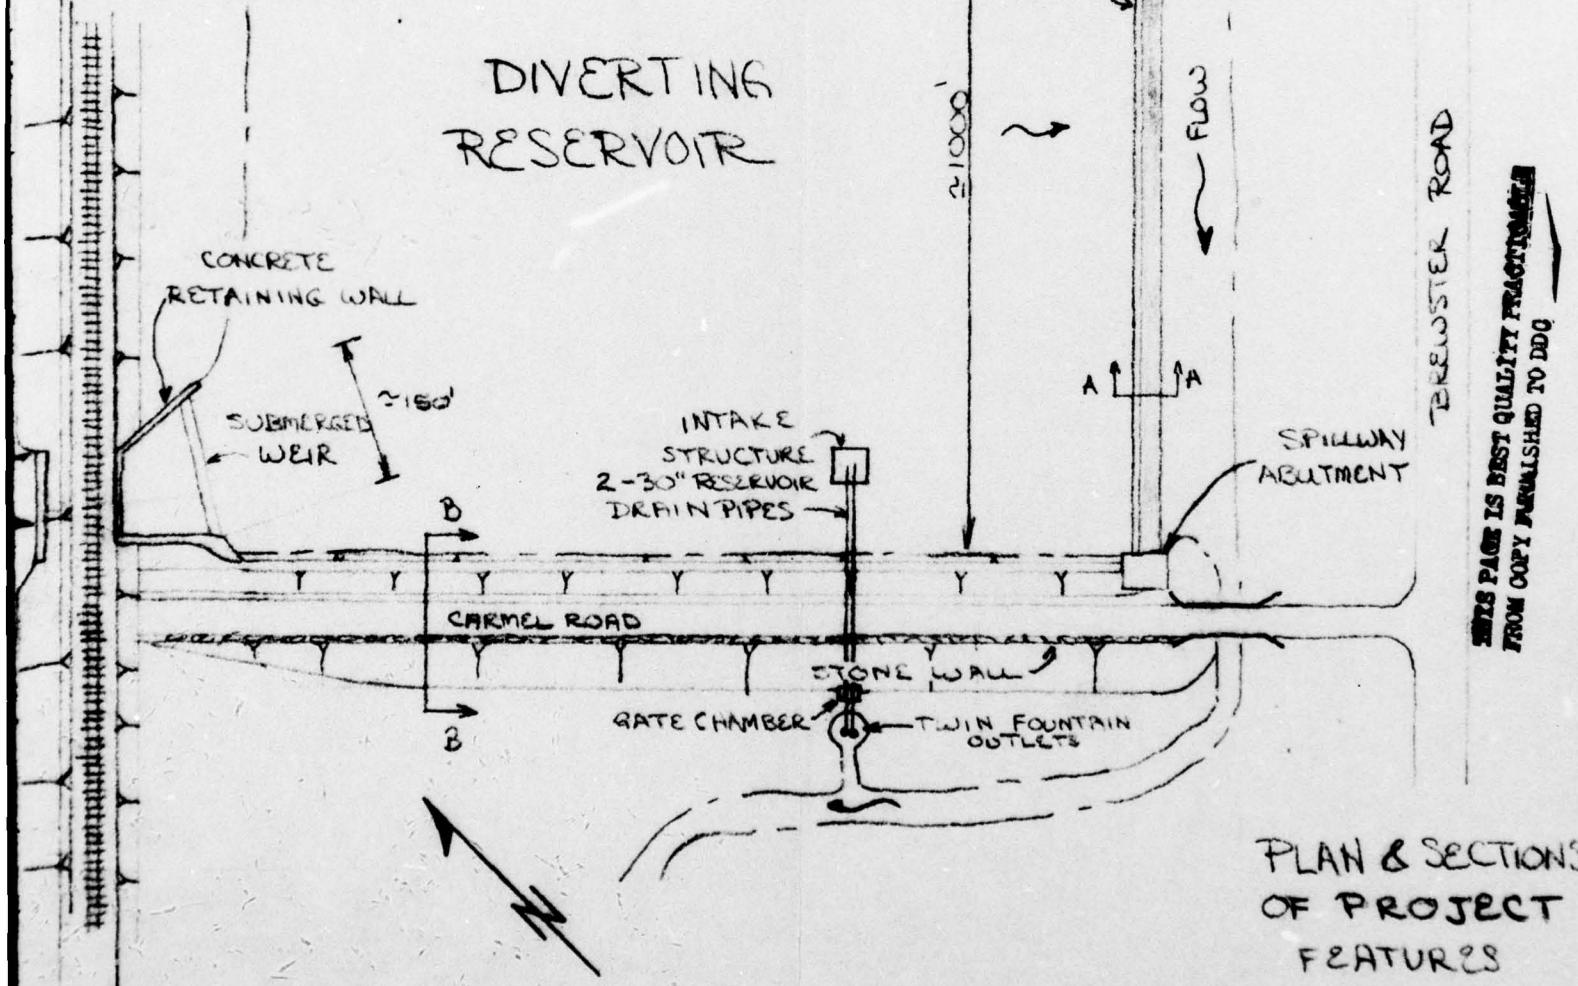
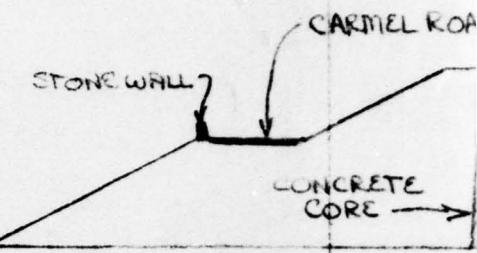
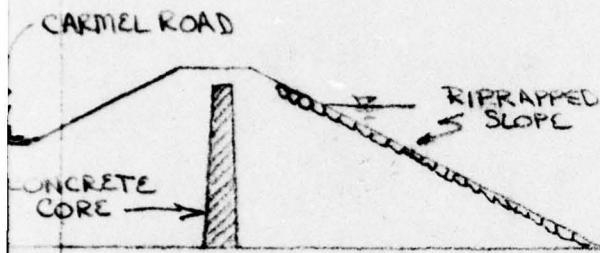
FIGURE 5

b. Dam - The cut stone masonry spillway shows no apparent horizontal or vertical misalignment. The stone blocks have worn less than 1 inch. The silt level appears to be at the spillway crest. A sketch included in an inspection report, prepared by the State of New York, Department of the State Engineer and Surveyor, (no date), shows a rolled earth embankment abutting the upstream face of the masonry spillway (See Figure 5). The northeast abutment of the spillway appears to be in good condition. No serious cracking or spalling of the concrete was observed. The concrete of the southwest abutment of the spillway has undergone surface spalling at several locations. A horizontal crack in the abutment was observed near the spillway crest elevation. The crack is continuous about the visible portion of the abutment. No seepage was observed in the abutment areas. The observed crack and localized surface spalling do not appear to adversely affect the safety of the abutment. An outcropping of what appears to be a tough micaceous gneiss or schist was observed next to the abutment.

The earth embankment is constructed perpendicular to the spillway, as shown on Figure 5. The horizontal and vertical alignment appear to be good. Riprap slope protection for the upstream face consists of large, near rectangular stone (12 to 15 cubic feet), set in place with smaller angular stone and gravel wedged between the large stone. The riprap appears in excellent condition. Brush was noted at several locations near the top of the upstream slope. A concrete retaining wall is constructed along the earth embankment near the railroad embankment. The wall extends about 100 feet along the railroad embankment and along the reservoir shoreline for about 150 feet as shown on Figure 5. Mr. John Birrell stated that a broad crested weir is constructed from the ends of the retaining wall. Mr. Birrell said that the weir is about 150 feet long, with the crest elevation about 5 feet below the normal pool.

According to Mr. Birrell, the reservoir is connected with the Croton Falls Reservoir through three submerged, arched culverts. A stoplog control structure on the Croton Falls side of the culverts is provided with four openings about 8 feet wide. This structure appears in good condition. No cracking or spalling of the concrete surfaces was detected during the inspection visit.

The gravity overflow section should be strengthened to provide adequate factors of safety for extreme loading conditions. This could be accomplished by making the structure more massive, or by the installation of post-tensioned tendons through the structure.
