COLD REGIONS RESEARCH AND ENGINEERING LAB HANOVER NH F/6 14/5
INFRARED THERMOGRAPHY OF BUILDINGS: 1977 COAST GUARD SURVEY. (U)
JUN 79 S J MARSHALL MIPR-7LB731-CO-206
CRREL-SR-79-20 NL

4. TITLE (and Subtitle) INFRARED THERMOGRAPHY OF BUILDINGS: 1977 COAST GUARD SURVEY		5. TYPE OF REPORT & PERIOD COVERED
		6. PERFORMING ORG. REPORT NUMBER

7. AUTHOR(s) Stephen J. Marshall		8. CONTRACT OR GRANT NUMBER(s)
9. PERFORMING ORGANIZATION NAME AND ADDRESS U.S. Army Cold Regions Research and Engineering Laboratory Hanover, New Hampshire 03755		10. PROGRAM ELEMENT, PROJECT, TASK AREA & WORK UNIT NUMBERS U.S. Coast Guard Project MIPR 7LB731CO206

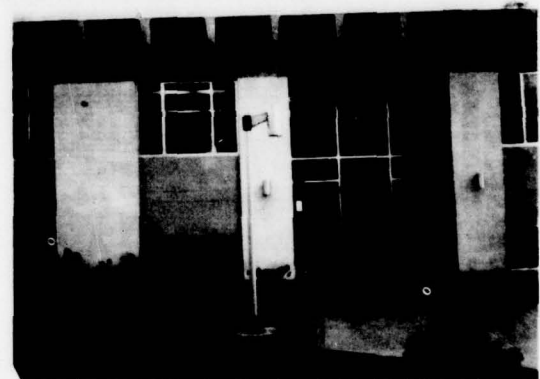
Figure 25 is a photograph of the main entrance on the east face of the building. It contains an excessively large glass area. There is no vestibule and the upper and lower open stairwells are just inside the door. Thermograms in Figures 26 and 27 were taken at a scale of 20, indicating that the glass is a very bad insulator compared with materials in other main entrances. The door itself appears to be uniformly dark and no leakage appears around it even though this door is heavily used.

Figure 25. Main entrance on east face of Point Allerton station.

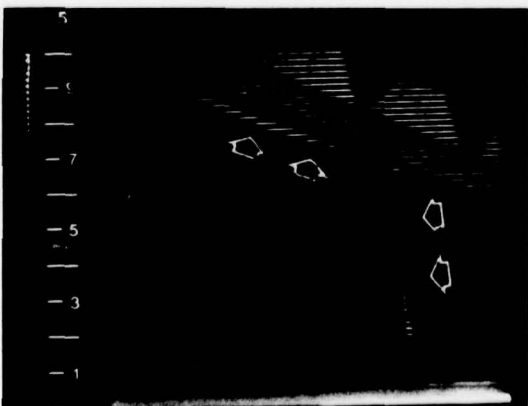
Figure 32. Exfiltration at window/wall interface.

Figure 32 shows upper and right-hand leakage between the window frame and concrete block wall interface (arrows). Figure 33 shows horizontal leakage between the upper and lower panels and between the panels and the concrete block wall (arrows). These wooden panels should be compared with the much superior insulated porcelain panels at the Portland Base (Fig. 93-97).

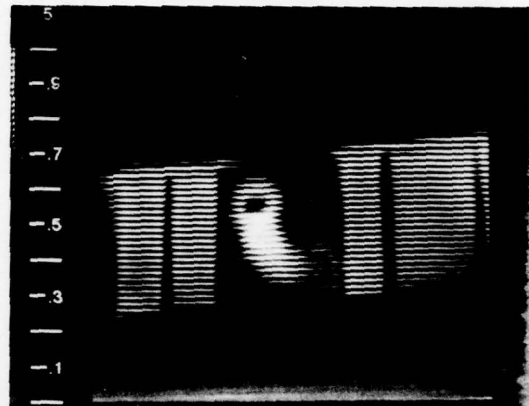
by this vent is not as intense as the plume from a vent on the north face (Fig. 55). Evidently the wind is drawing the warm air from the building's north face but inhibiting its outflow on the south face.

Figure 55. Plume of hot air coming from bathroom vent.

Figure 54 is a photograph of the north face, west section of the Gloucester Station. Figure 55 is a thermogram of a vent to the right of the second deck bathroom window. The plume of hot air from the vent is blowing down and to the right or west even though the wind was from the south-southwest at 18 knots.

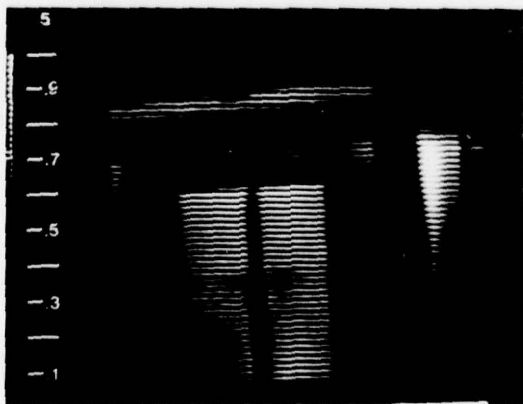
Figure 58. Boiler room window to right of main entrance door.

Figure 58 is of the glass main entrance door, which displays some heat loss at scale 5, despite a closed vestibule inside. Of more concern, however, is the exceedingly warm window immediately to the right of the main entrance. Windows of the unoccupied boiler room could be replaced with insulated panels to conserve energy. In Gloucester Station's case, the boiler was not providing sufficient heat for the building

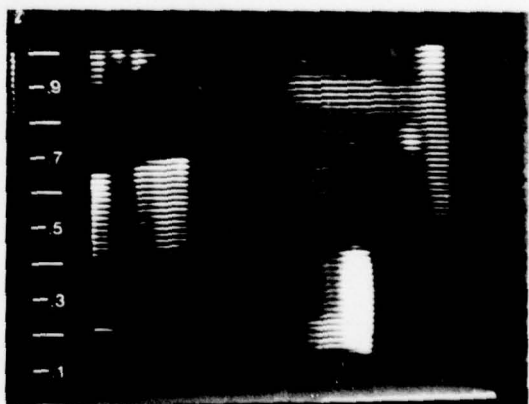
Figure 59. Hot transformer at 2316 hours.

and so most of the personnel had electric heaters in their rooms. The tremendous electrical load at 2316 hours is illustrated in Figure 59 by the hot transformer in the lower right corner of the thermogram, which corresponds to the lower right of the Figure 54 photograph. The vertical stairwell windows and the horizontal second floor can also be seen behind the transformer.

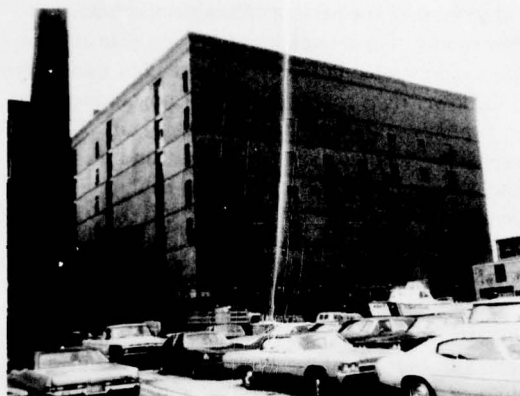
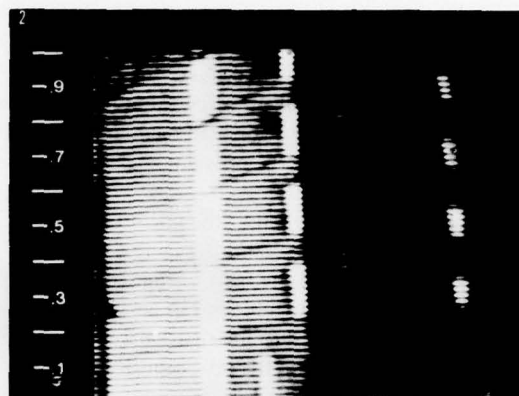
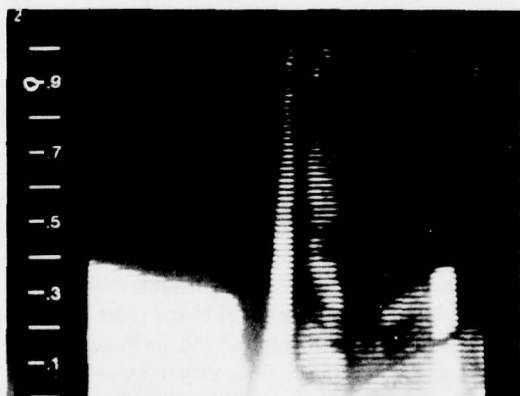
Figure 61. Northeast corner of recently renovated building 8.

Figure 62. East face of building 8 on left and north face on right.

Figure 63. Building 4 on left appears warmer than building 8 on right.

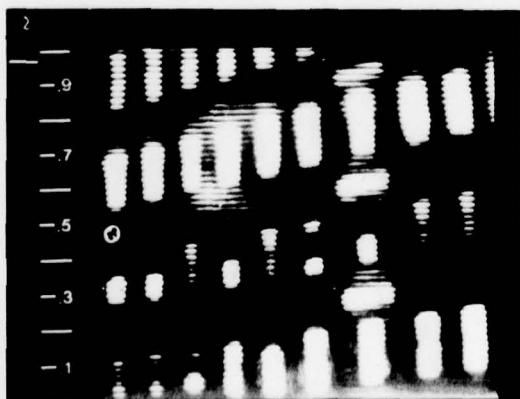
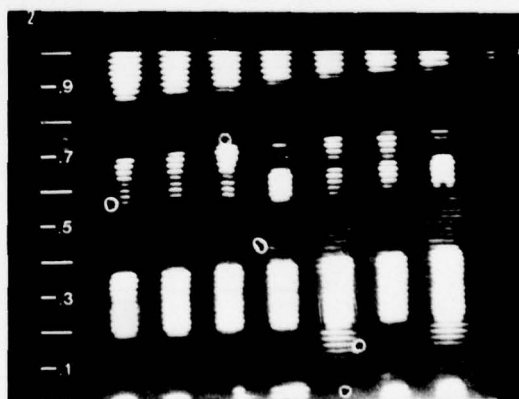
Figure 65. Thermal outlines of new windows and original windows.

Figure 66. Thermal patterns of some of the new windows.

north face. In addition to the somewhat obvious heat loss patterns due to open windows and/or storm windows, Figures 65 and 66 show the comparison between some new windows on the third deck and the original windows. In Figure 65 the second horizontal row from the bottom consists of new windows, and the warm rectangular area of each window is of smaller area than that of the old windows, although all windows are the same size. Also several of the windows have dark cool patterns which indicate how well the storm windows would work if kept closed. The warm granite stones between the vertical stairwell windows can be seen to the right of center in Figure 65. The third horizontal row in Figure 66 is of the third-deck windows to the right of the stairwell. In Figure 65, the fourth-deck windows to the left of the stairwell exhibit a large circular warm pattern on the brick. This type of typical pattern showed up on many of the faces of all the older buildings and indicates heat loss problems in the brick walls themselves.

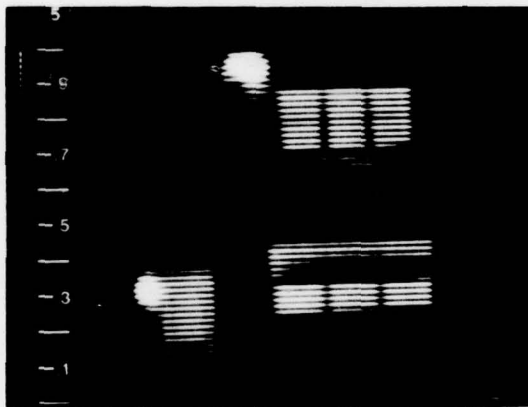
The Portsmouth Harbor Station (Fig. 73) in New Castle, New Hampshire, consists of a 35x12-m concrete masonry barracks with brick exterior built in 1967, a 18x9-m reserve building with brick exterior, and a motor pool with concrete block exterior. Figure 74 is a photograph of the east section of the north face of the two deck barracks and Figure 75 is the west section of the north face. Figure 76, a thermogram of the east section of the north face, shows a badly sprung stairwell door, a garage door with excessive leakage

Figure 76. Stairwell door badly sprung, garage door and second deck window.

through the glass windows and the top horizontal interface, a second-deck window exhibiting excessive leakage, in spite of the fact that the drapes are drawn, and the vague outline of a radiator under the window.

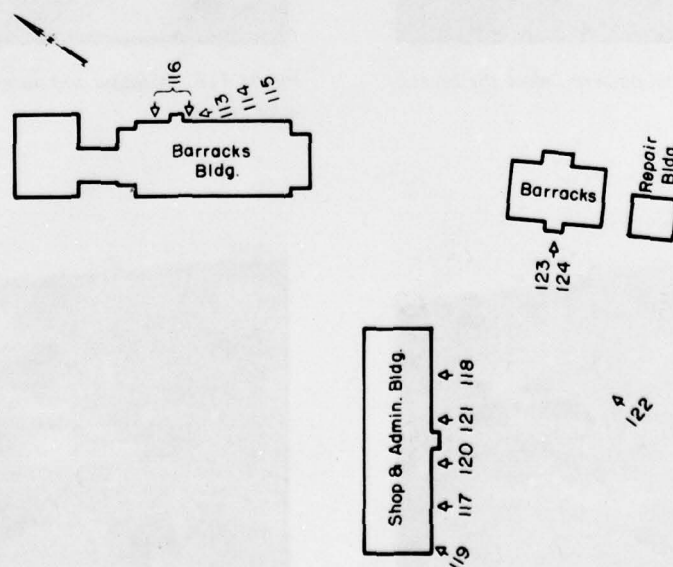
Figure 112. Southwest Harbor Base, Southwest Harbor, Maine.

The Southwest Harbor Base (Fig. 112) in Southwest Harbor, Maine, consists of a 32x12-m concrete masonry barracks with brick exterior, a 34x10-m concrete masonry administration building with brick exterior, a 15x10-m wooden supply building, a 12x11-m base exchange and several wooden duplex units. Figure 113 is a photograph of the north face of the new barracks building taken from the northeast corner. Closely adjacent private property and a thick row of trees prevented perpendicular shots, a problem sometimes encountered in ground survey work. The oblique angle thermograms still yielded valuable data. Figure 114 is a thermogram of the second deck windows to the left of the chimney, and Figure 115 the first deck windows under them. The radiators under the windows can be plainly seen. This is another one of the buildings that exhibited dark windows and warmer walls on all faces of the building. The north face was found to be warmer than the west face and a few of the windows were dark at the top panes and warm at the bottom panes, due either to frosted glass in the top panels or storms left in the top position. The third window from the right in

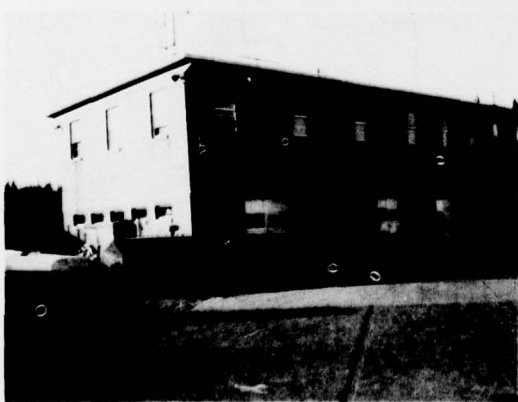
Figure 117. South section of east face of administration building.

Figure 117 is a photograph of the south section of the east face of the administration building and Figure 118 is a photograph of the north section of the east face. Figure 119, a thermogram of the southeast corner of this building, displays the solar effect of cold windows and uniformly warm walls. The south face on the left is at the same approximate temperature as the

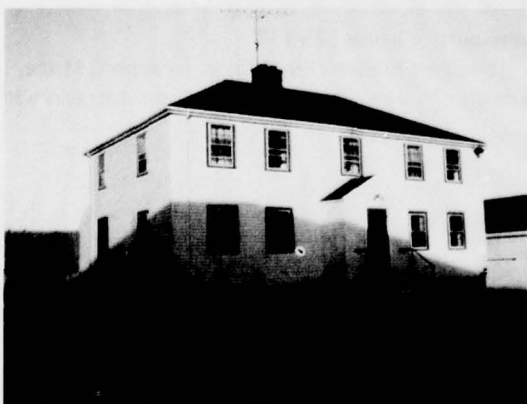
Figure 123. Southwest corner of wooden building constructed in 1942.

Figure 123 is a photograph of the southwest corner of the wooden supply building, an old barracks built in the 1940's. The blueprints show 7.5 cm of blanket insulation in the stud bays and in the ceiling. Figure 124 is a thermogram of the south face and shows leakage typical of all the wooden buildings surveyed at the various stations. The foundation is very warm, and the warmth in the eaves indicates inadequate insulation in the attic. Numerous closeups of any portion of the stud bays show cool bays and warm studs, indicating that insulation is present. It can also be seen that the warm chimney is at the center of the building, the radiators do not show through the walls, and the front entrance has an enclosed vestibule. These features show that architects in the 40's were more committed to energy conservation in buildings than many seem to be today.

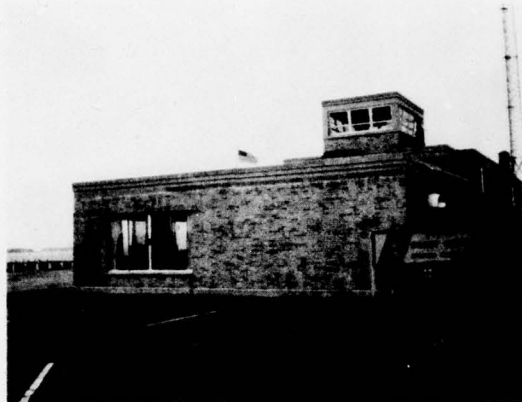
Figure 126. East face of mess deck and galley at Jonesport station.

brick exterior built in 1969, a 15x10-m wooden duplex, a motor pool with brick exterior, a heated boathouse with brick exterior, and several single-story housing units. Figure 126 is a photograph of the east face of the Jonesport Station mess deck and Figure 127 is a thermogram of the south face windows of the mess deck. These windows are of the horizontally sliding aluminum type, and they exhibit leakage along the vertical meeting rails and along the top horizontal interface. Figure 128 is a thermogram of the window unit on the east face of the mess deck which was sprung by the wind and which leaks quite badly whenever there is wind-driven rain from this direction. The thermogram of this window in Figure 128 shows that the first vertical meeting rail from the right is in poor condition and the top horizontal interface leaks badly.

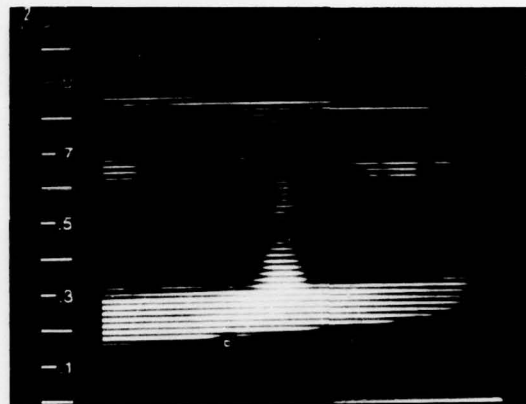
Figure 127. Mess deck windows on south face.

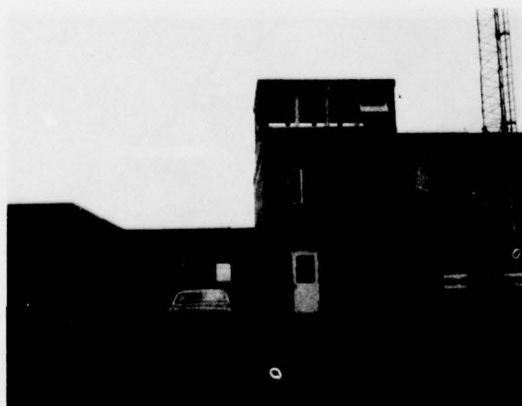
Figure 130. North face of galley and two-deck barracks section.

Figure 130 is a photograph of the north face of the galley, the connecting section, and the east section of the two-deck barracks. Figure 131 is a closeup thermogram of the galley door located in the northwest section of the galley. In addition to the noticeable leakage through the glass panel in the door, the vertical ribs in the lower portion of the doors can be seen (small arrows). The upper left-hand pattern is a vent, the metal portion of which is cool but the area around it is warm. The warm pattern in the lower left wall area is coming from a small locked room to the left of the door that contains a freezer. The warm vertical construction joint interface with the connecting section can be seen at the right-hand edge of the thermogram.

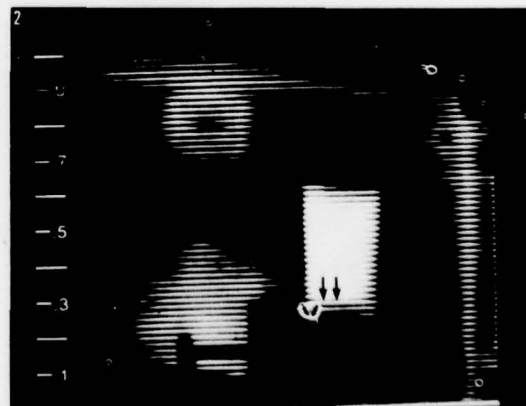
Figure 131. Galley door on the northwest face.
