NEW YORK STATE DEPT OF ENVIRONMENTAL CONSERVATION ALBANY F/G 13/2
NATIONAL DAM SAFETY PROGRAM, DIAMOND MILLS PAPER COMPANY DAM (N--ETC(U)
AUG 78 E A NOWATZKI, G S SALZMAN DACW51-78-C-0035

ENGINEERS FROM THE CONSULTING FIRM OF WARD-ZETLIN, UNDER CONTRACT TO THE STATE OF NEW YORK, DEPARTMENT OF ENVIRONMENTAL CONSERVATION INSPECTED THE DIAMOND MILL PAPER COMPANY DAM, ULSTER COUNTY, NEW YORK (I.D. NO. 89) ON 29 JUNE 1978 AS PART OF THE NATIONAL DAM INSPECTION PROGRAM.

BRIEF ASSESSMENT OF GENERAL CONDITION
AND
RECOMMENDED ACTION

APPENDIX D
PHOTOGRAPHS

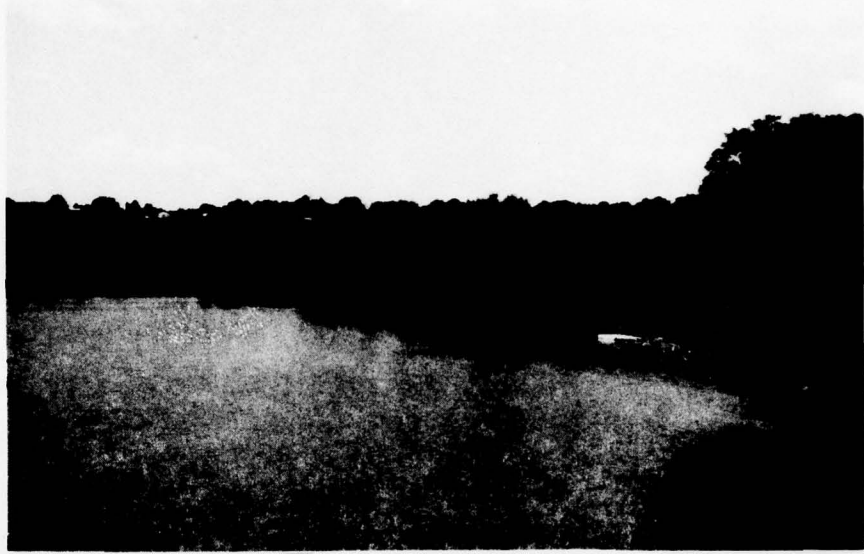
There are some recreational facilities in the low-lying upstream areas (Fig. 2, Appendix D). The banks are heavily wooded and vegetated, and there is no evidence of slope failure. About $\frac{1}{2}$ mile upstream from the highway bridge, the cliffs approach to within 350 feet of each other again, and the Esopus Creek is confined by both banks.

FIGURE 2 OVERVIEW OF RESERVOIR TAKEN FROM HIGHWAY BRIDGE

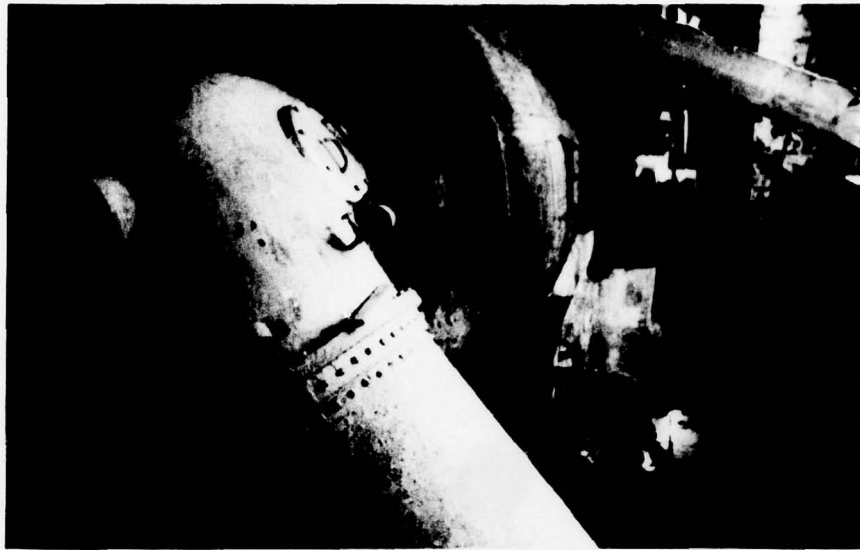
FIGURE 14 TURBINE WORKS

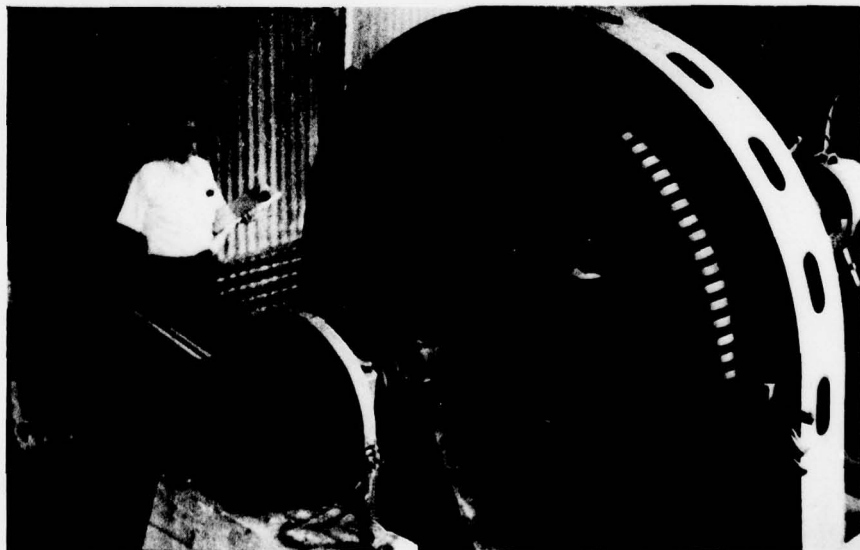
FIGURE 15 TURBINE

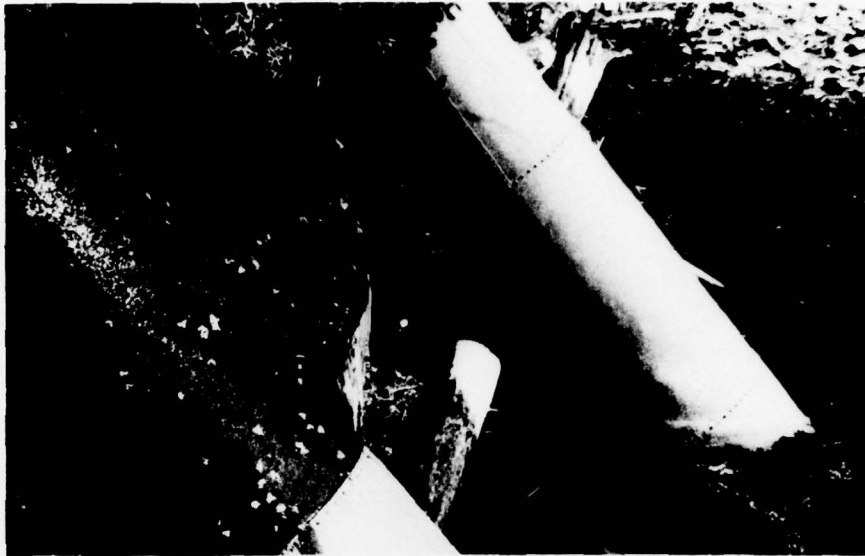
FIGURE 16 TURBINE OUTLET AT TAILRACE

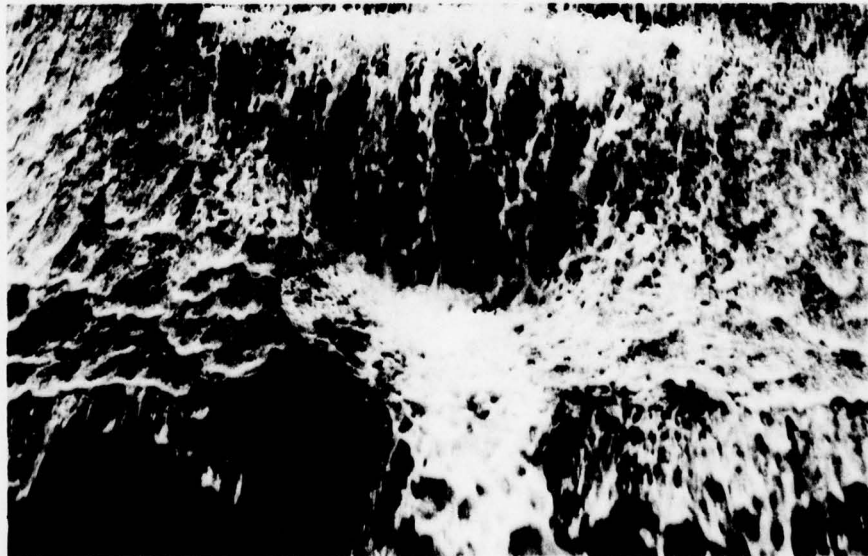
right wall of the channel (Fig. 18, Appendix D). They are located approximately 135 and 145 feet from the right channel wall. Because of the flow over the top of the spillway, it was not possible to see them clearly; however, from a vantage point as close as one could get to the downstream face, it appeared that little if any water was discharging from them (Figs. 18 and 19, Appendix D). According to the design drawings the turning nuts for the gates controlling flow through these pipes are located 5 feet below the crest on the upstream side of the dam. (Refer to Plate IV.) There was no way to access these turning nuts; they were not visible and the extension wrenches required to turn them could not be found.

FIGURE 19 EXIT PORTAL OF SLUICE PIPE (CLOSE-UP)

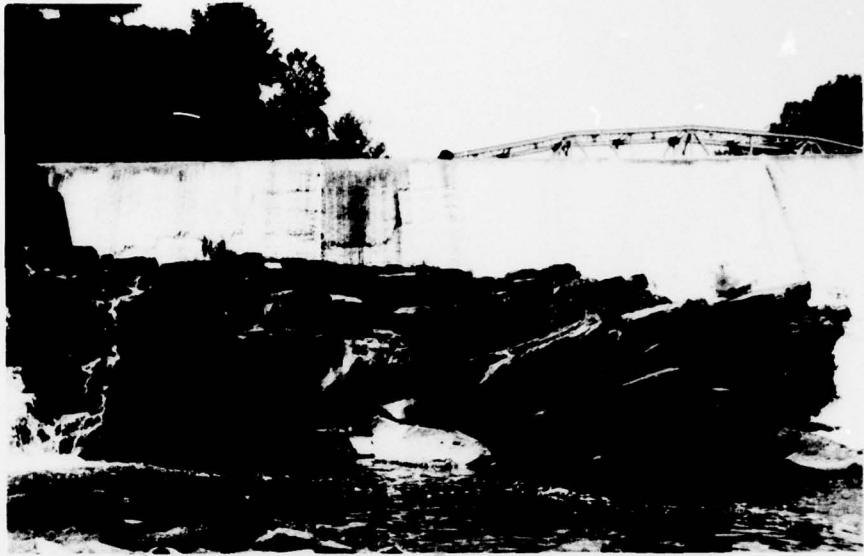
Because of the flow of water over the spillway, the foundation of this structure was not visible. For the most part, the rock in the area (channel walls, downstream outcrops) is shale, and in certain locations it is highly fractured (Fig. 20, Appendix D). Several deep, near-vertical cracks were observed in the rock above the right abutment. Some clay was noted on the banks downstream of the right abutment. It would not be surprising if there was substantial seepage beneath the dam; one local resident (name unknown, reliability questionable) maintained that there is a "space" under the dam.

FIGURE 20 ROCK BENCH DOWNSTREAM FROM RIGHT ABUTMENT

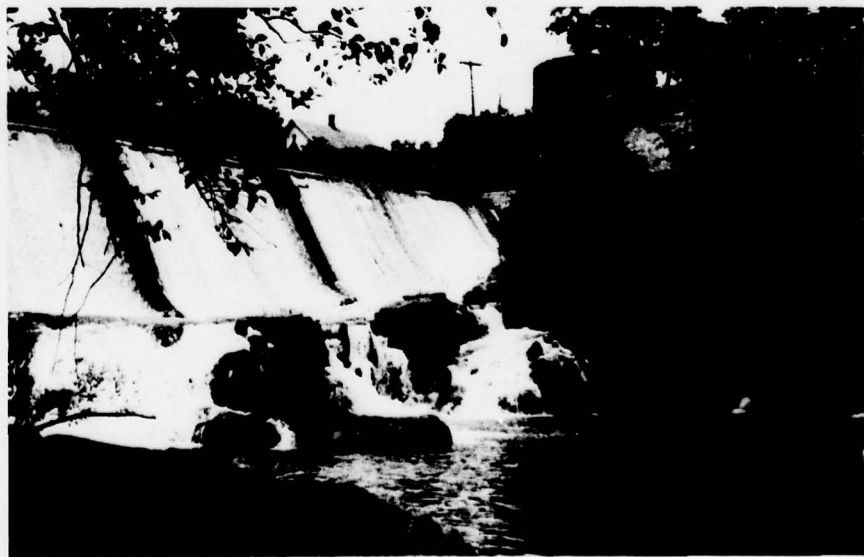
Immediately downstream of the dam, there is an energy dissipation apron composed of massive blocks of rock and natural bench outcrops (Figs. 21, 23 and 24, Appendix D). Farther downstream, the channel widens. There are numerous boulders in the stream and a lush growth of trees along the banks (Fig. 22, Appendix D). There is no significant amount of debris in the downstream channel. As is evident in Figure 1, the channel widens and the cliffs receded sufficiently about $\frac{1}{4}$ mile downstream for docks and houses to be built on the banks of Esopus Creek. These structures would probably be destroyed or severely damaged in the event of a dam failure. In general, the cliffs along the channel appear to be stable, although in certain areas the shale is badly fractured, and there are talus deposits and evidence of mass wasting.

FIGURE 21 ROCK BENCH DOWNSTREAM FROM LEFT ABUTMENT
