Name Of Dam: LAKE MONTCLAIR DAM
Location: PRINCE WILLIAM COUNTY
Inventory Number: VA. 15302

PHASE I INSPECTION REPORT

Lake Montclair Dam. Inventory Number:
VA-15302. Prince William County, Virginia.
Phase I Inspection Report.

MARCH 1979

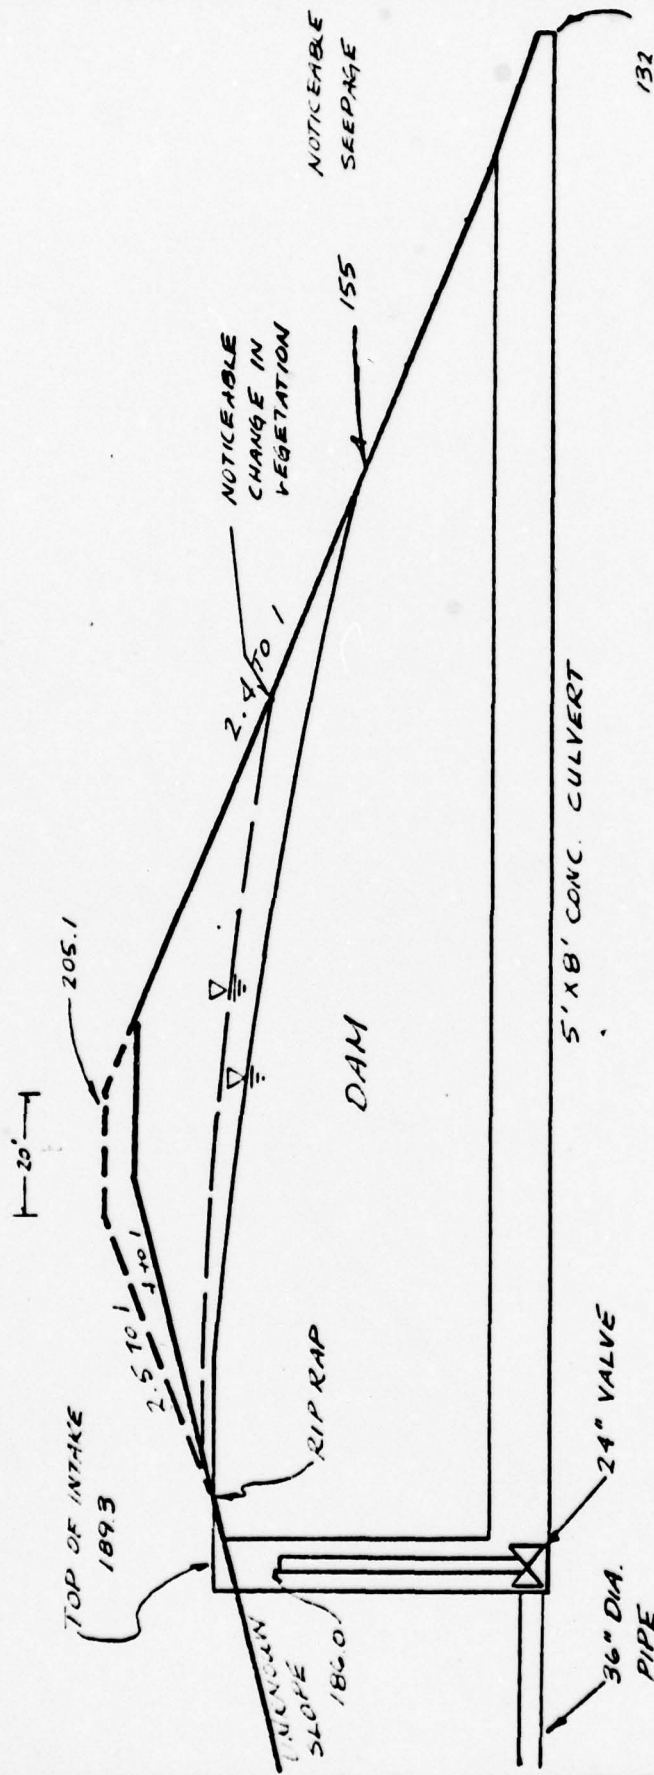
Typical Dam Cross-Section		LAW ENGINEERING TESTING COMPANY SOILS, MATERIALS, AND FOUNDATIONS ENGINEERS 7913 WESTPARK DRIVE, MCLEAN, VIRGINIA 22101	
Montclair Dam		SCALE	Drawn: DLR Checked: MJC Date 12-28-78
Prince William County, Virginia		NONE	Job No. WS-227C Dwg No. 3

***6.2 Stability Analysis:** As indicated in Section 2, a stability analysis was conducted by Bauer Engineering using data obtained by Soil Testing Services. Since the original stability calculations were not available, the loading assumptions, such as "steady state seepage", used in the analysis, are not known. However, as noted, the factor of safety calculated by Bauer Engineering was 2.24 (Reference Appendix IV). Previous experience with the drained shear strength values of similar soils from the Piedmont Province gives reason to question the high cohesion intercepts obtained. Theoretically, the drained cohesion intercept should be zero. However, a drained cohesion of 611 psf was used in the stability calculation by Bauer. Reducing the cohesion value to the theoretical value of zero for drained loading would result in significantly lower factors of safety. It is therefore imperative that a detailed stability analysis of the embankment be conducted.
