**ATTICA DAM
WYOMING COUNTY NEW YORK
INVENTORY NO 445**

**PHASE I INSPECTION REPORT
NATIONAL DAM SAFETY PROGRAM.**

Name of Dam Attica Dam No. 3 NY445

State Located New York
County Located Wyoming
Stream Crow Creek
Date of Inspection June 15, 1978

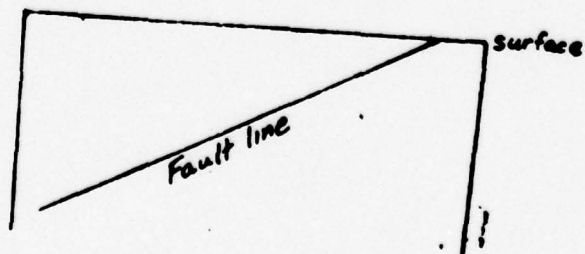
GEOLOGIC MAP
FIGURE 7

Location of Fault
