OSWEGO RIVER BASIN

JAMESVILLE RESERVOIR DAM

ONONDAGA COUNTY, NEW YORK
INVENTORY NO.418

PHASE I INSPECTION REPORT
NATIONAL DAM SAFETY PROGRAM

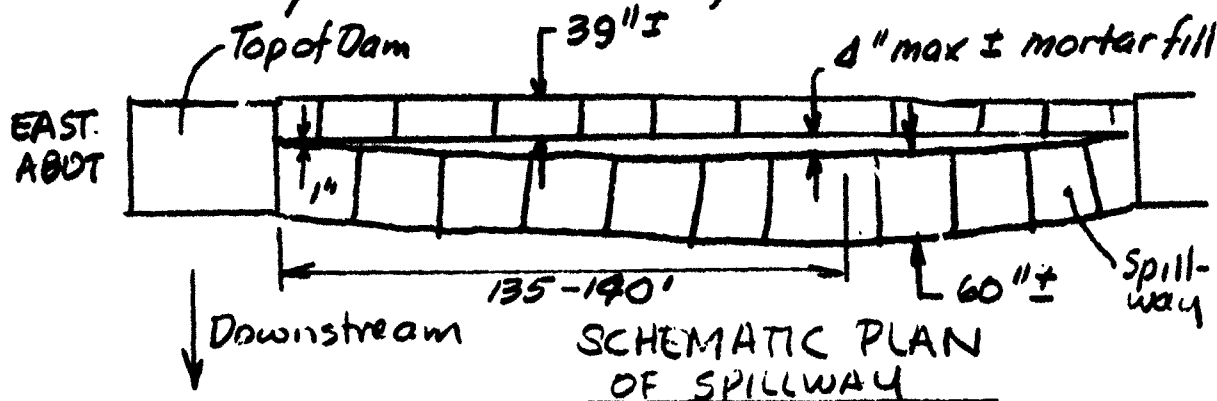
1. Back face of dam above the earth berm and portions of the front (D/S) face gunited in the 1930's or 1940's. Guniting is cracked and spalled in many areas; seepage on face of dam between gatehouse and west abutment worsens, reportedly, when water level is above or splashes over top of guniting.
2. Top two courses of stone in spillway section are displaced downstream, reportedly as a result of ice action and freezing and thawing.

Max downstream (D/S) movement of downstream stones approximately 9"-10" occurs 135-140 ft west of East limit of spillway. Gap between U/S and D/S stones filled with mortar; stones were reported to be pinned in place after movement.

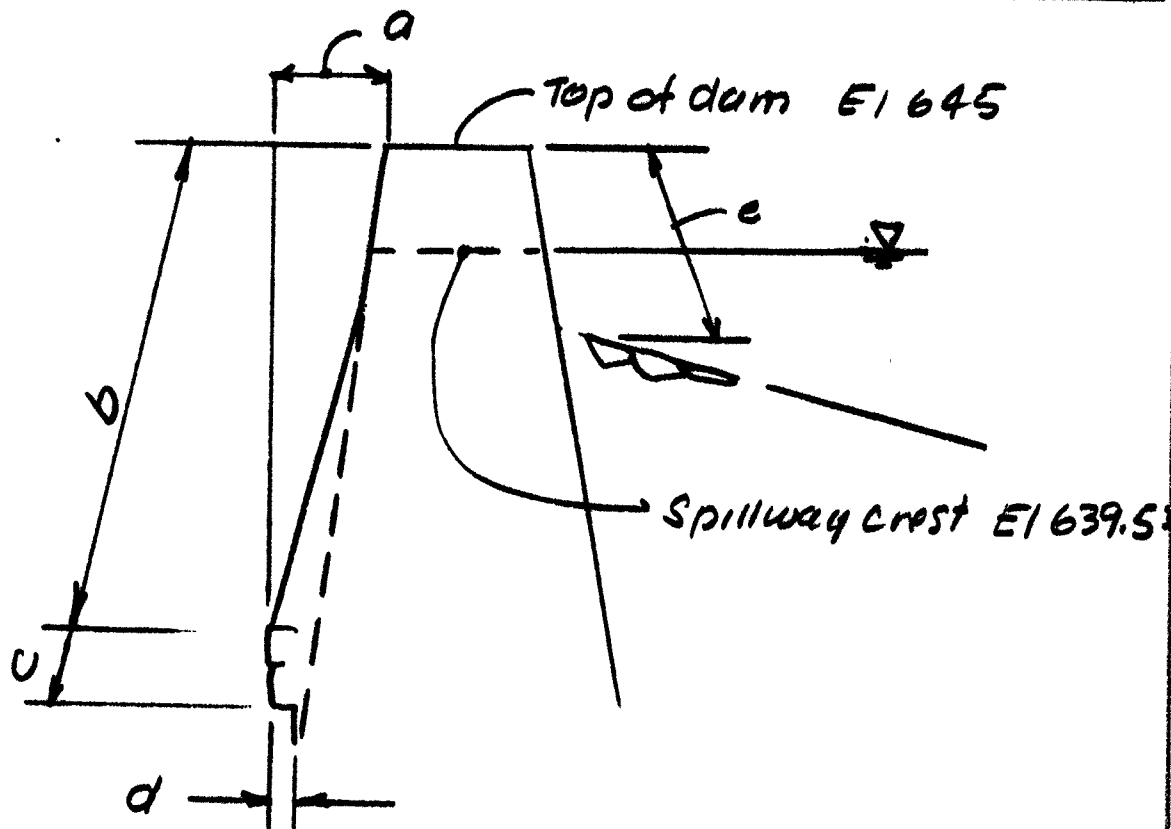
3. Bulging occurs on downstream face of masonry dam between gatehouse and west abutment. Point of maximum bulge generally 20 to 25 ft below top of dam. Measurement made at three locations as follows:
