# COUNTRY LAKES DAM NO. 3 NJ 00052

## PHASE 1 INSPECTION REPORT NATIONAL DAM SAFETY PROGRAM

Name of Dam: Country Lakes Number 3 Dam ID #NJ 00052  
State Located: New Jersey  
County Located: Burlington  
Stream: Cranberry Brook  
Coordinates: Latitude 39° 57'30" Longitude 74° 32'30"  
Date of Inspection: April 12, 1979

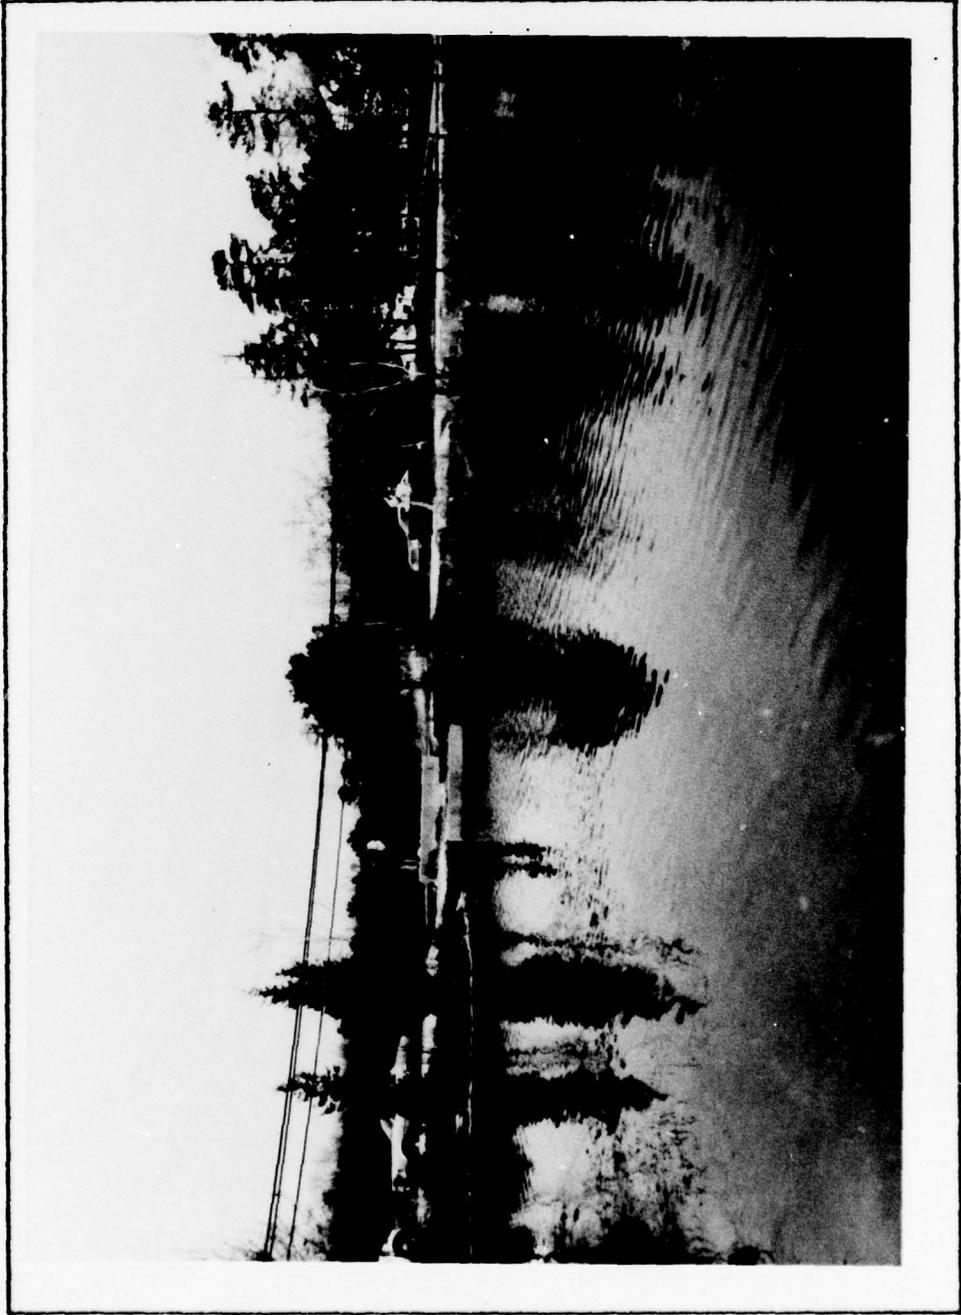
*OVERVIEW  
COUNTRY LAKES DAM NO. 3, BURLINGTON COUNTY, NEW JERSEY*
