MISCELLANEOUS PAPER SL-79-18

NONDESTRUCTIVE TESTING OF CONCRETE T-WALLS, ATCHAFALAYA BASIN PROTECTION LEVEES, NEW ORLEANS DISTRICT

14 August 1979
Final Report

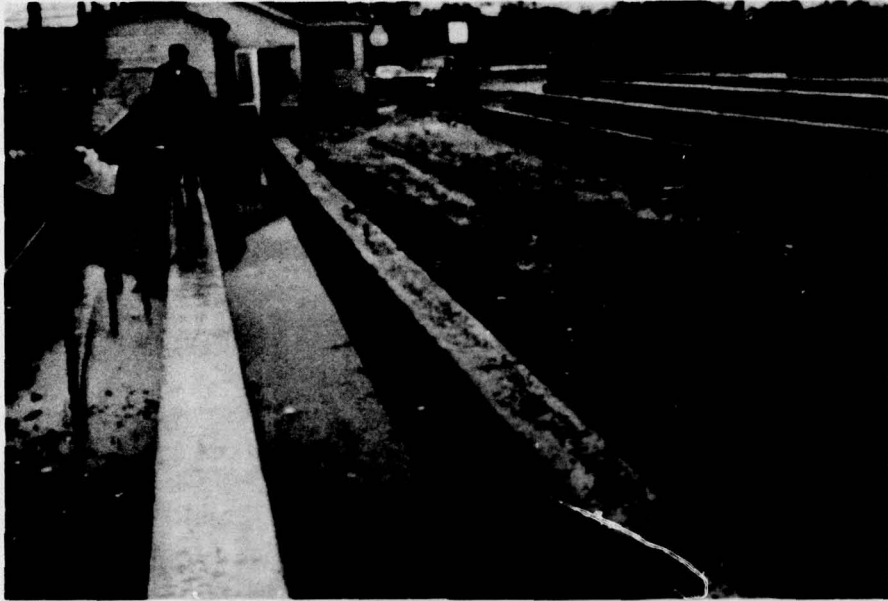
on companion piles which had not been driven. On 23 January 1979 Messrs. Henry Thornton and Michel Alexander travelled to the precast pile yard of Marine Concrete Structures, Inc., Metairie, La. Both shear mode and longitudinal mode pulse-echo measurements were made on cracked and uncracked piles. No difficulty was encountered in the measurements. Both shear and longitudinal echoes were received from the ends of the piles, and from the crack in the pile (see Photos 9 and 10). The results of these tests were considered to be excellent. With these results, and with expectations of having better access to the driven piles at the site, it was decided that there was at least an even chance for success. On 21 February 1979 Messrs. Thornton and Alexander returned to the east wall. More extensive excavation had been performed, but the exposed portions of the piles were still small (see Photo 11). After 2 days of intensive, exhaustive testing with no success the work was terminated. It was concluded that the damping factors of the surrounding soil and the 2.5-ft concrete cap were so high that the pile could not respond to the exciting impulse in either mode of test. An impulse of much higher energy than that available at the time would be required to excite piles in such an environment.

Photo 9. Companion pile, Metairie yard
