RARITAN RIVER BASIN
MANALAPAN BROOK, MONMOUTH COUNTY
NEW JERSEY

MILLHURST LAKE DAM NJ 00296

PHASE 1 INSPECTION REPORT NATIONAL DAM SAFETY PROGRAM.

Millhurst Lake Dam, NJ-00296.
Raritan River Basin, Manalapan Brook,
Monmouth County, New Jersey.
Phase I Inspection Report.

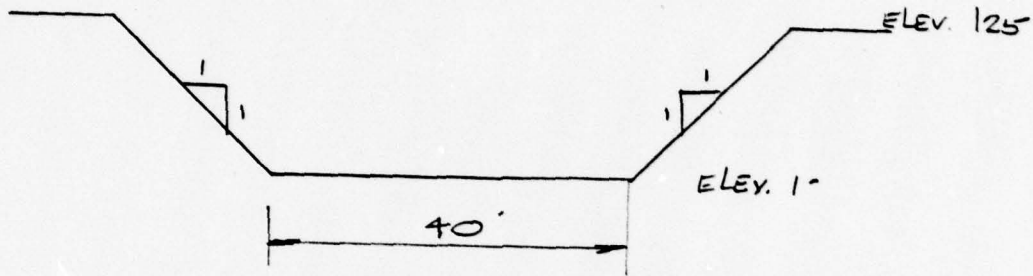
Assume breach begins to develop when reservoir stage reaches elev. 125.0. Time of fully develop = 1.0 hr.

Fully Developed BREACH

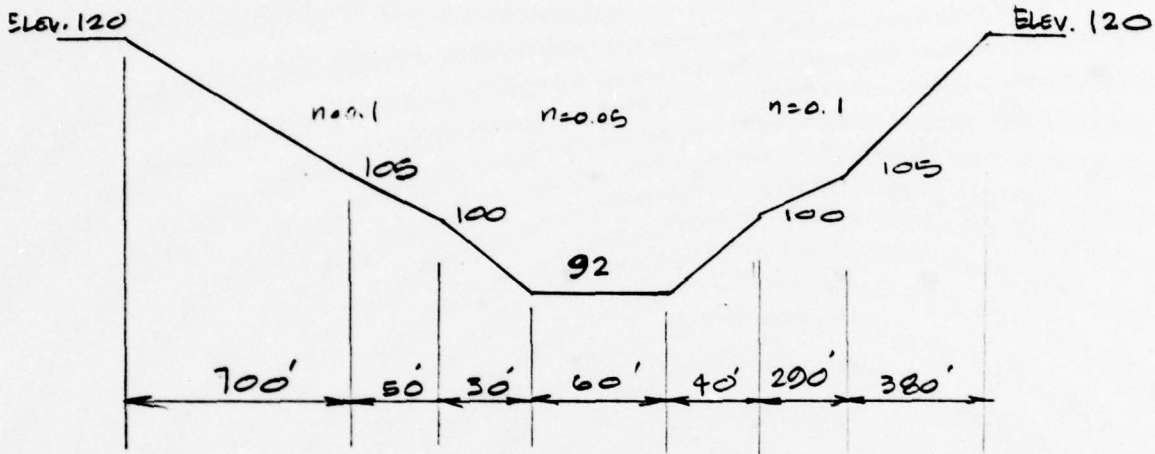
X-SECTION

END OF REACH 1 (STA. 1686+70)
