TECHNICAL REPORT GL-79-14

SUSCEPTIBILITY OF DISPERSIVE CLAY AT GRENADA DAM, MISSISSIPPI, TO PIPING AND RAINFALL EROSION

Edward B. Perry

September 1979

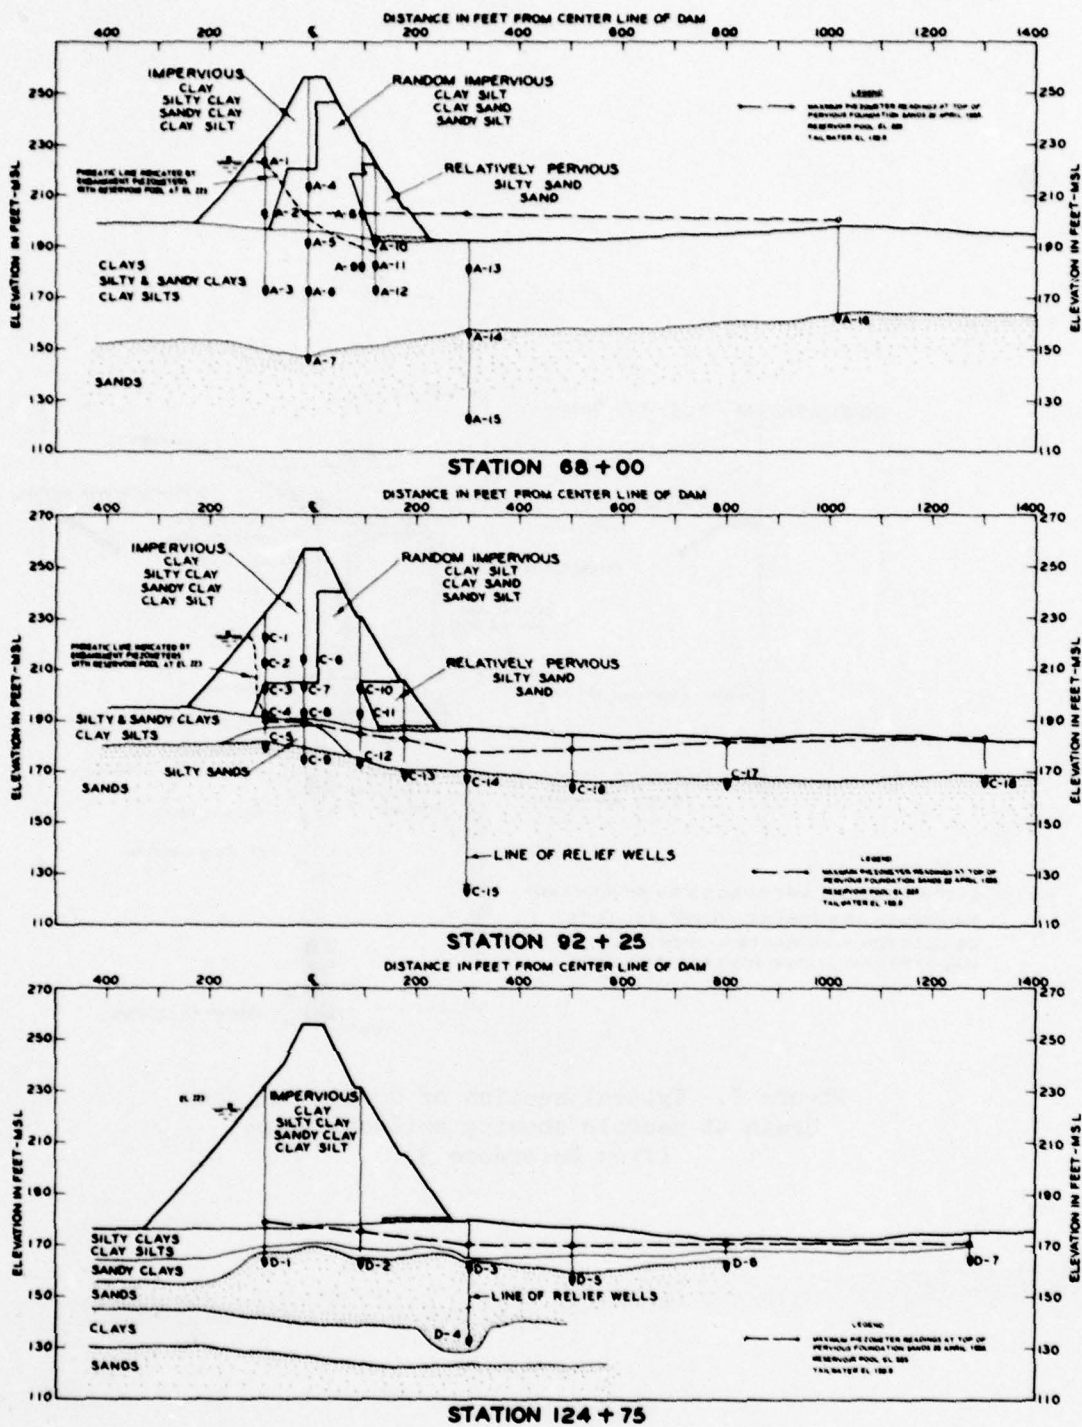
12. In February 1954, approximately a month after reservoir impounding began, fairly large cave-ins appeared over the collector pipe at sta 96+94, 98+75, and 144+86, with smaller cave-ins appearing in other locations. The reservoir was at conservation pool stage of 193.0 ft. Piezometer observations taken in April 1955 when the reservoir was at el 223, shown in Figure 8, indicate no seepage had occurred through the embankment. Inspection of the collector pipe showed piping of surrounding material through pipe joints in the vicinity of the sinks. Considerable quantities of sand and silt had been deposited in the pipe, probably as a result of the piping as well as from inwash from the downstream slope and toe road slope through the manholes. It was believed that piping through the joints of the collector pipe had been occurring for a considerable time since installation because of high groundwater level and was not the result of initial storage in the reservoir, although a rise of pool level might have accelerated the piping. Repairs were started immediately on the largest sink at sta 144+86 with excavation of the compacted fill over the pipe by open cut to approximately the top of the pipe where water was encountered. Wood sheet piling was driven in an area about 15 ft square around the pipe joint. When the excavation approached the elevation of the pipe invert, two boils appeared on the downstream side of the pipe near the joint. A boring was made and carried to el 151 on the upstream side of the pipe opposite the

Figure 8. Piezometer observations taken 26 April 1955 during second storage season of reservoir (from Reference 3)

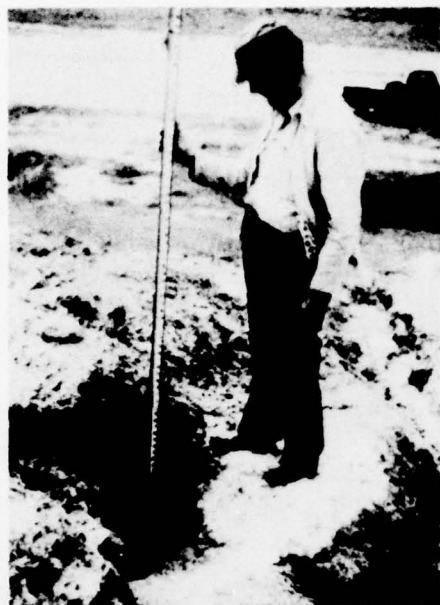
a. View downstream showing tunnel entrance

tunnel. Although Figures 10 and 11 show only one horizontal erosion outlet tunnel, there were often several horizontal erosion outlet tunnels for each cave-in. For example on 14 March 1956, there were 133 cave-ins and 459 horizontal outlet tunnels found on the downstream slope.¹³ The largest cave-in reported to date at Grenada Dam was located on the 205 el berm at sta 122+50 and was about 5 ft in diameter and 5 ft deep with a subsurface channel about 3 ft in diameter heading downslope.¹⁸ The largest cave-in reported by the Soil Conservation Service (SCS) occurred in the crown of a 25-ft-high dam in Oklahoma and was 4 ft in diameter and 7 ft deep.¹⁹ Both of these cave-ins occurred at locations where the contributing watershed areas were small.

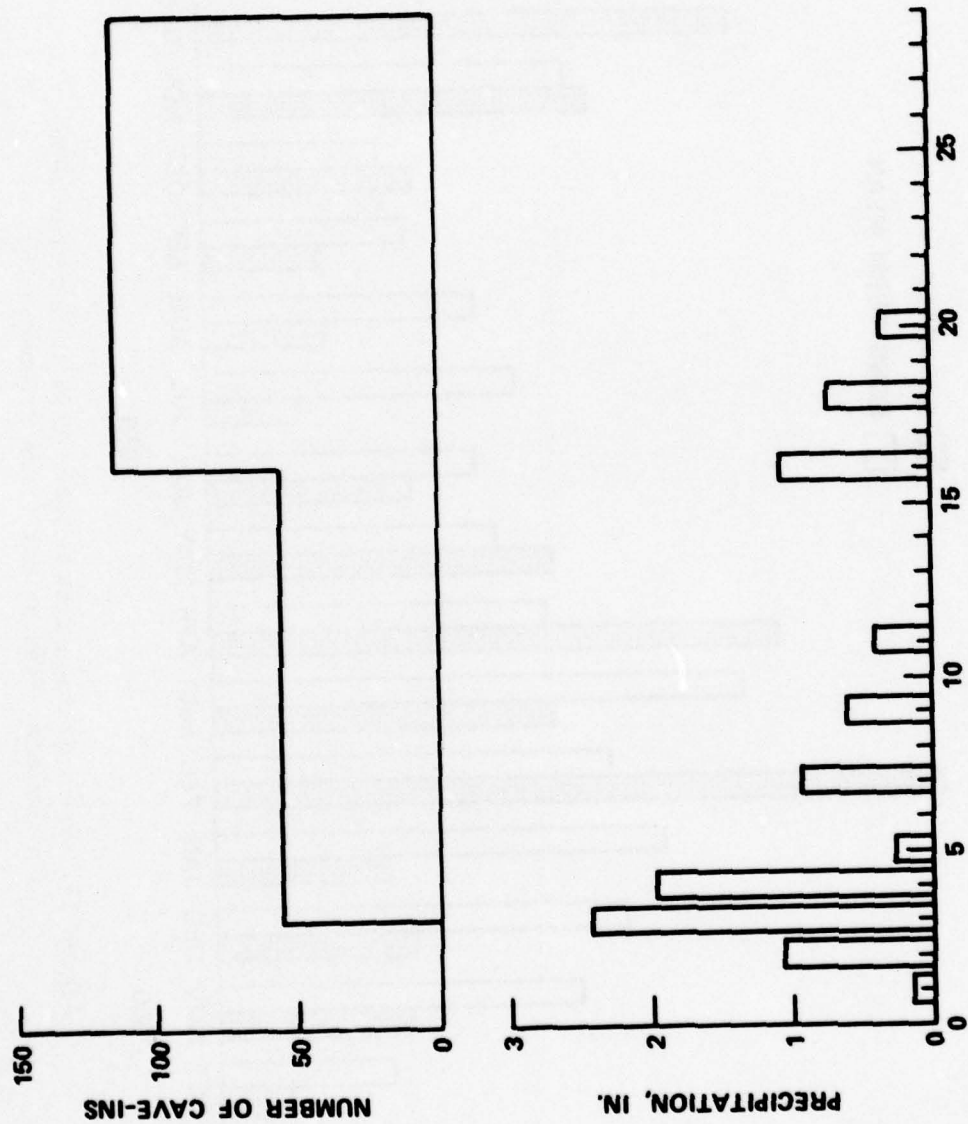
20. During the winter months from October 1955 to January 1956, the rainfall was 9.76 in. below normal as shown in Figure 15. Prior to 3 February 1956, there were no cave-ins noticed during an inspection of the downstream slope. From 1-6 February 1956, a total of 5.71 in. of rainfall occurred as shown in Figure 16. An inspection of the downstream slope on 7 February revealed 55 cave-ins and numerous horizontal outlet tunnels. During the period 16-20 February 1956, a total of 2.28 in. of rainfall occurred, after which it was found the number of cave-ins had increased to 114. Cave-ins were found over nine of the eighteen 15-in.-diam concrete slope drain pipes that carried surface drainage from the concrete drop inlets on the berm ditches to the collector pipe at manholes at the toe of the dam.²⁷ On 14 March 1956, there were 133 cave-ins and 459 horizontal outlet tunnels found on the downstream slope.²⁸

Figure 16. Precipitation and cave-ins during February 1956

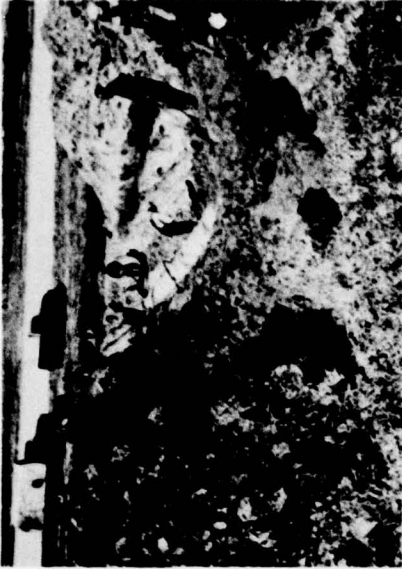
b. Backfilling around slope drain pipe sta 106+00, 19 March 1956

Figure 17. Repairing rainfall erosion tunnels, 19-28 March 1956
(from File 1514-02 Subsurface Erosion, Vicksburg District)

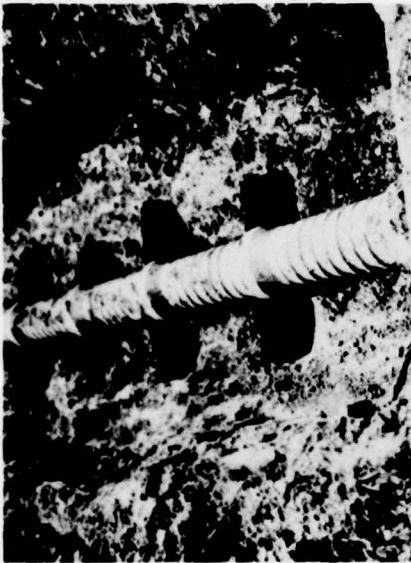
b. Close-up top view of excavation

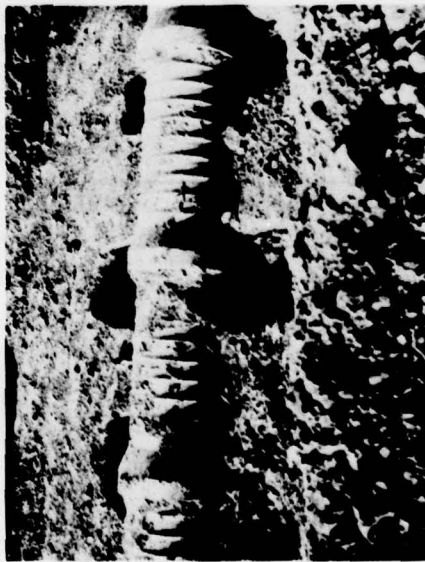
c. Close-up side view of excavation

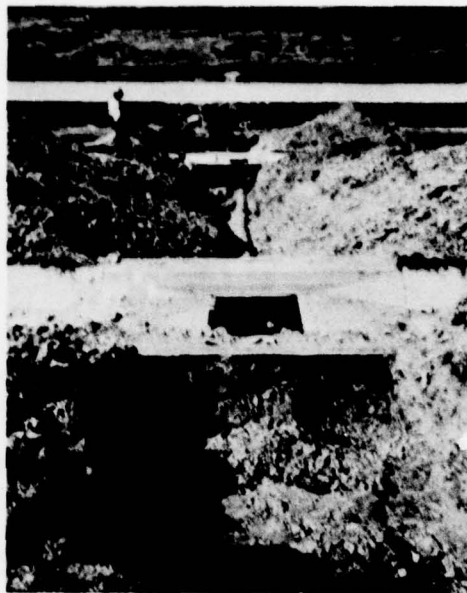
b. View downstream of excavation around concrete slope drain pipe and drop inlet, 26 March 1960

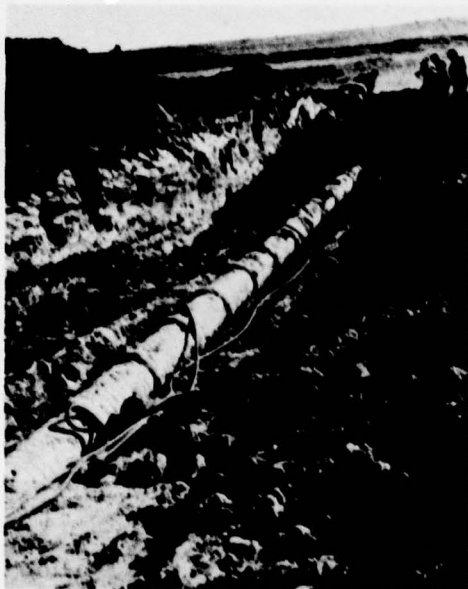
c. Backfilling around concrete slope drain pipe sta 106+00, 19 March 1960

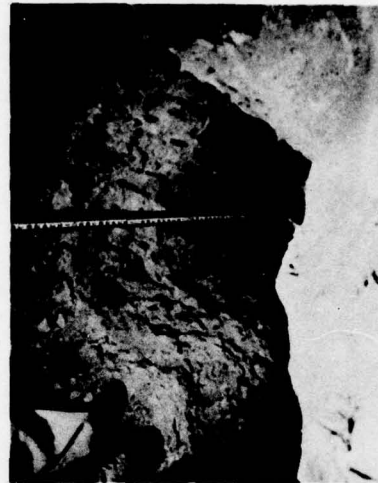
d. Rainfall erosion tunnel sta 144+00 (lower slope), 26 March 1956

Figure 22. Rainfall erosion tunnels, 26 March - 4 April 1956 (from File 1514-02 Subsurface Erosion, Vicksburg District)

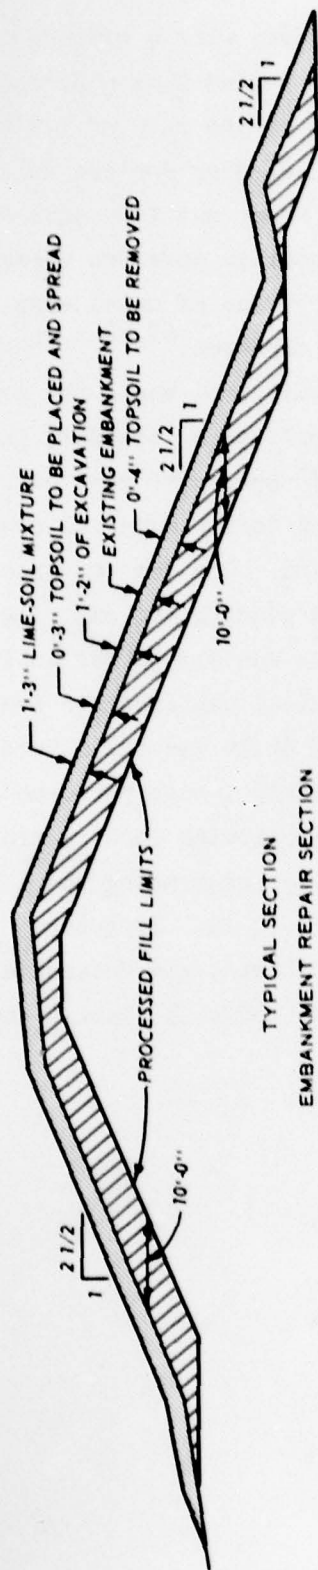
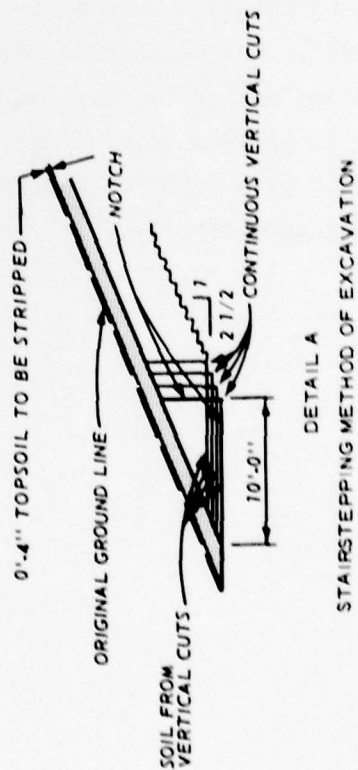
Figure 35. Excavation and embankment detail for lime-modified SCS dams in Mississippi (from Reference 65)

37. Figure 35 shows a typical excavation and embankment detail for lime-modified SCS dams in Mississippi. The 3-in. topsoil shown in Figure 35 was subsequently changed to 6 in. when observations indicated that root growth was restricted by the high initial pH (10 to 12) and cementation of the lime-modified soil. A Gradall was used to remove topsoil that was stockpiled for reuse. The side slopes were reworked to a depth (usually about 4 ft normal to the slope) below the rills, tunnels, and deep penetrating roots of *Sericea* grass by employing a bulldozer stair-step method (Figure 35). On sites where borrow material was available, the dams were "over built." Where the material to be lime modified was stripped from the dam, it was reconstructed to the original elevation. When lime was applied to a borrow site, the topsoil was stripped, the area disked and watered to slightly less than optimum water content, lime spread directly from trucks, and the area disked again and watered to tack the lime. Mixing was performed by a self-propelled pulvermixer with capacity to mix to a 13 in. depth. The surface was sealed with a pneumatic tire roller and allowed to cure 2 days. Before placing on the dam, the lime-modified soil was remixed (to 60 percent passing the No. 4 sieve) and transported to the toe of the dam with self-loading paddle wheel scrapers. The lime-modified soil was placed on the slopes of the dam in two lifts with bulldozers to form a 15-in. (normal to the slope) lime-modified soil blanket. Compaction was accomplished when the tread track of the bulldozer had traversed the surface of each lift a minimum of two passes. The final step was fine-line dressing of the dam with the bulldozer, placement of the topsoil, and application of vegetative treatment. The dams were treated with

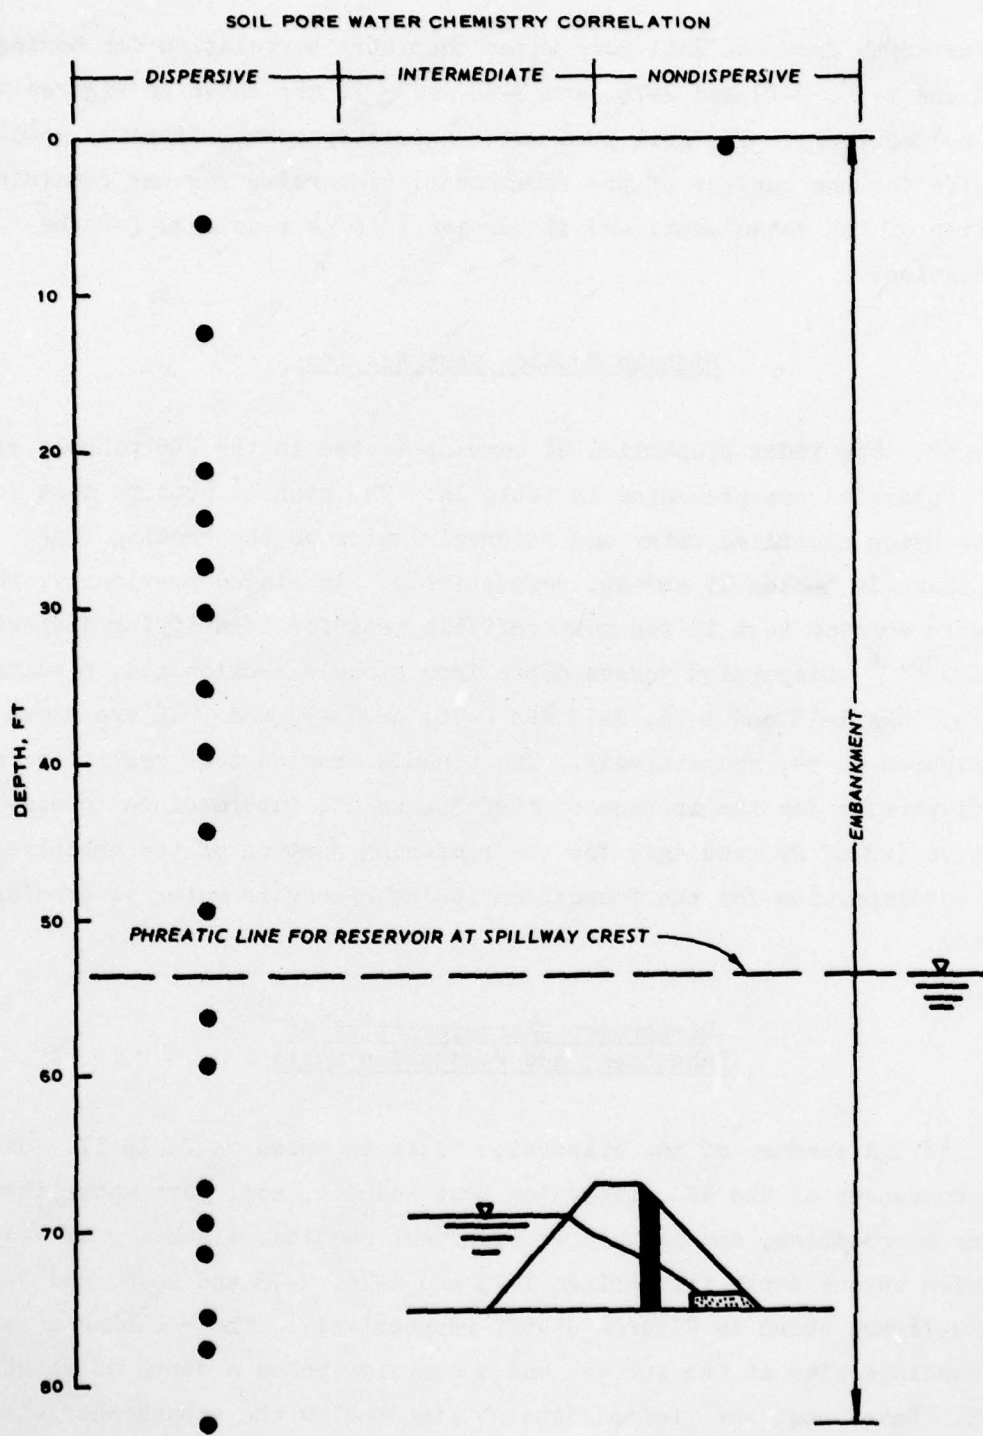
Figure 49. Dispersion versus depth from soil pore water chemistry correlation for borings 1-73 and 1-76

versus depth from the soil pore water chemistry correlation for borings 1-73 and 1-76, 2-73 and 2-76, and 3-73 and 3-76 are shown in Figures 49-51, respectively. The soil pore water chemistry correlation was nondispersive for the surface of the embankment, dispersive for the remaining portion of the embankment, and dispersive (3 of 4 readings) for the foundation.

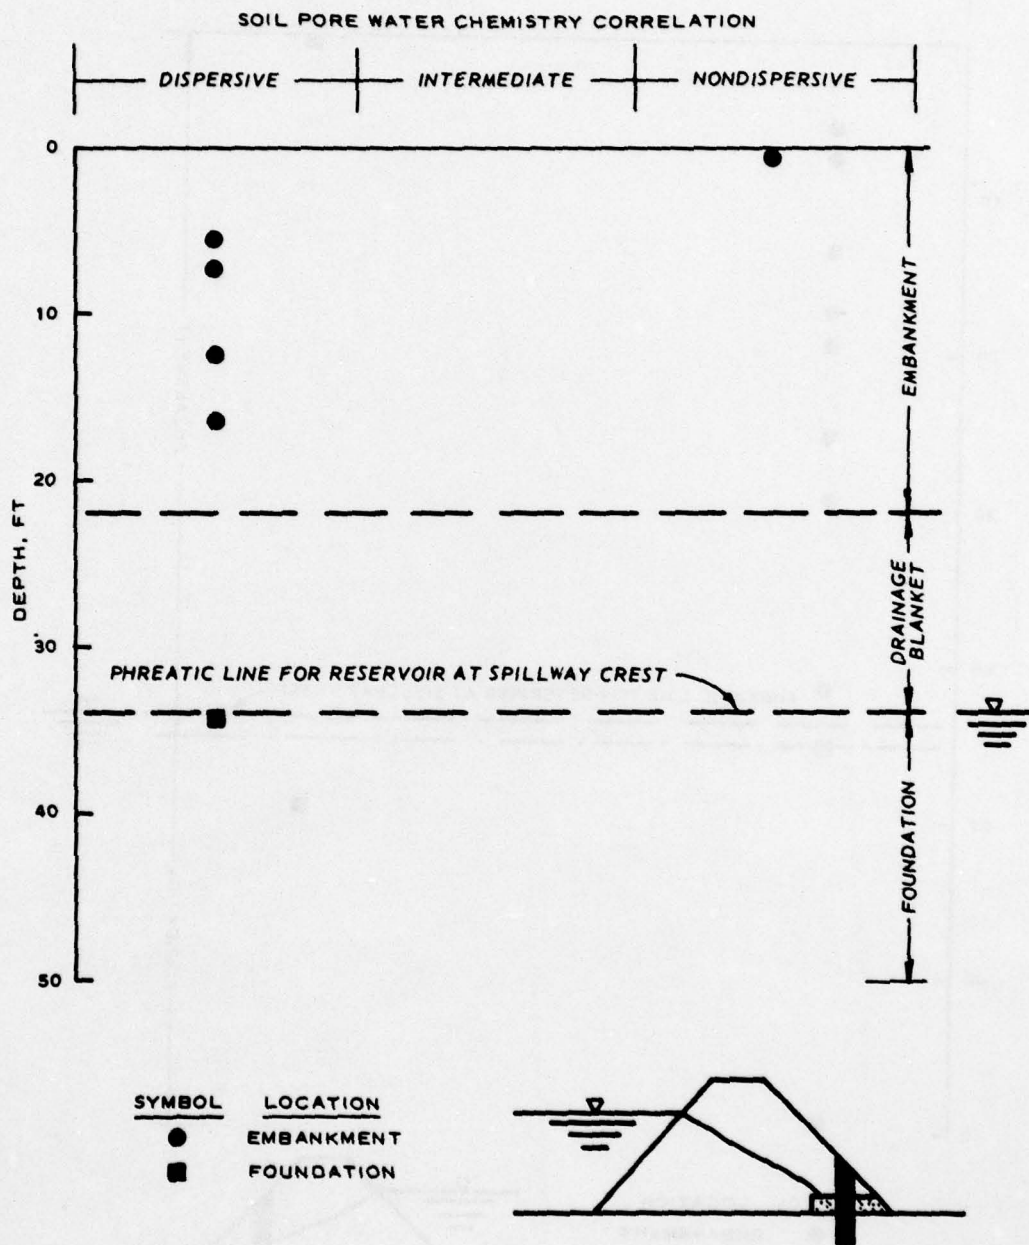
Figure 51. Dispersion versus depth from soil pore water chemistry correlation for borings 3-73 and 3-76

NOTE: DRAINAGE BLANKET CONTAINS INSUFFICIENT COLLOIDS (FRACTION FINER THAN 0.005 MM \leq 12 PERCENT AND PLASTICITY INDEX \leq 4) TO SUPPORT DISPERSIVE EROSION

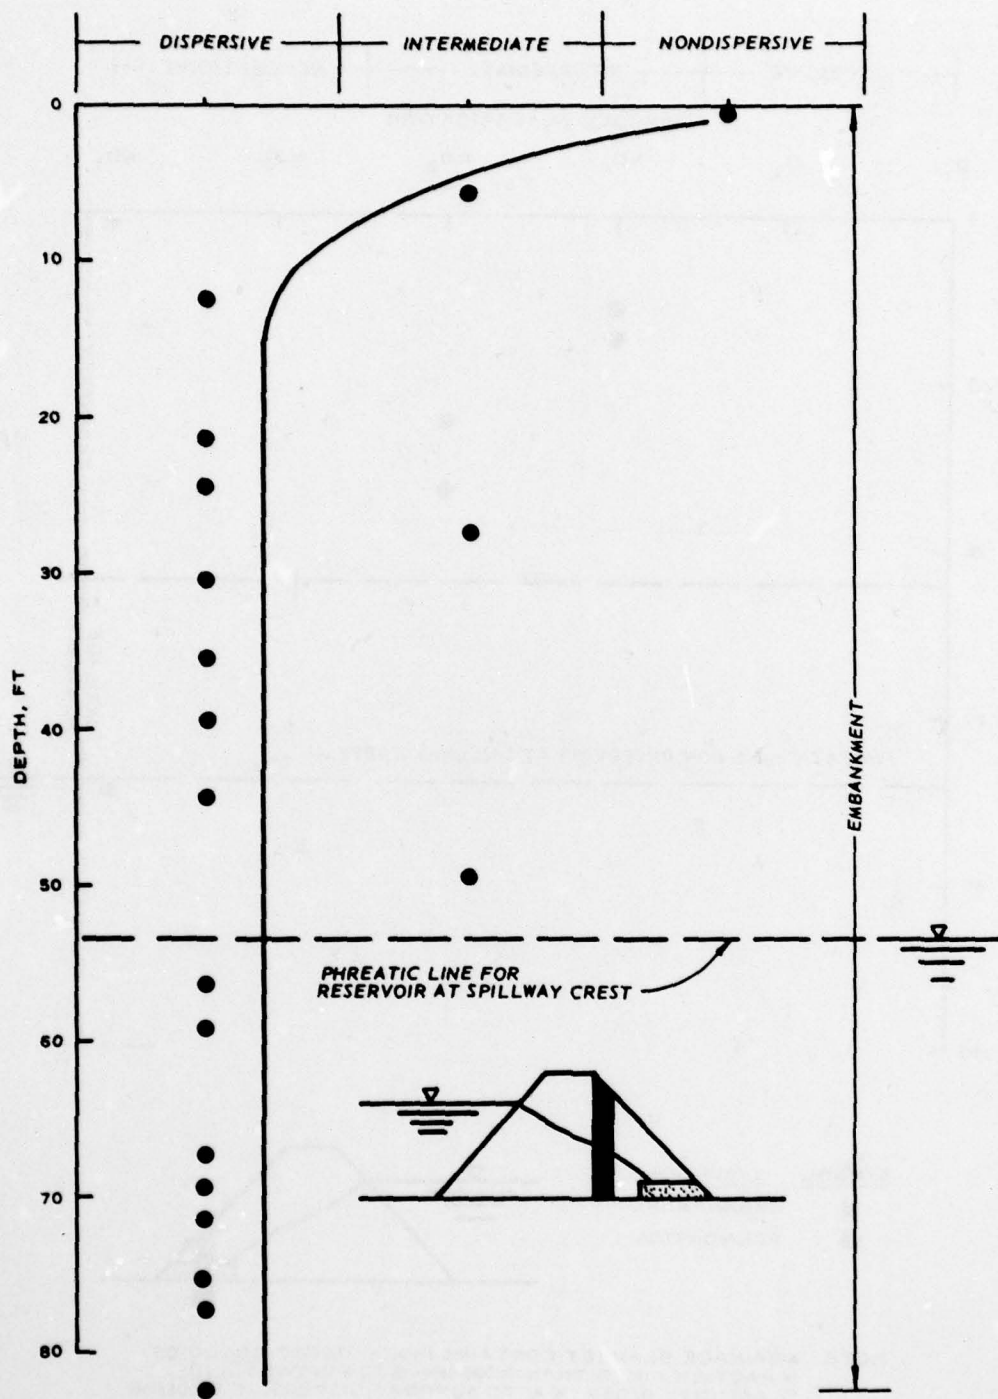
Figure 55. Summary of dispersion versus depth for borings 1-73 and 1-76

48. A summary of the dispersion tests is shown on Table 17. Using the consensus of the SCS dispersion test results, soil pore water chemistry correlation, and pinhole erosion test results, a summary of dispersion versus depth for borings 1-73 and 1-76, 2-73 and 2-76, and 3-73 and 3-76 are shown in Figures 55-57, respectively. The embankment soil is nondispersive at the surface and dispersive below a depth of about 6 ft. Based upon the limited data obtained below the embankment, the foundation soil is dispersive at the surface and nondispersive to dispersive with depth.

- b. Based upon laboratory test results obtained in this study, the embankment soil is nondispersive at the surface and dispersive below a depth of about 6 ft. Limited data obtained below the embankment indicate that the foundation soil is dispersive at the surface and nondispersive to dispersive with depth.

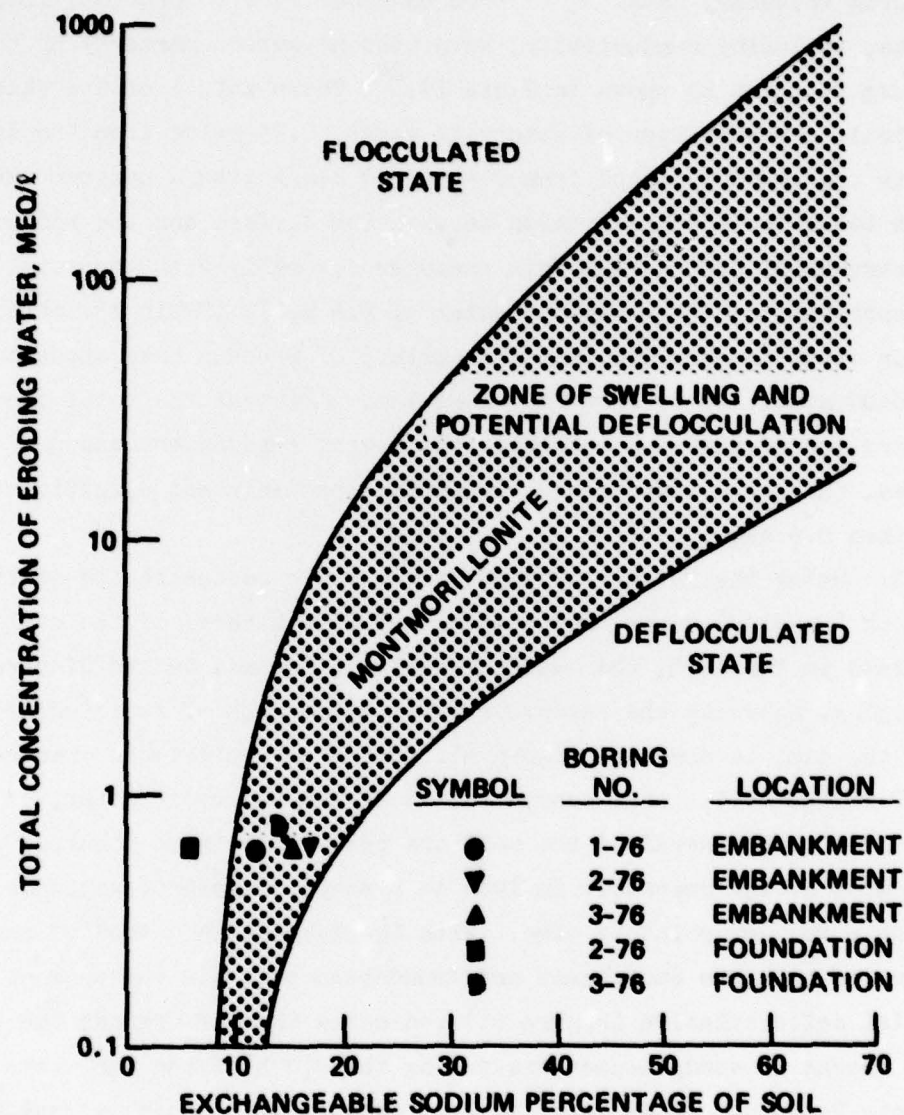
53. Using the ESP of the soil, total ionic concentration of the reservoir (eroding) water, and predominate clay mineral of the soil summarized in Table 20, the susceptibility of Grenada Dam to dispersive clay piping, assuming the reservoir water has a path of rapid access across the dam, is shown in Figure 61. Since no appreciable changes in the ESP of the soil, total concentration of the reservoir water, or predominate clay mineral of the soil are believed to have occurred from impoundment of the reservoir in 1954 to present, Figure 61 would be applicable for any point in time. With the Australian method of analysis, the plot of both the embankment and foundation soils in the zone of potential deflocculation (Figure 61) indicates that if Grenada Dam contained cracks or sandy lenses traversing the width of the dam where the reservoir (eroding) water would have a path of rapid access across the dam, there would be a potential for dispersive clay piping. Since piping failure through the embankment or foundation has not occurred at Grenada Dam, either the dam is free from cracks or sandy lenses traversing the width of the dam, or if cracks are present, the soil is able to swell and seal the flow channels.

Figure 61. Prediction of piping failure using the total ionic concentration of the eroding water and the ESP of the soil assuming the reservoir water has a path of rapid access across the dam (adapted from Reference 45 with the permission of the Publishers Butterworth, Sydney)

- c. The Australian method of analysis, using the ESP of the soil, total ionic concentration of the reservoir (eroding) water, and predominate clay mineral of the soil, indicates that both the embankment and foundation soils would be potentially susceptible to dispersive clay piping if Grenada Dam contained cracks or sandy lenses traversing the width of the dam where the reservoir water would have a path of rapid access across the dam. Since piping failure through the embankment or foundation has not occurred, either the dam is free from cracks or sandy lenses traversing the width of the dam, or if cracks are present, the soil is able to swell and seal the flow channels.

- a. There is no reason to suspect that a concentrated leak will develop through the embankment or foundation under ordinary conditions of reservoir operation. However, if a concentrated leak developed under unusual conditions, such as cracking from earthquake loading, piping failure would likely occur in a few hours. Therefore, if a concentrated leak develops, provisions should be made to immediately notify public officials in the City of Grenada and Grenada County and evacuate the Corps of Engineers recreation areas downstream of the dam.
