ULTRASONIC DETECTION OF SURFACE FLAWS IN GAS TURBINE CERAMICS.(U)

4. TITLE (and Subtitle) ULTRASONIC DETECTION OF SURFACE FLAWS IN GAS TURBINE CERAMICS		5. TYPE OF REPORT & PERIOD COVERED Final Technical Report	13. Sep 77-12 hlc 76

6. AUTHOR(s) Thomas/Derkacs Istvan M. Matay		7. PERFORMING ORG. REPORT NUMBER TRW-ER-7986-F	
8. PERFORMING ORGANIZATION NAME AND ADDRESS TRW Inc. 23555 Euclid Avenue Cleveland, OH 44117		9. CONTRACT OR GRANT NUMBER(s) (15) N62269-77-C-0136

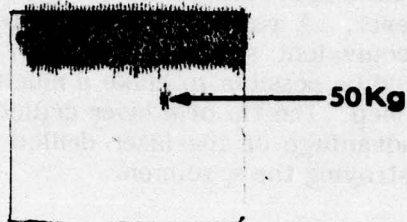
Figure 6. C-scan Recordings of 45 MHz Ultrasonic Inspections of Specimen of Ceralloy 147A HPSN Containing 1 and 50 kg Vicker's Indentations.

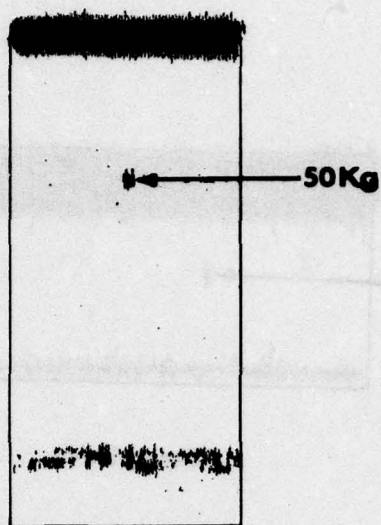
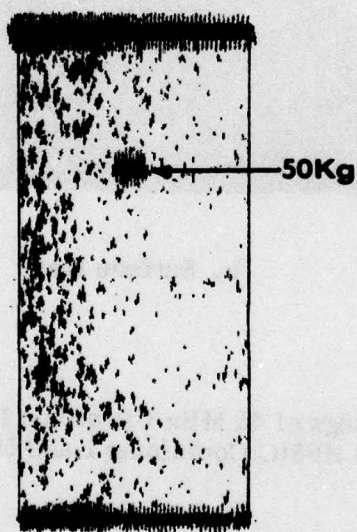
Figure 7. C-scan Recordings of 45 MHz Ultrasonic Inspections of Specimen of NC-350 RBSN Containing 1 and 50 kg Vicker's Indentations.

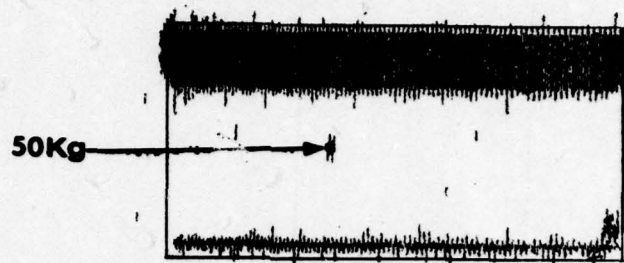
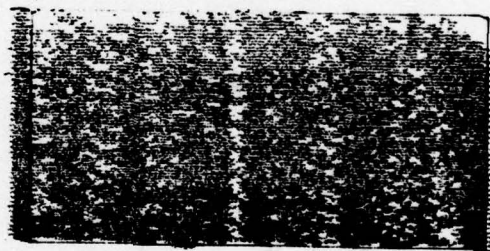
Figure 8. C-scan Recordings of 45 MHz Ultrasonic Inspections of Specimen of Ceralloy 146 HPSiC Containing 1 and 50 kg Vicker's Indentations.

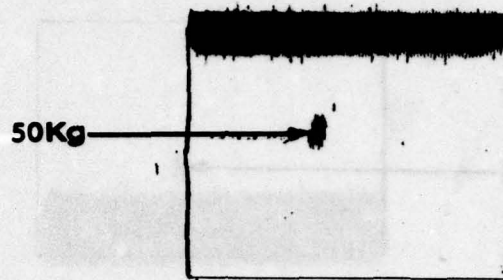
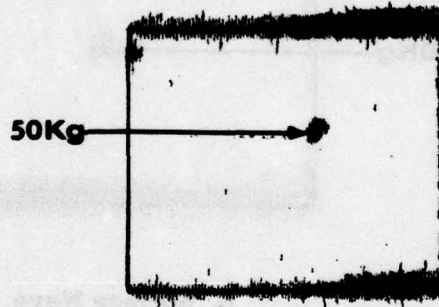
Figure 9. C-scan Recordings of 45 MHz Ultrasonic Inspections of Specimen of NC-230 HPSiC Containing 1 and 50 kg Vicker's Indentations.

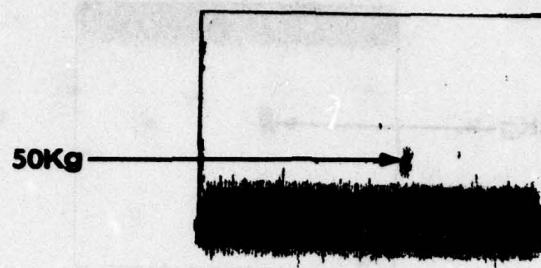
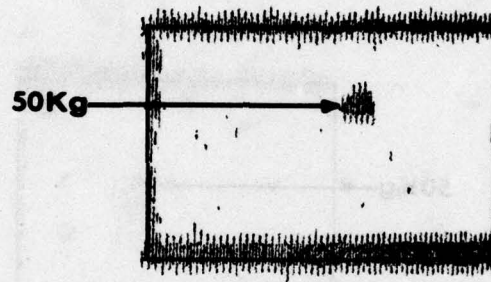
Figure 10. C-scan Recordings of 45 MHz Ultrasonic Inspections of Specimen of NC-132 HPSN Containing 1 and 50 kg Vicker's Indentations.

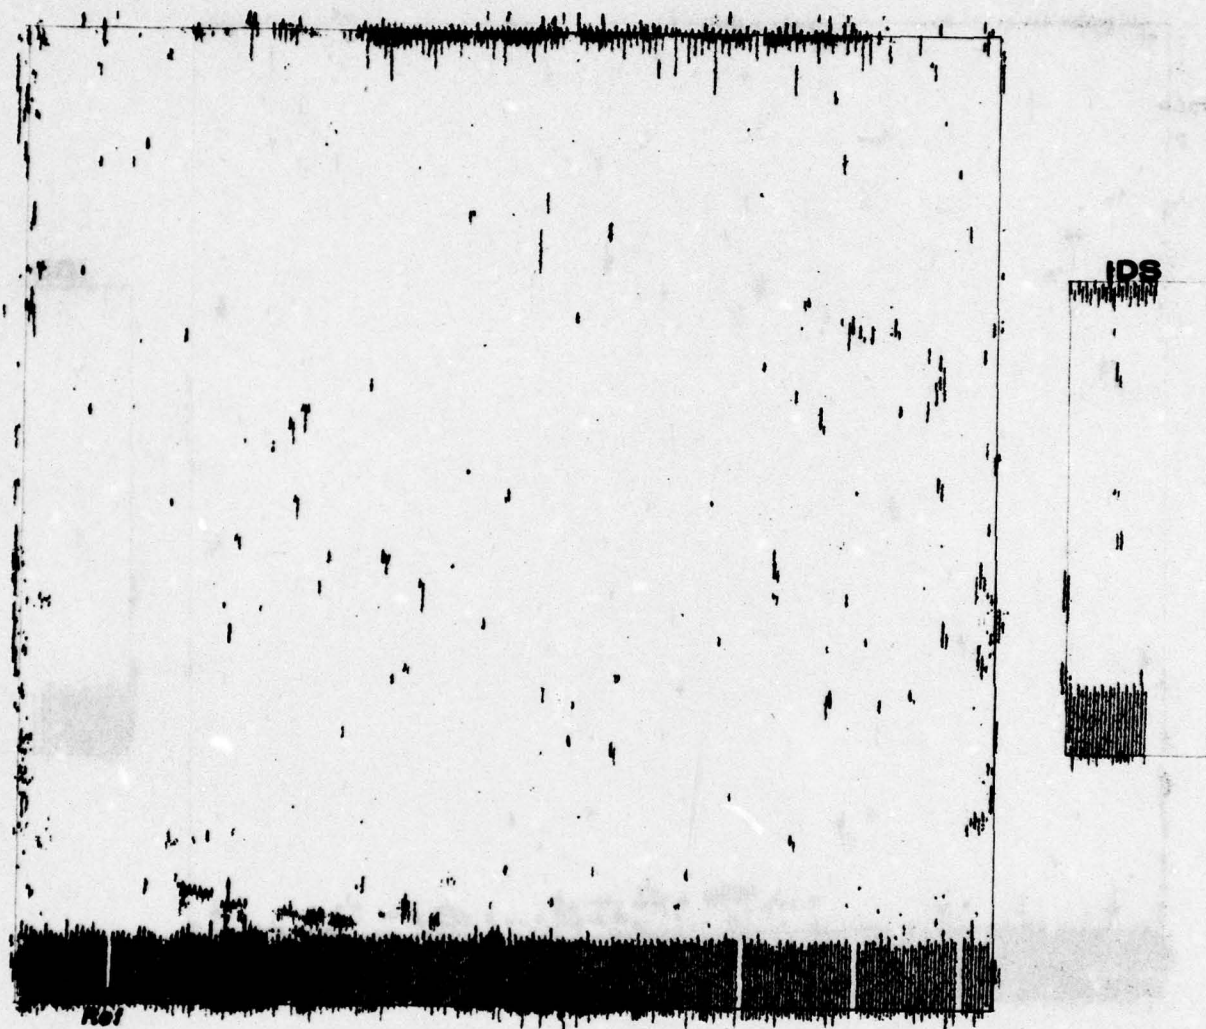
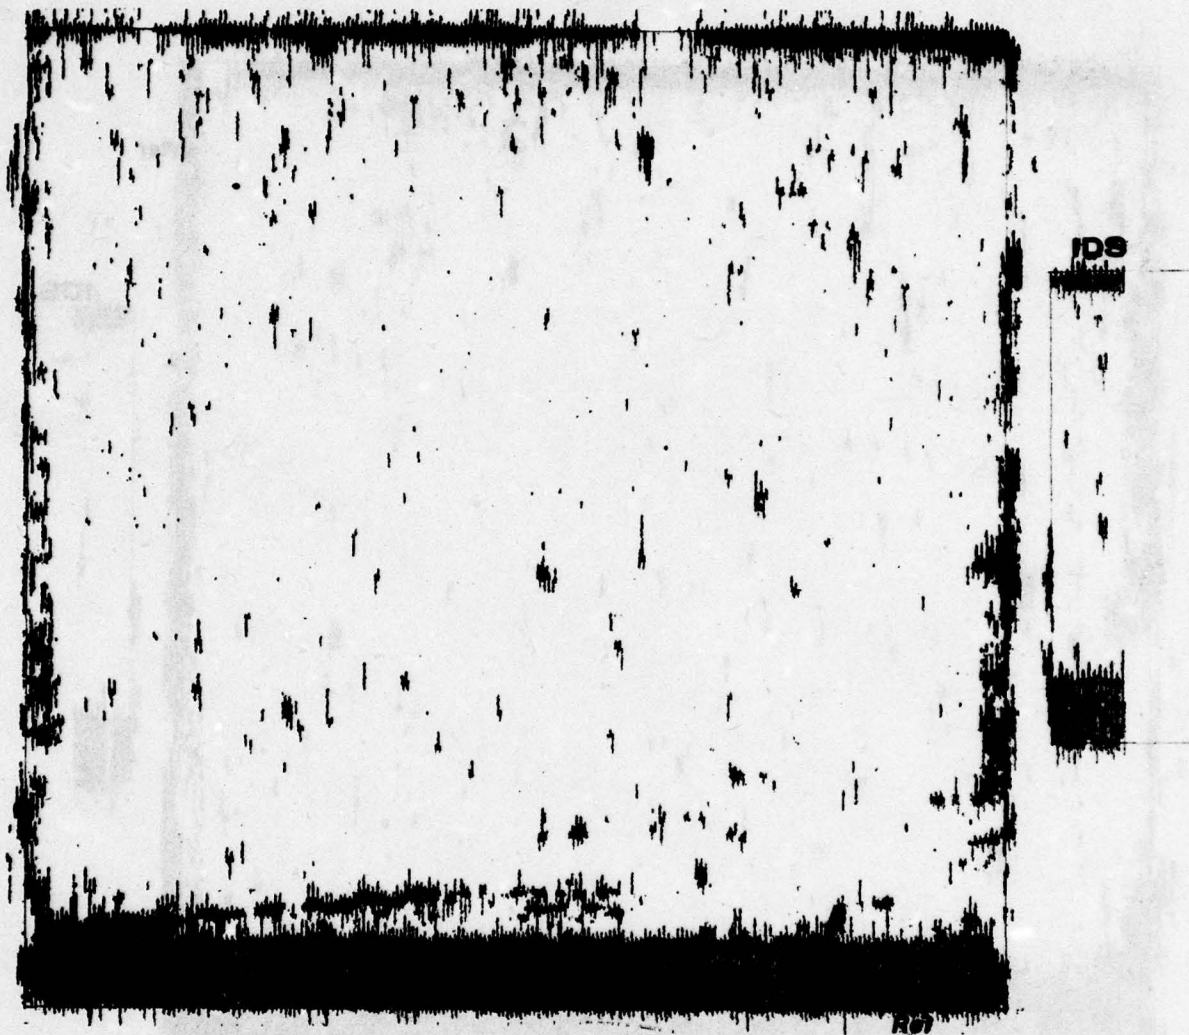
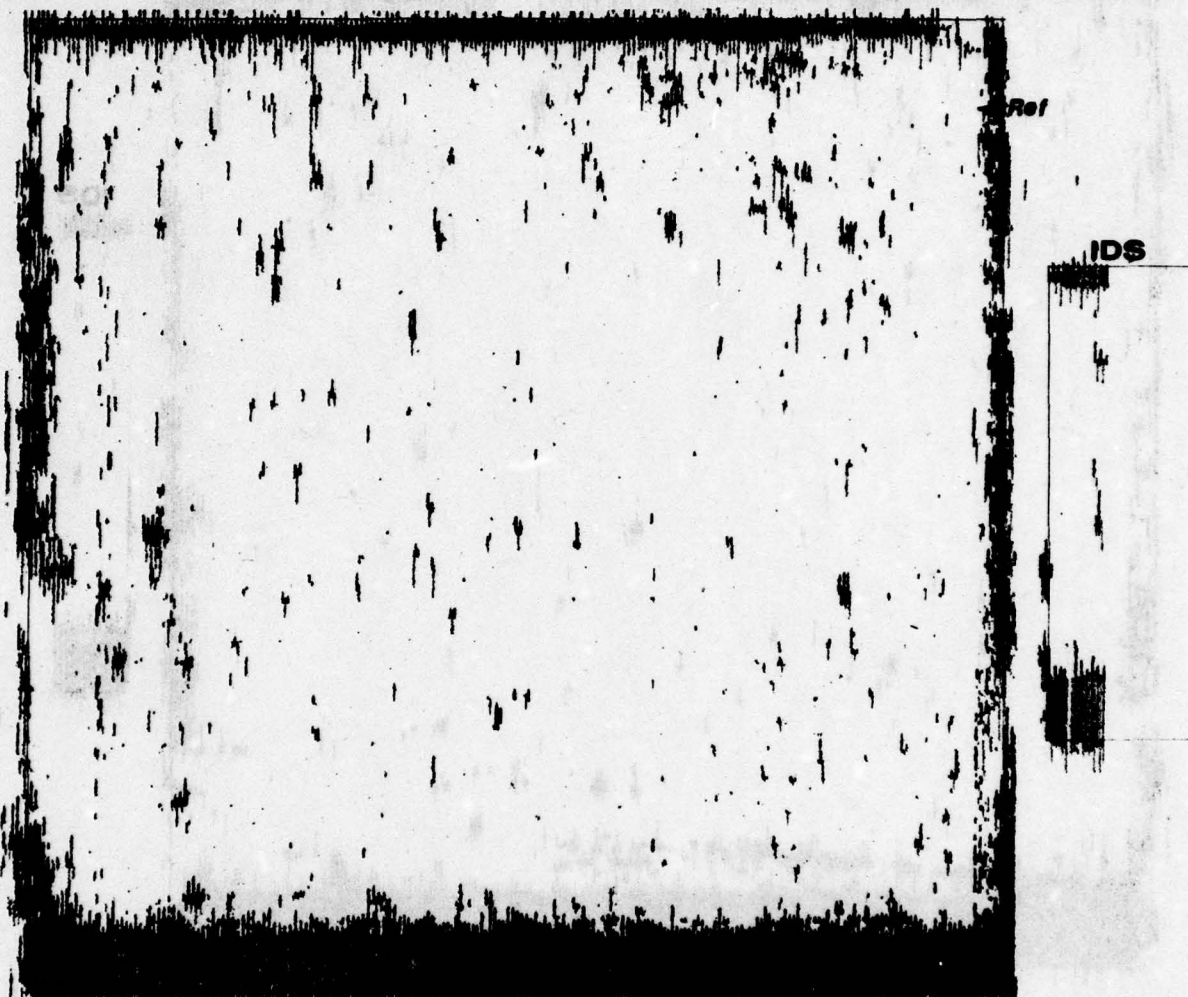
The C-scan recordings of the 45 MHz shear wave inspections of the billet of Ceralloy 147A are shown in Figures 12 through 15. As with previous samples of this material, these scans show a large number of defect indications. Figures 16 through 19 show the corresponding surface wave inspections. These scans also show large numbers of indications. The two types of scans were compared by means of transparencies. Since the shear wave inspection is performed from the opposite side of the surface than the surface wave inspection, the transparency of the shear wave C-scan is turned over on the surface wave C-scan so that the reference notches coincide. This type of comparison revealed that only a few of the defect indications correspond between the two types of scans. Most of the defects detected by the surface wave technique were not detected by the shear wave technique.

Figure 13. C-scan Recording of 45 MHz, 11° Shear Wave Inspection of Billet of Ceralloy 147A Hot Pressed Silicon Nitride (Rotated 90°, Notch Down).

Figure 14. C-scan Recording of 45 MHz, 11° Shear Wave Inspection of Billet of Ceralloy 147A Hot Pressed Silicon Nitride (Turned Over, Notch Up).

Figure 15. C-scan Recording of 45 MHz, 11° Shear Wave Inspection of Billet of Ceralloy 147A Hot Pressed Silicon Nitride (Rotated 90° , Notch Up).

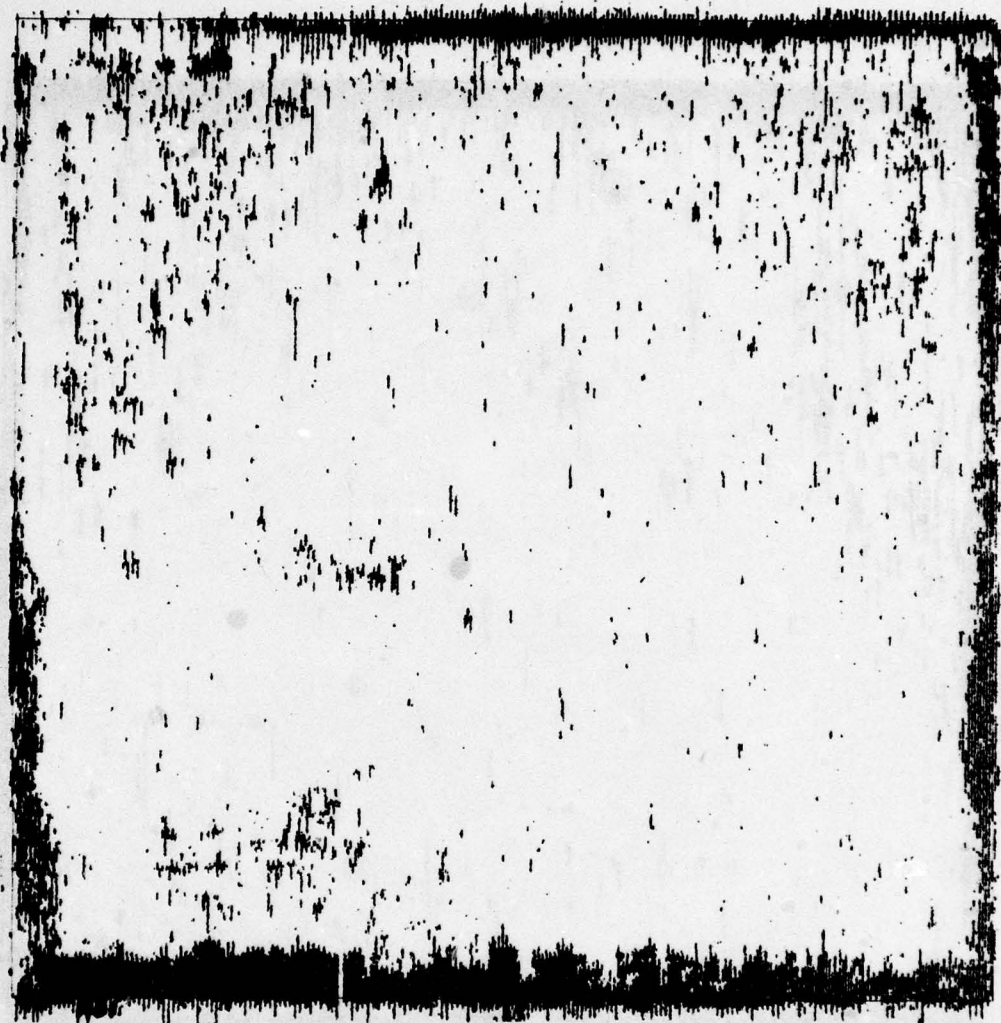
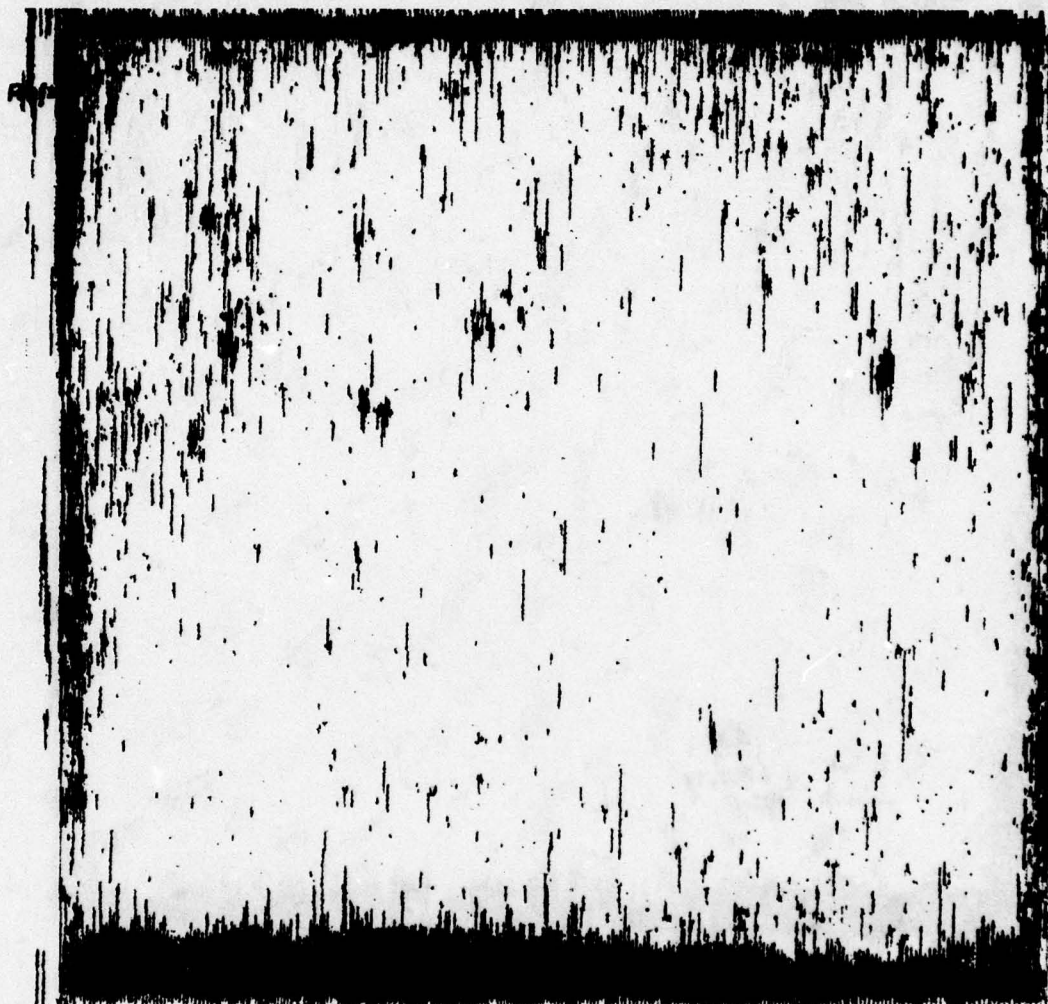
Figure 18. C-scan Recording of 45 MHz, 18° Surface Wave Inspection of Billet of Ceralloy 147A Hot Pressed Silicon Nitride (Turned Over, Notch Down).

Figure 19. C-scan Recording of 45 MHz, 18° Surface Wave Inspection of Billet of Ceralloy 147A Hot Pressed Silicon Nitride (Rotated 90°, Notch Down).

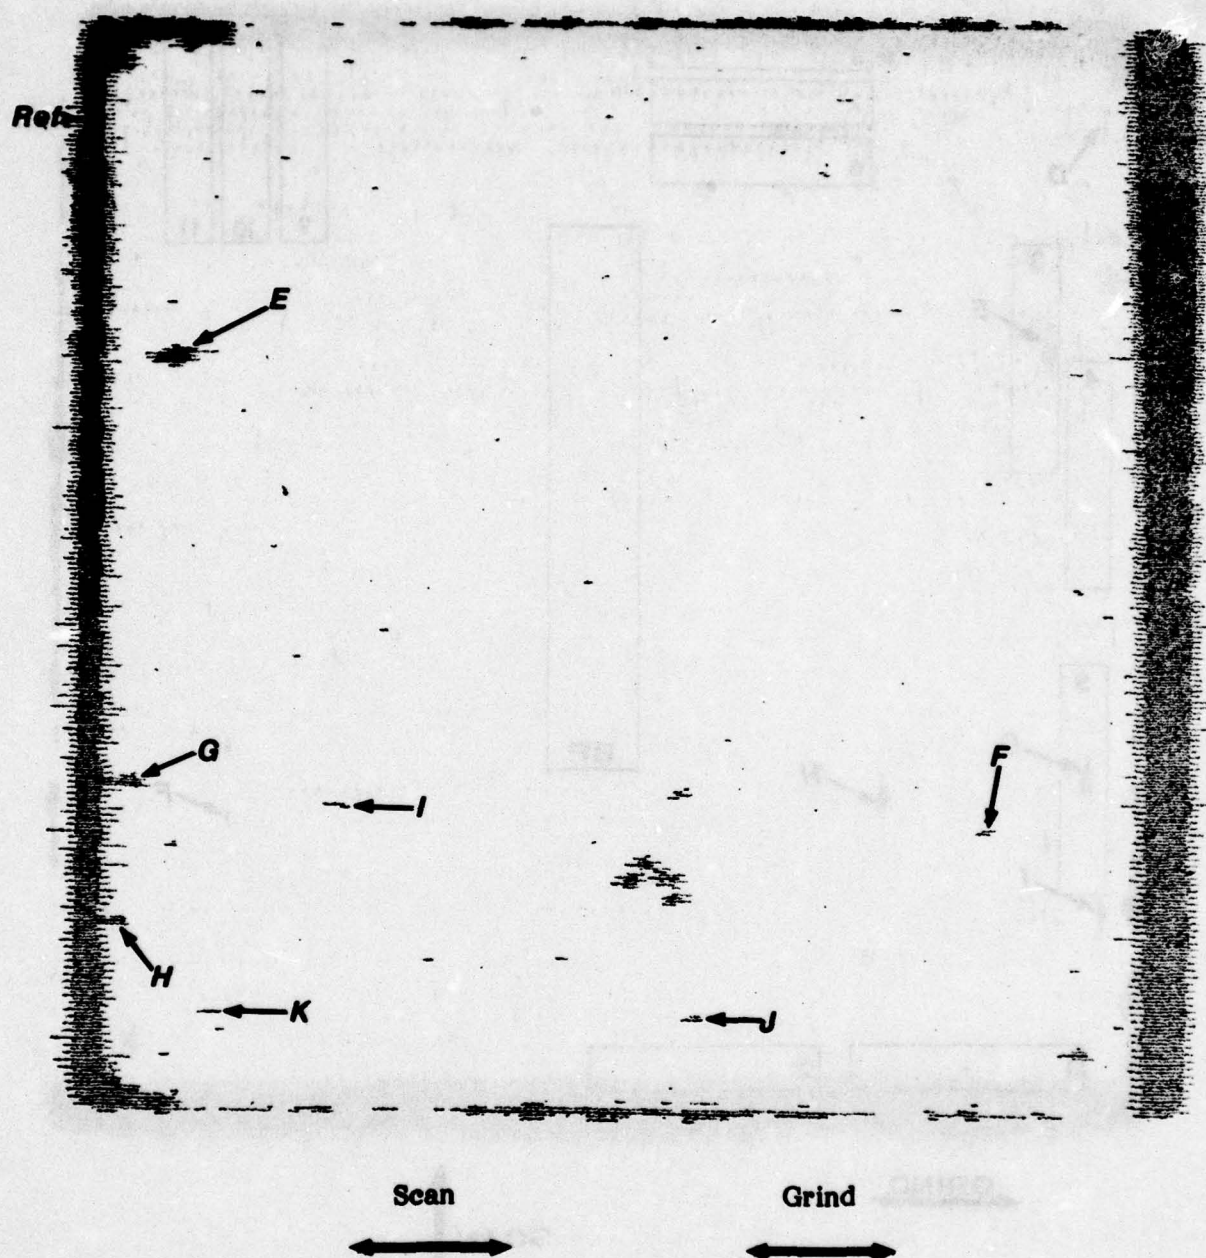
The surface wave inspection results after machining were compared with the results of both shear and surface wave inspections before machining. This was accomplished by making transparencies of one set of C-scan recordings and then overlaying them on the other C-scan recordings to look for common indications. No significant correlation was found between the corresponding surface wave inspections made before and after machining. This is as expected, since the amount of material removed during machining was much greater than the 130 μm (0.0052 inch) penetration depth of the 45 MHz surface wave. A correlation was found, however, between a number of the surface wave indications and the corresponding shear wave inspection made before machining. Those indications in Figures 21 through 24 that show an obvious correlation with indications in Figures 12 through 15 are labeled with letters from A through K in the figures where they appear. This correlation indicates that the machining operations exposed internal defects to the surface, which previously could only be detected by the shear wave technique. It is not known whether other defects, indicated by the surface wave inspection results after machining, were undetected by the shear wave techniques or were produced by the machining operation.

Based on the surface wave inspection results after machining, areas of the billet were selected for burner rig testing and for four-point-bend testing. Figures 22 and 24 show how these specimens relate to the inspection results on the two sides of the billet. In Figure 22 it can be seen that four-point-bend specimens were machined

Figure 23. C-scan Recording of 45 MHz, 18° Surface Wave Inspection of Bottom Surface of Billet of Ceralloy 147A HPSN After Machining (Scan Parallel to Grinding Direction).

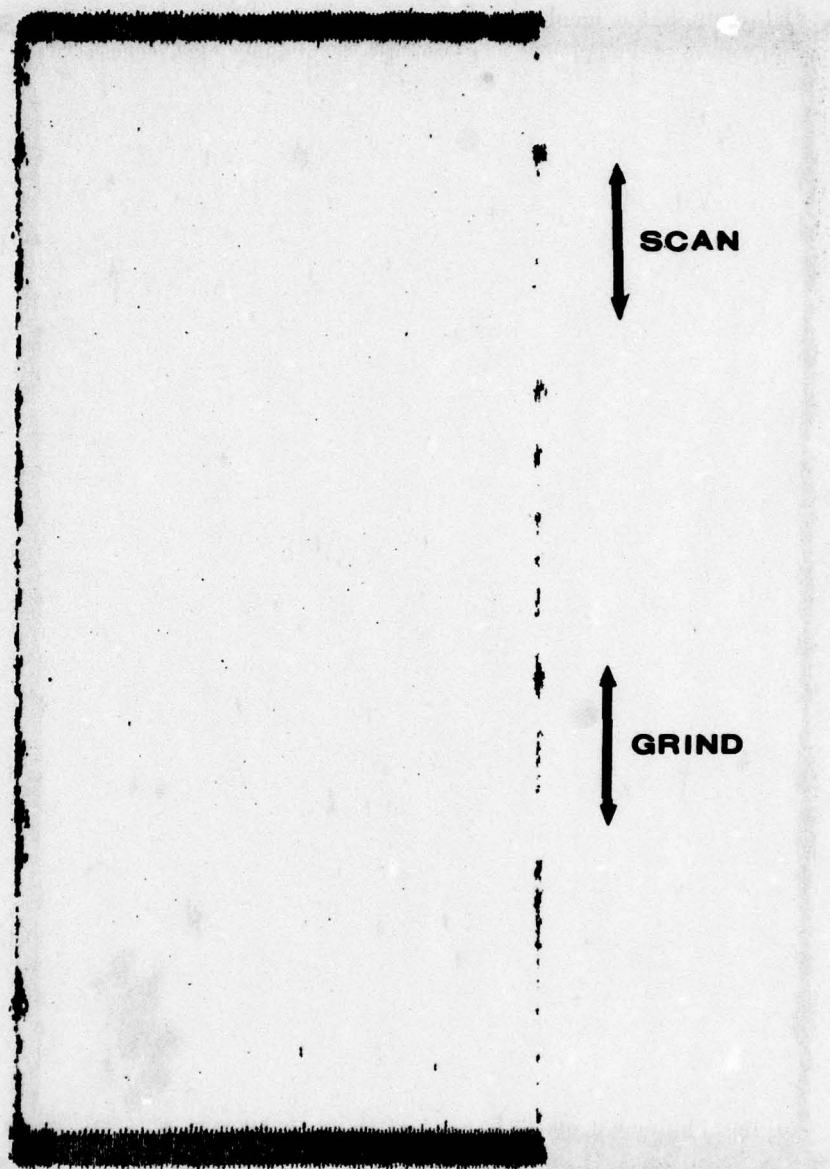
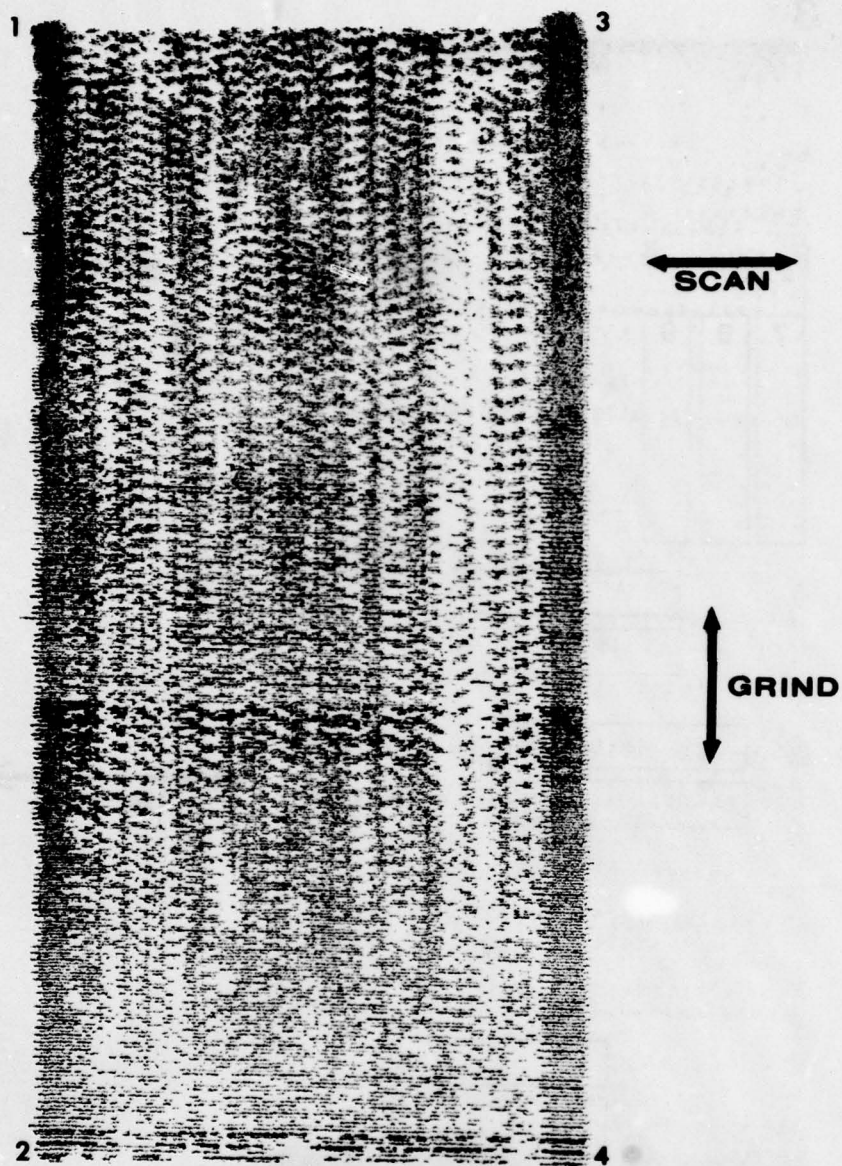
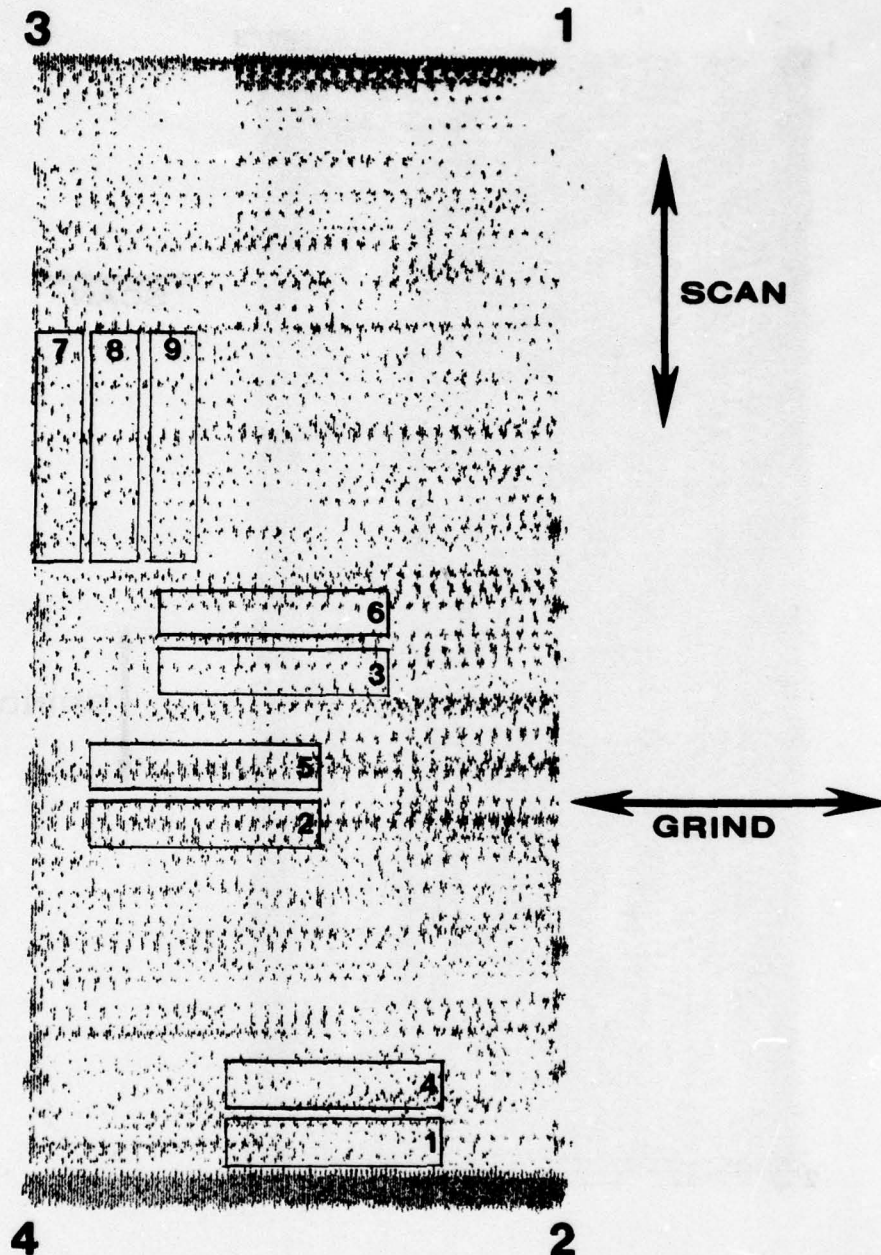
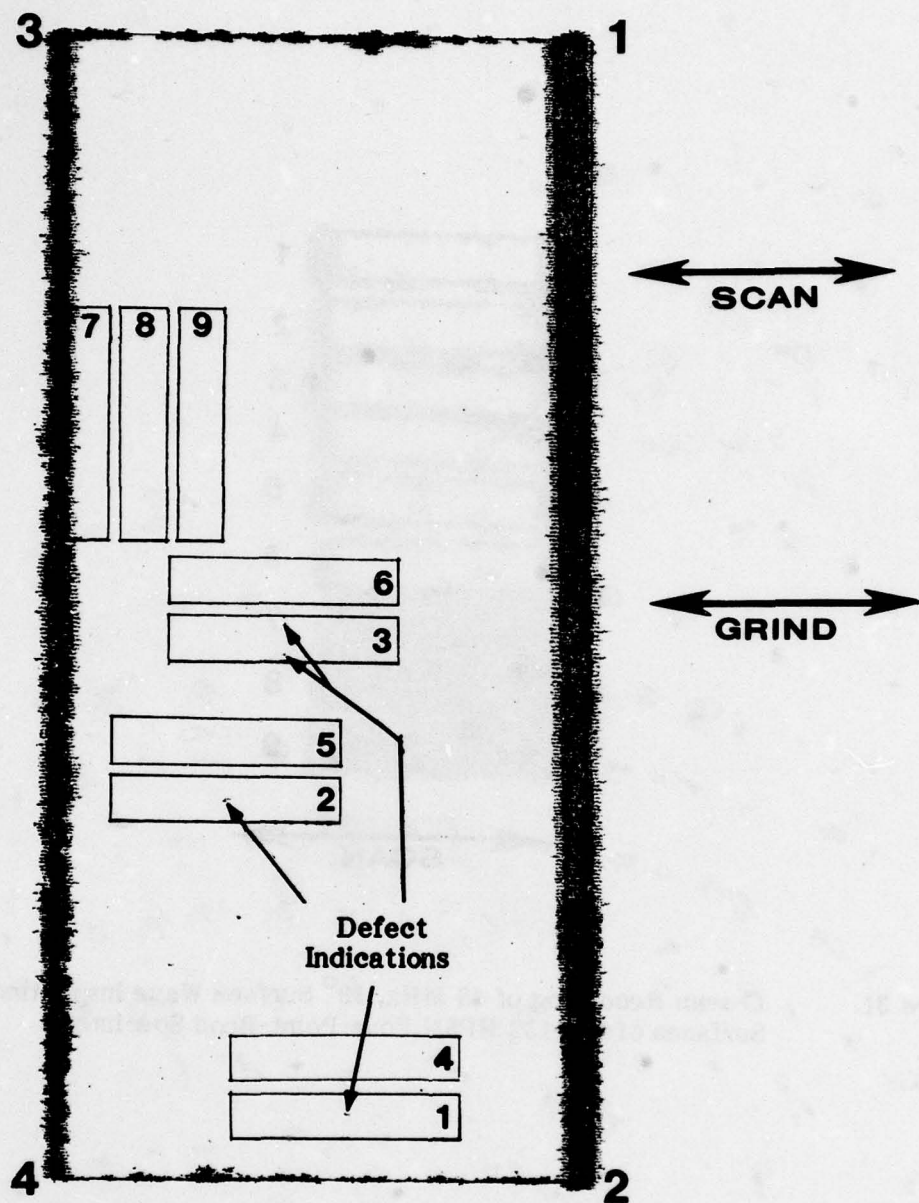
Figure 26 shows a C-scan recordings of a surface wave inspection of the billet of NC-132 HPSN. The cluster of defects in corner No. 4 are shallow surface pits. This corner was cut off and used as a burner rig specimen. Figures 27 through 30 show C-scan recordings of surface wave inspections of both sides of the remainder of the billet from two orientations each. Other than of few small indications in Figure 29, the only defects detected were the grinding marks. The location of four-point-bend specimens made from this billet are indicated in Figures 29 and 30. Specimens 1, 2 and 3 were centered around very small defect indications, as shown in Figure 29. Specimens 4, 5, and 6 run parallel to the grinding damage and specimens 7, 8 and 9 run perpendicular to the grinding damage, as is shown in Figure 30. The C-scan recording of the surface wave inspection of the tensile surface of the individual specimens is shown in Figure 31 prior to machining to final thickness.

Figure 27. C-scan Recording of 45 MHz, 18° Surface Wave Inspection of Top Surface of Billet of NC-132 HPSN (Scan Parallel to Grinding Direction).

Figure 28. C-scan Recording of 45 MHz, 18° Surface Wave Inspection of Top Surface of Billet of NC-132 HPSN (Scan Perpendicular to Grinding Direction).

Figure 29. C-scan Recording of 45 MHz, 18° Surface Wave Inspection of Top Surface of Billet of NC-132 HPSN (Scan Parallel to Grinding Direction).

Figure 30. C-scan Recording of 45 MHz, 18° Surface Wave Inspection of Bottom Surface of Billet of NC-132 HPSN (Scan Perpendicular to Grinding Direction).

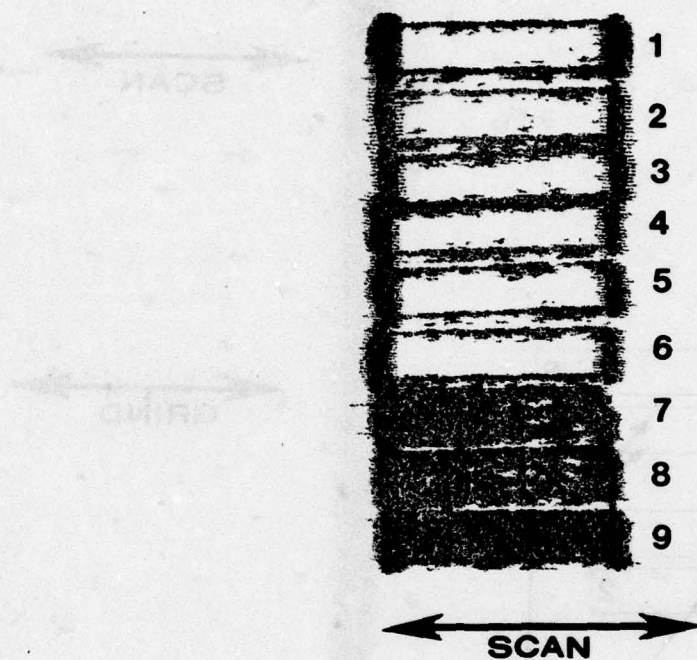
Figure 31. C-scan Recording of 45 MHz, 18° Surface Wave Inspection of Tensile Surfaces of NC-132 HPSN Four-Point-Bend Specimens.

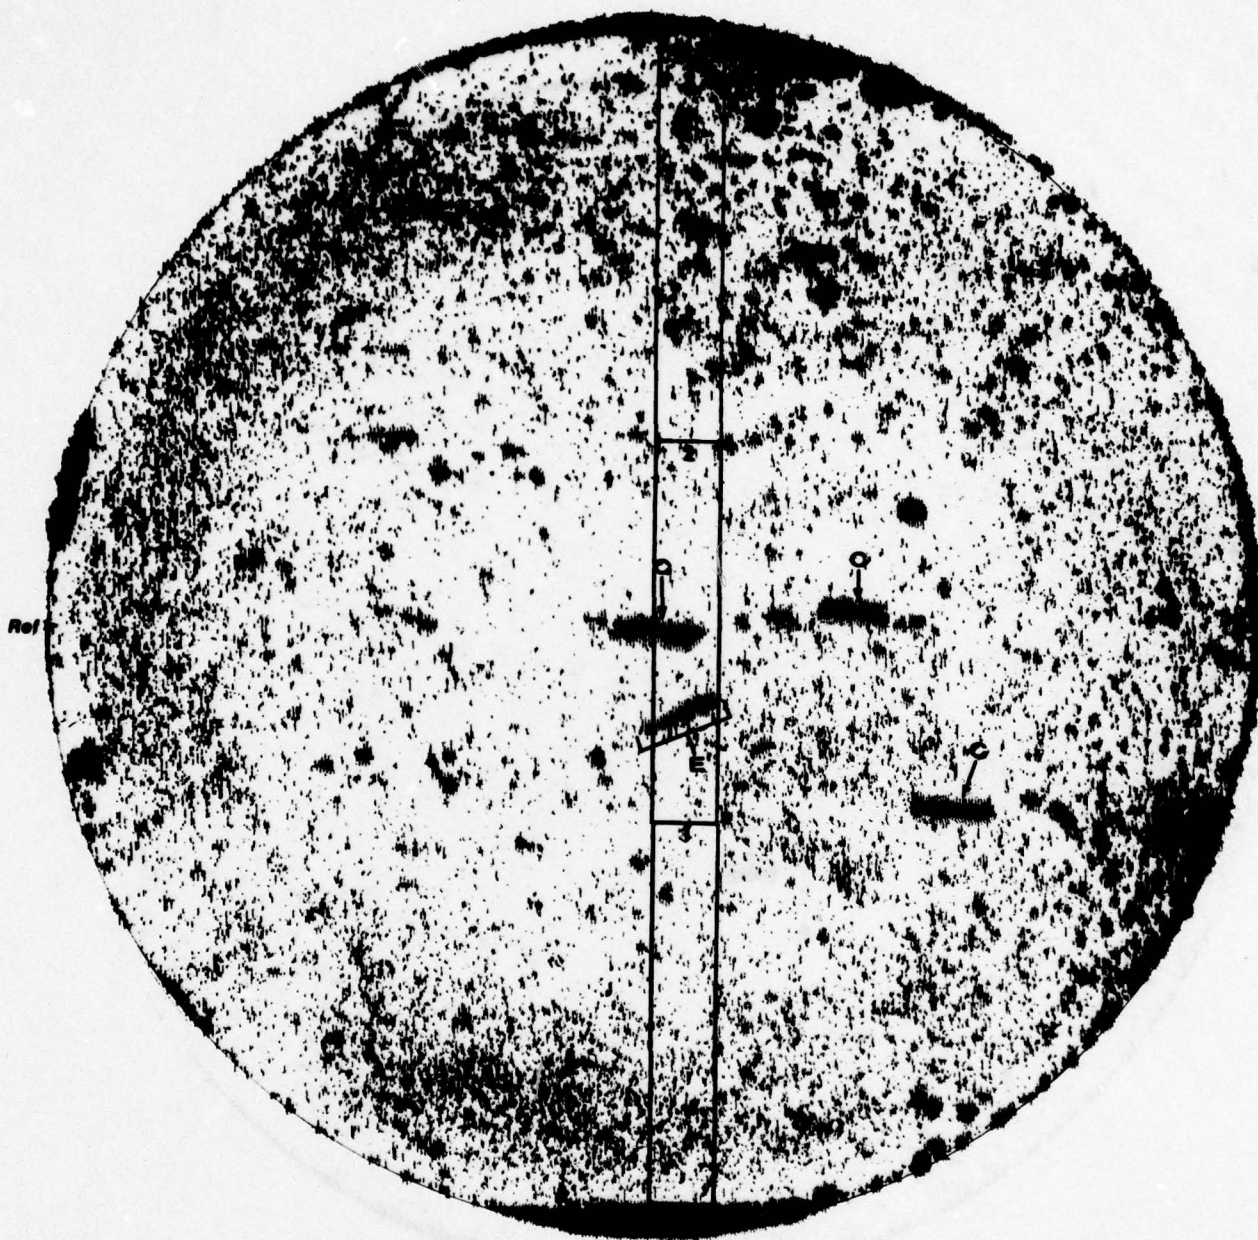
Figure 40 is a reproduction of Figure 37 showing the bottom view of the billet overlaid with the locations of three 1.3 x 7.6 cm (1/2 x 3-inch) burner rig specimens. Burner rig specimen #2 contains indication E, and one of the crack-like indications labeled C. Figure 41 shows the top view of the billet. In this C-scan recording the scan direction is rotated slightly from that of Figure 40, in order to eliminate the background of linear indications from the surface lines and to allow a better definition of the crack-like indication. In addition to showing the three burner rig specimens, this view shows an area where the surface lines were machined off (shaded area). This area contains indication F and half of the crack-like indication. The surface lines were removed by grinding off 15 μ m (0.0006 inches) using a 320 grit diamond wheel to achieve a surface finish of about 20 microinches. The grinding was carried out perpendicular to the straight edge left by cutting out the burner rig specimens.

Figure 40. Location of Burner Rig Specimens Overlaid on C-scan Recording of 45 MHz, 18° Surface Wave Inspection of Bottom Surface of Billet of NC-350 RBSN.

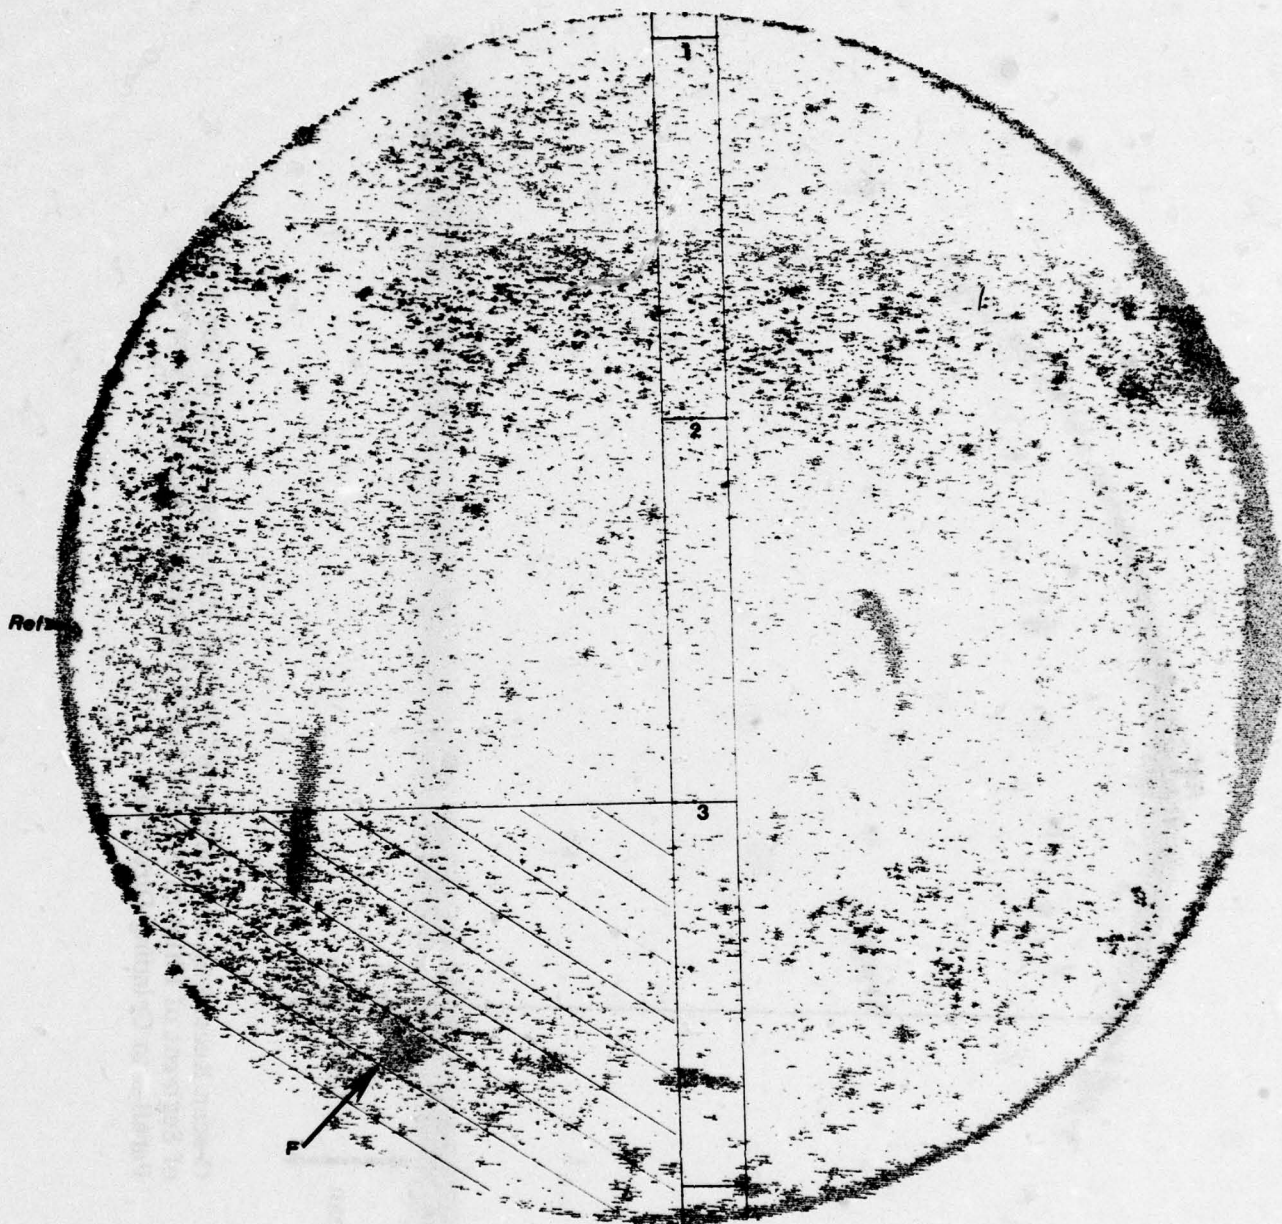
Figure 41. Location of Burner Rig Specimens and Machined (Shaded) Area Overlayed on C-scan Recording of 45 MHz, 18° Surface Wave Inspection of Top Surface of Billet of NC-350 RBSN.

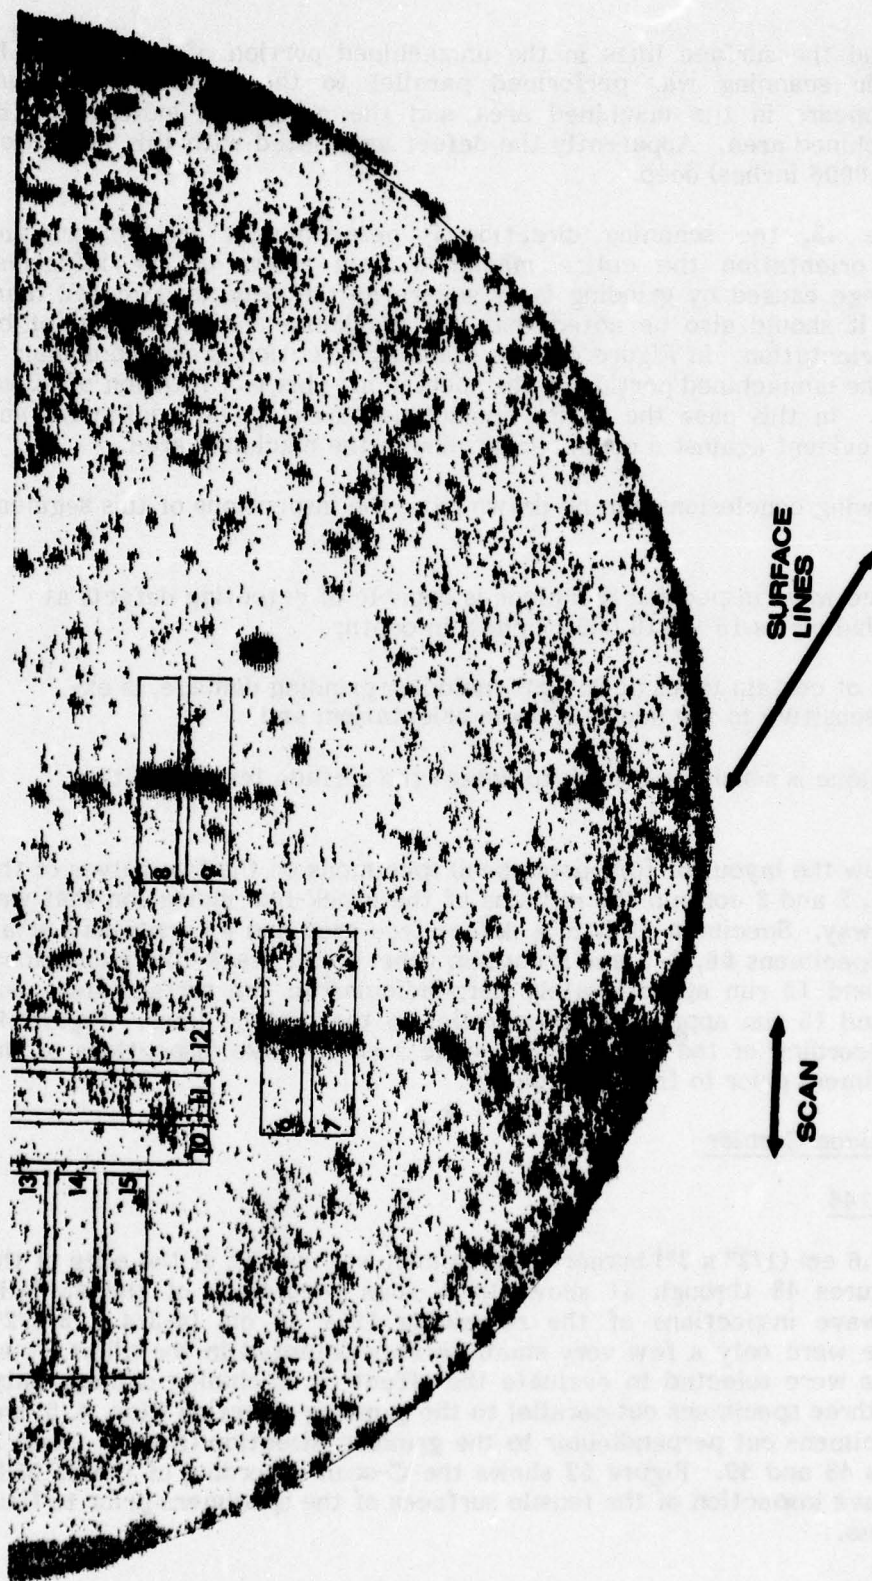
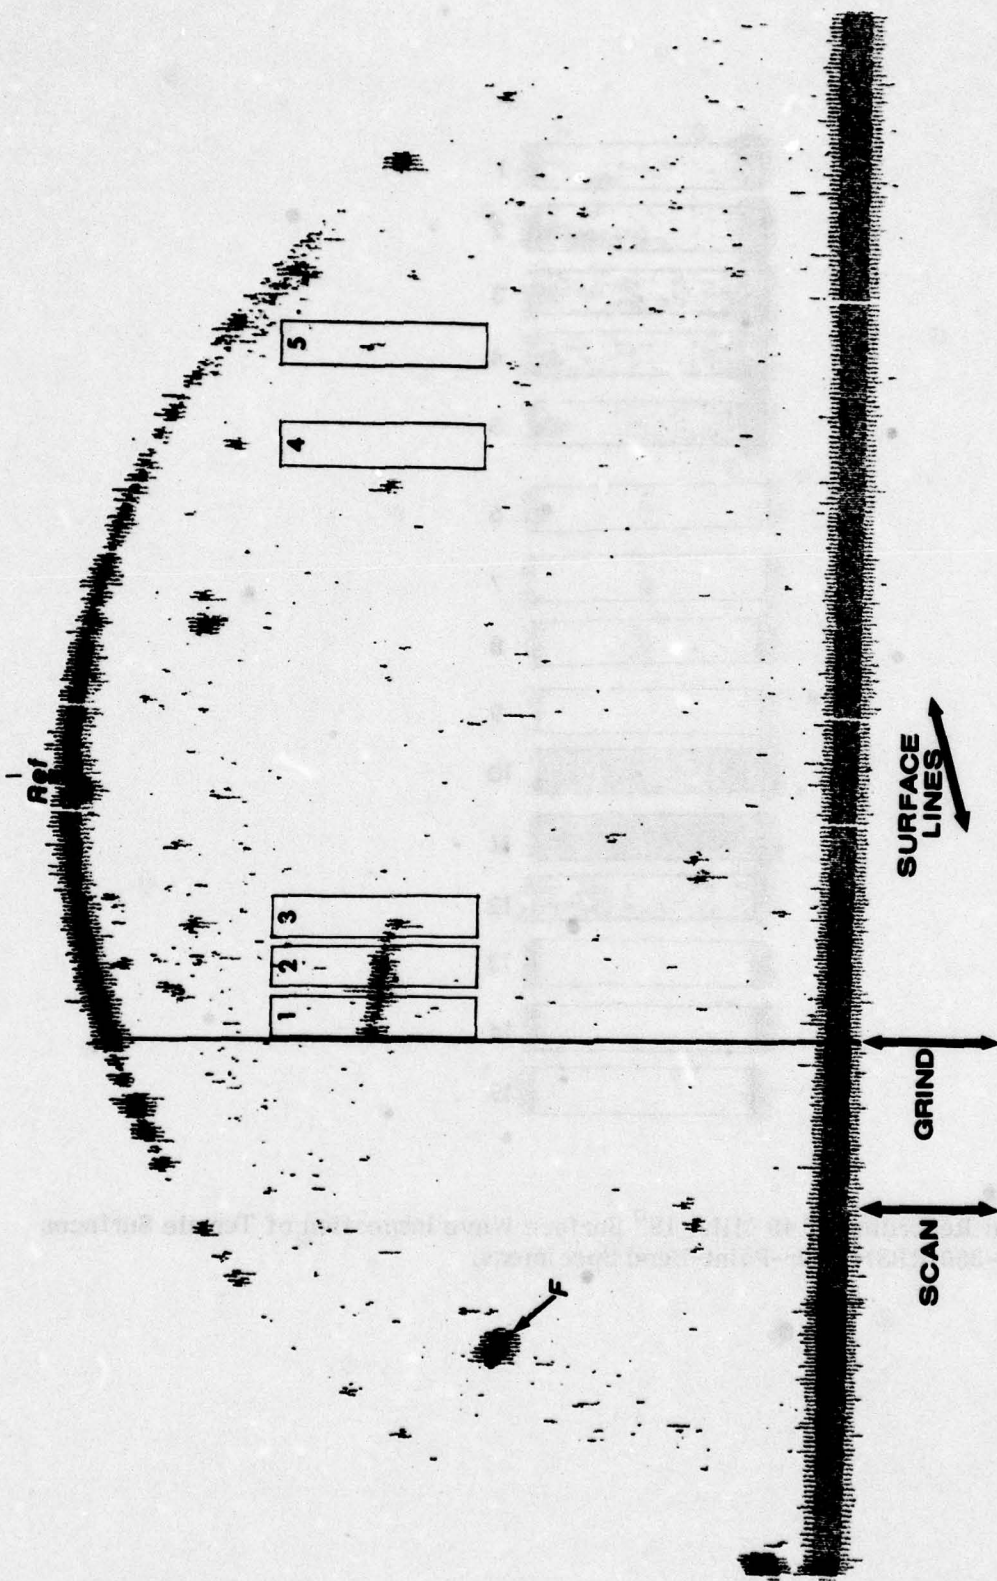
Figures 45 and 46 show the layout of four-point-bend specimens on the two halves of the billet. Specimens #1, 2 and 3 contain the remains of the crack-like indication that was partially machined away. Specimen #4 is in a defect-free area and #5 contains a small surface indication. Specimens #6, 7, 8 and 9 contain other small crack-like indications. Specimens #10, 11 and 12 run approximately perpendicular to the surface lines and specimens #13, 14 and 15 run approximately parallel to the surface lines. Figure 47 shows the C-scan recording of the 45 MHz ultrasonic surface wave inspections of the four-point-bend specimens prior to final machining.

Figure 45. Layout of Four-Point-Bend Specimens on Bottom Surface of Unmachined Segment of Billet of NC-350 RBSN.

Figure 46. Layout of Four-Point-Bend Specimens of Top Surface of Partially Machined Segment of Billet of NC-350 RBSN.
