ULTRASONIC DETECTION OF SURFACE FLAWS IN GAS TURBINE CERAMICS.(U)

4. TITLE (and Subtitle) ULTRASONIC DETECTION OF SURFACE FLAWS IN GAS TURBINE CERAMICS		5. TYPE OF REPORT & PERIOD COVERED Final Technical Report	13. Sep 77-12 hlc 76

6. AUTHOR(s) Thomas/Derkacs Istvan M. Matay		7. PERFORMING ORG. REPORT NUMBER TRW-ER-7986-F	
8. PERFORMING ORGANIZATION NAME AND ADDRESS TRW Inc. 23555 Euclid Avenue Cleveland, OH 44117		9. CONTRACT OR GRANT NUMBER(s) (15) N62269-77-C-0136

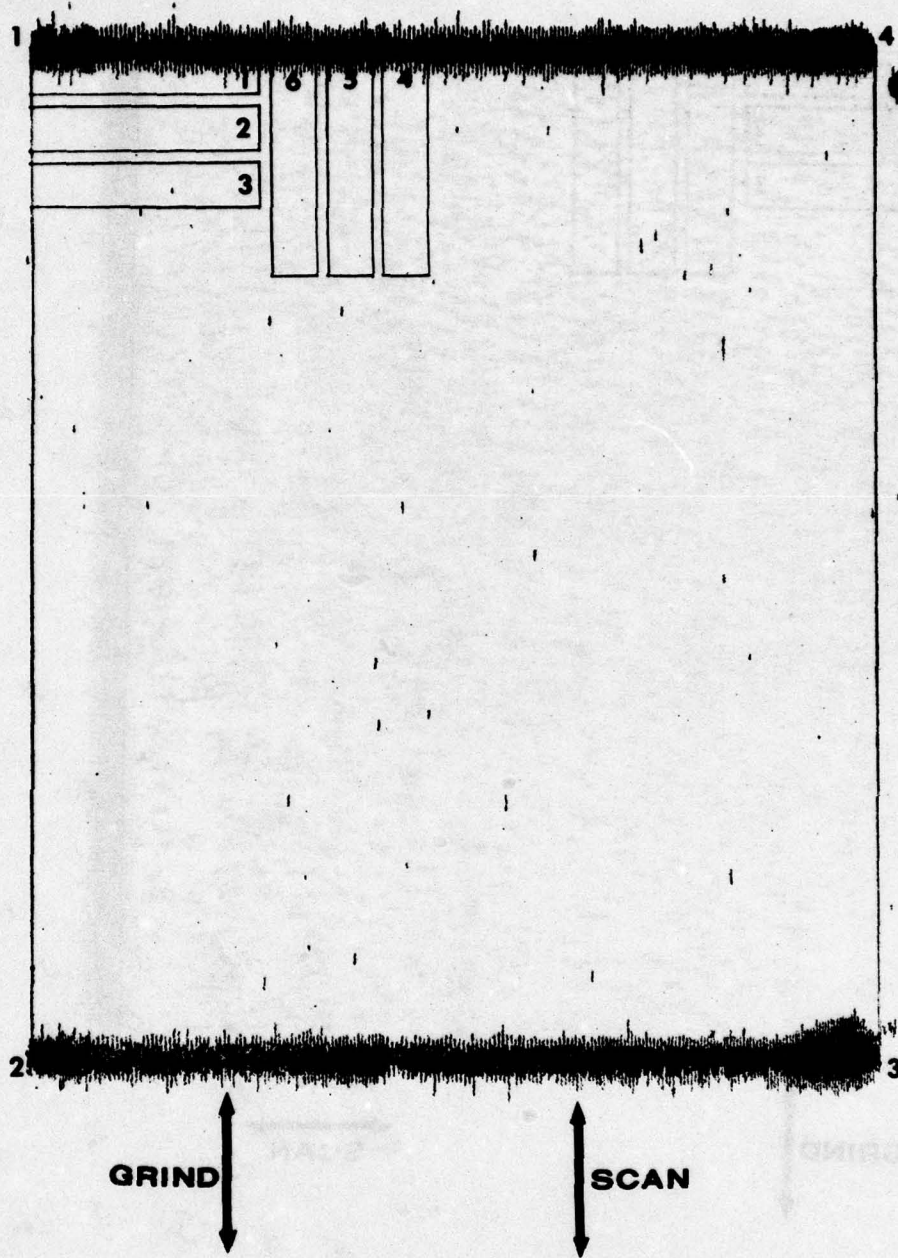
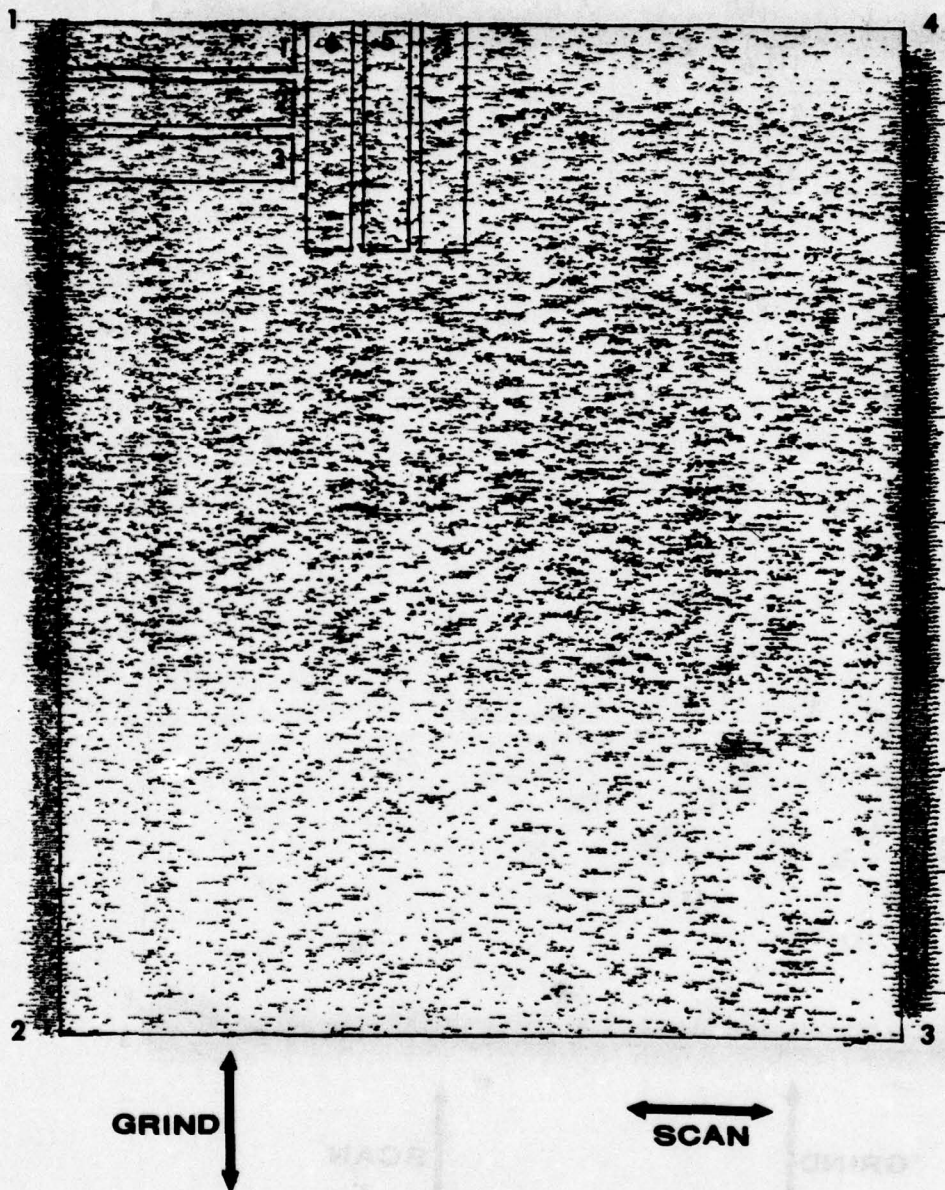
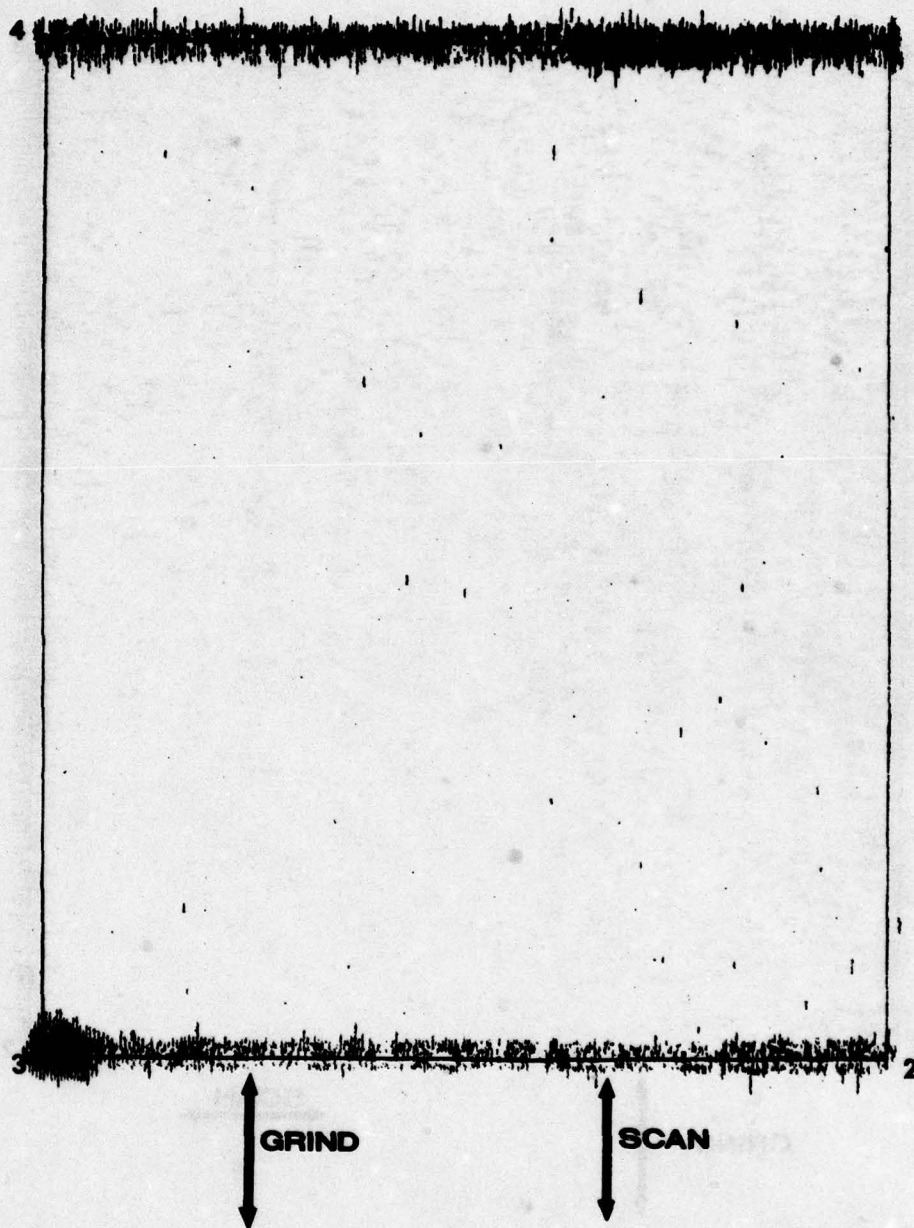
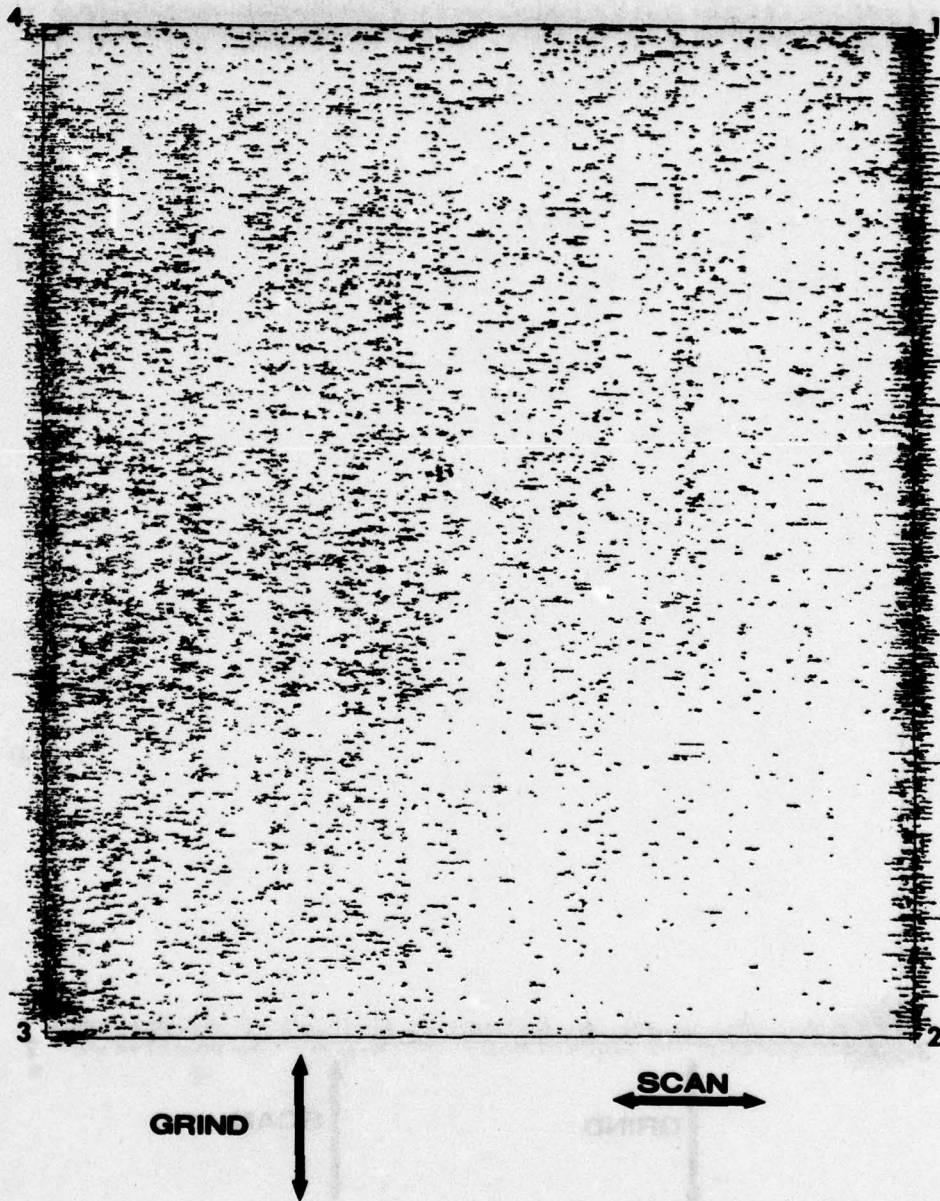
A 1.2 x 7.6 cm (1/2" x 3") burner rig specimen was cut out of the edge of the original billet. Figures 48 through 51 show the C-scan recordings of the 45 MHz ultrasonic surface wave inspections of the remaining 12 x 14 cm (4-3/4 x 5-1/2") portion. Since there were only a few very small defects detected in the billet, four-point-bend specimens were selected to evaluate the effect of machining damage only. The location of the three specimens cut parallel to the grinding direction (Nos. 4, 5, and 6) and the three specimens cut perpendicular to the grinding direction (Nos. 1, 2 and 3) are shown in Figures 48 and 49. Figure 52 shows the C-scan recording of the 45 MHz ultrasonic surface wave inspection of the tensile surfaces of the specimens prior to final machining to thickness.

Figure 48. C-scan Recording of 45 MHz, 18° Surface Wave Inspection of Top Surface of Billet of Ceralloy 146 HPSiC (Scan Parallel to Grinding Direction).

Figure 49. C-scan Recording of 45 MHz, 18° Surface Wave Inspection of Top Surface of Billet of Ceralloy 146 HPSiC (Scan Perpendicular to Grinding Direction).

Figure 50. C-scan Recording of 45 MHz, 18° Surface Wave Inspection of Bottom Surface of Billet of Ceralloy 146 HPSiC (Scan Parallel to Grinding Direction).

Figure 51. C-scan Recording of 45 MHz, 18° Surface Wave Inspection of Bottom Surface of Billet of Ceralloy 146 HPSiC (Scan Perpendicular to Grinding Direction).

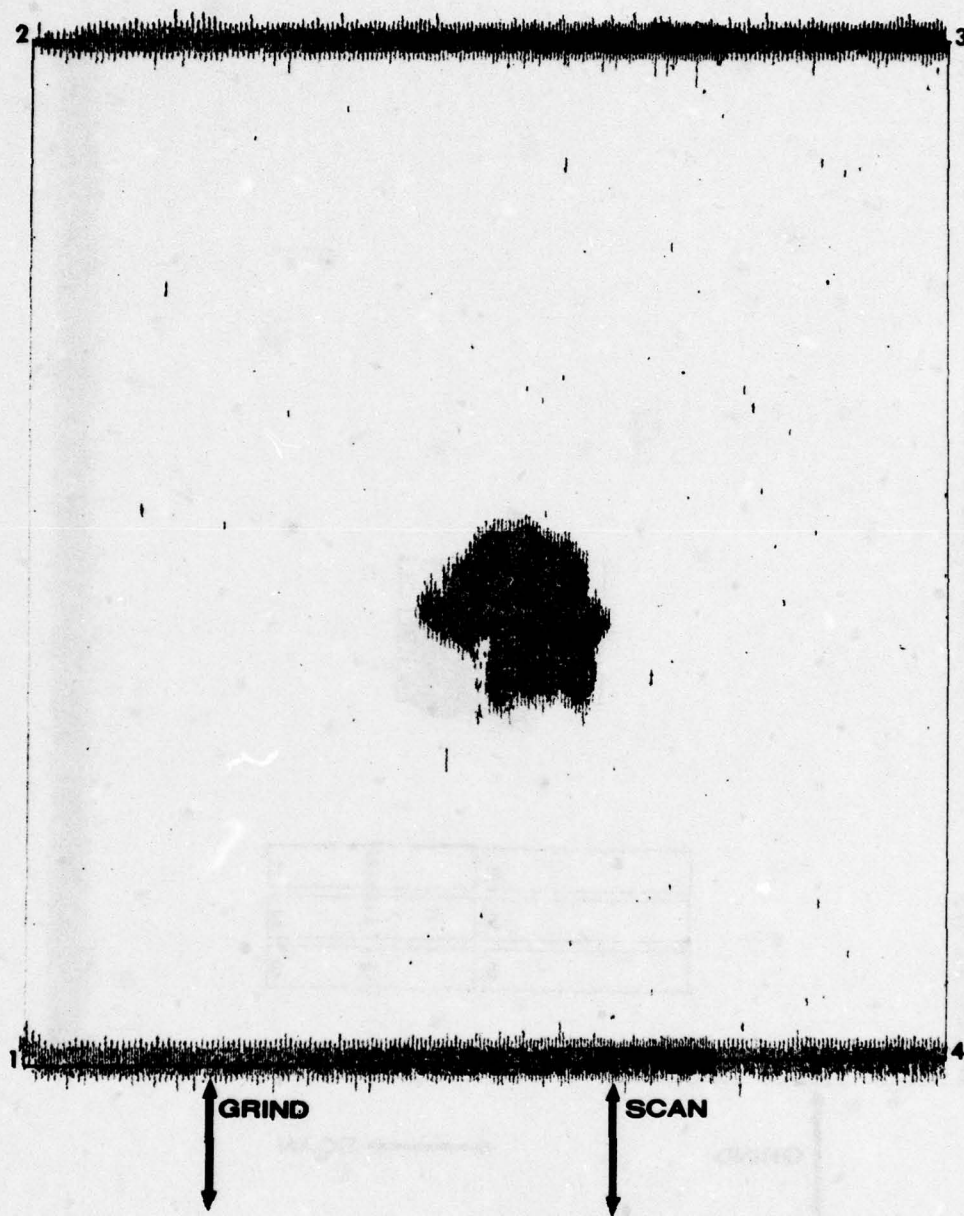
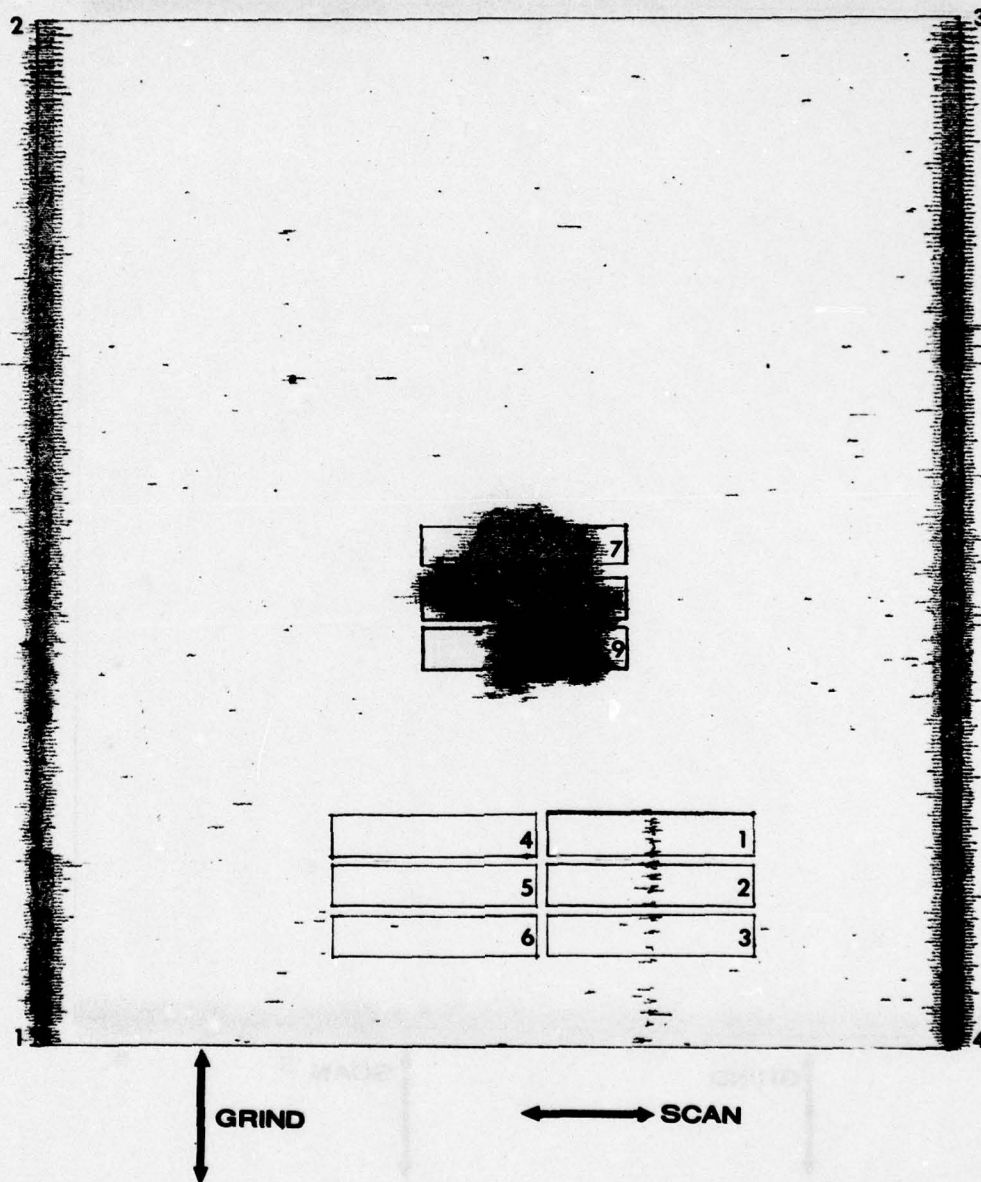
A 1.2 x 7.6 cm (1/2 x 3-inch) burner rig specimen was cut out of the edge of the original billet. Figures 53 through 56 show the C-scan recordings of the 45 MHz ultrasonic surface wave inspections of the remaining 14 x 16 cm (5-1/2 x 6-1/4-inch) portion. This billet has a large defective area near the center that was shown by shear wave inspection (Ref. 2) to go all the way through the part. This shows up as a heavy indication on the top surface (Figures 53 and 54) and as a cluster of scattered indications on the bottom (Figures 55 and 56). This billet had extremely smooth surfaces so that none of the scans shows heavy patterns of indications from grinding marks. As shown in Figure 54, the four-point-bend specimens were selected to compare an area free of indications (specimens Nos. 4, 5 and 6) with an area showing the only apparent machining damage present in the billet (specimen Nos. 1, 2 and 3) and with the large defective area (specimen Nos. 7, 8 and 9). Figure 57 is a C-scan of the 45 MHz ultrasonic surface wave inspection of the tensile surfaces of the four-point-bend specimens prior to finish machining.

Figure 53. C-scan Recording of 45 MHz, 18° Surface Wave Inspection of Top Surface of Billet of NC-203A HPSiC (Scan Parallel to Grinding Direction).

Figure 54. C-scan Recording of 45 MHz, 18° Surface Wave Inspection of Top Surface of Billet of NC-203A HPSiC (Scan Perpendicular to Grinding Direction).

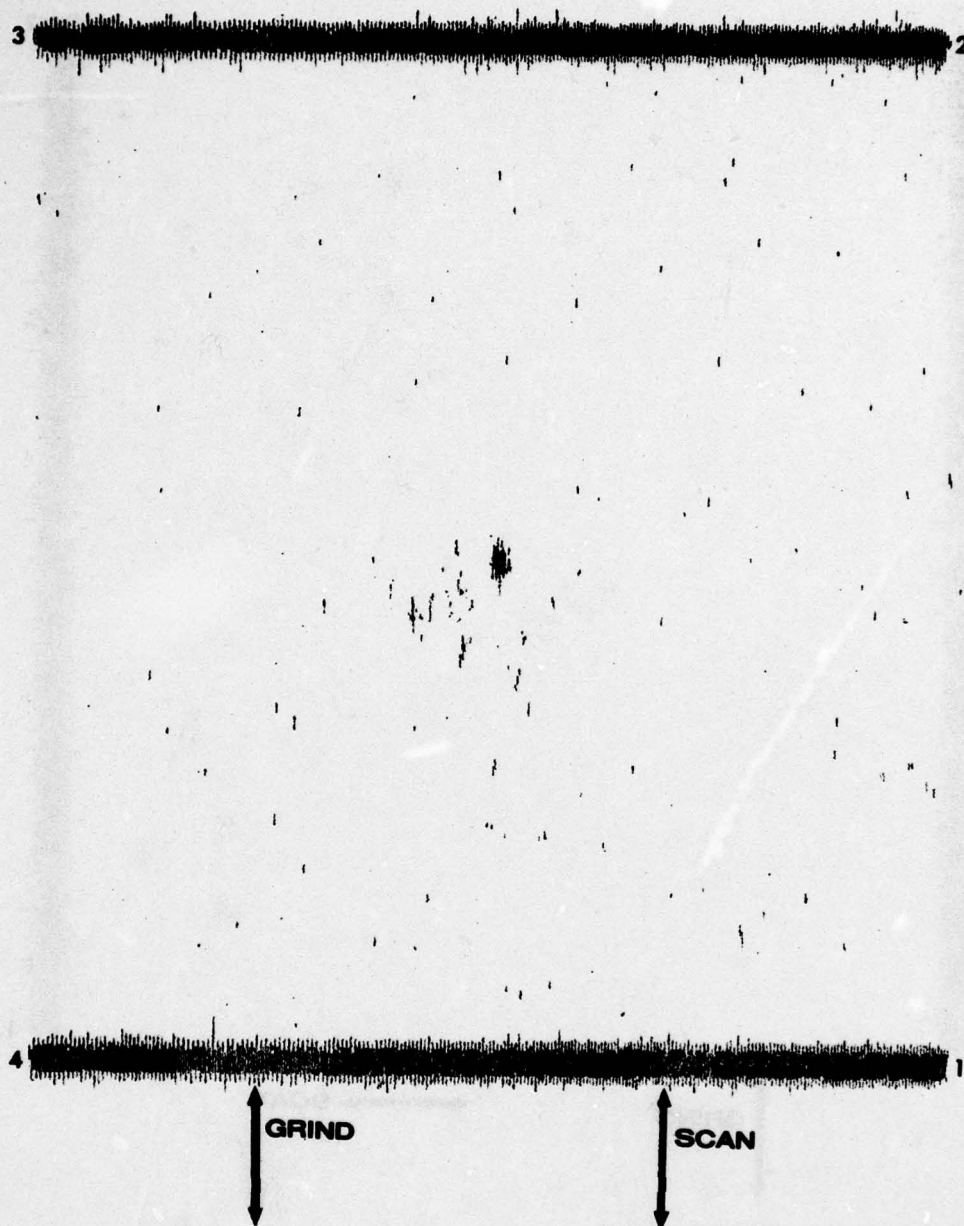
Figure 55. C-scan Recording of 45 MHz, 18° Surface Wave Inspection of Bottom Surface of Billet of NC-203A HPSiC (Scan Parallel to Grinding Direction).

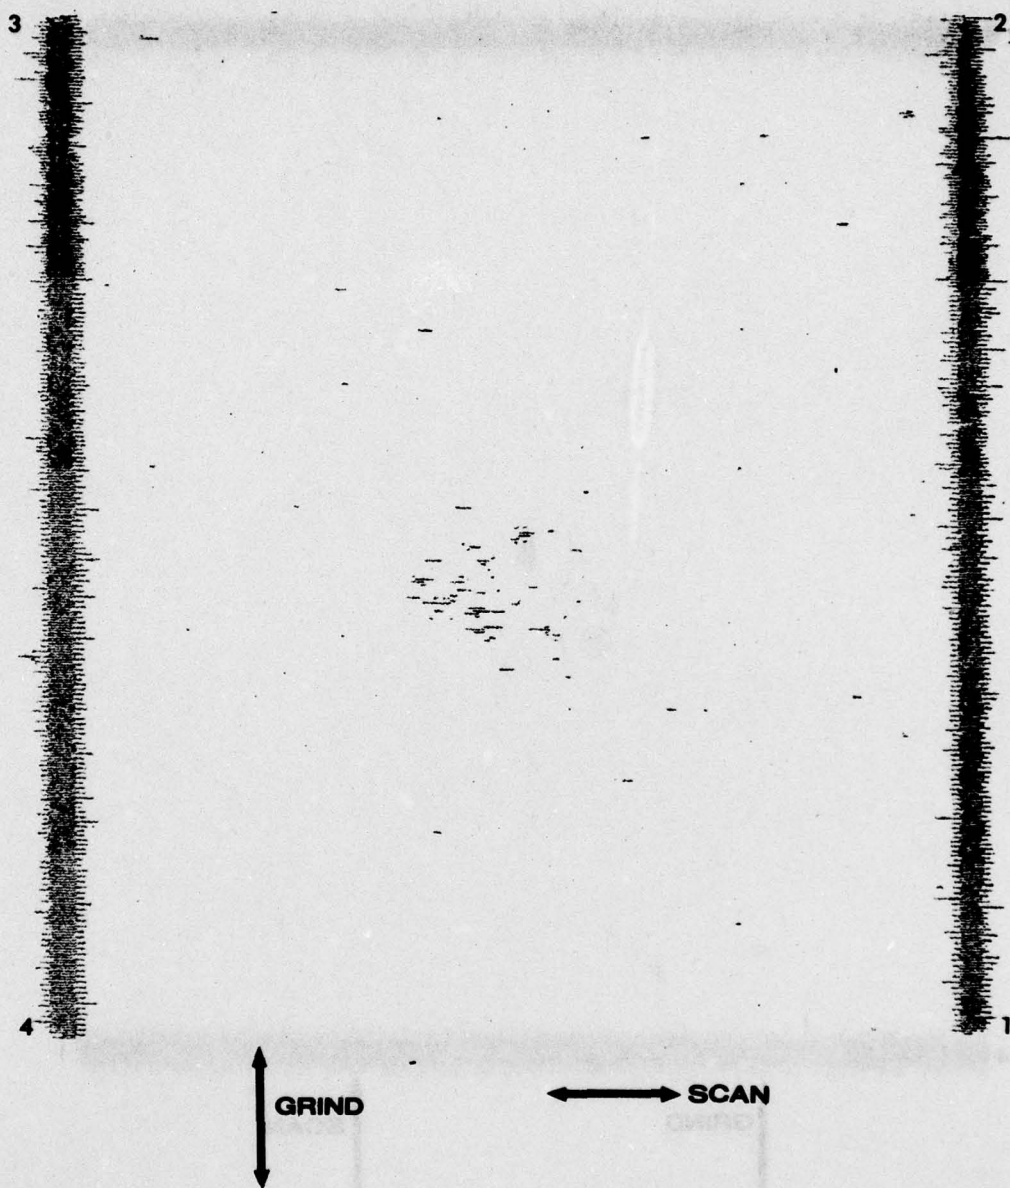
Figure 56. C-scan Recording of 45 MHz, 18° Surface Wave Inspection of Bottom Surface of Billet of NC-203A HPSiC (Scan Perpendicular to Grinding Direction).

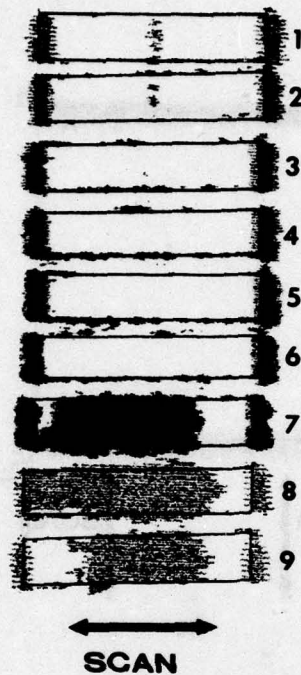
Figure 57. C-scan Recording of 45 MHz, 18° Surface Wave Inspection of Tensile Surfaces of NC-203A HPSiC Four-Point-Bend Specimens.

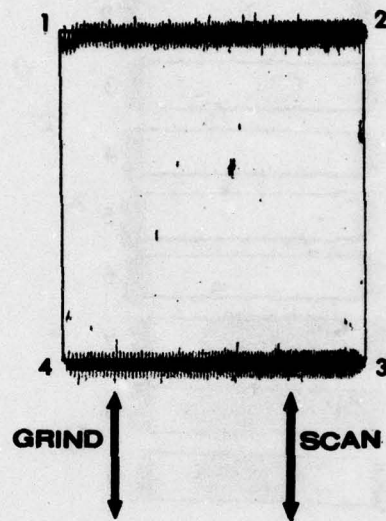
Figures 58 through 61 show the C-scan recordings of the 45 MHz ultrasonic surface wave inspections of the billet of boron-doped SSiC. These inspections detected a number of small defects, particularly on the bottom surface, in the scans made parallel to the grinding direction. They also detected a number of lines of grinding damage running across the billet in the scans made perpendicular to the grinding direction. Since this billet was small, there was not enough material to make a burner rig specimen or to make many four-point-bend specimens. Figure 59 shows the locations of the four-point-bend specimens that were made from this billet. Specimen No. 1 is centered around a 64 mm (1/4 inch) long indication caused by a defect which appears visually to be a shallow scratch. Specimen No. 2 is centered around one of the lines of grinding damage that runs across the top surface of the billet. Specimen Nos. 3 and 4 are parallel to specimen Nos. 1 and 2 in defect-free areas. Figure 62 shows the C-scan recording of the 45 MHz ultrasonic surface wave inspection of the tensile surfaces of the four-point-bend specimens from the billet of boron-doped SSiC. The grinding damage present in specimen No. 2, as seen in Figure 59, was not detected in this scan.

Figure 58. C-scan Recording of 45 MHz, 18° Surface Wave Inspection of Top Surface of Billet of Boron Doped SSiC (Scan Parallel to Grinding Direction).

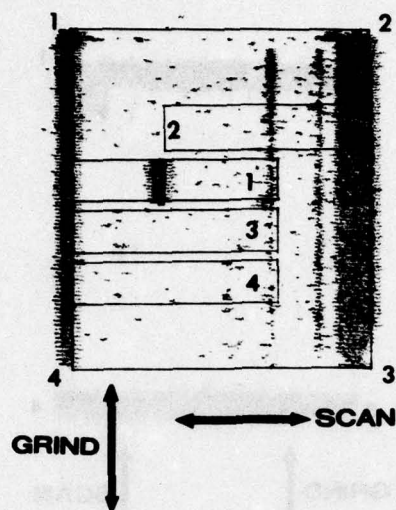
Figure 59. C-scan Recording of 45 MHz, 18° Surface Wave Inspection of Top Surface of Billet of Boron Doped SSiC (Scan Perpendicular to Grinding Direction).

The results of the four-point-bend tests on boron-doped SSiC are listed in Table IV. All the specimens were machined perpendicular to the grinding damage. As can be seen in Figure 59, specimen No. 1 contained a severe individual linear defect indication. It failed at the defect location at a strength of only 192 MN/m^2 (27.9 ksi). Specimen No. 2 contained machining damage less severe than the defect in specimen 1. It failed at the defect location at a strength of 358 MN/m^2 (51.9 ksi). Specimens 3 and 4 showed no machining damage at the sensitivity of inspection. Their average strength was $423 \pm 27 \text{ MN/m}^2$ (61.4 - 3.9 ksi). Figure 80 shows the fracture surfaces of specimen No. 1. While there is a well defined fracture origin at the surface near one corner, the failure appears to have propagated along a line of pre-existing surface damage over most of the width of the specimen. Figure 81 shows 100X views of this damage away from the fracture origin. The depth of the defective area is estimated to have been about $50 \mu\text{m}$ (0.0020 inches). Specimen No. 2 shows similar results, except that the defect depth is only about $15 \mu\text{m}$ (0.0006 inches). Specimens 3 and 4 shattered so badly that a fracture origin could not be identified.

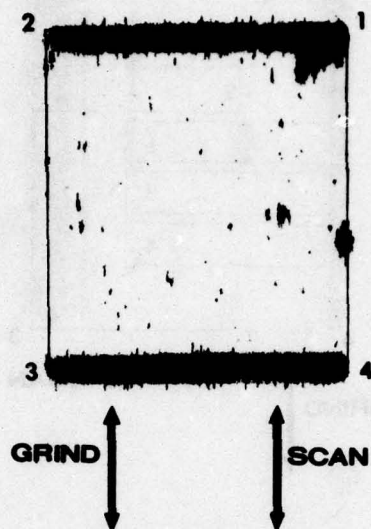
Figure 60. C-scan Recording of 45 MHz, 18° Surface Wave Inspection of Bottom Surface of Billet of Boron Doped SSiC (Scan Parallel to Grinding Direction).

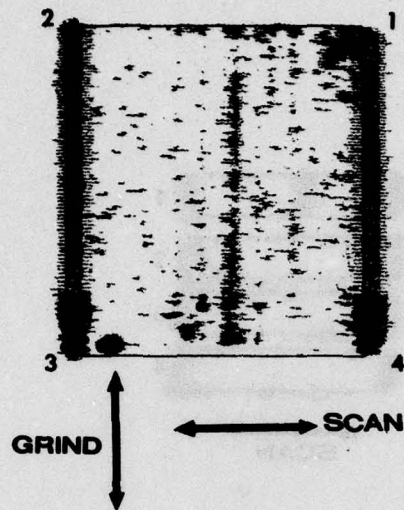
Figure 61. C-scan Recording of 45 MHz, 18° Surface Wave Inspection of Bottom Surface of Billet of Boron Doped SSiC (Scan Perpendicular to Grinding Direction).

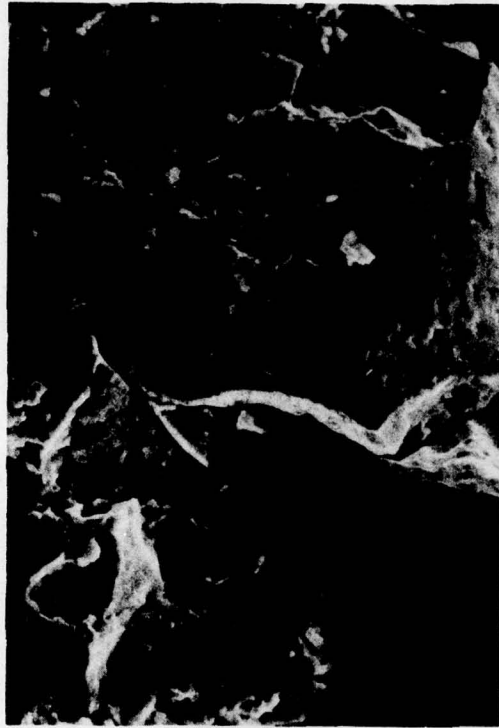
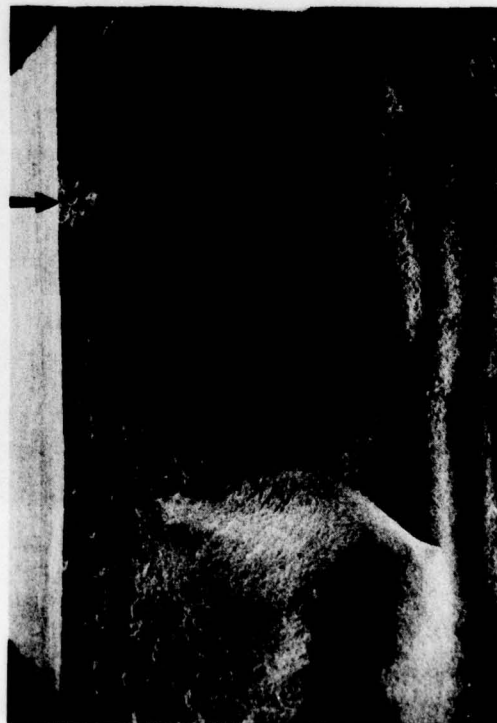
The fracture origin in specimen No. 2 can be seen in Figure 65 to be a surface pit, 180 μm (0.007 inches) wide by 75 μm (0.003 inches) deep. The fracture origin in specimen No. 3 can be seen in Figure 66 to be an area of large crystals extending down from the surface. It is about 500 μm (0.020 inches) across and 350 μm (0.014 inches) deep. This is defect E in Figures 23 and 24. The fracture origin in specimen No. 4 can be seen in Figure 67 to be a flake-like inclusion oriented parallel to the specimen surface. It is about 400 μm (0.016 inches) long, 50 μm (0.002 inches) wide and located about 100 μm (0.004 inches) below the surface. This is defect A in Figures 21 and 22. In comparing the defects that have been examined in specimen Nos. 2, 3 and 4 with the other indications in Figures 21 through 24, it can be seen that these are among the largest defects that were detected.

Figure 66. Fracture Surfaces of Ceralloy 147A HPSN Specimen No. 3, Showing Ultrasonically Detected Defect at Fracture Origin.

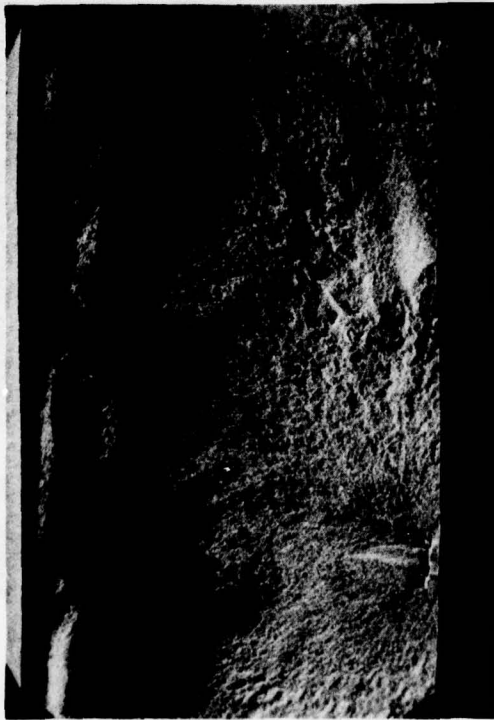
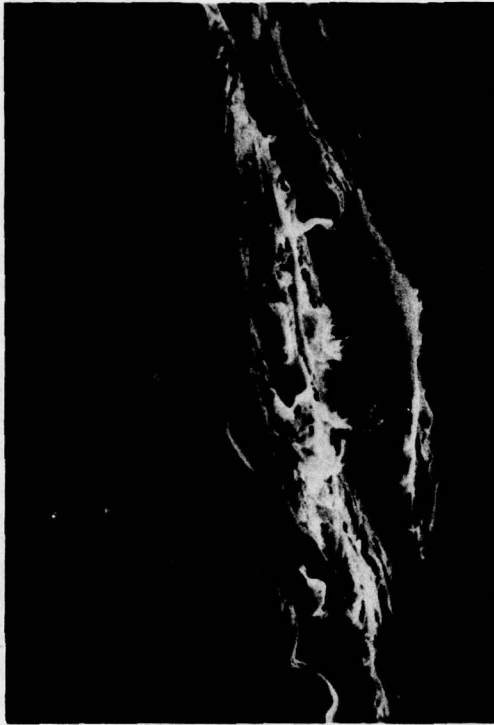
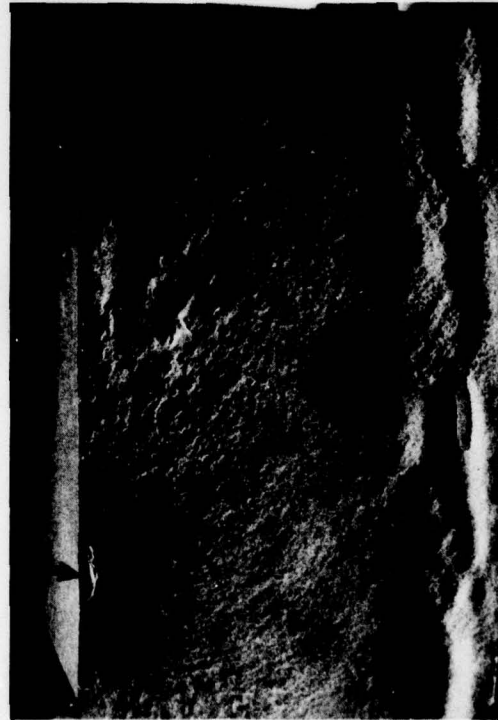
Figure 67. Fracture Surfaces of Ceralloy 147A HPSN Specimen No. 4, Showing Ultrasonically Detected Defect at Fracture Origin.

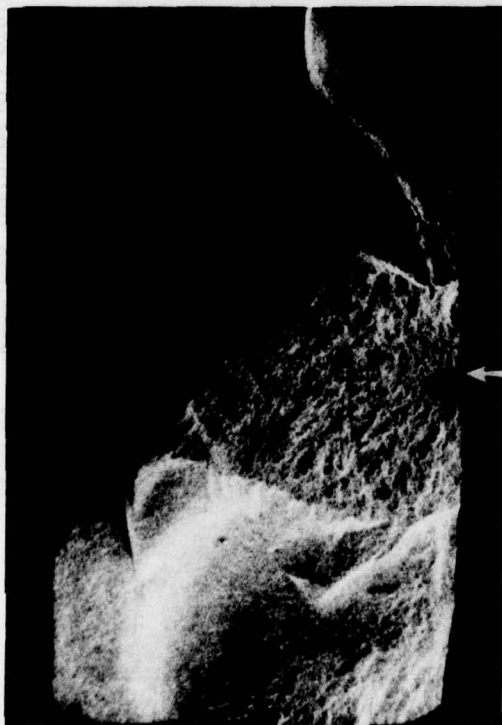
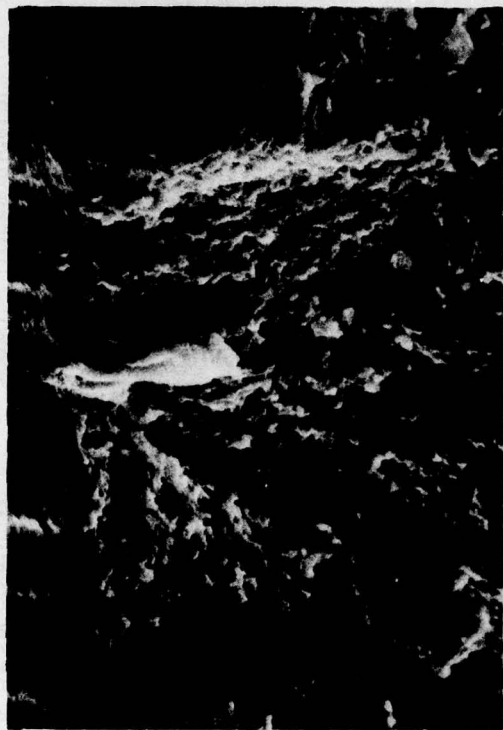
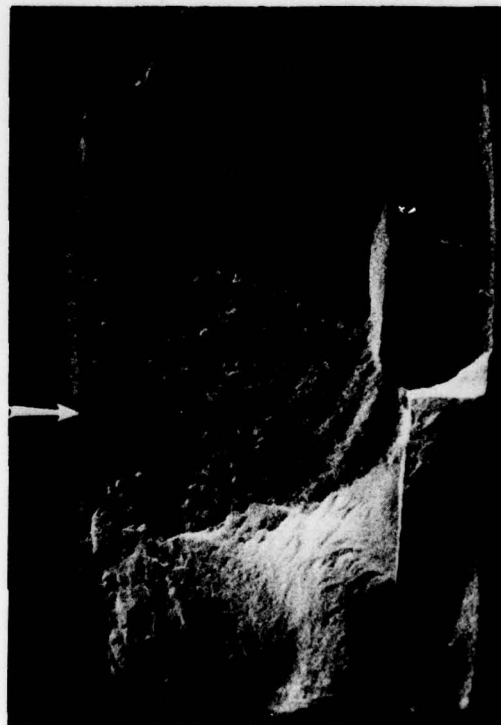
Figure 68. Fracture Surfaces of Ceralloy 147A HPSN Specimen No. 6, Showing 1kg Vicker's Indentation at Fracture Origin.

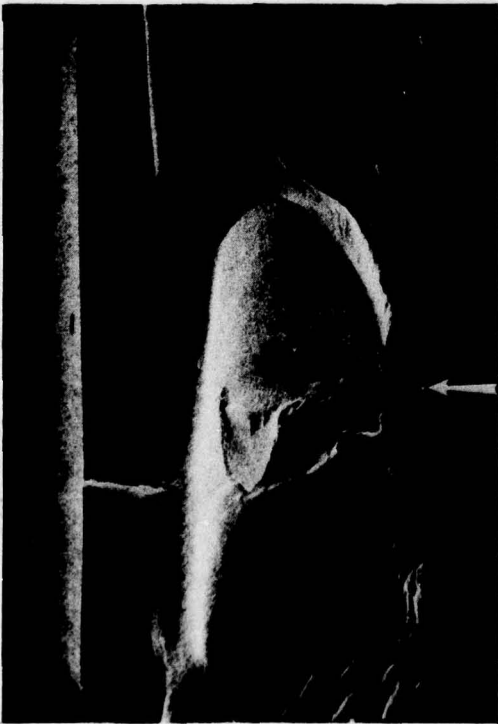
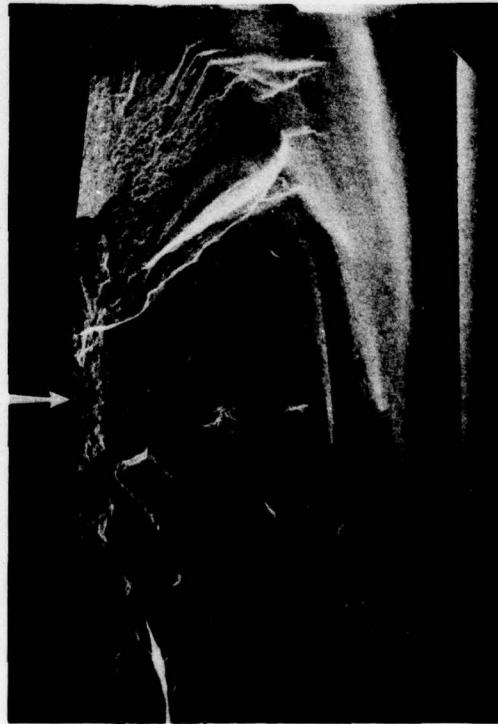
Figure 70 shows the fracture surfaces of specimen No. 1 of NC-132 HPSN. The fracture origin is seen to be an area of large grains $16\text{ }\mu\text{m}$ (0.0006 inches) wide by $20\text{ }\mu\text{m}$ (0.0008 inches) deep. The location of the defect as well as its size correlate well with the indication in Figure 29. The fact that the same indication was not seen in Figure 31 cast some doubt on the correlation. However, with such a small defect, this may simply be normal statistical variation in sensitivity. Specimens No. 2 and No. 3 do not appear to have fractured through the ultrasonically detected defects. Specimen No. 2 broke from a fracture origin at the surface (see Figure 71) associated with several 10 to $20\text{ }\mu\text{m}$ (0.0004 to 0.0008 inch) grains. Specimen No. 3 broke through a fracture origin at the surface in which no defect could be identified.

Figure 70. Fracture Surfaces of NC-132 HPSN Specimen No. 1, Showing Ultrasonically Detected Defect at Fracture Origin.

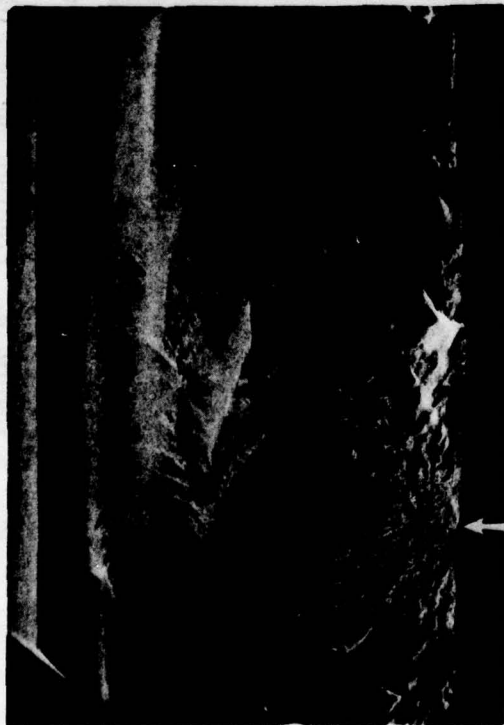
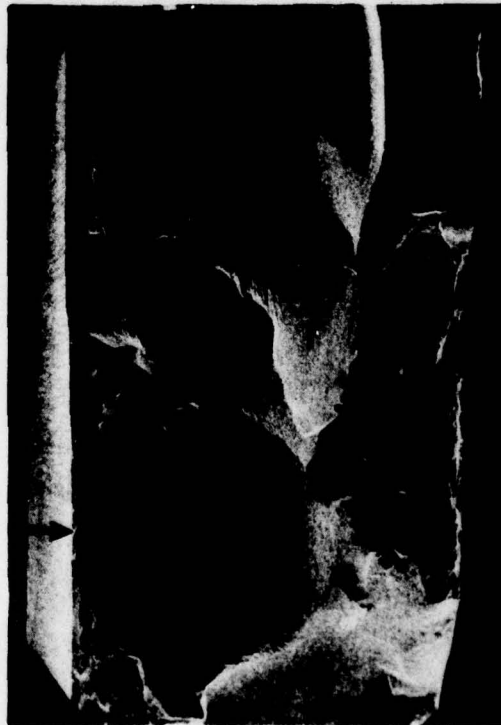
Figure 71. Fracture Surfaces of NC-132 HPSN Specimen No. 2, Showing Fracture Origin.

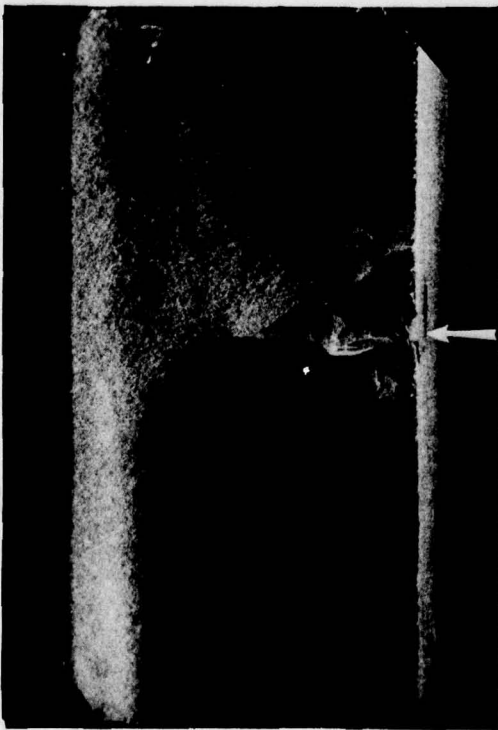
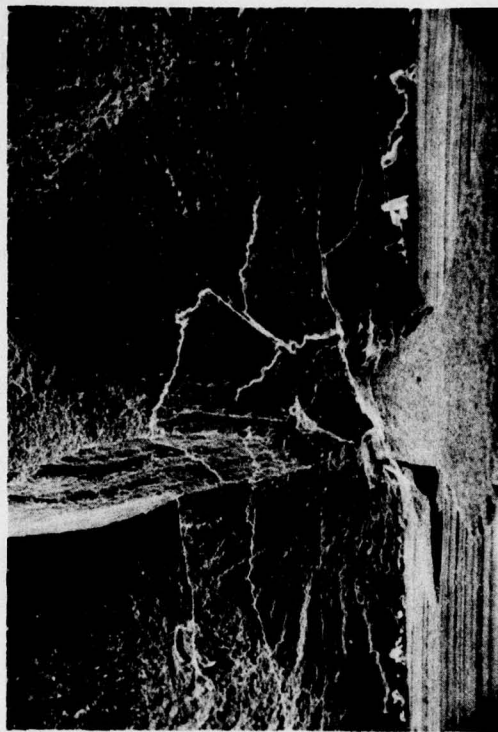
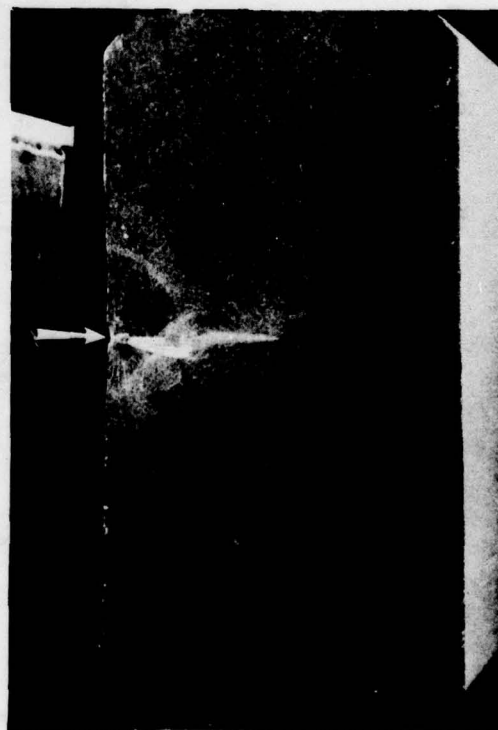
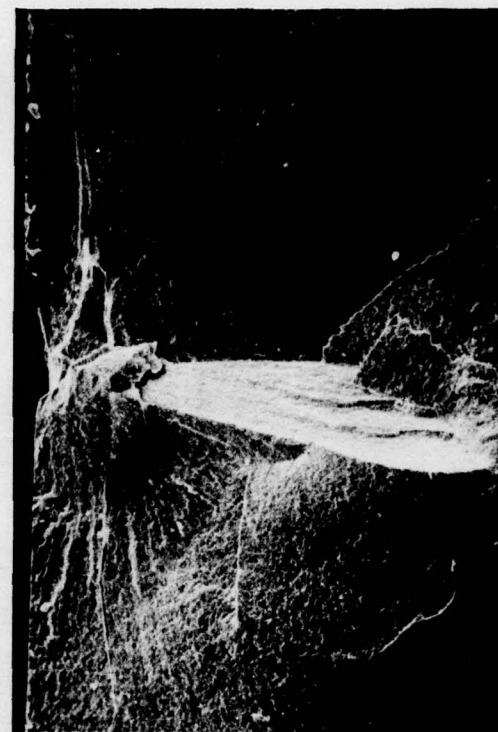
Figure 72. Fracture Surfaces of NC-132 HPSN Specimen No. 7, Showing 50 kg Vicker's Indentation at Fracture Origin.

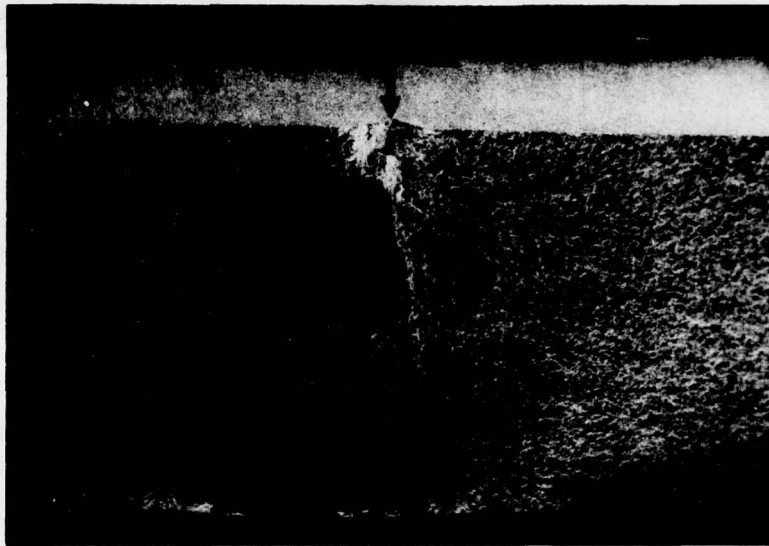
Specimen No. 12, which contained a 50 kg Vicker's indentation, broke in two along a diagonal when the indentation was made. Figure 73 shows one side of the fracture surface. The pit is about $600 \mu\text{m}$ (0.026 inches) across and $200 \mu\text{m}$ (0.0079 inches) deep and the crack extends all the way through the $3150 \mu\text{m}$ (0.124 inch) thickness of the specimen. Specimen 15, which contained a 1 kg Vicker's indentation, broke at a low strength and shattered so that it was not possible to determine if it fractured from the indentation or not.

Figure 73. Fracture Surfaces of NC-350 RBSN Specimen No. 12, Showing 50 kg Vicker's Indentation at Fracture Origin.

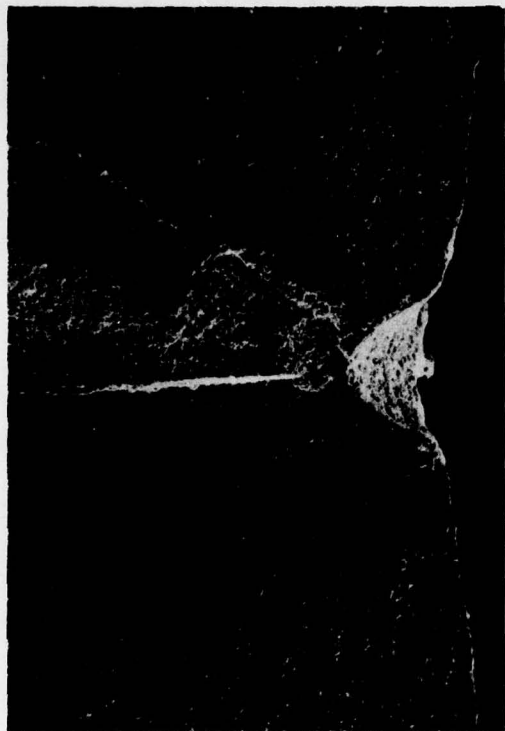
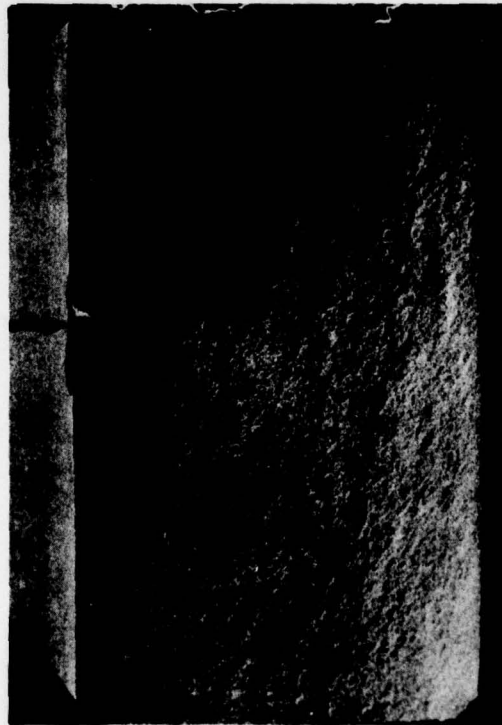
The results of the four-point-bend tests on HPSiC are listed in Table III. Specimens 1 and 4 of Ceralloy 146 contained the 50 kg and 1 kg Vicker's, respectively. The fracture surfaces of these specimens are shown in Figures 74 and 75. In Figure 74 it can be seen that the 50 kg Vicker's indentation consisted of a pit $200 \mu\text{m}$ (0.008 inches) wide by $160 \mu\text{m}$ (0.0064 inches) deep with a crack extending $605 \mu\text{m}$ (0.0242 inches) deep. The 1 kg Vicker's indentation shown in Figure 75 consists of a pit $20 \mu\text{m}$ (0.0008 inches) wide by $2 \mu\text{m}$ (0.00008 inches) deep with a crack extending about $25 \mu\text{m}$ (0.0010 inches) deep. Specimens 2 and 3 of Ceralloy 146, which were machined perpendicular to the grinding damage, had an average strength of $429 \pm 16 \text{ MN/m}^2$ ($62.3 \pm 2.3 \text{ ksi}$) compared to $509 \pm 61 \text{ MN/m}^2$ ($73.8 \pm 8.8 \text{ ksi}$) for specimens 5 and 6 which were machined parallel to the grinding direction. While this difference is large, there is too much scatter in the data and too few specimens to conclude that it is significant with a high degree of confidence. The specimen containing the 1 kg Vicker's was significantly weaker, 299 MN/m^2 (43.3 ksi) than those machined perpendicular to the grinding damage. Specimens 2, 3, 5 and 6 all failed through identifiable fracture origins in which no specific defect could be identified.

Figure 74. Fracture Surfaces of Ceralloy 146A HPSiC Specimen No. 1, Showing 50 kg Vicker's Indentation at Fracture Origin.

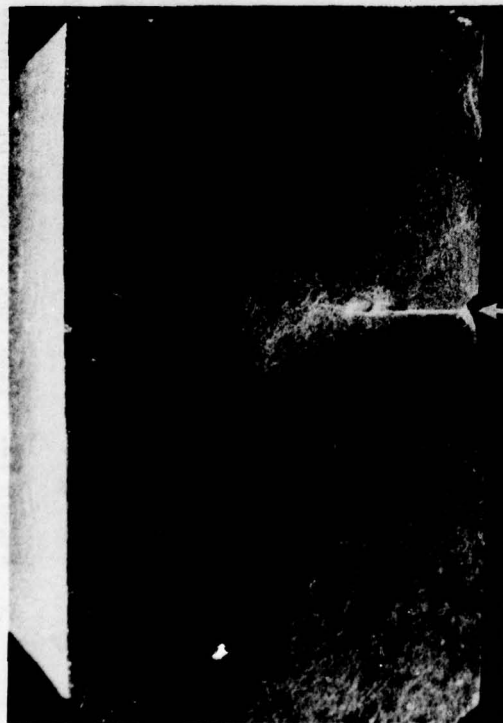
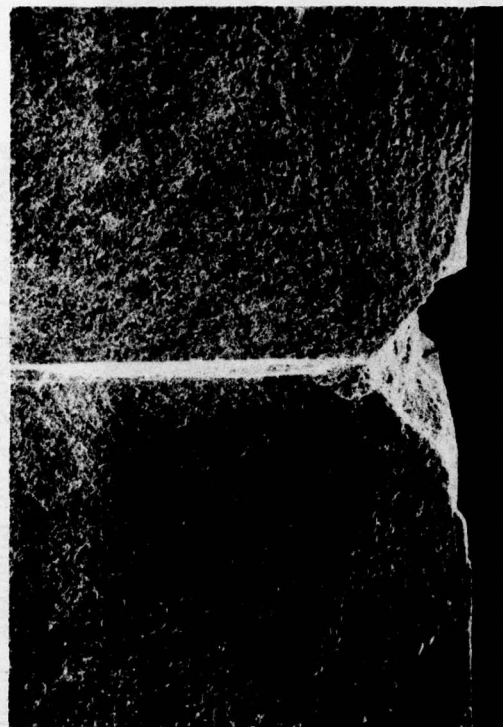
Specimens 1 and 4 of NC-230 also contain 50 kg and 1 kg Vicker's indentations, respectively. The fracture surfaces of these specimens are shown in Figures 76 and 77, respectively. In Figure 76 it can be seen that the 50 kg Vicker's indentation consists of a $200 \mu\text{m}$ (0.0008 inch) wide by $160 \mu\text{m}$ (0.0064 inch) deep pit with a $510 \mu\text{m}$ (0.0204 inch) deep crack. The 1 kg Vicker's indentation shown in Figure 77 consists of a $20 \mu\text{m}$ (0.0008 inch) wide by $5 \mu\text{m}$ (0.0002 inch) deep pit with a $35 \mu\text{m}$ (0.0014 inch) deep crack. Specimens 2 and 3 were machined in an area of heavier grinding damage while specimens 5 and 6 were machined in an area of lighter grinding damage, but all specimens were machined perpendicular to the damage. Specimen 2 was damaged during finish machining and was not tested. Specimen 3 had a strength of 412 MN/m^2 (59.8 ksi) compared to $504 \pm 13 \text{ MN/m}^2$ ($73.1 \pm 1.9 \text{ ksi}$) for specimens 5 and 6. Here again there is a considerable difference in strengths which corresponds with the ultrasonic results, but the data is insufficient to draw a statistically valid conclusion. Specimens 7, 8 and 9 were from an area that showed extensive ultrasonic indications, not only by the surface wave technique, but also by shear and longitudinal wave techniques. The average strength of these specimens was $187 \pm 21 \text{ MN/m}^2$ ($27.2 \pm 3.1 \text{ ksi}$). This is significantly lower than the average of specimens 3, 5 and 6, 473 ± 54

Figure 76. Fracture Surfaces of NC-230A HPSiC Specimen No. 1, Showing 50 kg Vicker's Indentation at Fracture Origin.

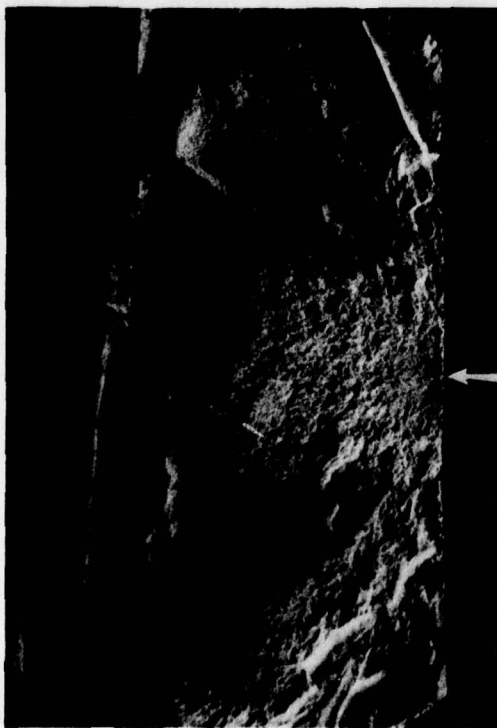
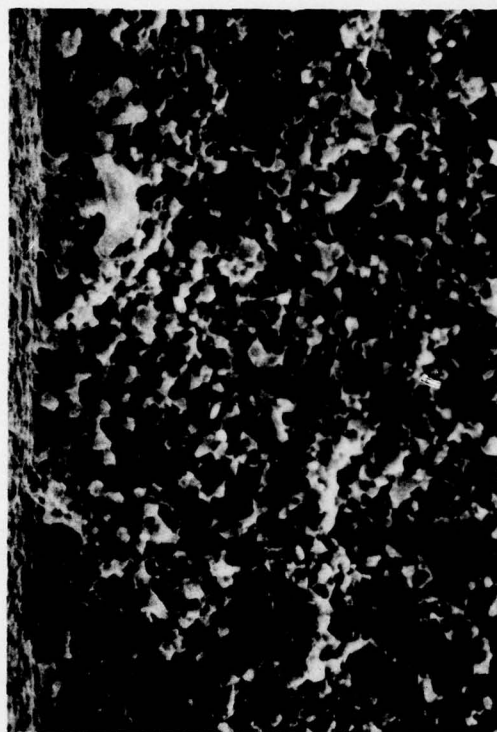
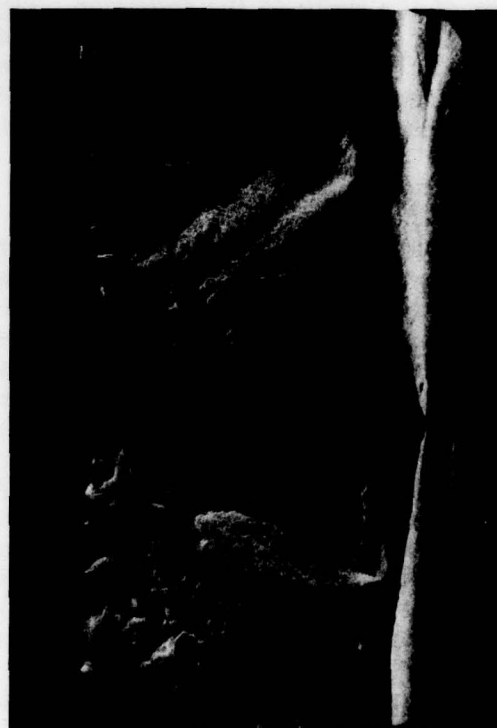
Figure 77. Fracture Surfaces of NC-230A HPSiC Specimen No. 4, Showing 1 kg Vicker's at Fracture Origin.

MN/m^2 (68.6 ± 7.8 ksi). The specimen containing the 1 kg Vicker's indentation was weaker at 380 MN/m^2 (55.1 ksi) than specimen 3, but stronger than specimens 7, 8 and 9. The specimens not containing Vicker's indentations all failed from fracture origins on the surface except for specimen 8 which failed from a corner. Only specimen 6 showed a well defined defect at the fracture origin. In Figure 78, which shows the fracture surfaces of specimen 6, it can be seen that the fracture origin is at an area of missing material at the surface $20 \mu\text{m}$ (0.0008 inches) wide by $10 \mu\text{m}$ (0.0004 inches) deep which probably represents a pre-existing pit or crack. Figure 79 shows the fracture surfaces of specimen 7. Even in the 1000X view it is not clear what difference between this specimen and No. 6 accounts for the great difference in ultrasonic response by all techniques.
