ULTRASONIC DETECTION OF SURFACE FLAWS IN GAS TURBINE CERAMICS.(U)

4. TITLE (and Subtitle) ULTRASONIC DETECTION OF SURFACE FLAWS IN GAS TURBINE CERAMICS		5. TYPE OF REPORT & PERIOD COVERED Final Technical Report	13. Sep 77-12 hlc 76

6. AUTHOR(s) Thomas/Derkacs Istvan M. Matay		7. PERFORMING ORG. REPORT NUMBER TRW-ER-7986-F	
8. PERFORMING ORGANIZATION NAME AND ADDRESS TRW Inc. 23555 Euclid Avenue Cleveland, OH 44117		9. CONTRACT OR GRANT NUMBER(s) (15) N62269-77-C-0136

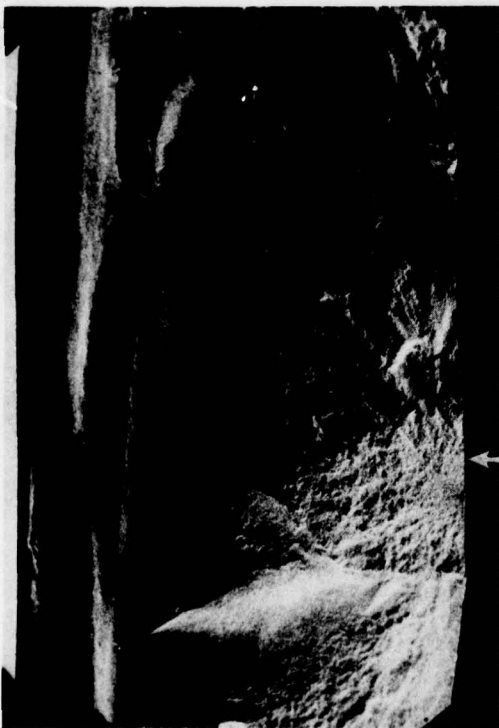
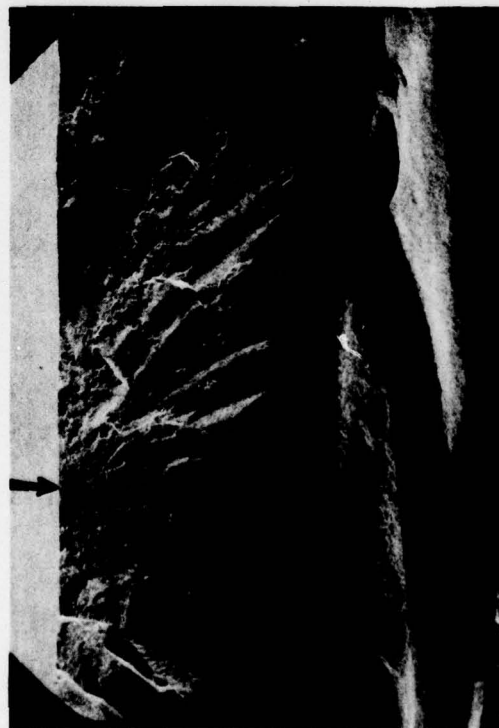
Figure 78. Fracture Surfaces of NC-203A HPSiC Specimen No. 6 (Typical Sound Material With Light Grinding Damage).

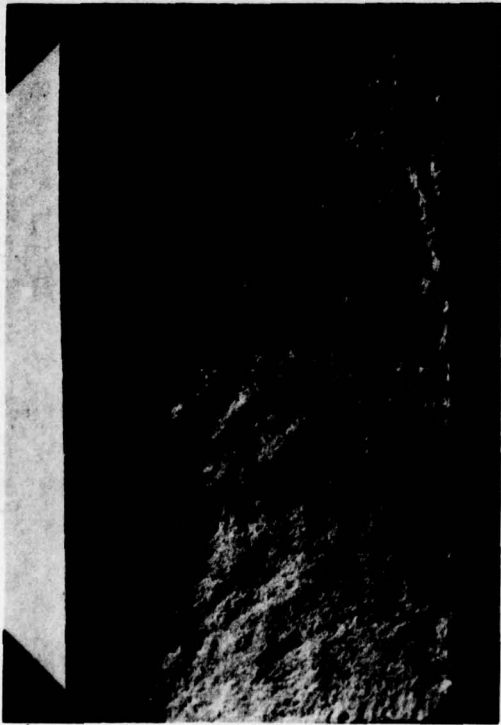
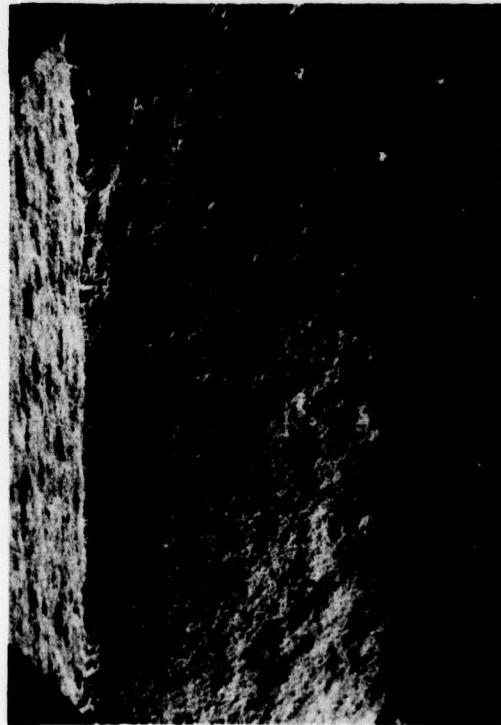
Figure 79. Fracture Surfaces of NC-203A HPSiC Specimen No. 7 (Typical Defective Material).

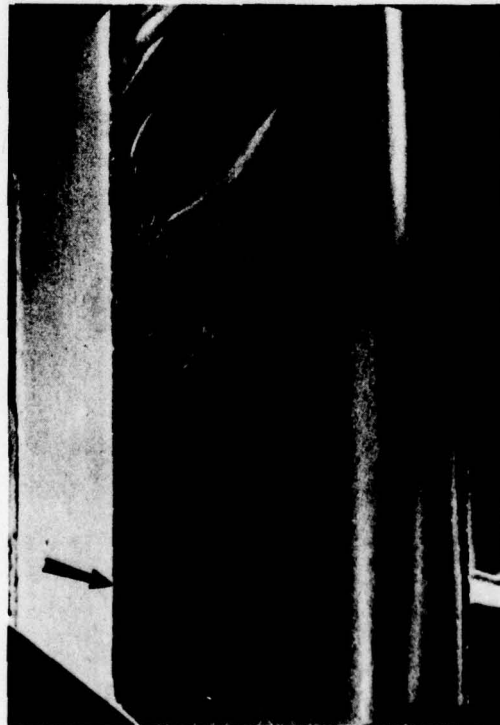
The results of the four-point-bend tests on boron-doped SSiC are listed in Table IV. All the specimens were machined perpendicular to the grinding damage. As can be seen in Figure 59, specimen No. 1 contained a severe individual linear defect indication. It failed at the defect location at a strength of only 192 MN/m^2 (27.9 ksi). Specimen No. 2 contained machining damage less severe than the defect in specimen 1. It failed at the defect location at a strength of 358 MN/m^2 (51.9 ksi). Specimens 3 and 4 showed no machining damage at the sensitivity of inspection. Their average strength was $423 \pm 27 \text{ MN/m}^2$ (61.4 - 3.9 ksi). Figure 80 shows the fracture surfaces of specimen No. 1. While there is a well defined fracture origin at the surface near one corner, the failure appears to have propagated along a line of pre-existing surface damage over most of the width of the specimen. Figure 81 shows 100X views of this damage away from the fracture origin. The depth of the defective area is estimated to have been about $50 \mu\text{m}$ (0.0020 inches). Specimen No. 2 shows similar results, except that the defect depth is only about $15 \mu\text{m}$ (0.0006 inches). Specimens 3 and 4 shattered so badly that a fracture origin could not be identified.

Figure 80. Fracture Surfaces of Boron Doped SSiC Specimen No. 1, Showing Fracture Origin Along Ultrasonically Detected Linear Defect.

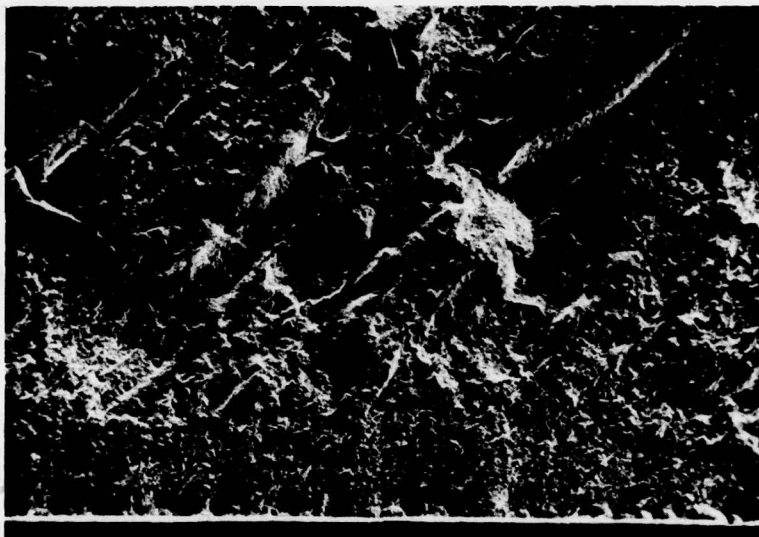
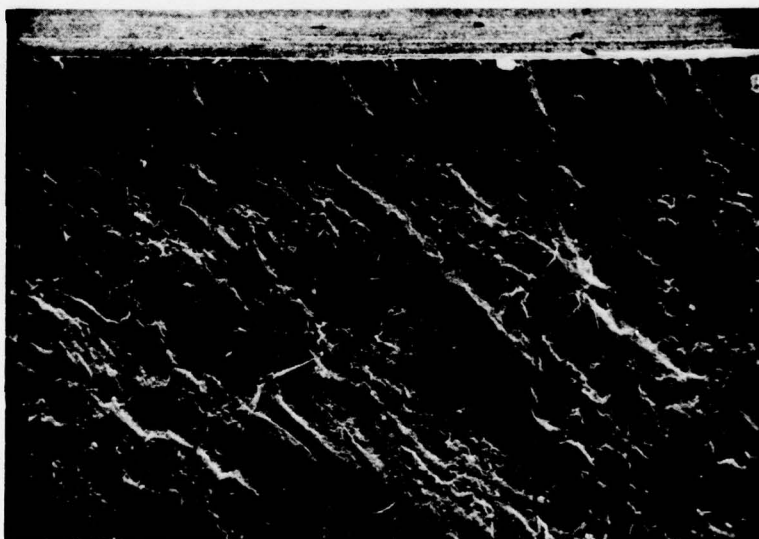
Figure 81. Fracture Surfaces of Boron Doped SSiC Specimen No. 1, Showing Ultrasonically Detected Linear Defect in Area Away From Fracture Origin.

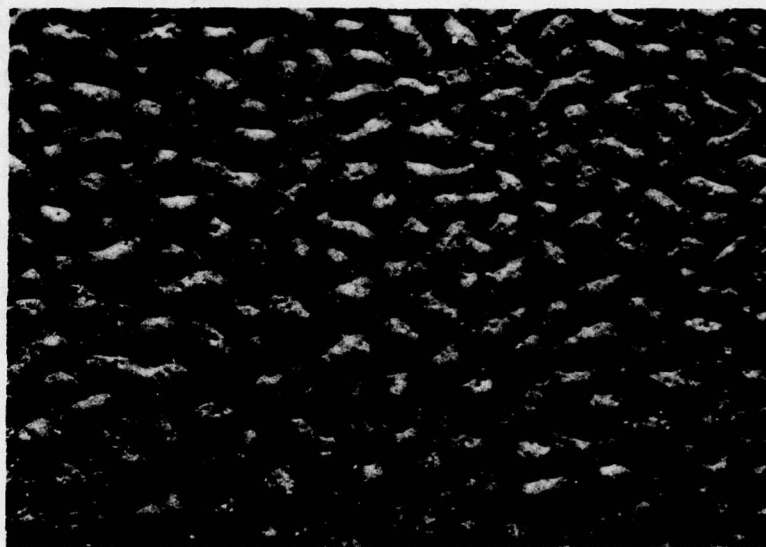
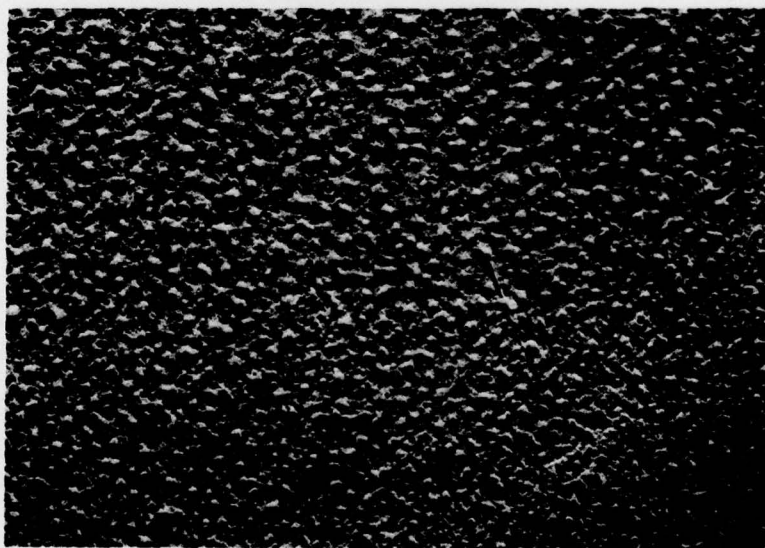
The condition that made the specimens uninspectable is shown in Figure 87. The surface became covered with material that had the appearance of droplets of liquid that had solidified on the surface. These beads were transparent and varied in size, being smallest at the point where the center of the flame struck the specimen and getting larger with decreasing temperature. The largest beads were on the backsides of the specimens. Although each of the specimens had this condition, the distribution of sizes varied from one to the other. The possibility that the deposit was salt was considered. However, efforts to remove it using water or soap and water were unsuccessful.

Following final inspection of the specimens, electron microprobe analysis was run on the specimens to determine the nature of the surface deposits. The only elements found in large concentrations on the surface of the parts were silicon and oxygen. It was concluded that the surface condition was the result of fused silica beading up on the surface of the material.

Figure 87. Photomicrographs of Typical Burner Rig Specimen Surfaces After Testing, Showing Beads of Fused Silica.
