SERIAL NUMBER: WADC-TR-52-68

DATE: April 1952

PHASE V (ALL WEATHER) TESTING OF T-29A AIRCRAFT

All Weather Section
Flight Test Division
Project No. S207-20

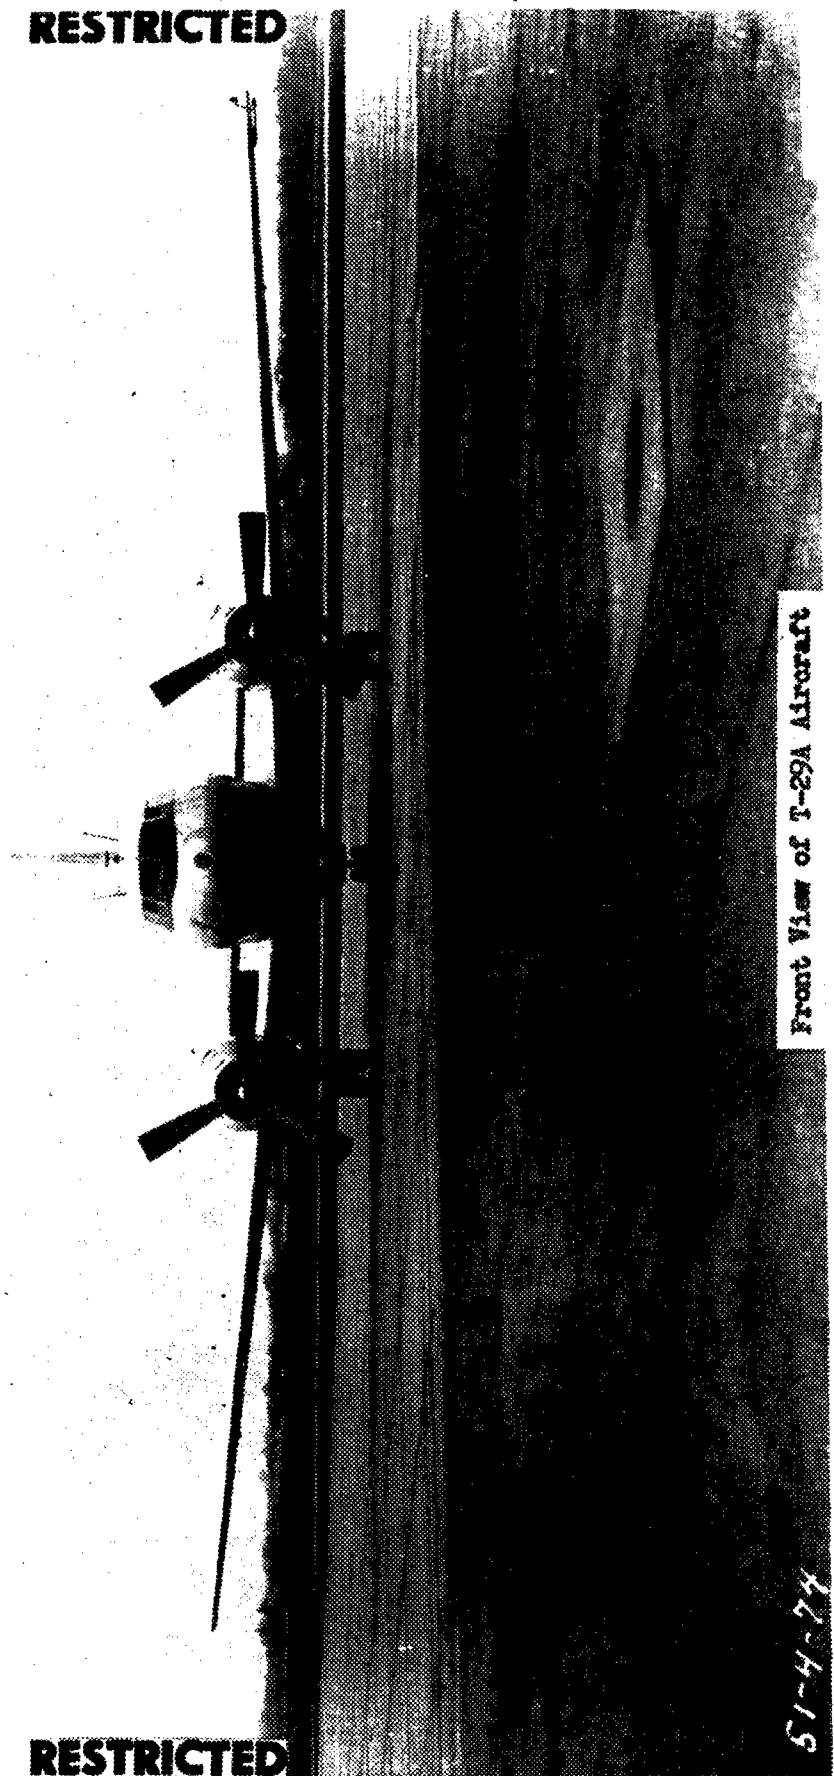
The sensing antenna for the No. 1 Radio Compass, located on the under side of the fuselage and routed around the radome, failed several times during the test flights. One break occurred at the bottom of the mast and the other breaks occurred at the junction of the insulator and the antenna. (See Fig 3).
