Name Of Dam: BENS BRANCH DAM
Location: WISE COUNTY, VIRGINIA
Inventory Number: VA. NO. 19509

PHASE I INSPECTION REPORT

NATIONAL DAM SAFETY PROGRAM

Name of Dam: Bens Branch Dam, Va. No. 19509
State: Virginia
County: Wise
Coordinates: Lat 36° - 54.1' Long 82° - 45.1'
USGS Quad Sheet: Appalachia
Stream: Bens Branch
Date of Inspection: May 23, 1979

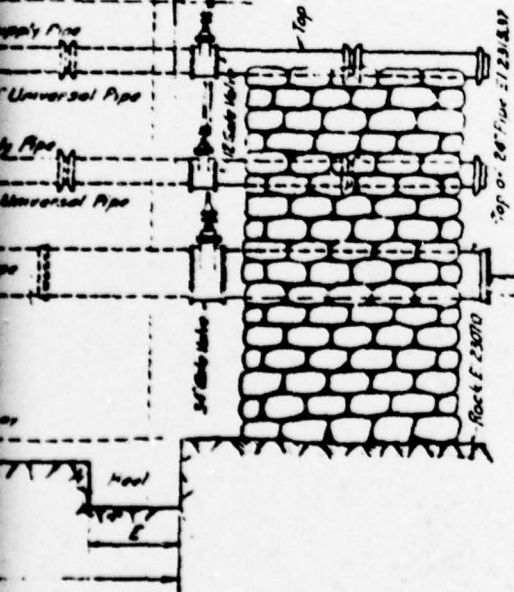
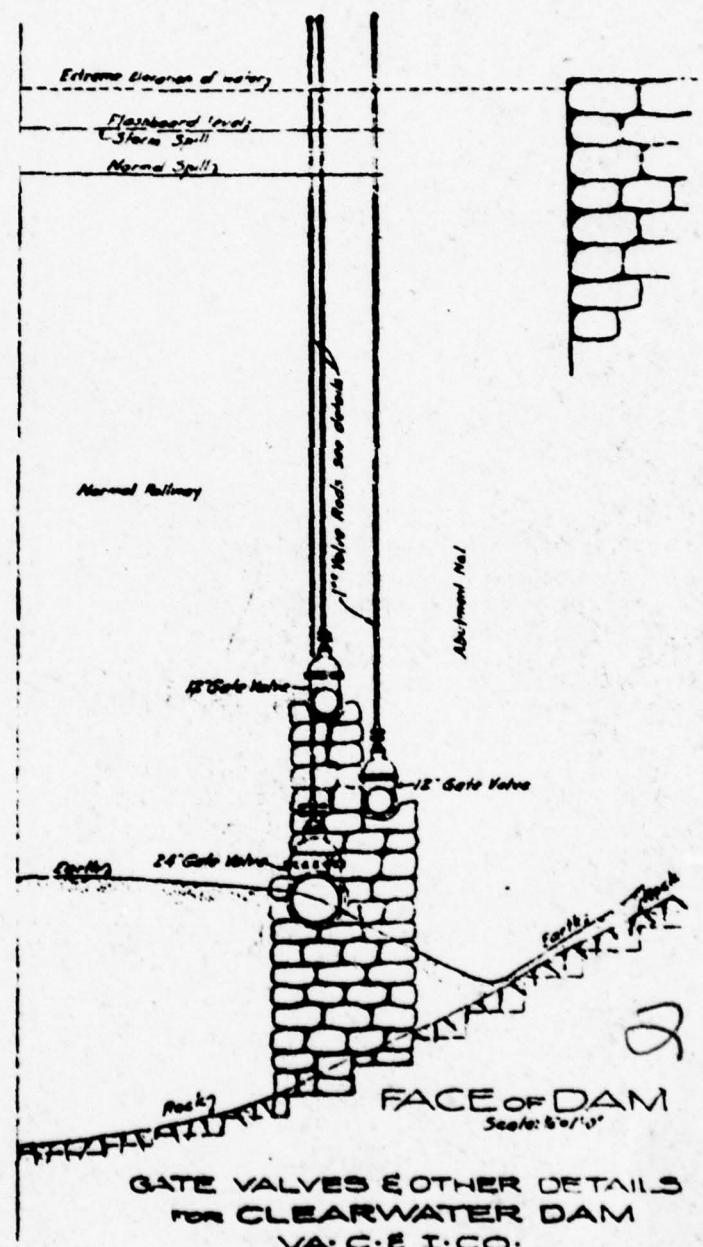
PLATE NO 2

The dam is a stone masonry, gravity structure, apparently designed to be overtopped since the spillway capacity is minor. As designed, the core of the dam was "made of very heavy stone laid on natural beds in matrix of hard placed small stone grouted in 8" layers - horizontal". Plates No. 2 and 3 show the dam embedded into "hard" or "solid" bedrock with both a heel and toe key trench provided. The horizontal extent of the trenches and actual depth of embedment are not known. Plate No. 2 provides a description of the gate valves and other details as designed.

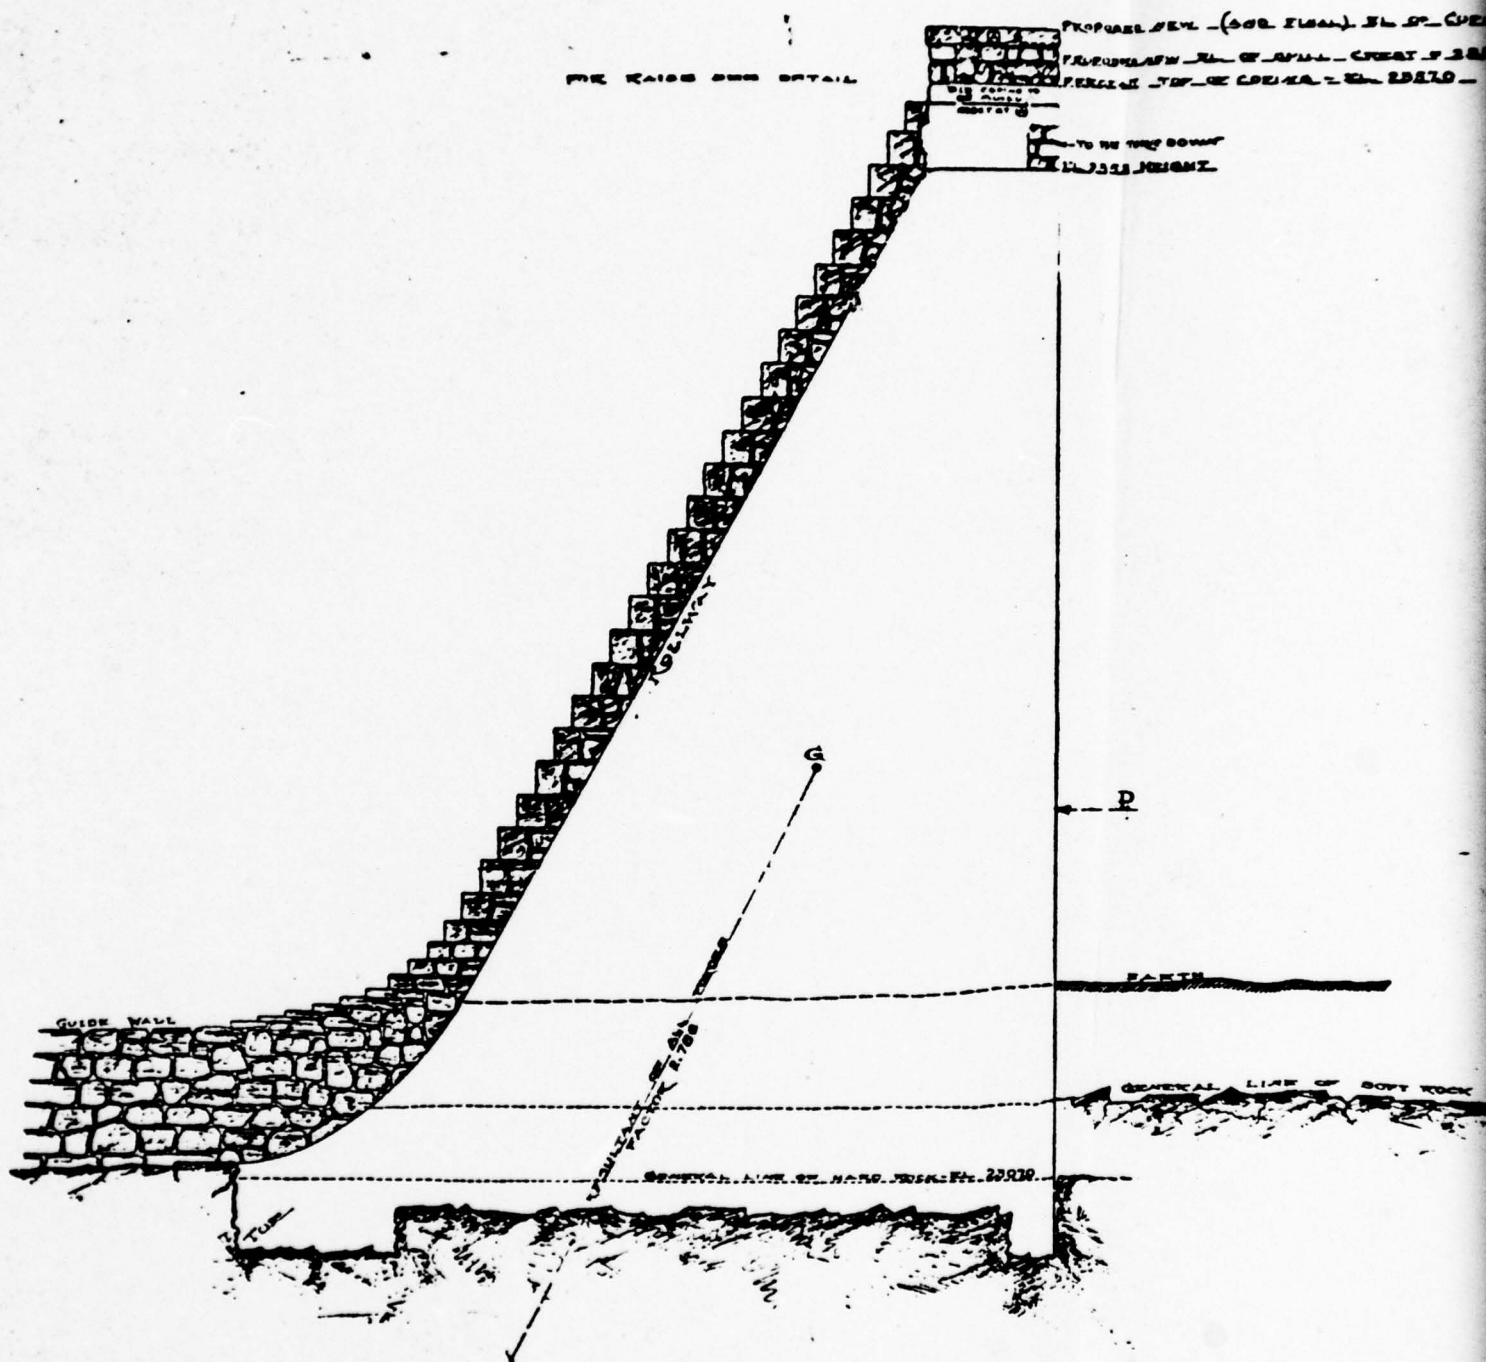
PLATE N° 3

The dam was constructed in 1918 and was designed and constructed under the supervision of a consulting engineer from New York City. Original design data is presented on Plate 2, Appendix I. Since the dam was originally constructed in 1918, it is assumed that the "section at center" presented on Plate 3, Appendix I is an "as built" representation.

A stability analysis was apparently made since Plate 3, Appendix I includes a "Resultant of All Forces/Factor 2.780." It is not known whether this refers to the as built structure or to the modified structure. Details are not available.
