Name Of Dam: DIXIANA DAM
Location: WISE COUNTY, VIRGINIA
Inventory Number: VA. NO. 19505

PHASE I INSPECTION REPORT

NATIONAL DAM SAFETY PROGRAM

SCHNABEL ENGINEERING ASSOCIATES, P.C./
J. K. TIMMONS AND ASSOCIATES, INC.

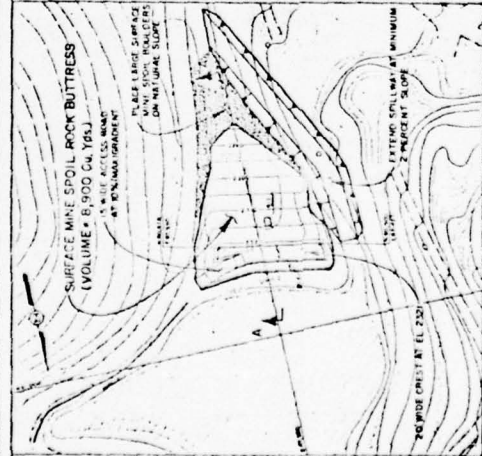
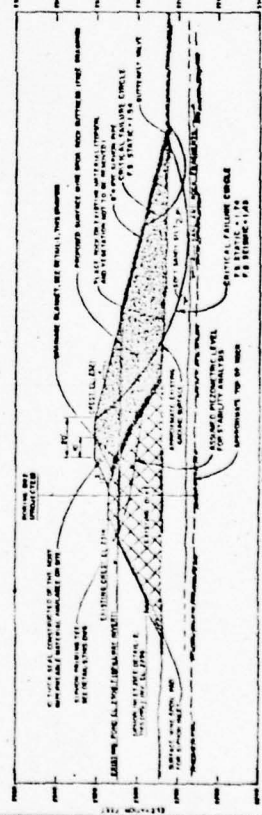
PROJECT NO.	77-892-E23	SHEET NO.	12 of 16	FIGURE NO.	16
MAKEUP WATER FACILITY					
SHEET 1 OF 2					
DIXIANA, WISE COUNTY, VIRGINIA					
PREPARED FOR					
FLAT GAP MINING COMPANY, INC.					
DIXIANA, WISE COUNTY, VIRGINIA					
PLATE NO. 3					
ID: A11101A

A seal consisting of a 10-foot-wide zone of the most impermeable soil available is also required along the upstream face to minimize seepage through the upper portion of the buttress, as shown in Figure 16.

mining. The siphon consists of an eight-inch-diameter polyvinylchloride (PVC) pipe, upstream check valve, and downstream butterfly valve as shown in Figure 16. Storm water that collects in the reservoir will be siphoned off after the system is primed. Priming requires that both valves be closed and water pumped into the pipe through a tee located at the maximum elevation of the pipe. Specifications and manufacturers recommendations for the siphon equipment are shown in Figure 16 and in the guideline technical specifications in Figure 19.

The siphon inlet and check valve will be supported by a saddle as shown in detail in Figure 16. The siphon inlet riser should be slotted and a trash rack attached to prevent clogging. A pad-constructed of surface mine spoil rock will form a platform for the siphon inlet works. During cold weather, no water should be allowed to remain in the siphon when not in operation.
