SAW CREEK CLUB DAM

NDI ID NO. PA-00764
DER ID NO. 52-7

PHASE I INSPECTION REPORT
NATIONAL DAM INSPECTION PROGRAM

FEBRUARY 1980

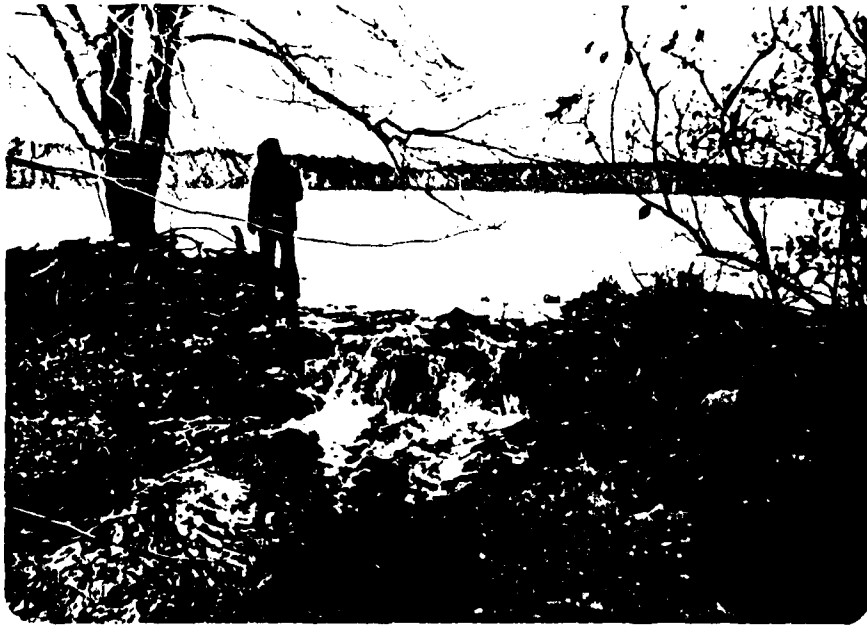
I. Seepage Area Near Right Abutment

(2) Perform investigations and studies as necessary to assess the cause of the seepage observed at the dam and to determine if additional seepage is occurring to the left of the outlet works. This will probably require that the pool be drawn down below spillway crest for a brief period. These investigations and studies should address the potential of the seepage to cause piping and to adversely affect the embankment stability. Take appropriate action as required.
