CANONSBURG DAM No. 2 (JOHNSONS RUN DAM)
~~WASHINGTON COUNTY, COMMONWEALTH OF PENNSYLVANIA~~

NDI Number PA 00506

PHASE I INSPECTION REPORT
NATIONAL DAM INSPECTION PROGRAM

Prepared for: DEPARTMENT OF THE ARMY
Baltimore District, Corps of Engineers
Baltimore, Maryland 21203

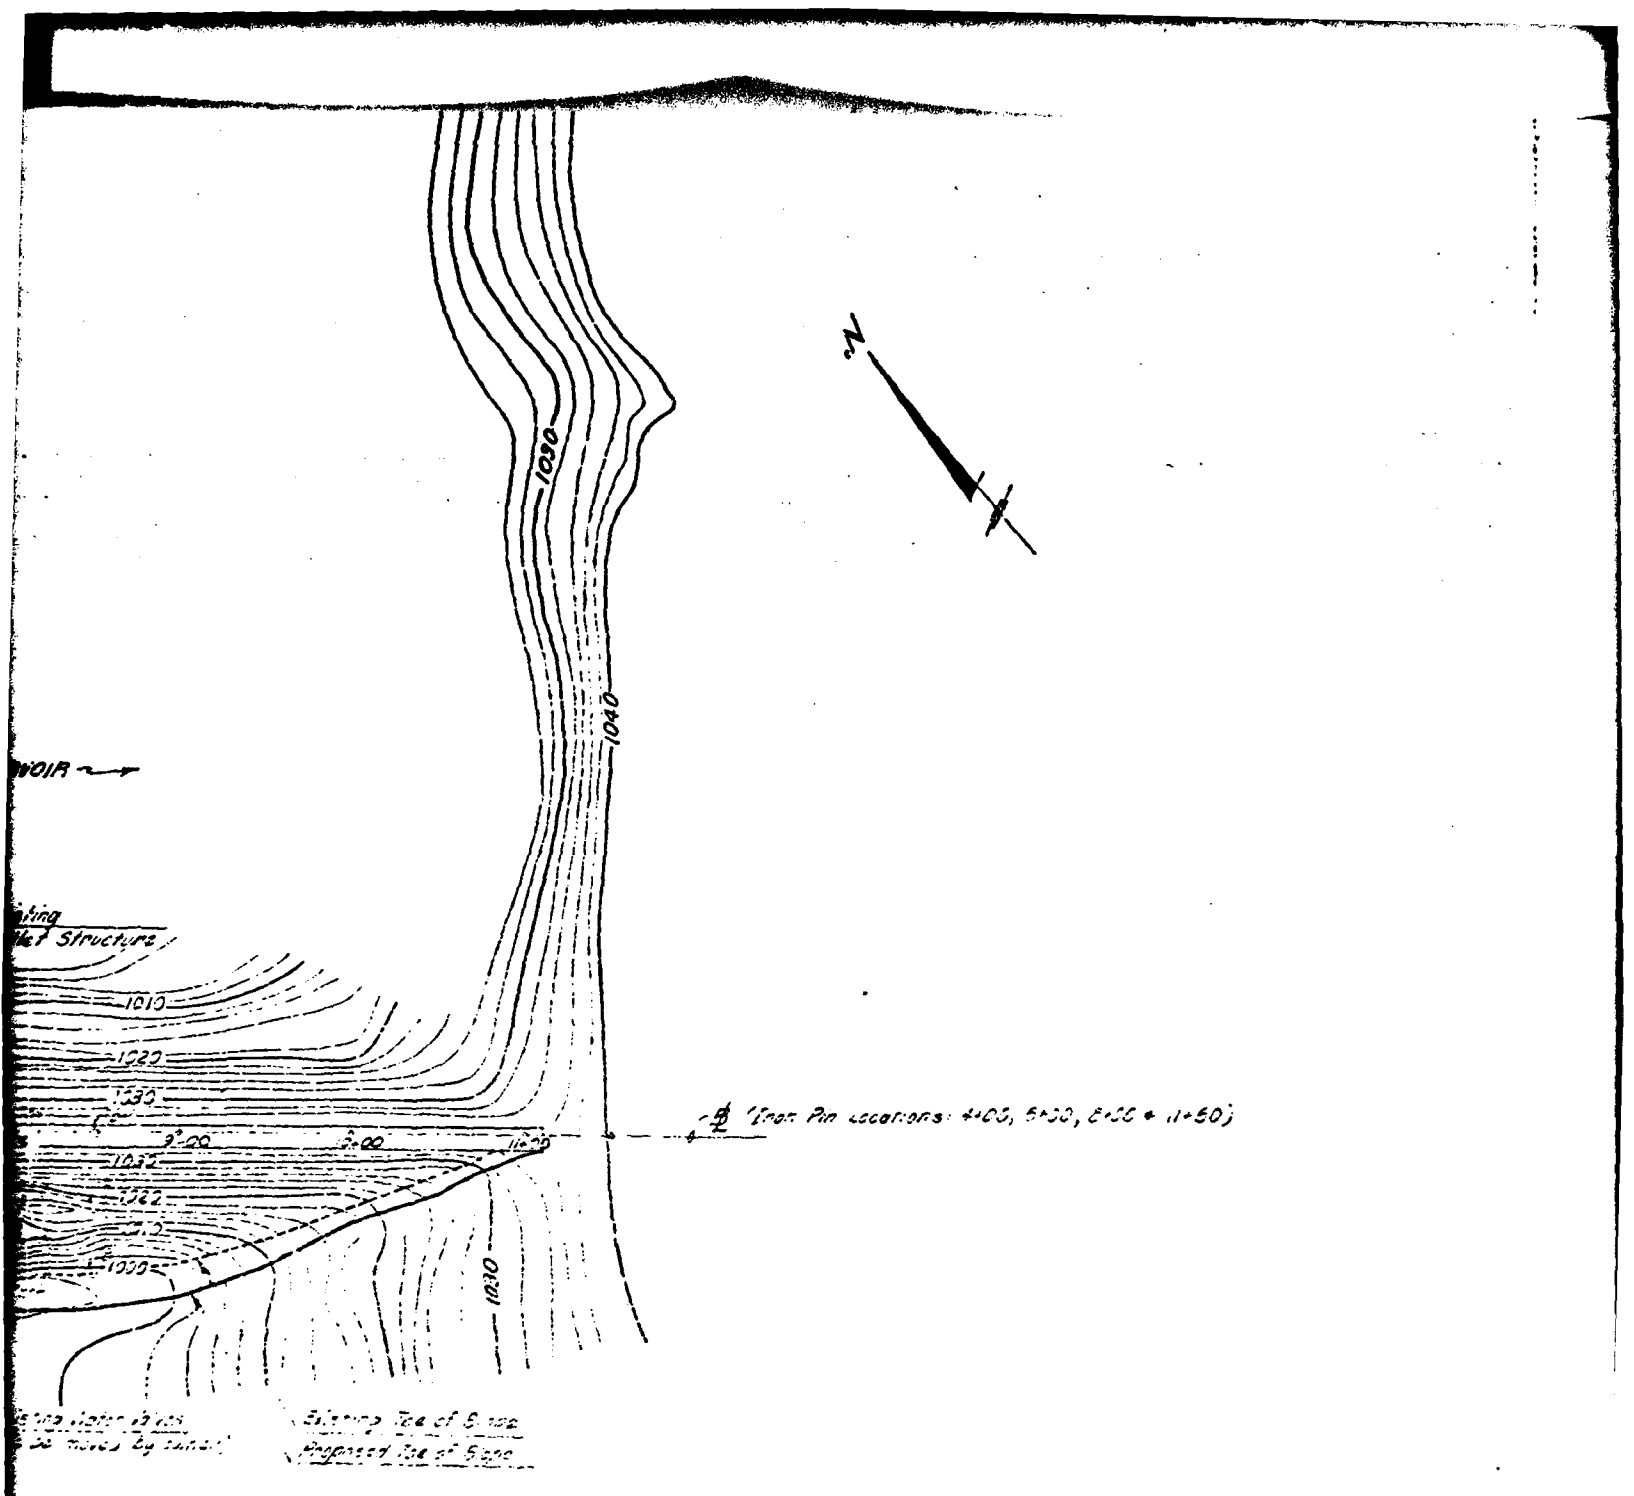
TITLE: PLAN OF DAM SHOWING
 PROPOSED SLOPE MODIFICATIONS

²Original design top of dam (1931) converted to elevations set by Burgess and Niple, Limited (1979). Note on Plates 8 through 12, Appendix E, that proposed modifications include raising the top of the embankment to a minimum Elevation of 1035.5 feet.
