OHIO RIVER BASIN  
BEAR ROCK RUN, CAMBRIA COUNTY

BEAR ROCK NO. 2 DAM

NDI I.D. NO: PA-0441

PHASE I INSPECTION REPORT  
NATIONAL DAM INSPECTION PROGRAM

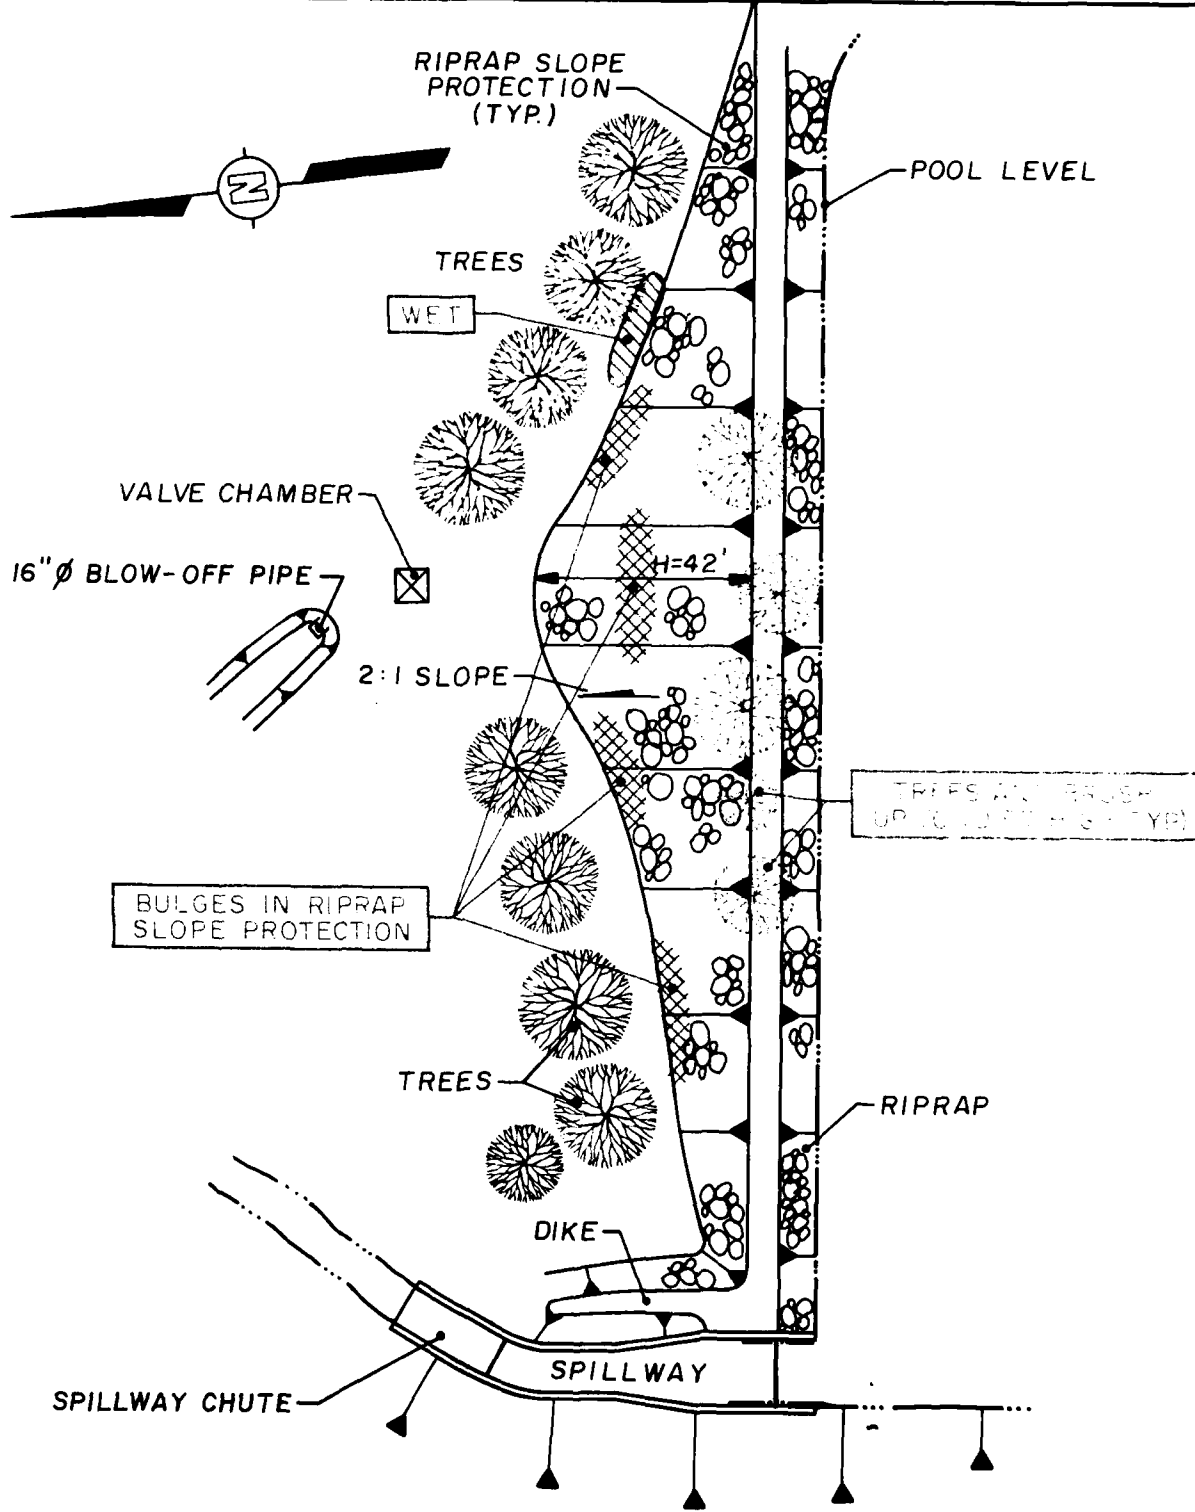
PLATE 5  
 BEAR ROCK NO 2 DAM  
 GENERAL PLAN  
 FIELD INSPECTION NOTES  
 FIELD INSPECTION DATE: NOV. 13, 1979

The specific observations are illustrated in Plate 5.

**NOTES:**  
 I. POOL LEVEL DATE OF INSPECTION:  
 AT SPILLWAY CREST
