BEAR ROCK NO.1 DAM

NDI I.D. NO: PA-00439

PHASE I INSPECTION REPORT
NATIONAL DAM INSPECTION PROGRAM

NAME OF DAM: Bear Rock No. 1 Dam
STATE LOCATED: Pennsylvania
COUNTY LOCATED: Cambria
STREAM: Bear Rock Run
SIZE CLASSIFICATION: Small
HAZARD CLASSIFICATION: High
OWNER: Highland Sewer and Water Authority
DATE OF INSPECTION: November 13 and December 28, 1979

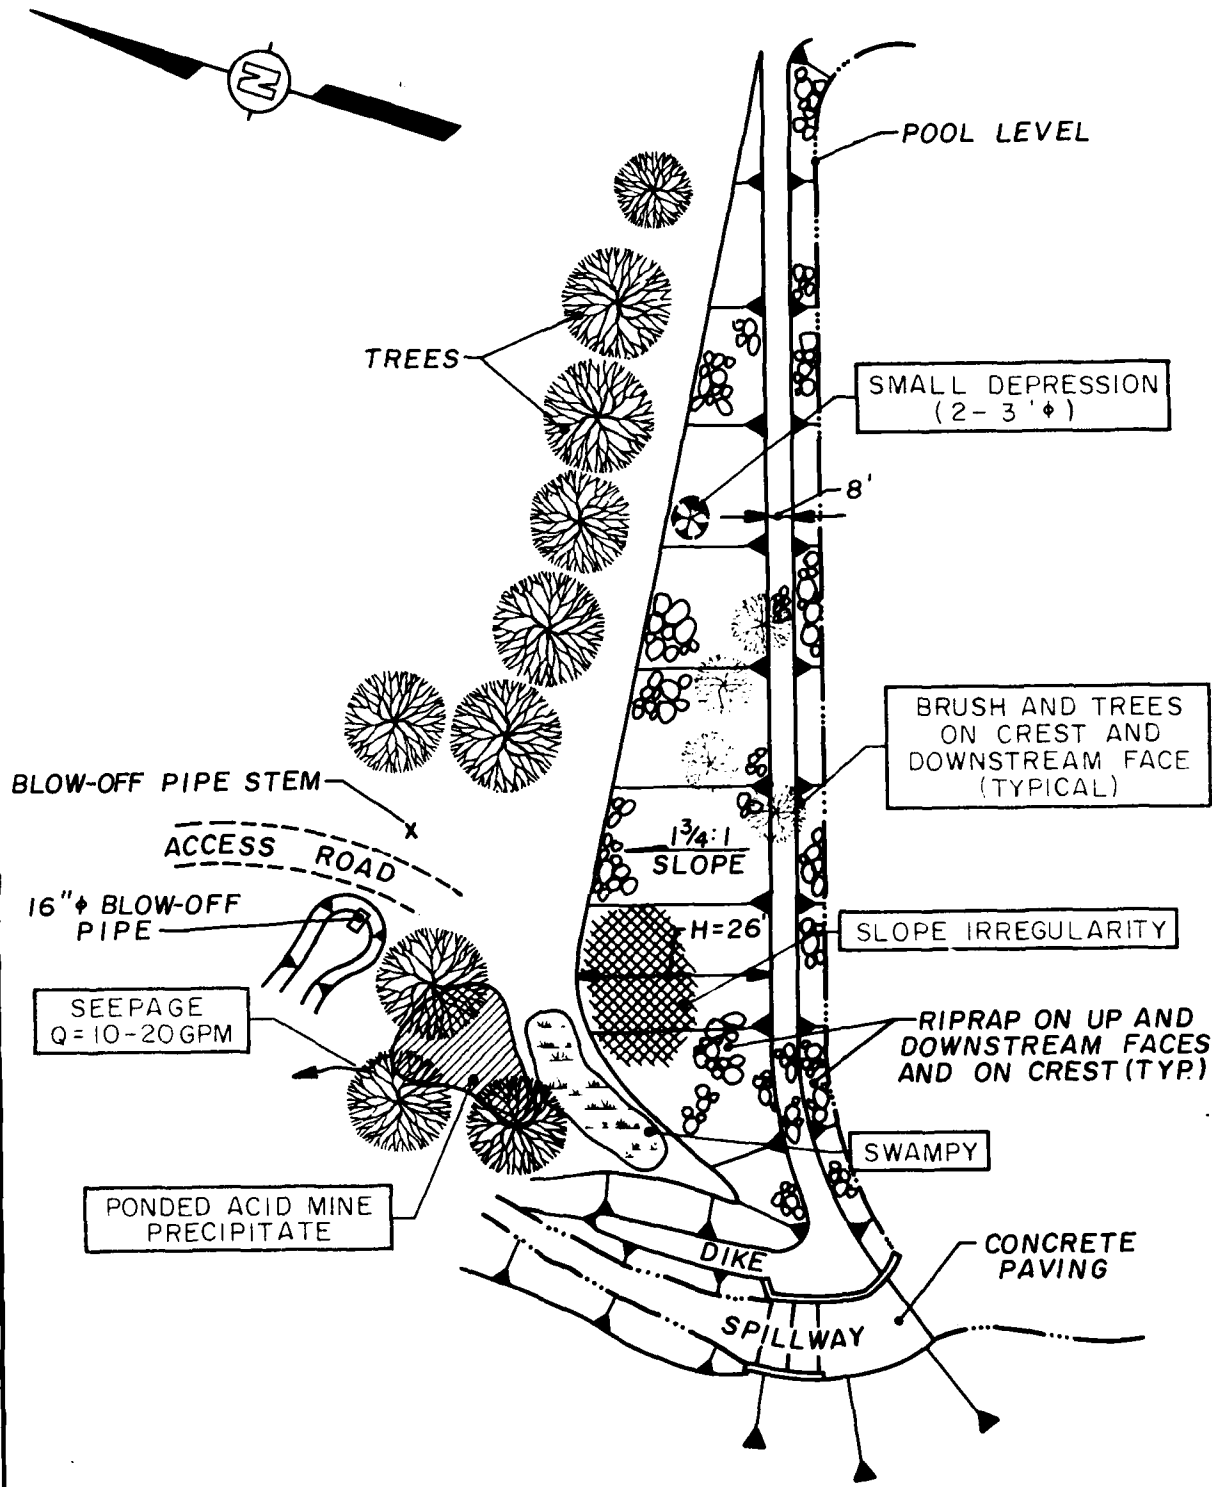
DRAWING 79-543-A19
 NUMBER
 2/28/80
 2/14/80
 CHECKED BY 73c
 APPROVED BY JHP
 ACS
 11-30-79
 DRAWN BY

1. POOL LEVEL DATE OF INSPECTION:
AT SPILLWAY CREST.
