MARINE CASUALTY REPORT: M/V CHESTER A. POLING; SINKING IN THE A--ETC(U)

1. Report No. USCG-16732/73448	2. Government Accession No. AD-A084834	3. Recipient's Catalog No. 11
4. Title and Subtitle Marine Board Casualty Report: M/V CHESTER A. POLING; Sinking in the Atlantic Ocean on 10 January 1977 With Loss of Life.	5. Report Date 27 Dec 1979	6. Performing Organization Code G-MMI-1/TP24

M/V CHESTER A. POLING; SINKING IN THE ATLANTIC OCEAN ON 10 JANUARY 1977 WITH LOSS OF LIFE

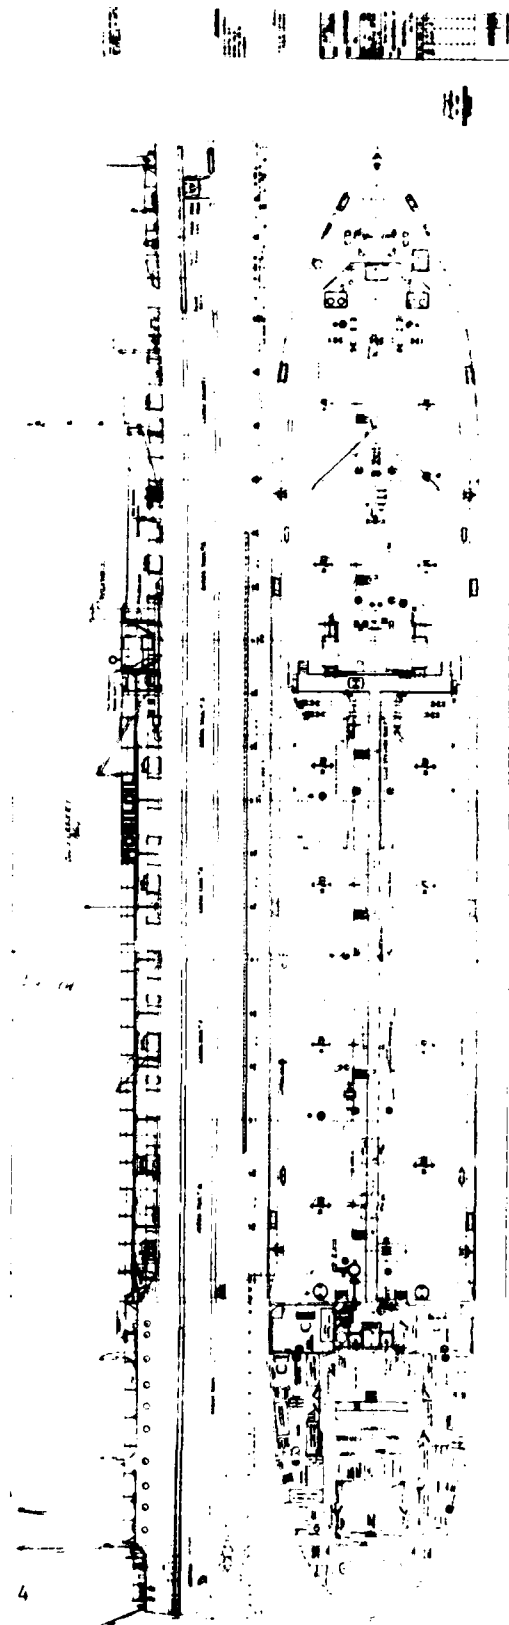
Figure 1.

4. When viewed in profile, the tanker displayed a very low flush decked silhouette, having been originally designed to negotiate inland canals where a ship with a high superstructure would not clear low bridges, figure (1). The wheelhouse deck level was 6.5 feet above the main deck. The designation for loadline administration purposes was self-propelled tank barge; it was withdrawn from American Bureau of Shipping class by owner's request in January 1976. The most recent Loadline Certificate for vessels on special service coastwise voyages established a winter freeboard of three feet, eleven and one quarter inches below the main deck. Records reflect a relatively unremarkable life history. There were no significant structural casualties suffered during the tanker's long service. A pump room fire and explosion in Narragansett Bay in May 1972 was relatively minor and resulted in no major structural damage;
