Roof leaks in cold regions: School at Chevak, Alaska

Wayne Tobiasson and Philip R. Johnson

April 1980

ROOF LEAKS IN COLD REGIONS: SCHOOL AT CHEVAK, ALASKA

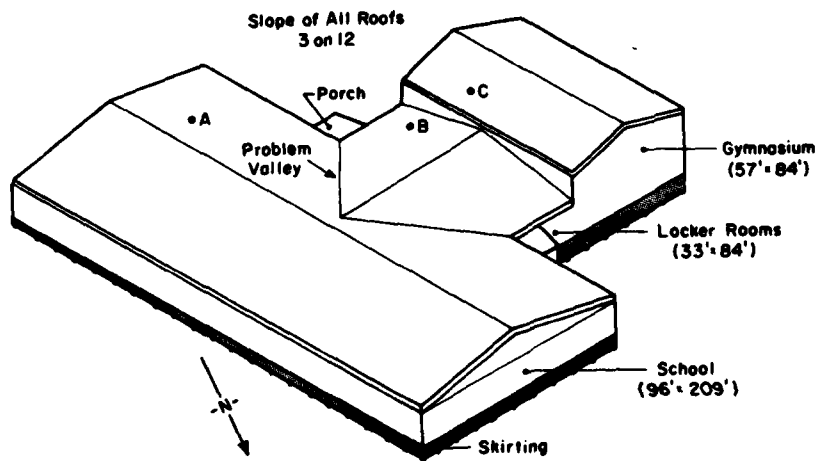
Figure 2. Isometric drawing of Chevak school.

Once the building was occupied, severe leaks developed in the areas of the roof valleys, particularly in the lower portion of the "problem valley" shown in Figure 2. Valley leaks were caused by entry of snow meltwater. These leaks did extensive damage to the suspended ceilings and threatened to ruin the carpet and other inside furnishings.

We did not investigate the leaks at the intersection of the gymnasium wall and the locker room roof. BIA personnel speculated that meltwater from the gymnasium roof was entering the ridge vent of the locker room roof where that roof intersects the wall of the gymnasium (Figs. 2 and 11).

were lifted at points A, B and C in Figure 2. A small amount of frost was present on the underside of the roofing at point A. A quarter-inch of frost was present at B and 3/8 in. was present at C where some ice was observed on the insulation. These observations convinced all concerned that large quantities of warm moist air from within the building passed into the roof through gaps in the plywood deck and others in the insulation above. The underside of the cold corrugated metal roofing was an excellent condenser and, as the warm moist air passed up through the roof sandwich, frost formed on the metal. Warmer weather and sunshine warmed the frosted underside of the corrugated metal roofing. At some point it was warm enough to melt the frost and meltwater dripped onto the insulation where it either refroze, or in warmer weather flowed downslope. At a gap or seam in the insulation, the water flowed down to the deck. Since there were many gaps in the plywood deck, the water leaked into the building.

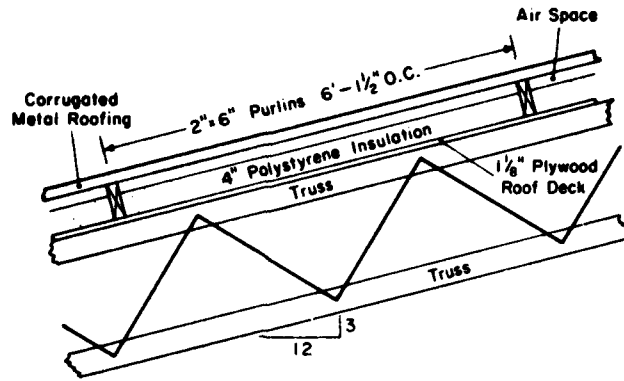
Figure 3. Cross section of roof.

The complex is elevated above the ice-rich permafrost on wooden piles. Wooden skirting, open near the ground, is present along the perimeter of the building. Glued laminated wooden floor beams placed on the piles support wood floor trusses. Steel and wooden columns and bearing walls with 2 × 6 studs support the roof which, like the floor, consists of glued laminated roof beams, wooden trusses and the roof itself. Each roof is sloped 3 on 12 and consists of a 1-1/8-in. plywood deck resting on the roof trusses. Above the plywood, 2 × 6 purlins run along the roof, 6 ft—1 1/2 in. on center, parallel to the eaves. Four inches of expanded bead polystyrene insulation is placed between the purlins which support corrugated metal roofing. This roof system is shown in Figure 3. No vapor barrier is indicated on the as-built drawings.
