RARITAN RIVER BASIN
SOUTH BRANCH OF RARITAN RIVER
HUNTERDON COUNTY
NEW JERSEY

CLINTON MILLS DAM

NJ 00122

**PHASE 1 INSPECTION REPORT
NATIONAL DAM SAFETY PROGRAM**

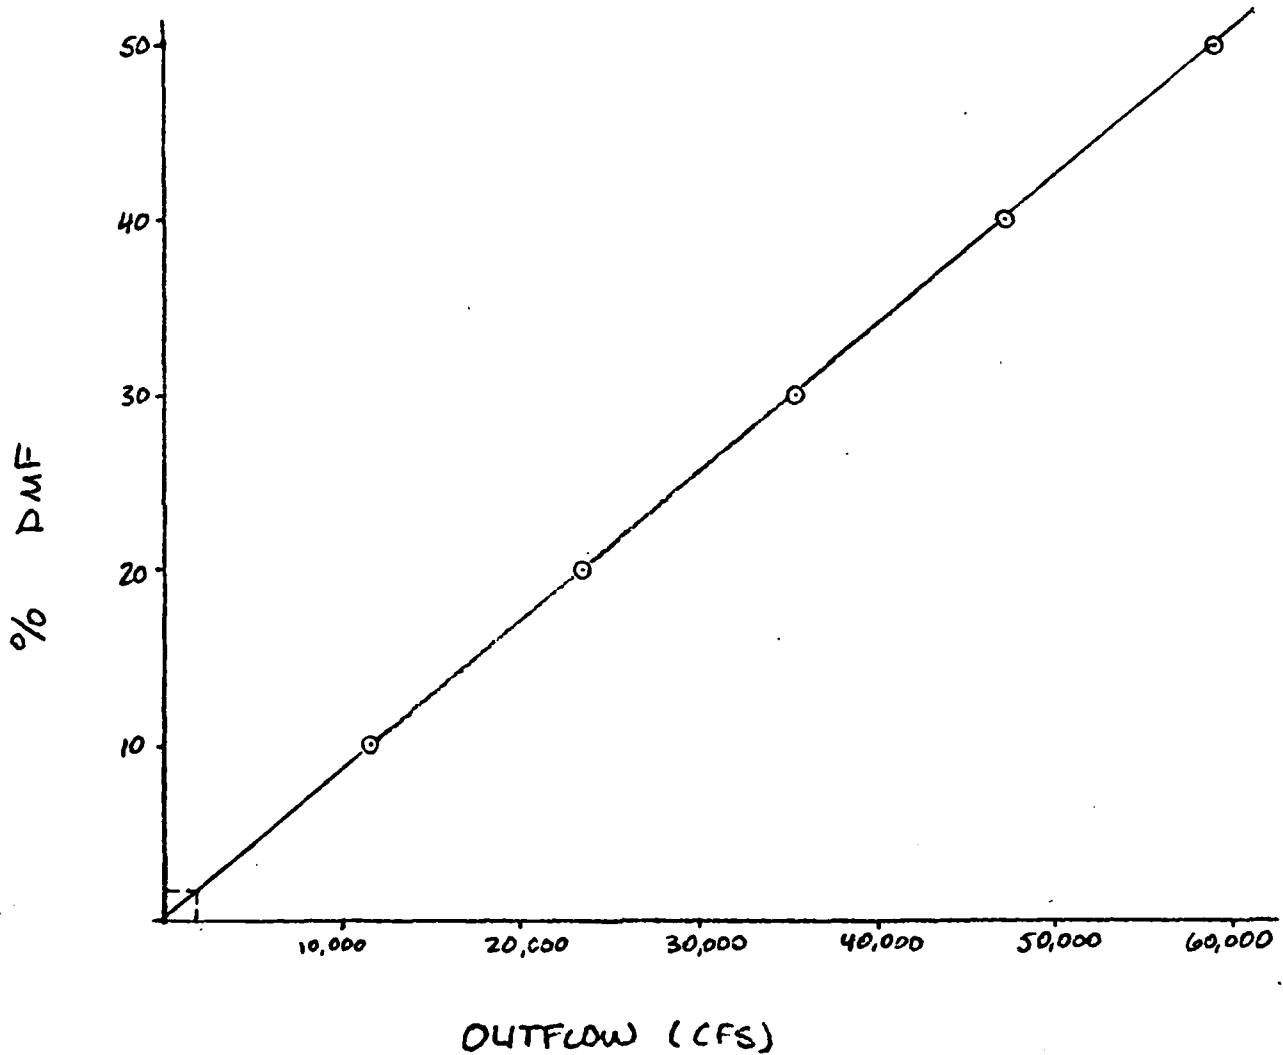
OVERTOPPING POTENTIAL

OVERTOPPING OF THE DAM OCCURS AT ELEVATION
190.3 WITH $Q = 1906$ CFS \therefore DAM CAN PASS
APPROXIMATELY 3.2% SDF OR 1.6% DMF
