SMITH RESERVOIR DAM
ERIE COUNTY, COMMONWEALTH OF PENNSYLVANIA
NDI No. PA 00017
PennDER No. 25-28

⑥ PHASE I INSPECTION REPORT
NATIONAL DAM SAFETY PROGRAM

Smith Reservoir Dam, Erie County, Pennsylvania
NDI No. PA 00017, PennDER No. 25-28
West Branch of Sixteen Mile Creek
Inspected 12 May 1980

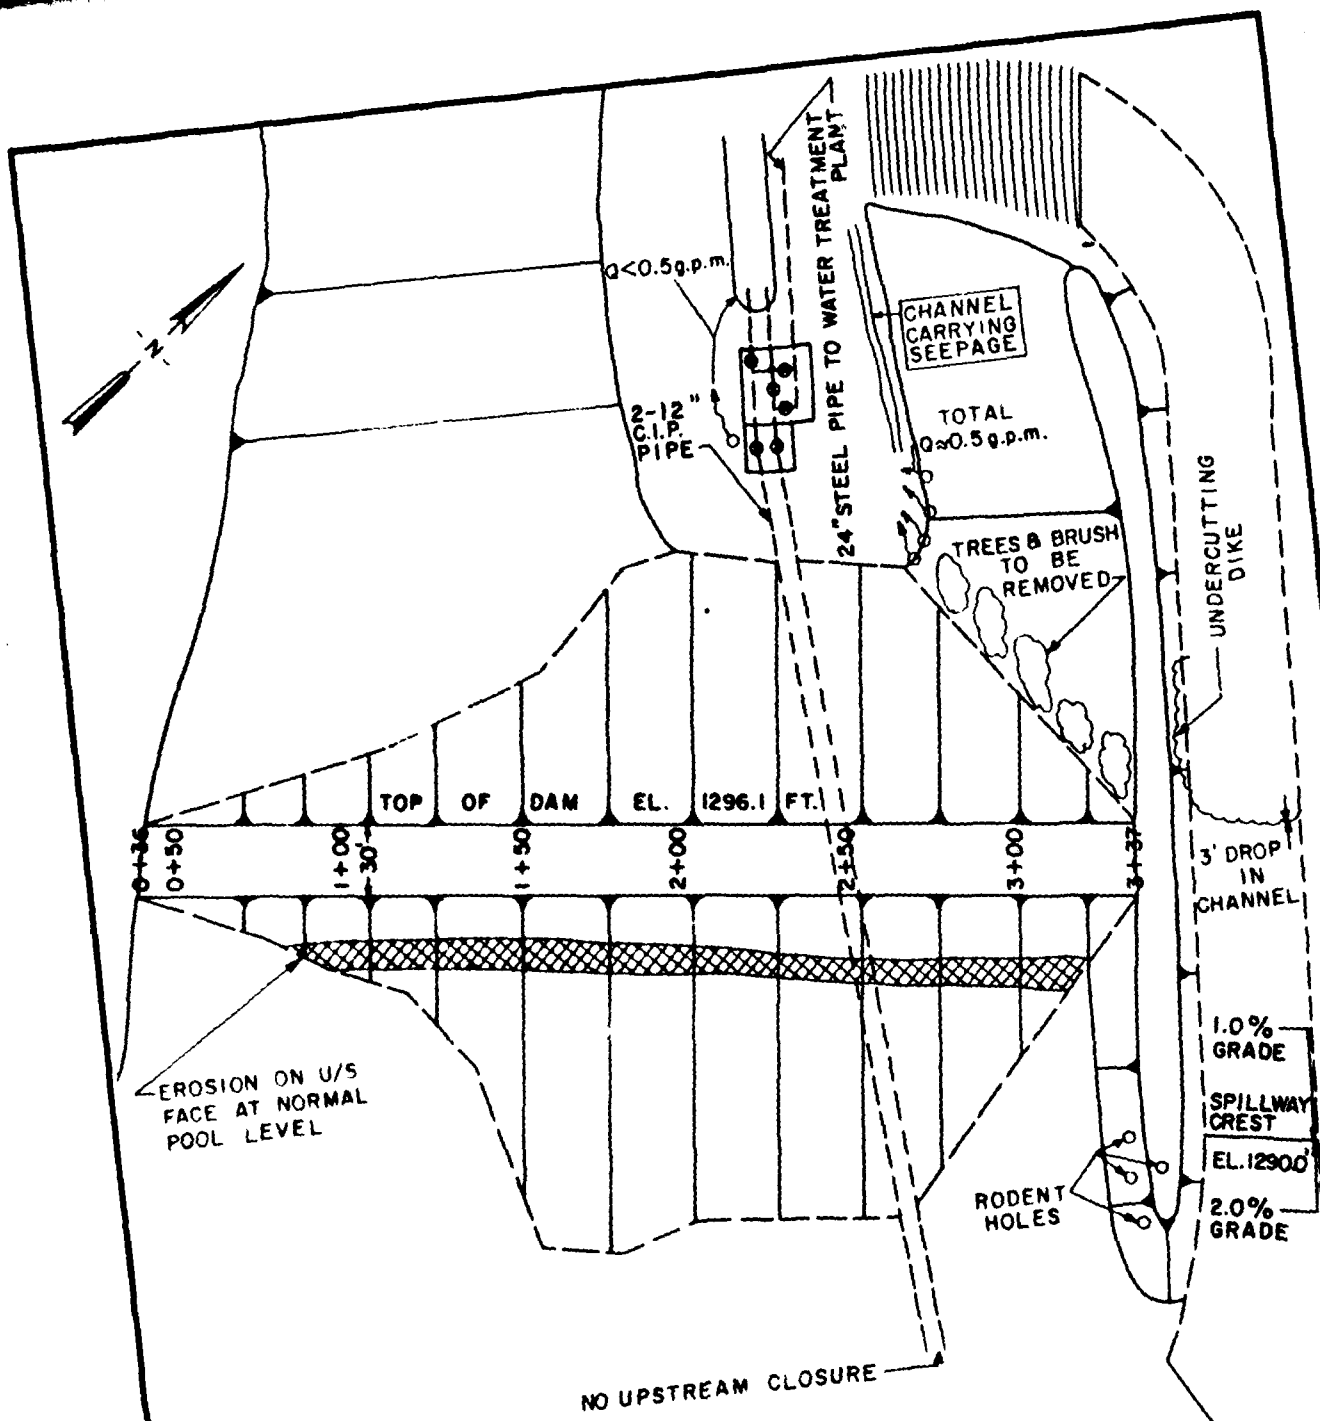
SMITH RESERVOIR DAM
TOP OF DAM PROFILE
TYPICAL CROSS-SECTION

- SEEPAGE (QUANTITY AS SHOWN)
- RODENT HOLES
- CHANNEL CONVEYING SEEPAGE AWAY FROM DAM

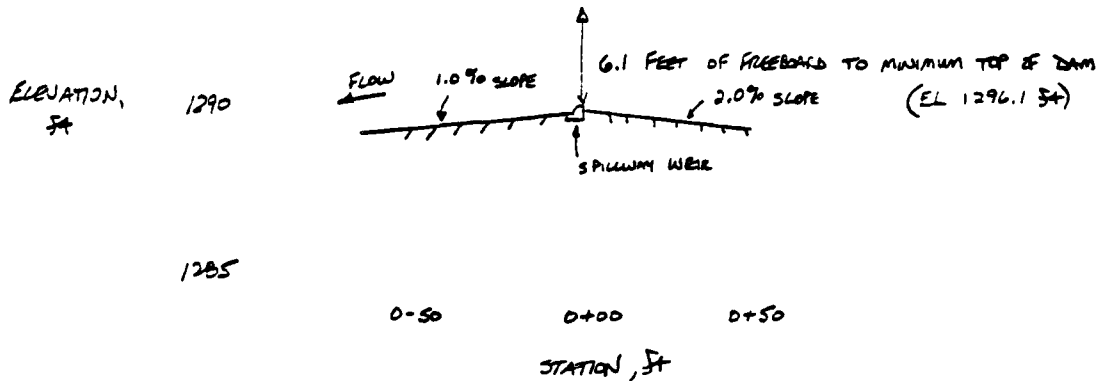
SPILLWAY PROFILE :

THE RELATIVELY SMALL HEIGHT OF THE WEIR COMBINED WITH THE MILD SLOPE OF THE SPILLWAY CHANNEL MAKES THE WEIR HYDRAULICALLY INSIGNIFICANT EXCEPT FOR SMALL FLOW DEPTHS. FOR LARGE FLOW DEPTHS, FLOW RATE WILL DEPEND UPON THE CHARACTERISTICS OF THE SPILLWAY CHANNEL (SLOPE, ROUGHNESS, GEOMETRY). MANNING'S EQUATION IS USED TO CALCULATE THE SPILLWAY CAPACITY AS FOLLOWS:

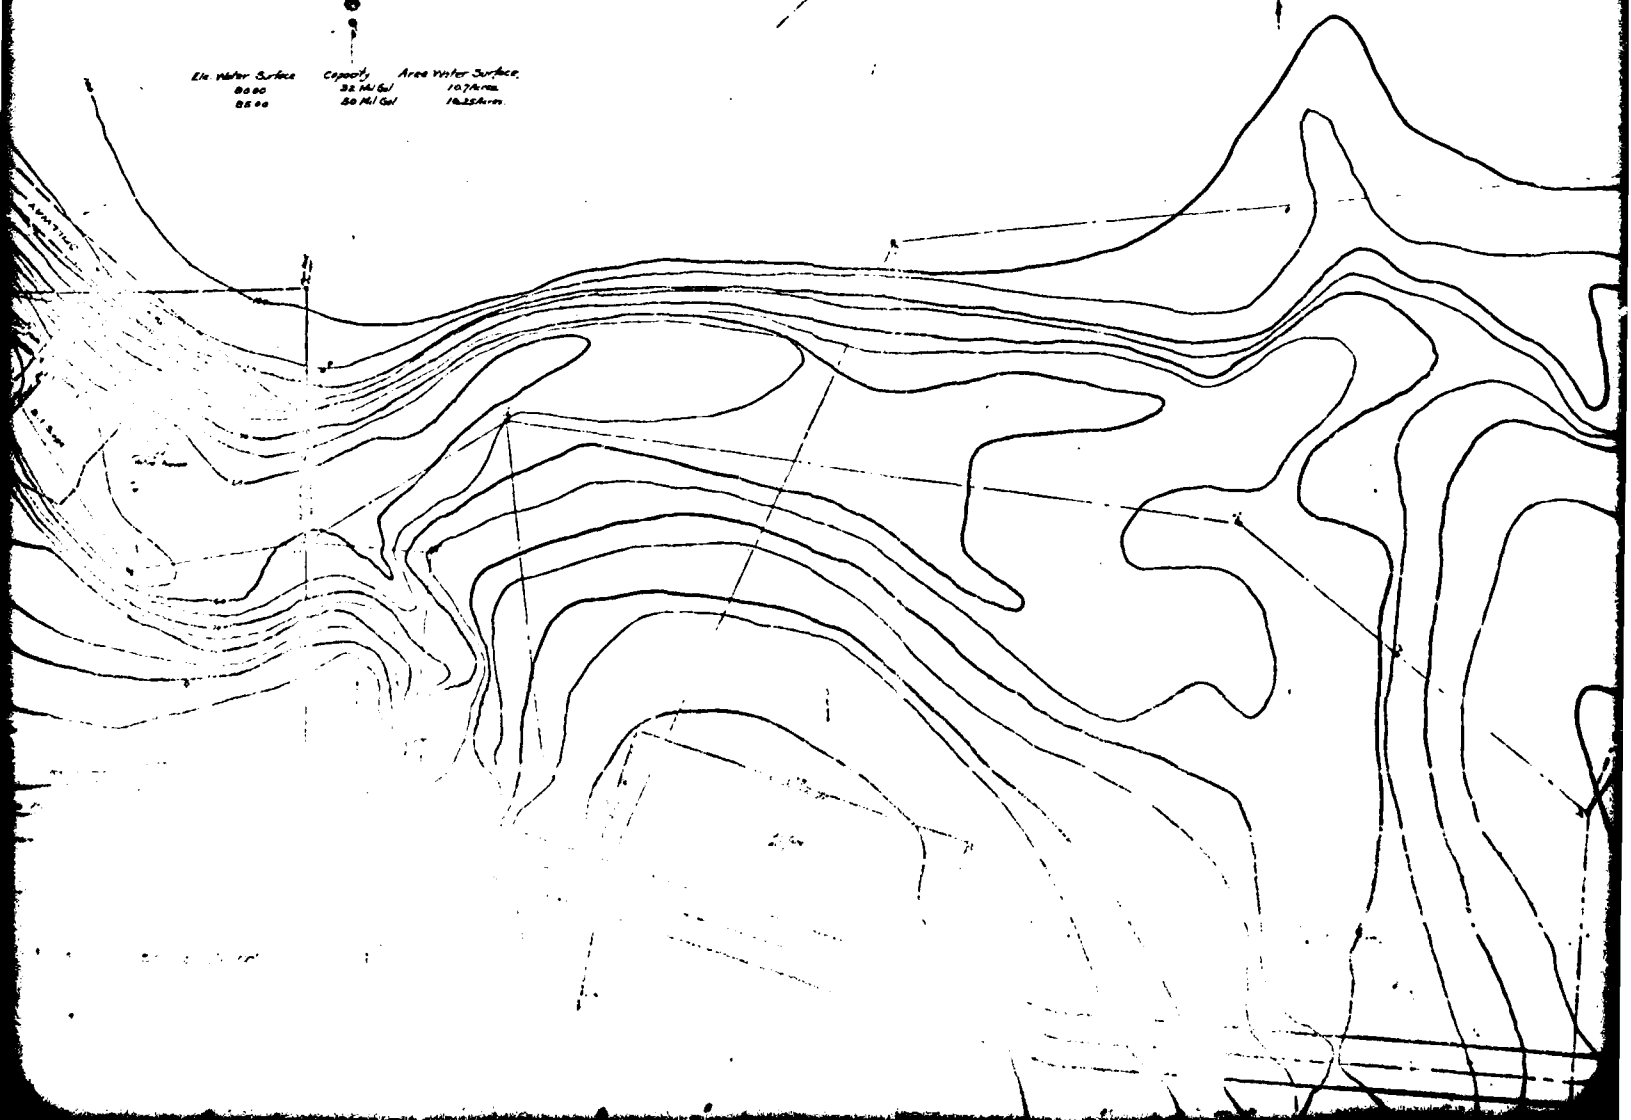
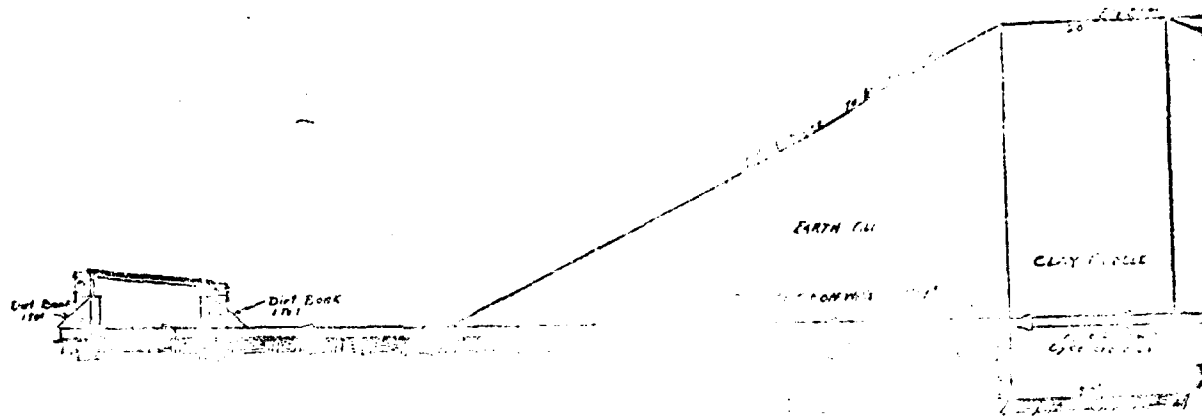
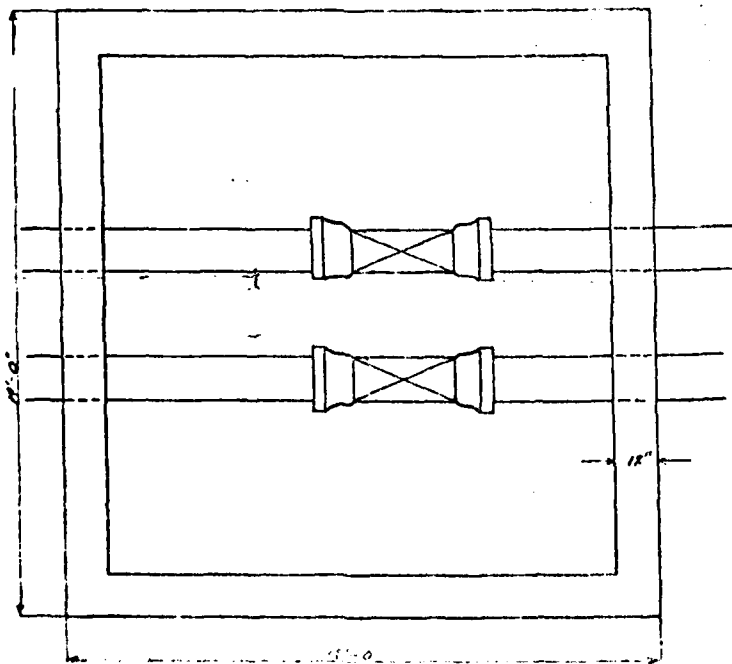
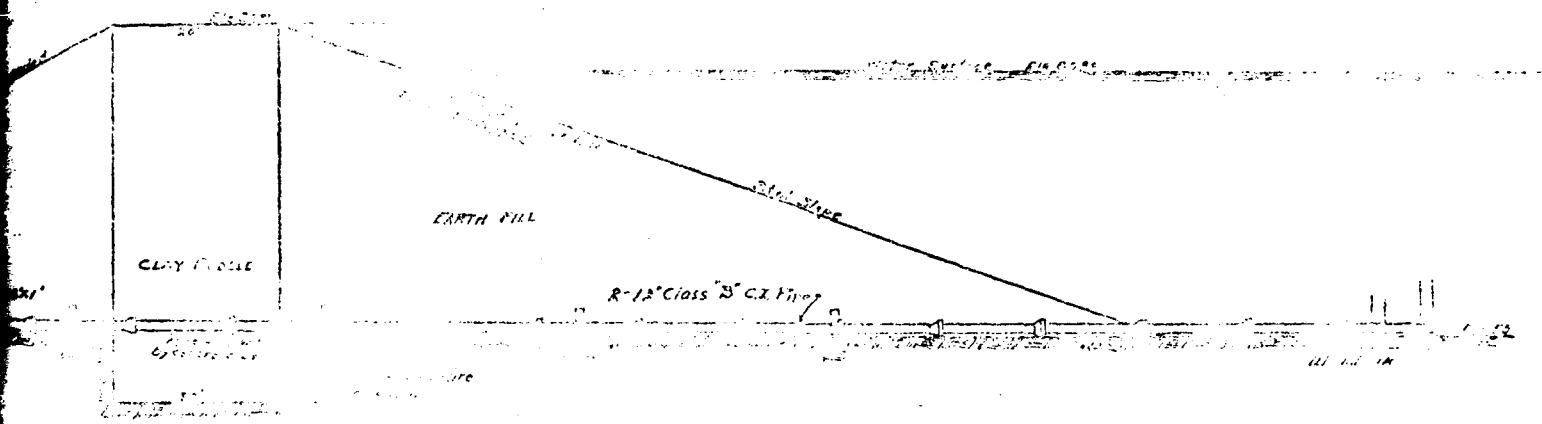
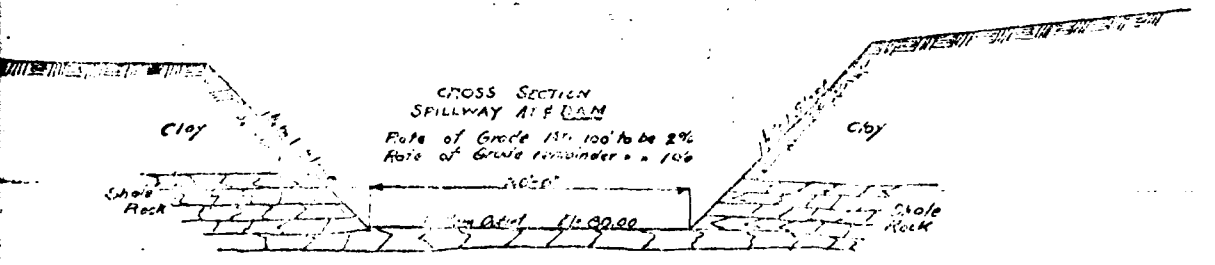
PLATE 4

Details of Valve House
 scale 1/2" = 1'

CROSS SECTION
of
DAM
Scale 1"=10'

CROSS SECTION
of
SPILLWAY
Scale 1/2"=1'
