MAINTENANCE AND PRESERVATION OF CONCRETE STRUCTURES

REPAIR OF EROSION-DAMAGED STRUCTURES

James E. McDonald

April 1980

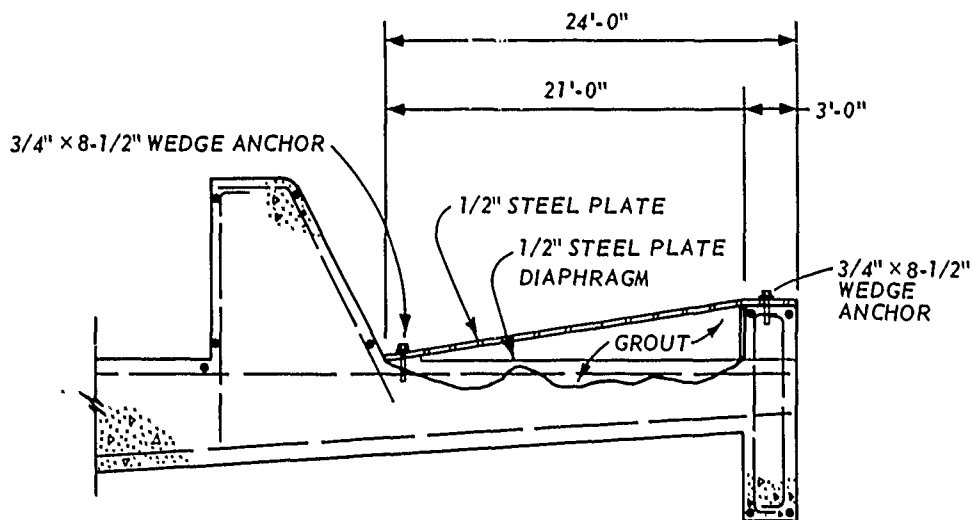
the plate and to provide a formed void in which to retain the grout. Modules were prefabricated in New Orleans and were shipped to the job site by barge. The first module installed (No. 12), 6 ft wide and 24 ft long, was placed (Figure 8) behind gate bay 5 in the low bays. The

Figure 8. Typical placement of prefabricated module, Old River

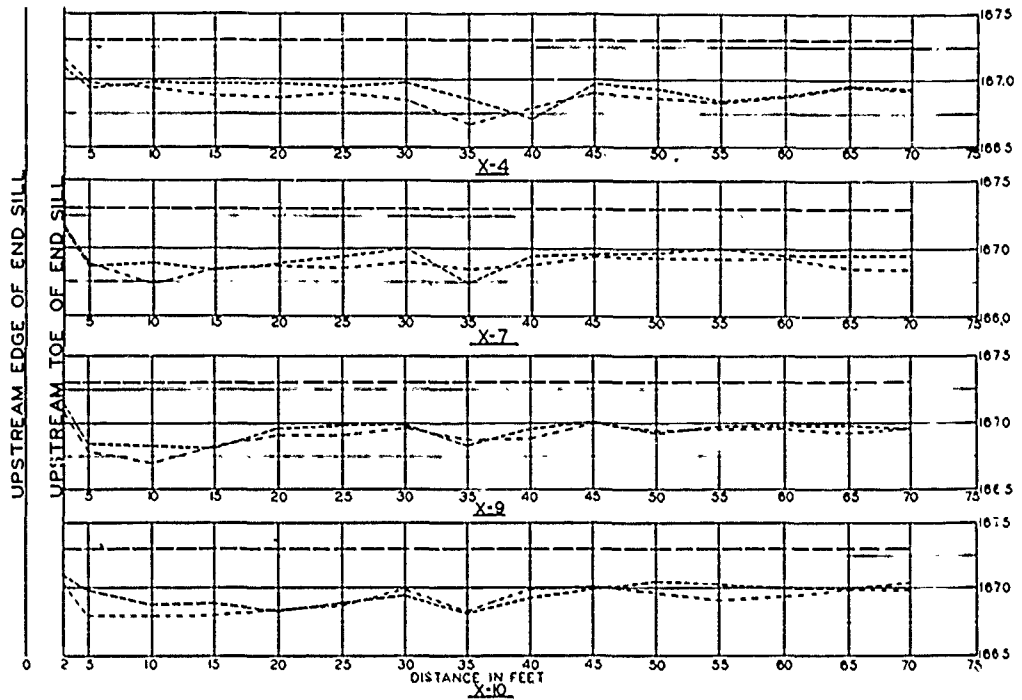
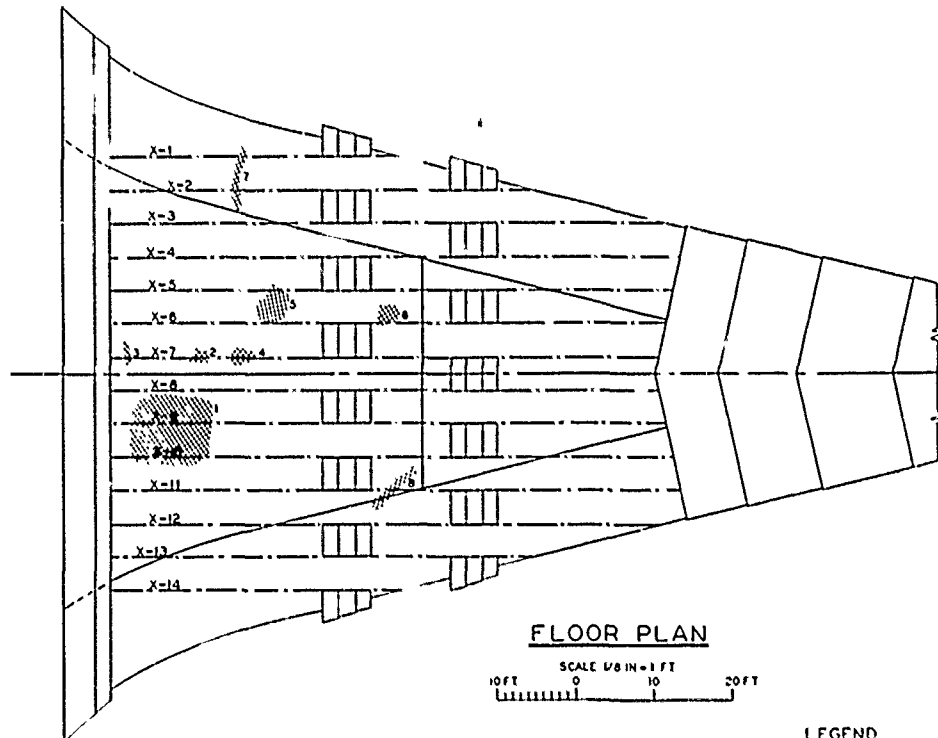
since the last inspection. The increase in eroded depth was estimated at approximately 1 in. The number of areas in the basin slab with exposed reinforcing had doubled since the 1969 inspection (Figures 13 and 14). The concrete patches made at the time of the initial inspection (shown at the base of the baffle on the left in Figure 15) appeared in good condition with little effect of erosion noted. Therefore, it was decided to patch the eight eroded areas shown in Figure 13 with the same material. Two baffles were also repaired in a similar manner.

AREA 1 - NINE REINFORCING BARS EXPOSED AREA SIZE 8' X 11'
 AREA 2 - TWO REINFORCING BARS EXPOSED AREA SIZE 2' X 1/2' 10' FROM ENDSILL
 AREA 3 - TWO BARS EXPOSED AREA 8' X 4' 2' FROM ENDSILL
 AREA 4 - THREE BARS EXPOSED AREA 32' X 12' 16' FROM ENDSILL
 AREA 5 - THREE BARS EXPOSED AREA 30' X 28' 8' DOWNSTREAM FROM SW CORNER OF THIRD BLOCK FROM THE NORTH
 AREA 6 - THREE BARS EXPOSED AREA 2' X 2'
 AREA 7 - SCOUR AREA 7' X 8' WIDE X 1' 2" DEEP 10' FROM ENDSILL
 AREA 8 - SCOUR AREA 7' X 16' WIDE X 3' 2" DEEP

Figure 13. Cross sections of outlet works stilling basin, Arkabutla

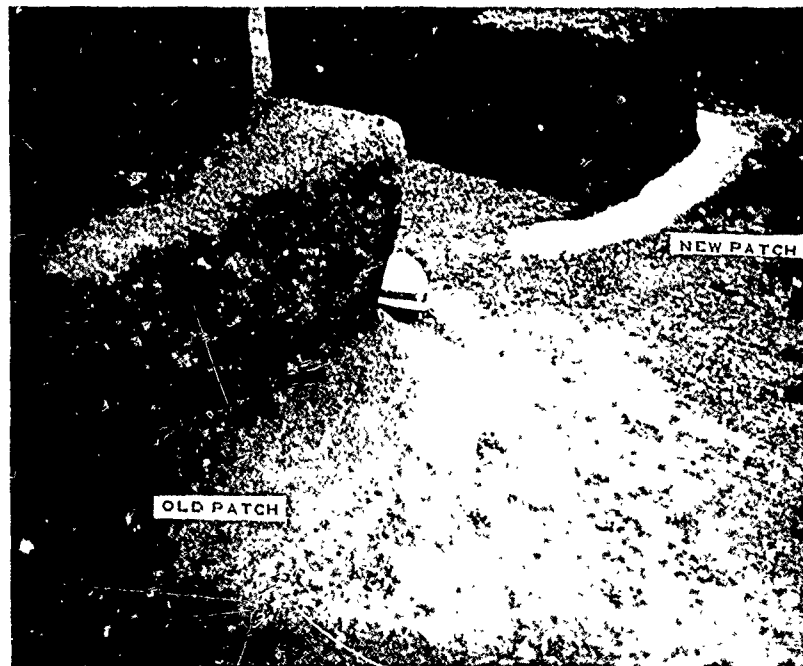
Figure 15. Stilling basin baffles showing old and new concrete patches, Arkabutla

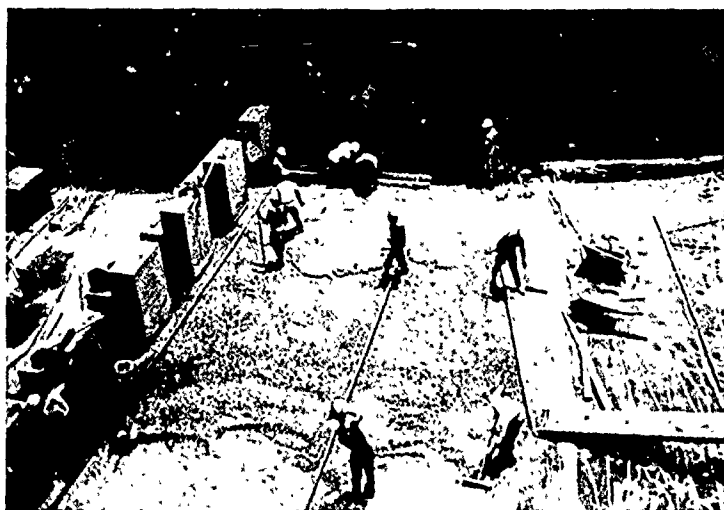
Figure 16. Stilling basin floor slab repairs, Arkabutla Dam

42. The epoxy resin bonding material was mixed and applied to the receiving surfaces immediately prior to placement of the filler concrete. Stiff stable brooms were used to ensure complete coverage of the receiving surface with bonding material (Figure 16). Filler concrete proportioned with 3/4-in. maximum size aggregate, as shown in the following tabulation for 28-day compressive strength of 4000 psi, was placed (approximately 53 cu yd) while the bonding course was still wet.

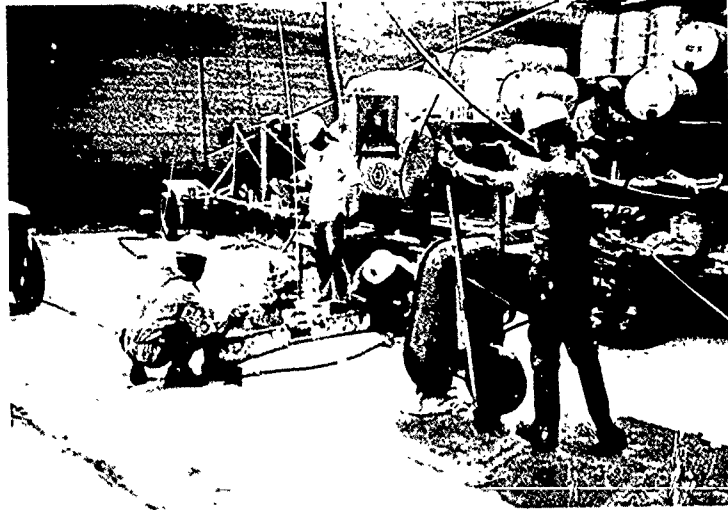
Figure 17. Application of epoxy mortar sealer and wearing course, Arkabutla Dam

laitance and produced a roughened surface. A light prime coat of neat epoxy was applied to the thoroughly cleaned and dried surface and followed by a 1/4-in. epoxy mortar sealer and wearing course (Figure 17). The mortar, consisting of one part epoxy to three parts silica sand, was mixed in a 4.5-cu-ft mortar mixer. The mortar was finished to desired grade with steel trowels. Existing expansion joints were replaced with premolded, sponge rubber joint filler and extended upward to the new surface.

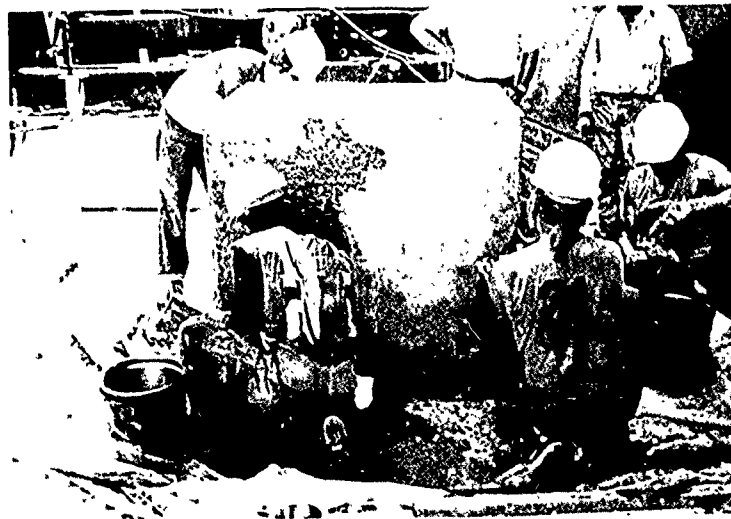
Figure 18. Epoxy mortar repair of baffle, Arkabutla Dam

44. Surface preparation on the baffles was similar to that previously described for the basin floor slabs. Immediately after application of the epoxy bonding material, epoxy mortar was hand-trowelled onto uneroded areas of the baffles (Figure 18) to a minimum thickness of 1/4 in. On eroded areas, the thickness of coating was that necessary to restore the baffles to their original dimensions.

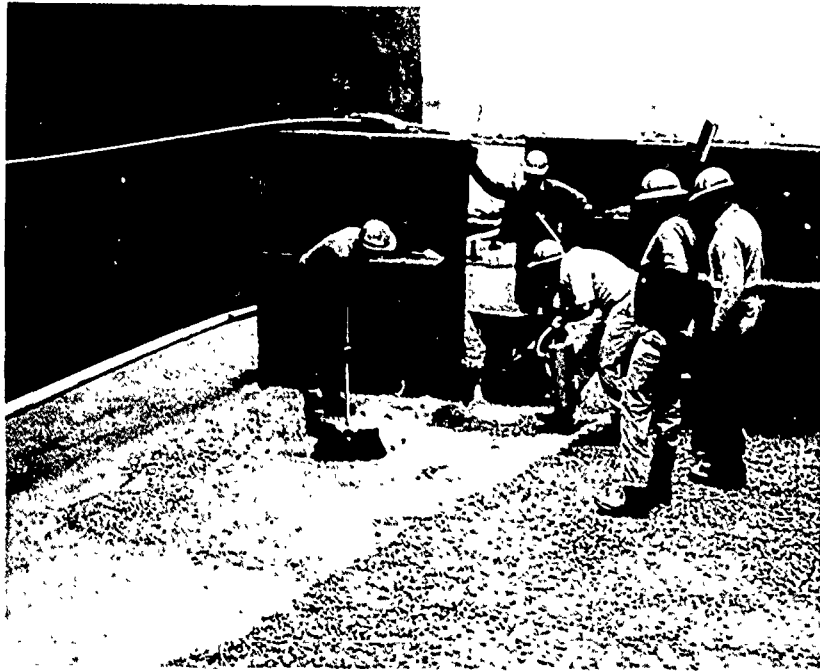
Figure 21. Temporary repairs to stilling basin,
Enid Dam

50. Areas of most advanced erosion were repaired (Figure 21) at the time of the 1968 inspection with a temporary protective coating. The material and method of application was the same as previously described for the Arkabutla stilling basin. Although erosion on the steps was not as extensive as that on the stilling basin floor, two test patches were made on the seventh step, el 192, in both the north and south passages. These patches were exposed each time the gates were closed so that durability could be monitored.

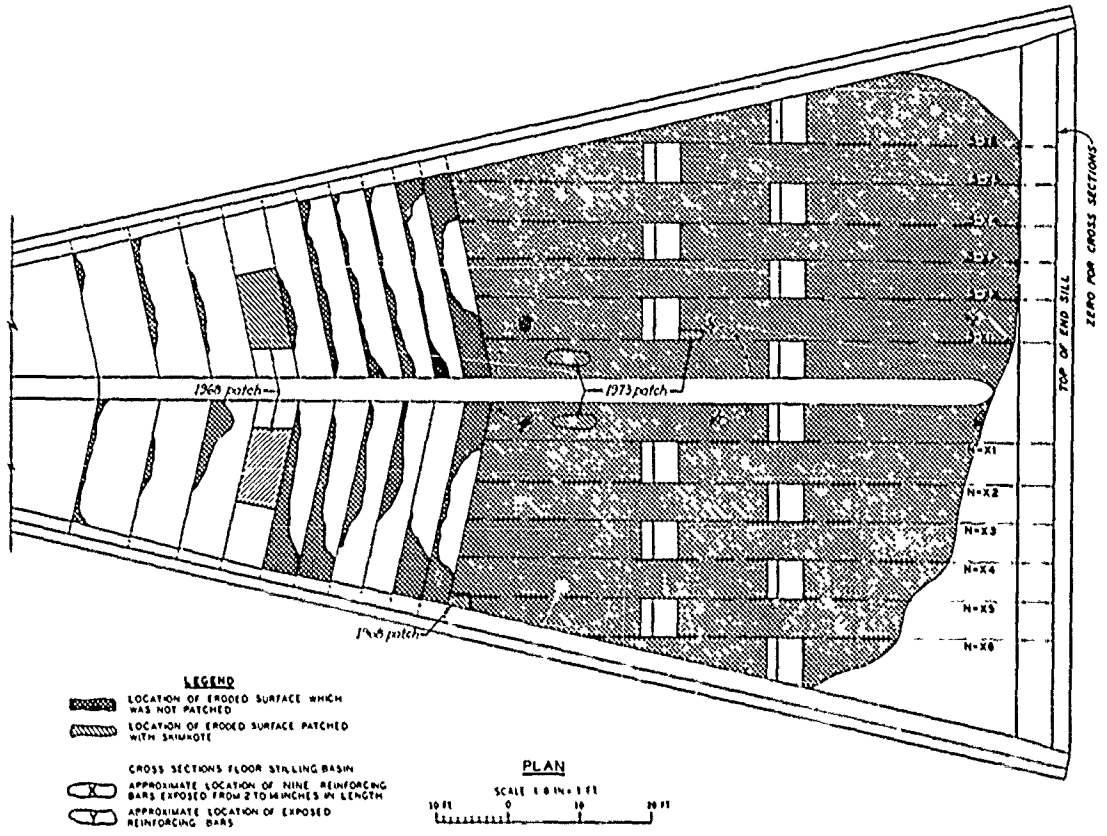
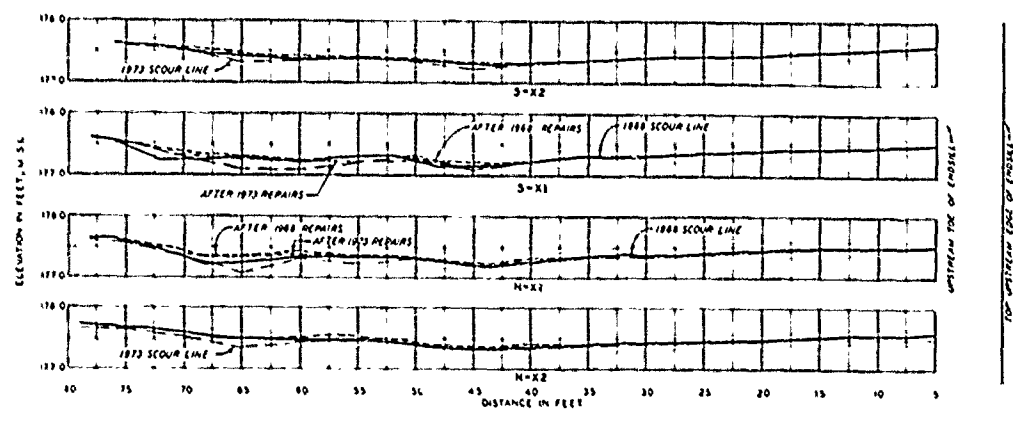
the major areas of erosion were located approximately 5 to 6 ft from the splitter wall and midway between the lower step and first row of baffle piers (Figure 22). In addition, there were two deeply eroded areas in each passage, approximately 3 ft from the splitter wall and midway between the two rows of baffles. Maximum depth of erosion was approaching 1 ft. Nine pieces of reinforcement were exposed in the south passage, ranging from 2 to 14 in. in length. Also, in the north passage, six reinforcing bars were exposed, ranging in length from 2 to 12 in. Until permanent repairs could be made, these areas with exposed reinforcement were temporarily repaired with the protective coating previously used.

Figure 22. Cross sections, outlet works stilling basin, Enid Dam

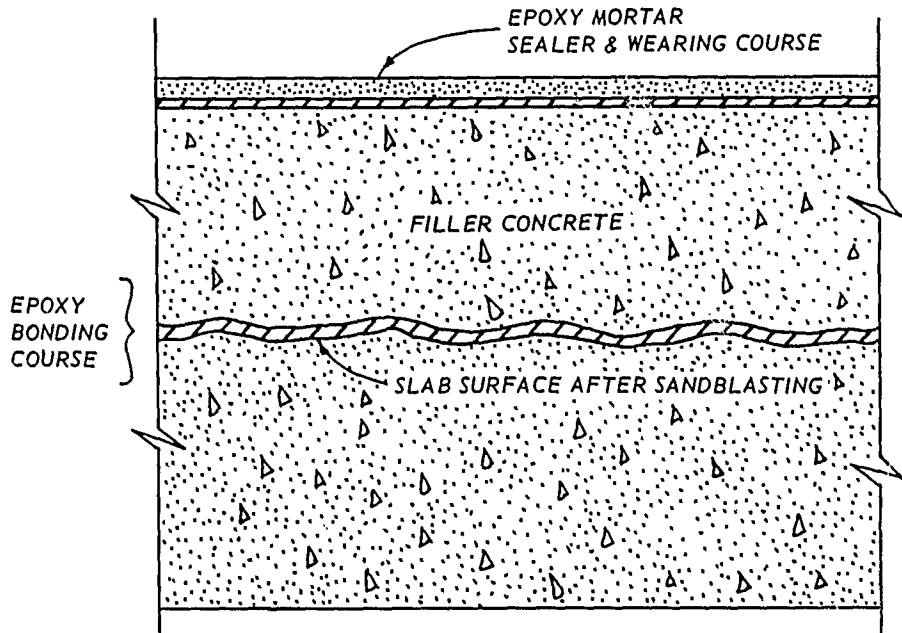
Figure 23. Stilling basin slab repair, Enid Dam

53. In 1976, permanent repairs were made to the stilling basin floor slab and baffles. This work was accomplished under the same contract with essentially the same materials and techniques previously described for Arkabutla. The stilling basin slab was restored to original grade with an epoxy-bonded unreinforced concrete overlay (approximately 93 cu yd) and epoxy mortar sealer and wearing course (Figure 23). Strength gain characteristics of the filler concrete are shown in

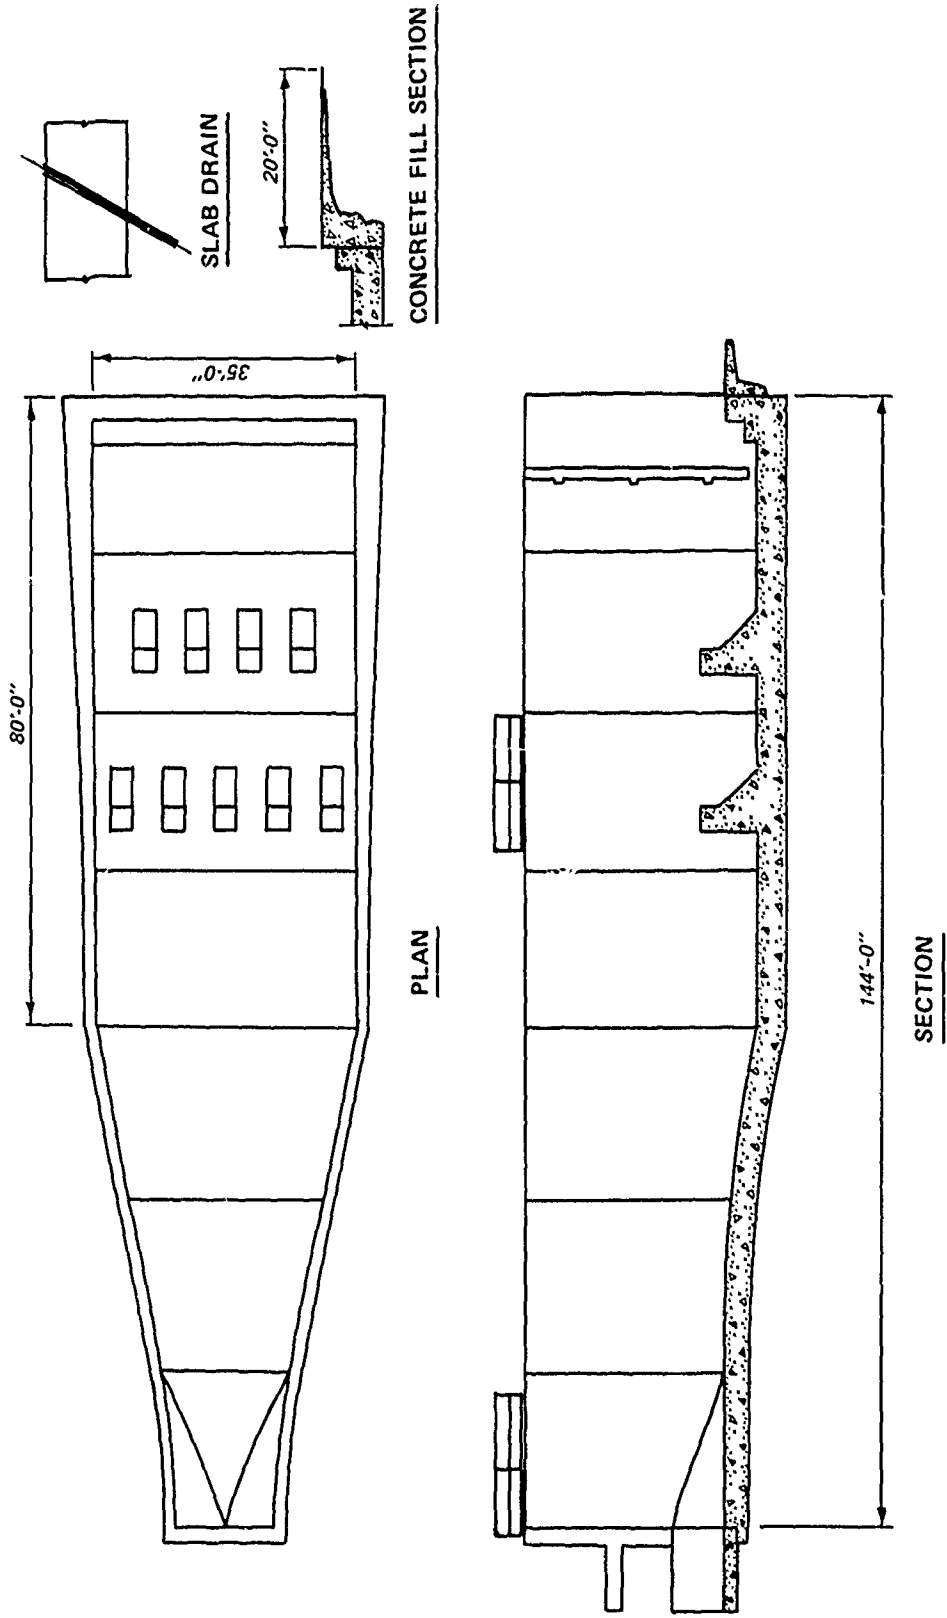
Figure 30. Stilling basin plan and section, Pomona Dam

67. The initial dewatering of the basin was made in February 1968 as part of first periodic inspection. Erosion caused by the abrasive action of rocks and other debris had occurred at the downstream end of the transition slab and on the upstream one third of the basin slab. Reinforcing steel was exposed in the upstream left third of the basin and just upstream of the baffles. A supplemental inspection of the stilling basin was made in October 1970. The inspection revealed significant additional concrete erosion and extensive reinforcing steel exposure. The major damage was attributed to the flow conditions caused by relatively low discharges, since approximately 97 percent of the releases have been 500 cfs or less.

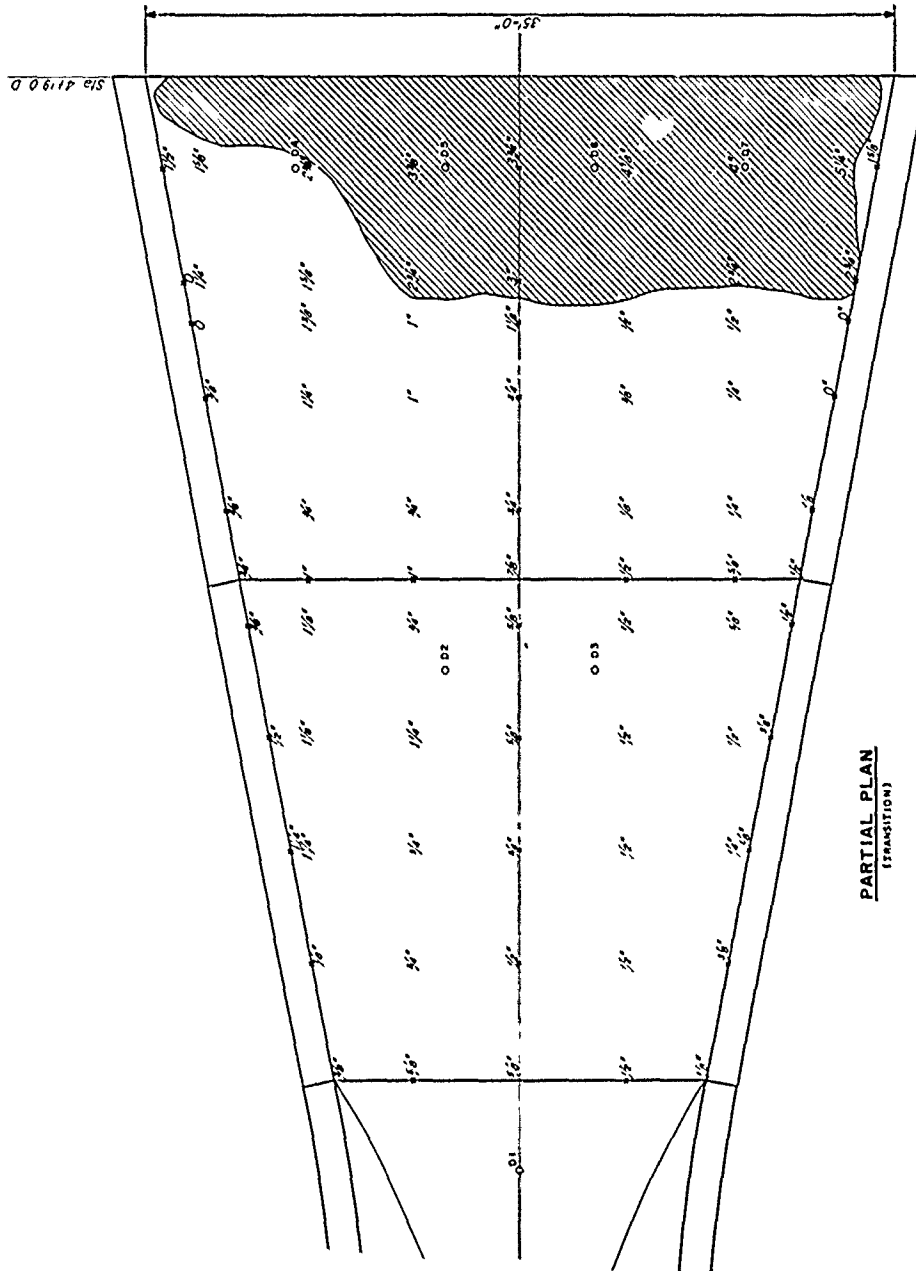
70. The basin was dewatered for inspection and repair in October 1972. Additional erosion was observed; however, the rate of erosion appeared to be less. The reduced rate of erosion was attributed to a decrease in the number of days with discharges above 500 cfs. The erosion observed before the repair is shown in Figures 33 and 34.

Figure 33. Transition erosion, Pomona Dam

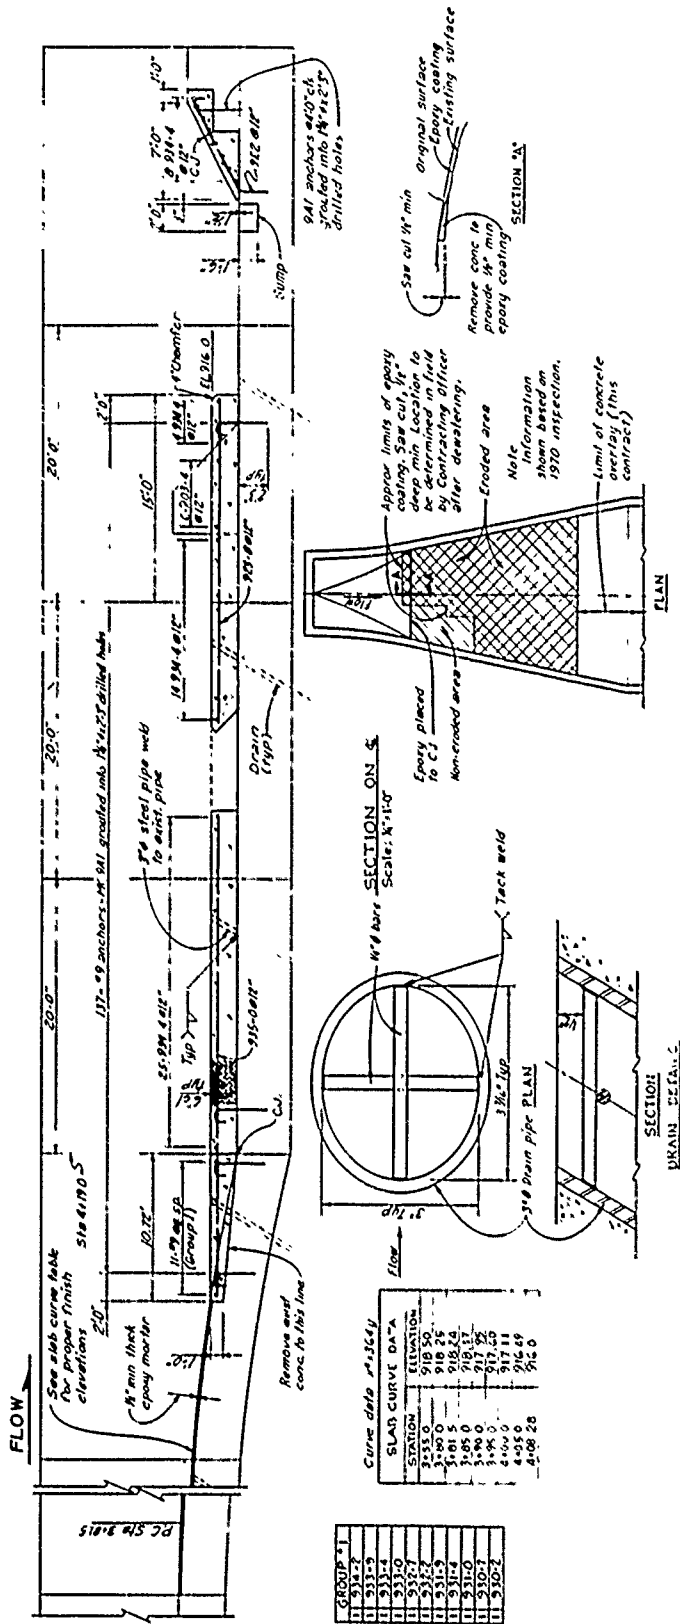
Figure 35. Repair details, Pomona Dam

76. The basin was dewatered in April 1977 as part of the third periodic inspection. The depression at the downstream end of the overlay slab, which serves as a rock trap, appeared to function well. Most of

the rocks, approximately 1 cu yd, were found in the trap and were adjacent to the overlay slab.

77. The concrete overlay had suffered only minor damage. Generally, the erosion depth was about 1/8 in. with maximum depths of 1/2 in. The major wear pattern was on the left third of the overlay slab and was in the upstream half of the basin. The location of wear, the same as the major wear before placement of the overlay slab, indicates rocks are being circulated at some discharge rate. Selected discharge rates with the percent of time and the number of days the basin has operated at these rates for the periods of time between dewaterings are as follows:

74. The concrete overlay, a reinforced concrete slab, was anchored to the original basin slab. The upstream end of the overlay slab was recessed into the original transition slab (Figure 35). Iron Mountain trap rock, an abrasion-resistant coarse aggregate, was used. Concrete materials and mixture proportions for the repair concrete were as follows.

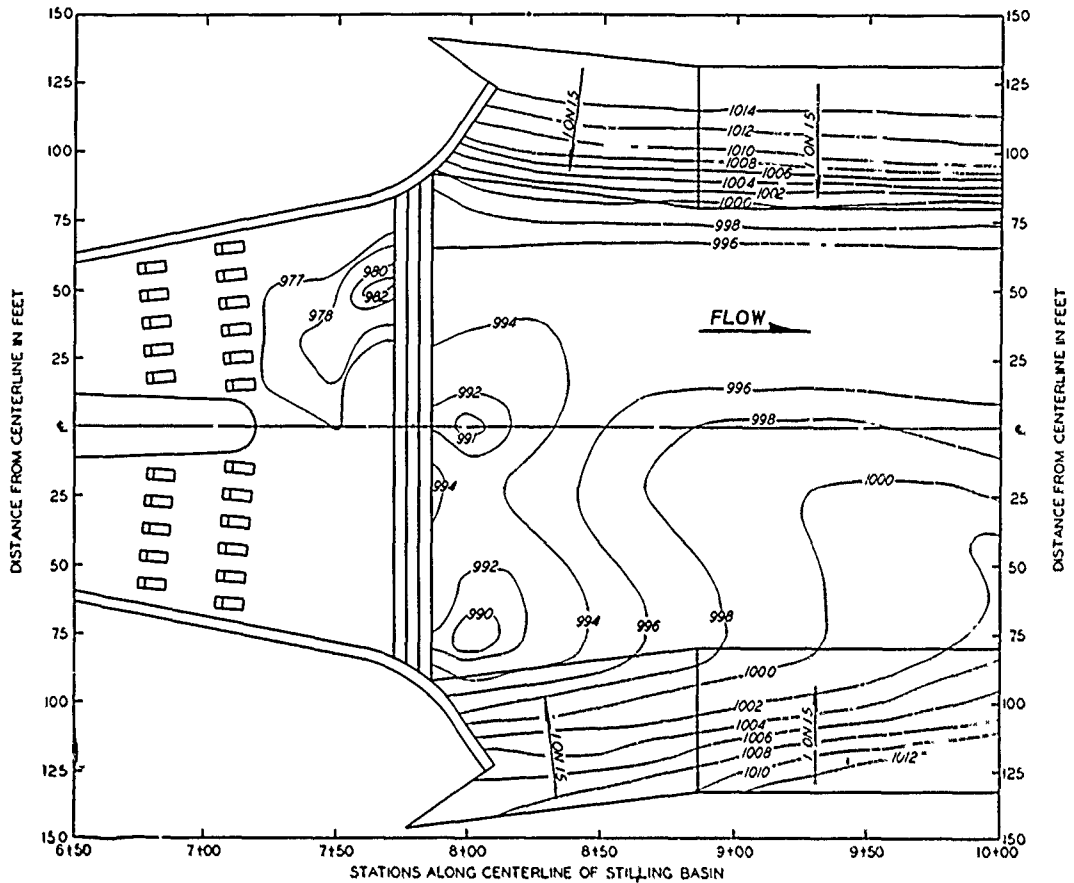
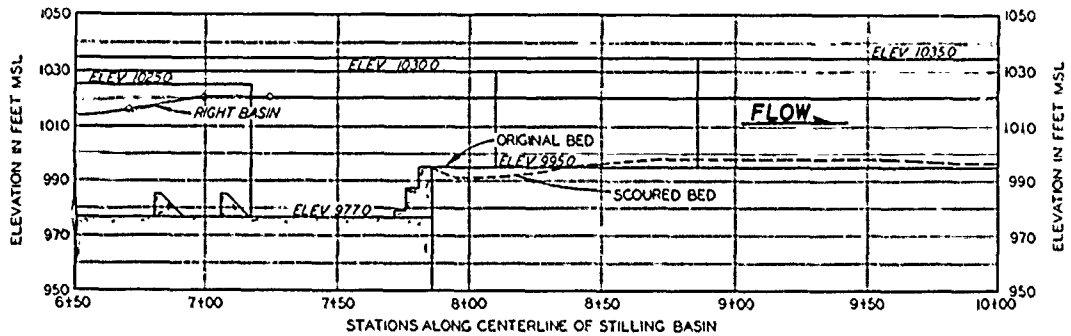
SCOUR PATTERN
 RECOMMENDED DESIGN STILLING BASIN
 RIGHT CONDUIT FLOW

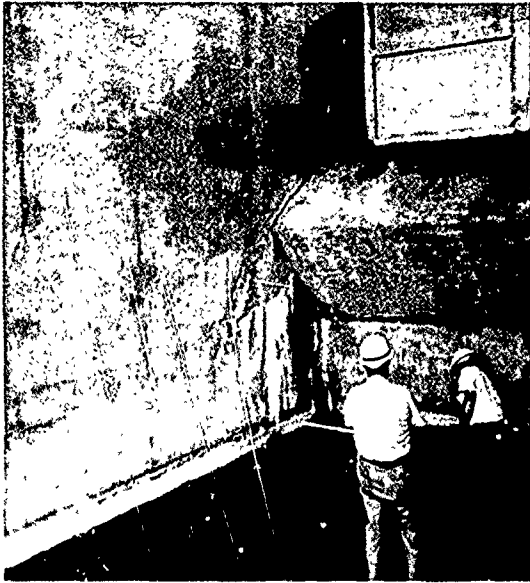
98. After the cofferdams were constructed and the structure was dewatered, representatives of the U. S. Army Engineer District, St. Paul, inspected the structure (St. Paul District 1974) to determine the exact extent of repair required. At the time of the inspection, all bays of the control structure, except bay 12, were dewatered, allowing for a thorough inspection of each bay. Several areas of concrete deterioration (Figure 49) were found in the piers, generally along the waterline in each bay. Several base slabs exhibited severe wear and exposed reinforcement. The most severe erosion was in bay 2 (Figure 50) where there was a hole about 1 ft in diameter and 2 ft deep caused by rocks trapped between the gates and weir. Other examples of the concrete deterioration are shown in Figure 51.

Figure 49. Different views of concrete deterioration along waterline, Lac Qui Parle Dam (from St. Paul District 1974)

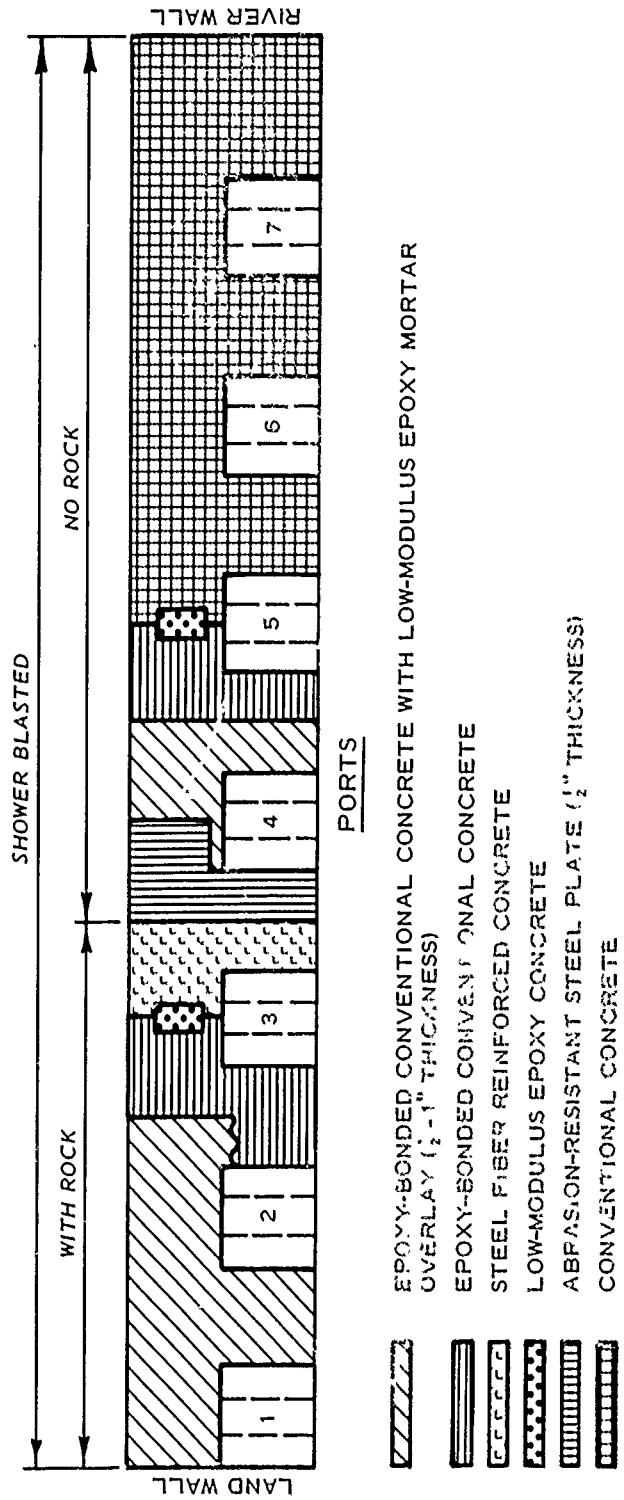
Figure 61. Experimental lateral (bay H), Upper St. Anthony Falls Lock

- a. Epoxy mortar. A low-modulus epoxy mortar, 1/2- to 1-in. thickness, was to be used to overlay two sections of conventional concrete (Figure 61). Concrete to receive the overlay was left approximately 1 in. below grade. The mortar consisted of one part epoxy to three parts silica sand. Conditions during the repair were described as fair to poor with too much standing water to do a good job.

- e. Steel plate. One section of an abrasion-resistant steel plate (1/2-in. thickness) was anchored to conventional concrete. After completion of repairs and prior to filling the lock chamber, rocks that caused the erosion damage were returned to their original positions in the lateral (Figure 61) to provide a positive test of the repairs.

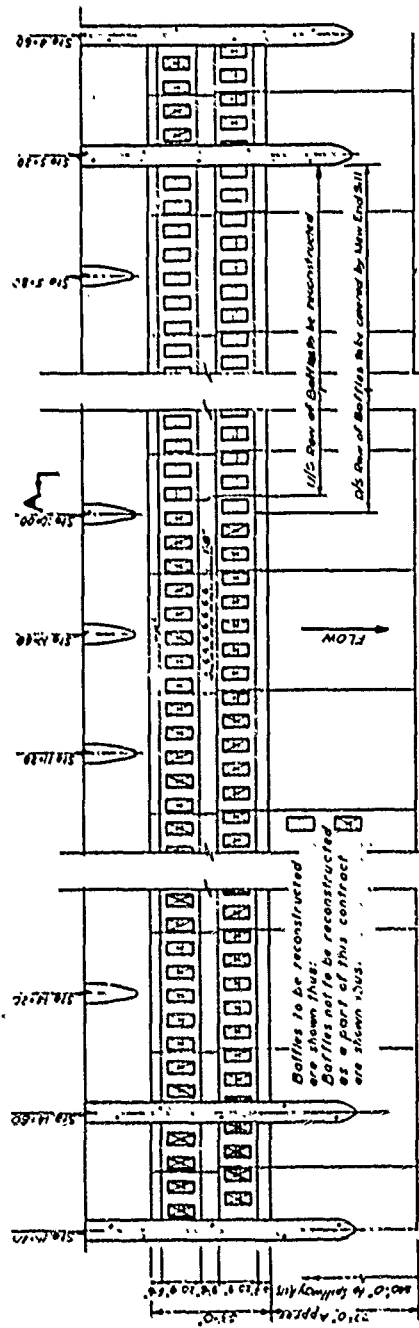
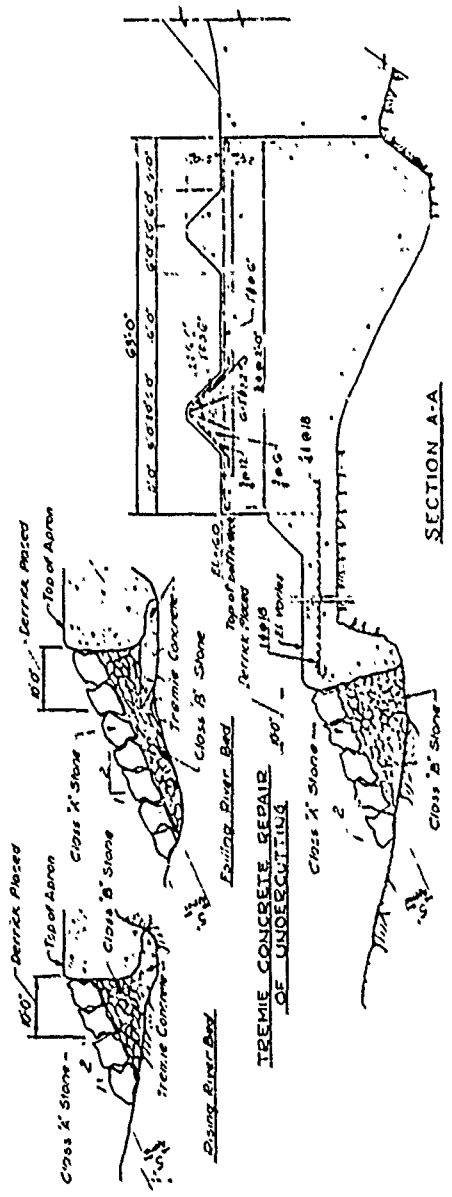
Figure 70. Apron and baffle repair, Bonneville Dam

118. Details of the apron and baffle repairs are shown in Figures 70 and 71. The upstream row of baffles was reconstructed whereas the downstream row was covered by the new end sill. The baffle deck was repaired by anchoring a reinforced concrete slab (12-in. minimum thickness) over the existing deck.

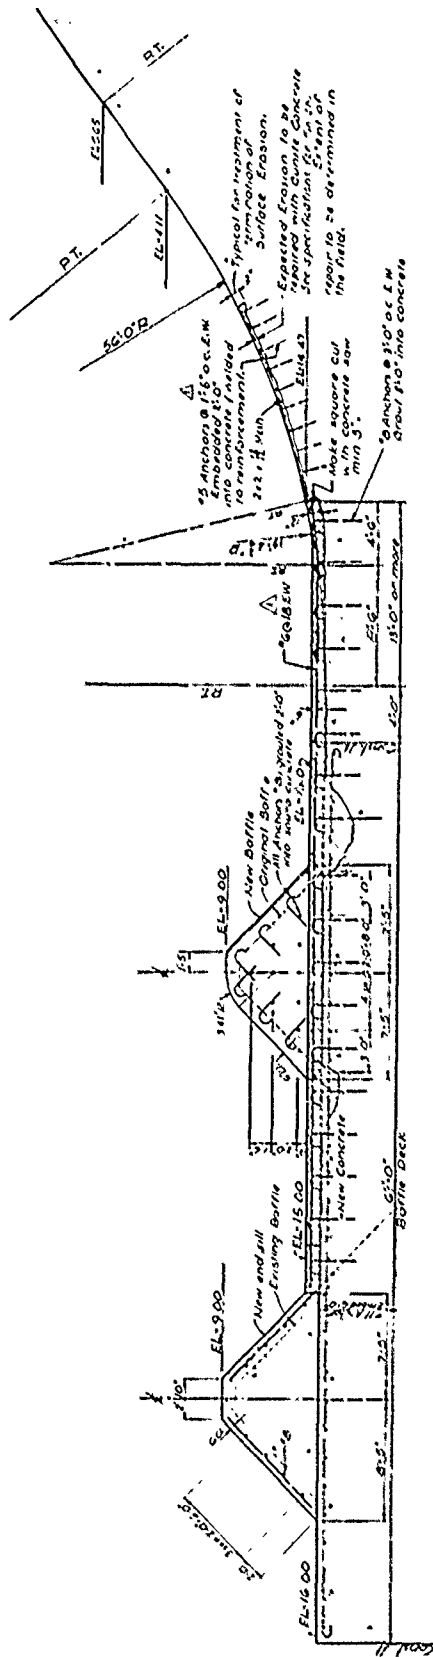
Figure 71. Baffle deck overlay details, Bonneville Dam

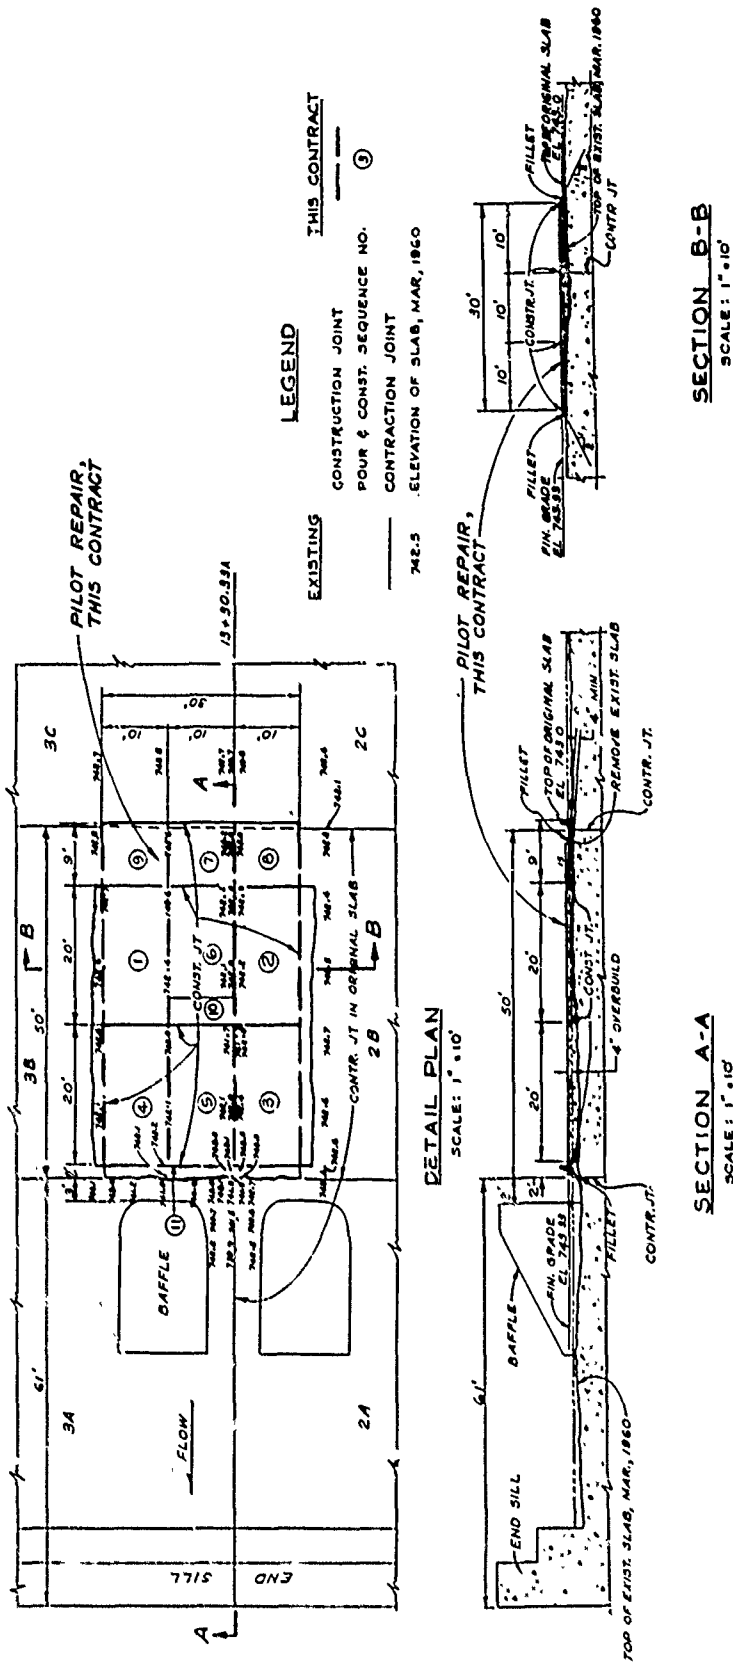
127. An eroded section of concrete 30 by 49 ft in the stilling basin floor (Figure 74) was selected for the pilot repair. The damage in this area was typical of eroded areas with exposed aggregate and an erosion depth ranging from 3 to 16 in. This area in blocks 28 and 38 presented problems typical of many damaged areas, repair of which required a flat concrete overlay slab and a sloped upstream transition slab.

Figure 74. Pilot repair, stilling basin, Chief Joseph (from Seattle District 1961)

129. Repairs were accomplished under water at a depth of about 26 ft and in a current of approximately 0.5 fps. Repair work was done by two divers in hard helmet deep-sea diving gear. The repair site was located by measurements from the stilling basin contraction joints. The sequence for placing the various slabs is shown in Figure 74.

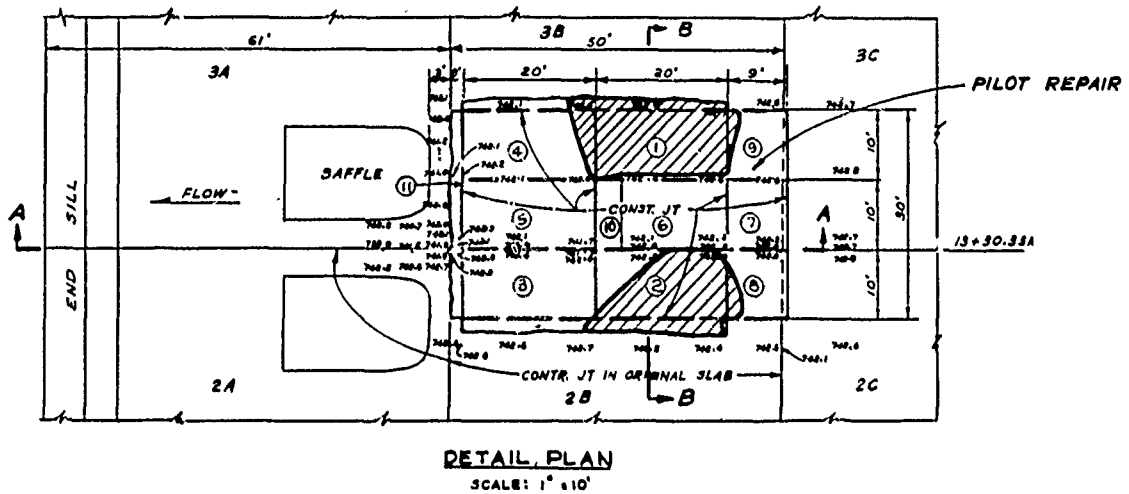
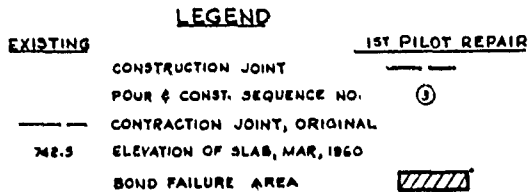
136. Although parts of the slab were found to be damaged (Figure 75), the major portion of the slab was in excellent condition. A large part of sections 1 and 2, which are each 10 by 20 ft, was gone. The original concrete surface was exposed, indicating a bond failure of repair concrete to original concrete. The bond failure is attributable to several factors. Considerable difficulty was encountered when the side forms were removed from sections 1 and 2. An excessive amount of

Figure 75. November 1961 inspection of pilot repair, Chief Joseph Dam (from Seattle District 1962)

grout was intruded into the two sections and flowed over the top and along the outside of the forms. This overflow caused the side forms to be concreted in and necessitated the use of 15-ton capacity railroad jacks to remove them. The force used to lift the side form pieces out of the concrete could have been sufficient to break the bond between the freshly placed repair concrete and the original concrete. In later sections, the divers used extreme care to avoid overtopping the side forms. This precaution permitted forms to be removed with relative ease.

137. A secondary cause of failure may have been the lesser degree of fluidity of grout in the first two sections than in succeeding pours. Flow cone measurements of grout in sections 1 and 2 varied from 21 to 24 seconds while the flow cone measurements of most of the remaining sections varied from 19 to 20 seconds. The greater degree of fluidity in the later sections may have improved the intrusion flow around and

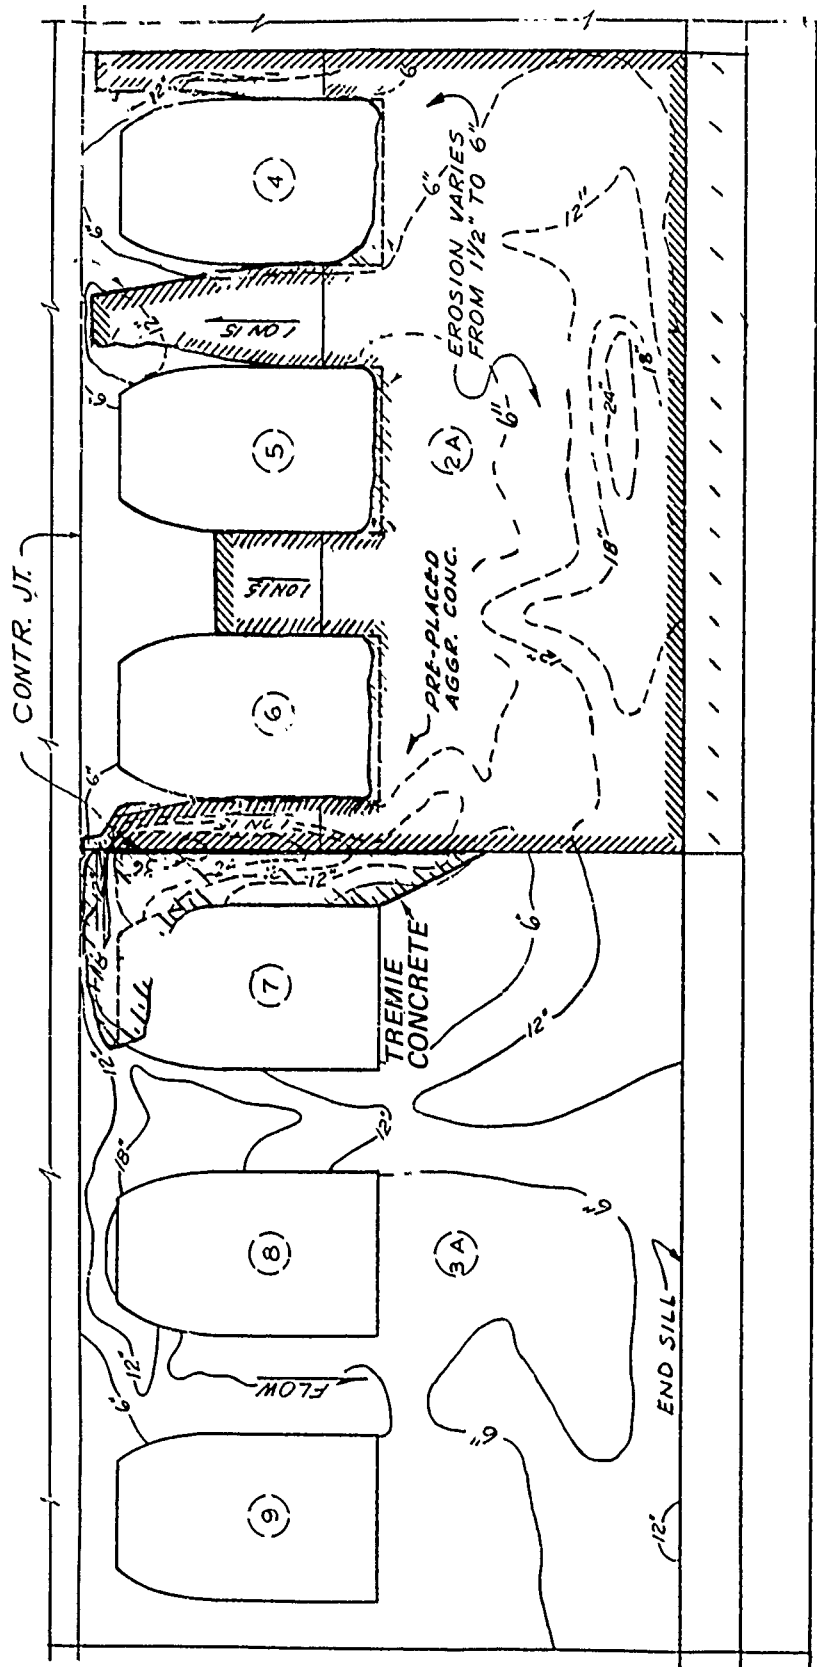
Figure 77. Preplaced aggregate concrete repair of stilling basin erosion, blocks 2A and 3A, Chief Joseph Dam

147. In order to maintain a 4-in. minimum slab thickness of preplaced aggregate concrete at the upstream terminus, an estimated 120 sq ft of concrete had to be removed from block 2A. This was accomplished with a barge-mounted air drill. A diver guided the placing of the point using a metal guide and loaded the broken concrete into a ship. Concrete buckets containing the coarse aggregate were guided into position and dumped by a diver. Screeds placed on the preset edge forms were then used by the divers for leveling the aggregate to the proper grade before placing the top form panels. Grout pipes were driven the full depth of the coarse aggregate.

148. A firm experienced in producing preplaced aggregate concrete was retained to provide equipment and to supervise the grouting operation. The mixer and pumps were set up on the south training wall, and grout was pumped first through grout pipes in the deepest area of the placement until a return showed through the vent pipes surrounding that area. The pipes were plugged with corks when good sanded grout appeared. When grout showed in the next row of vent pipes, the grout hose was moved to an adjacent pipe and the grout hole was plugged. This procedure was continued until the entire form had been pumped. Approximately

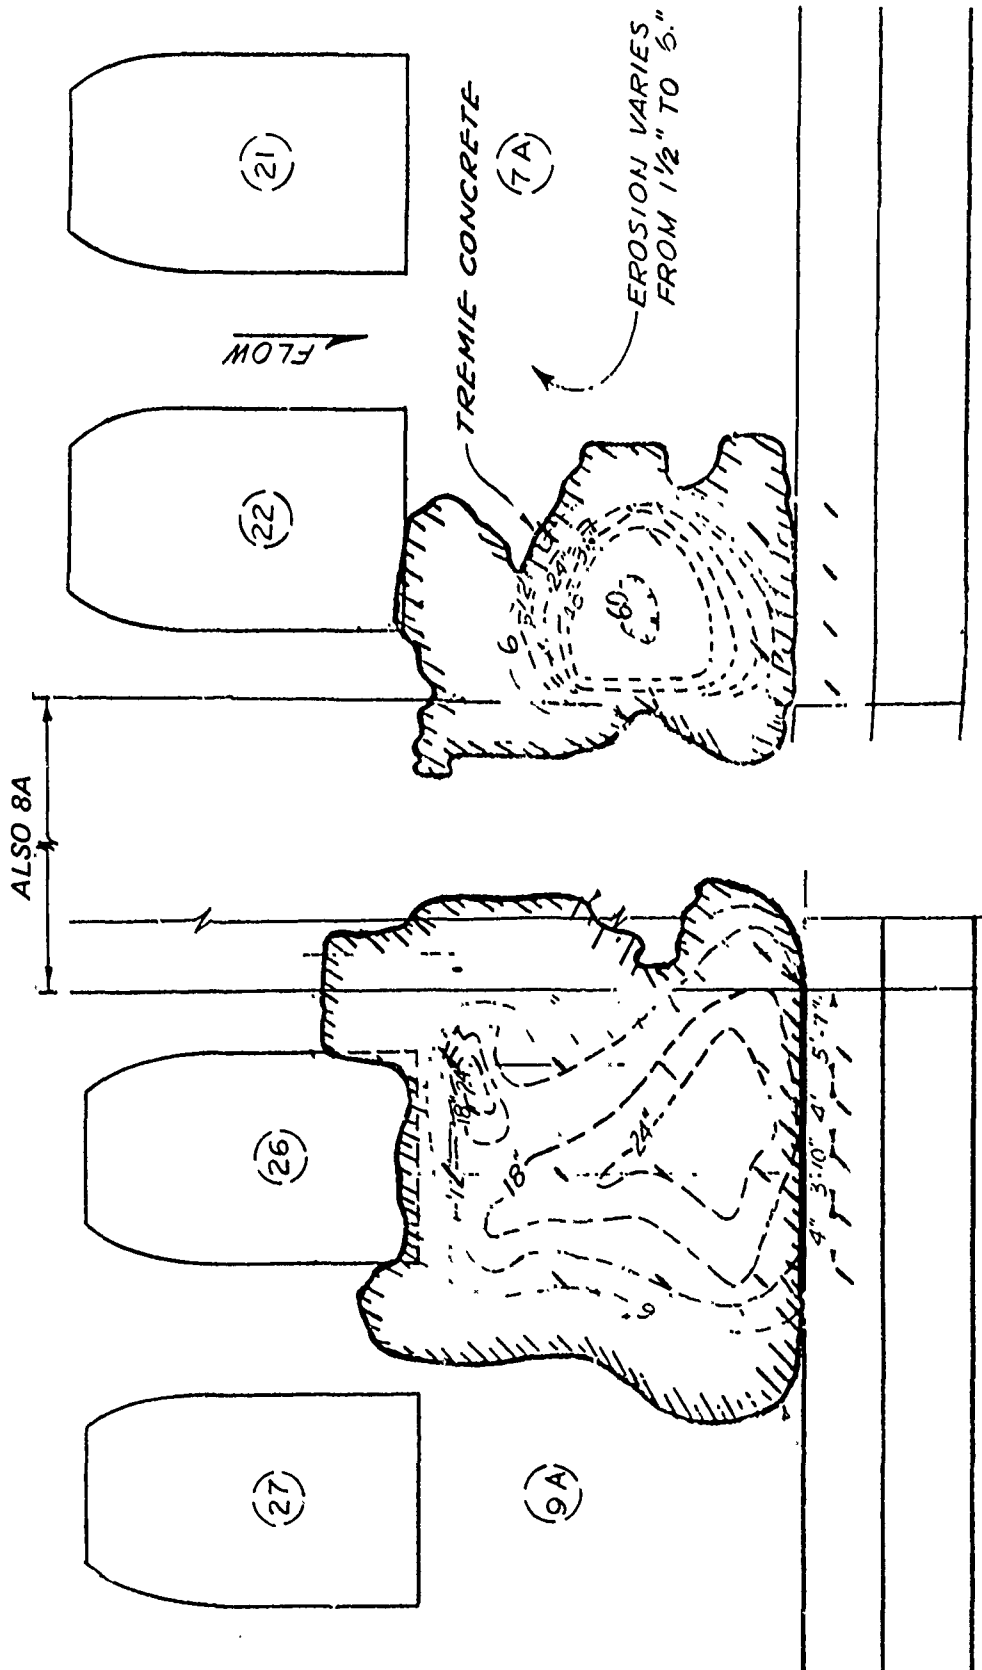
Figure 78. Tremie concrete repair of stilling basin erosion, blocks 7A-9A, Chief Joseph Dam
