MAINTENANCE AND PRESERVATION OF CONCRETE STRUCTURES

REPAIR OF EROSION-DAMAGED STRUCTURES

James E. McDonald

April 1980

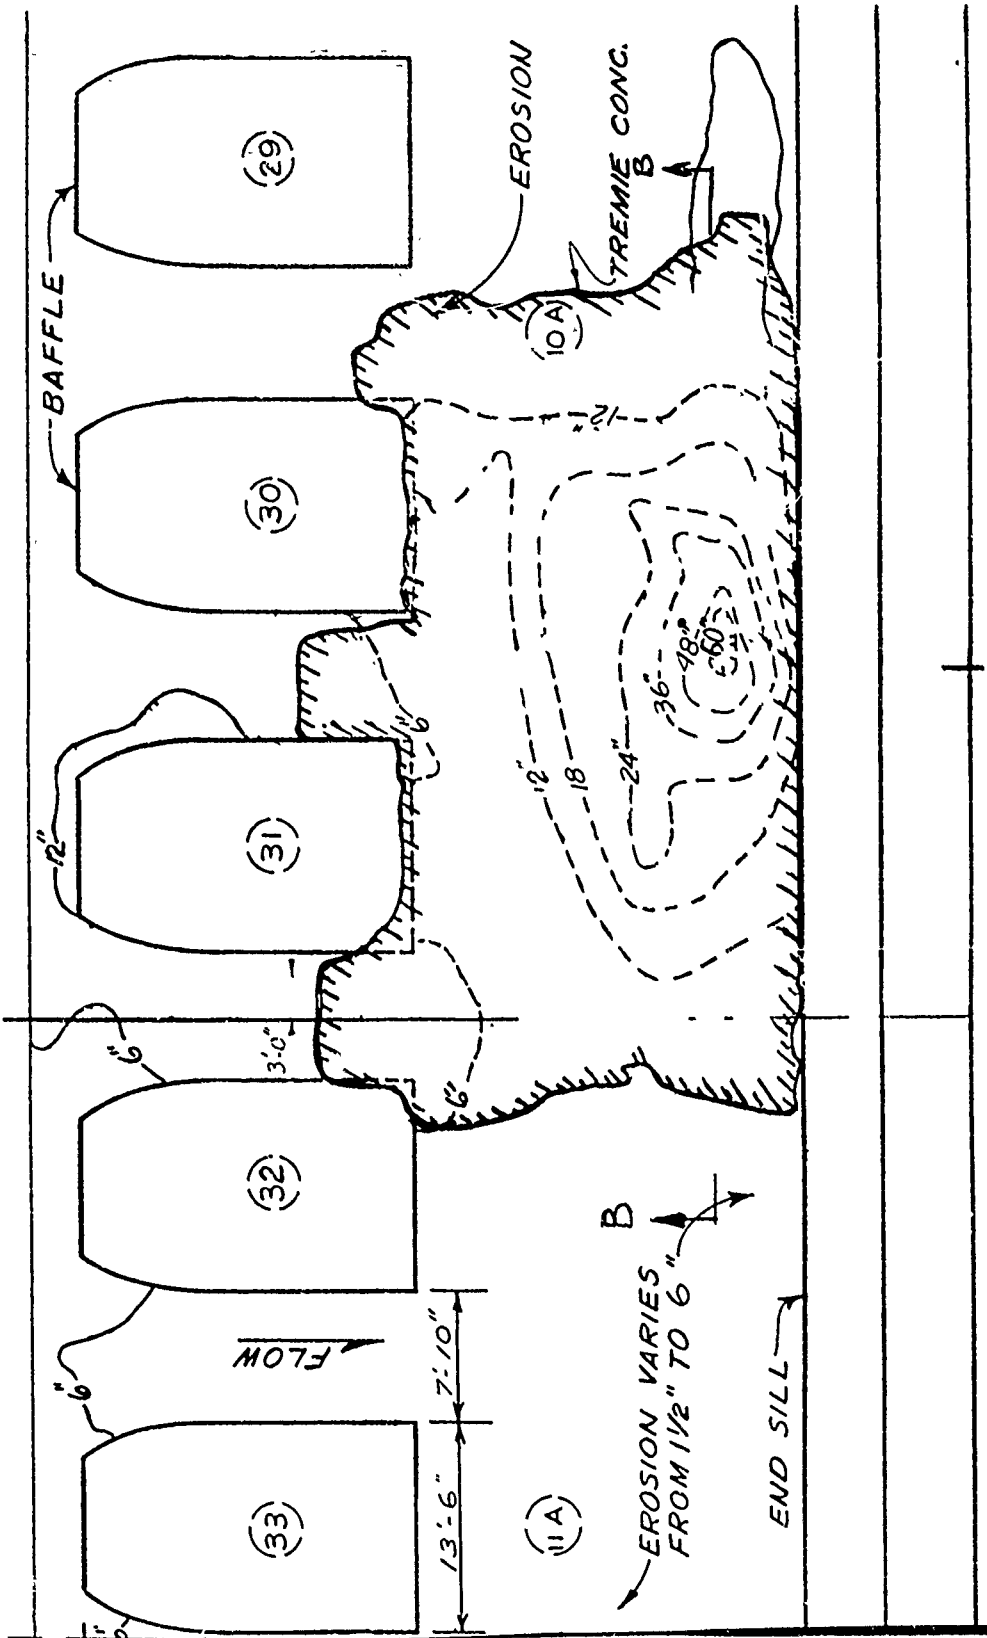
Figure 79. Tremie concrete repair of stilling basin erosion, blocks 10A and 11A, Chief Joseph Dam

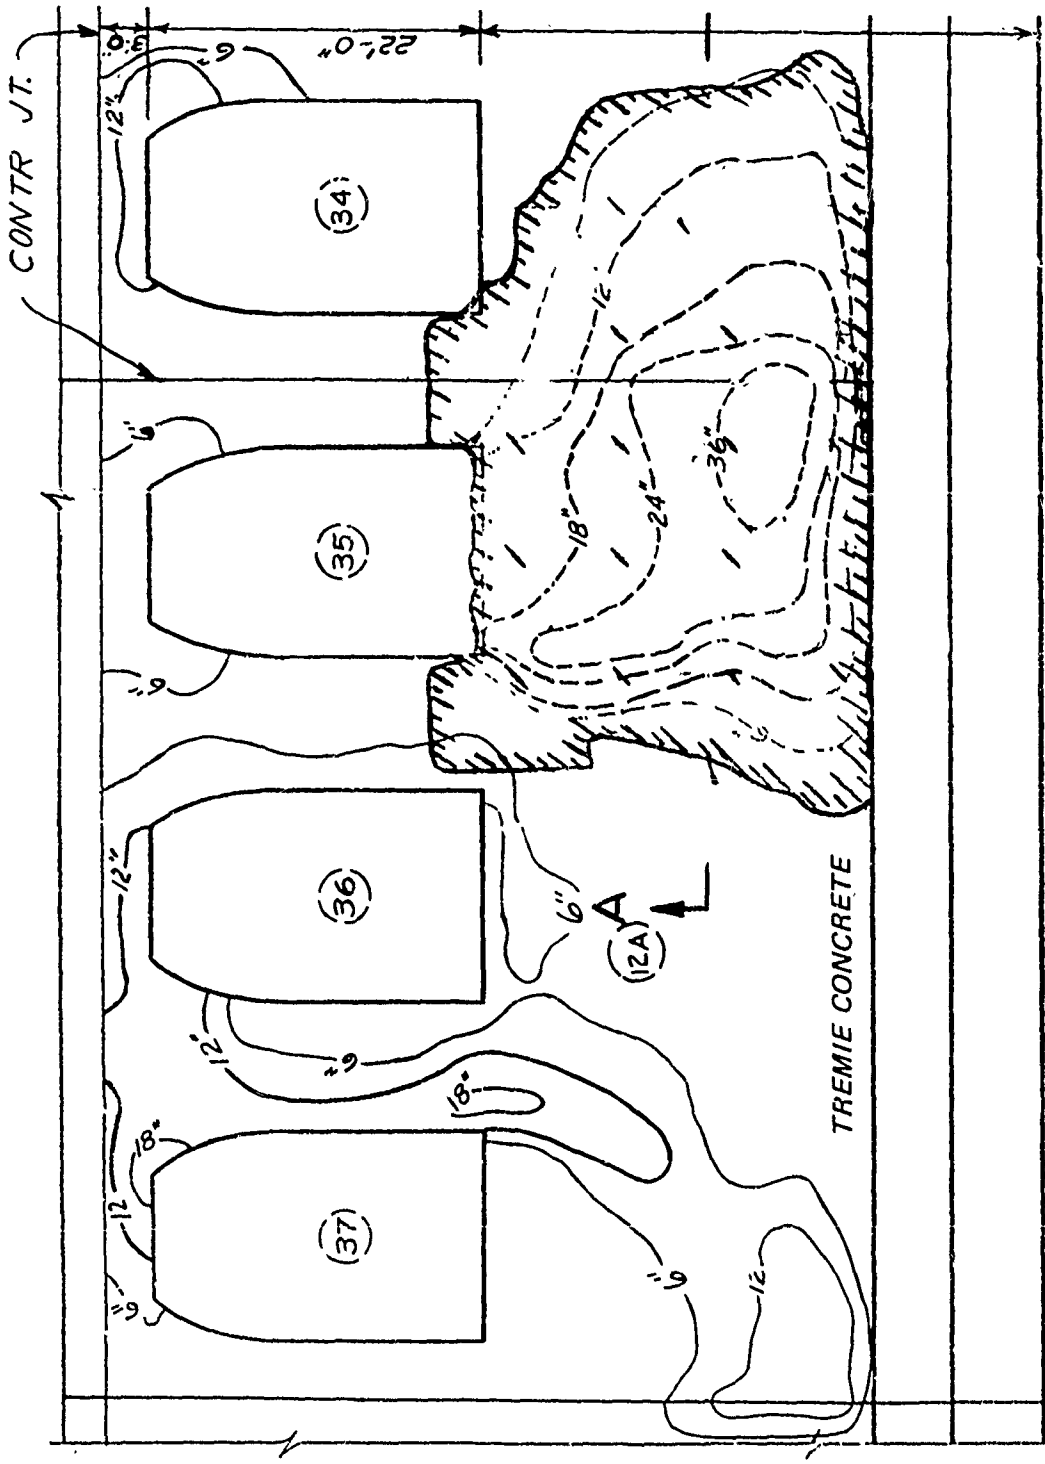
Figure 82. Tremie concrete repair of stilling basin erosion, block 12A, Chief Joseph Dam

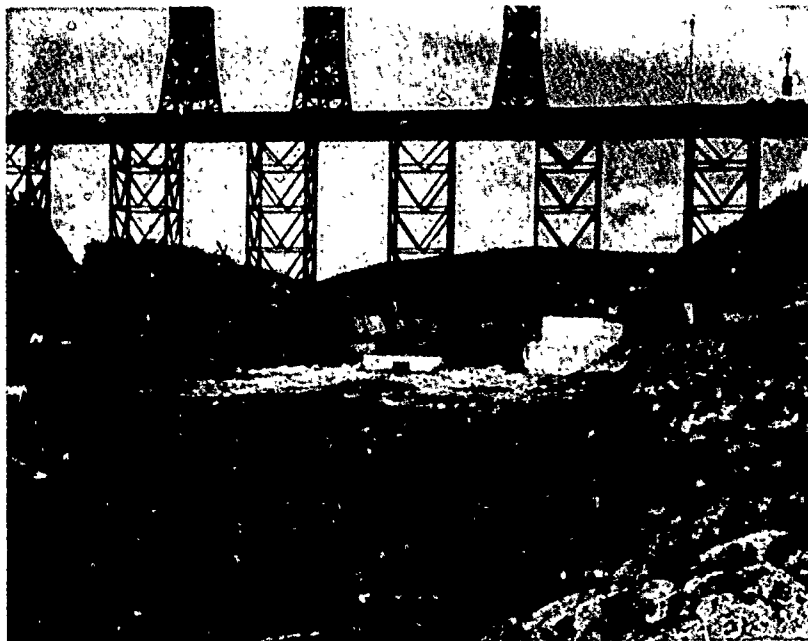
164. Following the 1968 construction season, the river was diverted over low blocks on the left side of the stilling basin (Figures 86 and 87). Prior to the low block diversion, the stilling basin was thoroughly cleaned. Later in the construction sequence diversion over the low blocks was stopped, and the river was diverted through three temporary sluices (Figure 88) also located on the left side of the stilling basin. During these two diversions, strong eddy currents transported approximately 8000 cu yd of sand and silt with a small amount of gravel and boulders into the basin. In the spring of 1972, most of this material was removed by suction dredge. However, about 50 cu yd of large rock and boulders remained near the end sill. Before

Figure 86. Upstream view of diversion flow over low blocks on the left side of the Libby Dam stilling basin, 1969 (from Seattle District 1973)

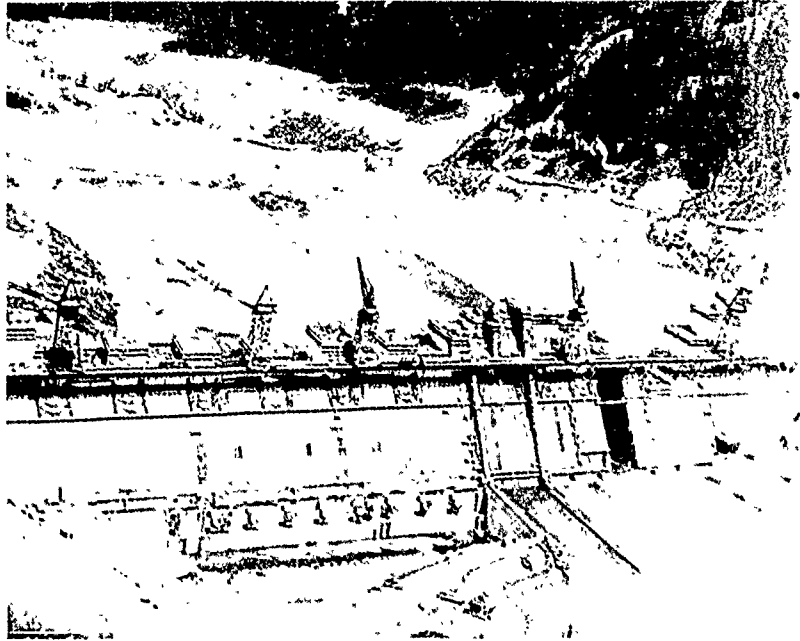
Figure 87. Riverflow through low monolith 33 and temporary sluices, July 1971 (from Seattle District 1973)

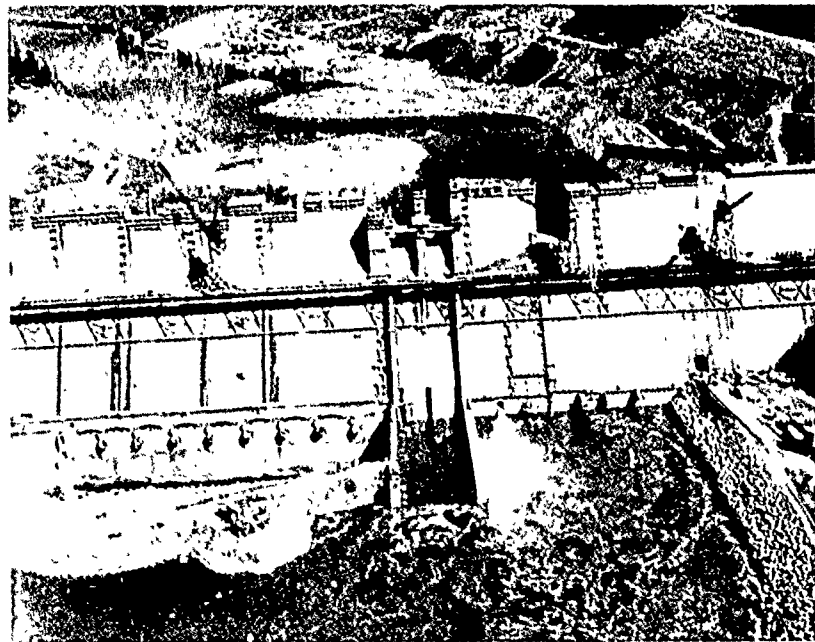
Figure 88. River diversion through temporary sluice in monolith 31, March 1972 (from Seattle District 1973)

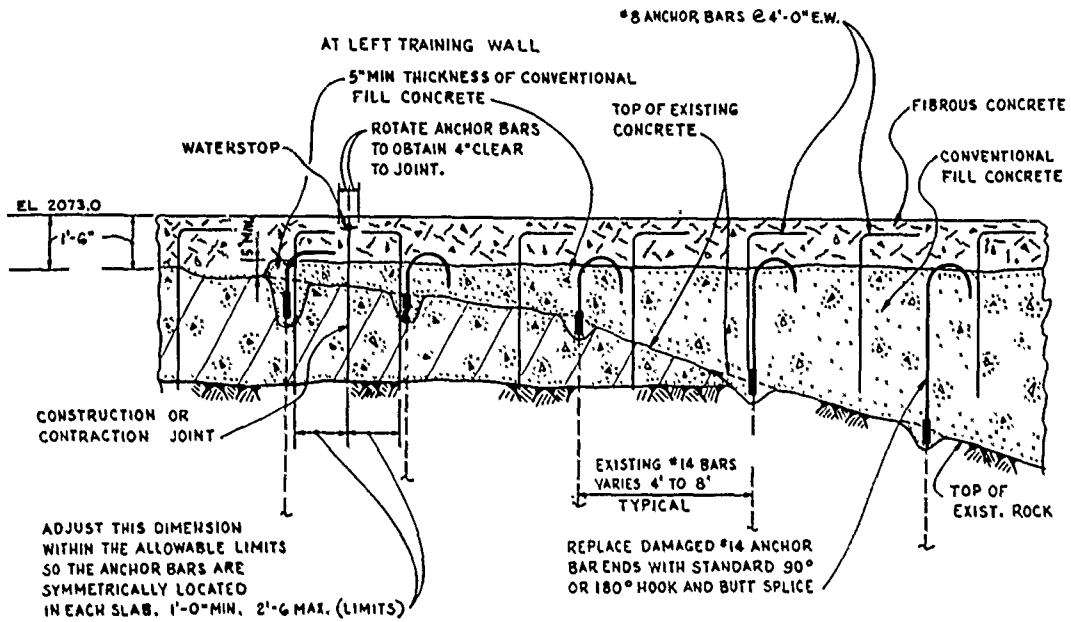
Figure 97. Repair detail, stilling basin slab, Libby Dam

175. Following a thorough cleanup, structural grade unreinforced fill concrete was used as necessary (Figure 97) to bring the stilling basin floor up to el 2071.5 (1 $\frac{1}{2}$ in. below finished grade). This concrete, 1-1/2-in. MSA, was placed by pumping into formed areas coinciding with the original construction joints. A fiber-reinforced concrete topping, 18-in. minimum thickness, was used to bring the basin floor slab up to final grade. A local ready-mix producer furnished the fiber concrete from a 35-cu-yd/hr capacity batch plant (Figure 98) set up on the site. The steel fibers (0.01 by 0.02 by 1.0 in.) were batched through a shaker onto the aggregate conveyor belt simultaneously with the aggregate. Four 8-cu-yd-capacity truck mixers, each with 6 cu yd of concrete, were used for mixing and for transportation to the stilling basin.

The fiber concrete was placed by pump with a 6-in. line. A form-type vibrator was attached to the truck chute during discharge to assist the concrete in sliding down the chute. In addition, a spud vibrator was attached to a 2- by 3-in. auxiliary screen over the pump hopper (Figure 99) to help break up fiber balls before they could get into the pump. Internal vibrators were used to consolidate the concrete and a vibrating screed was used to finish the floor slab. Waterstops were placed along construction joints as shown in Figure 97. Curing was by white pigmented curing compound.

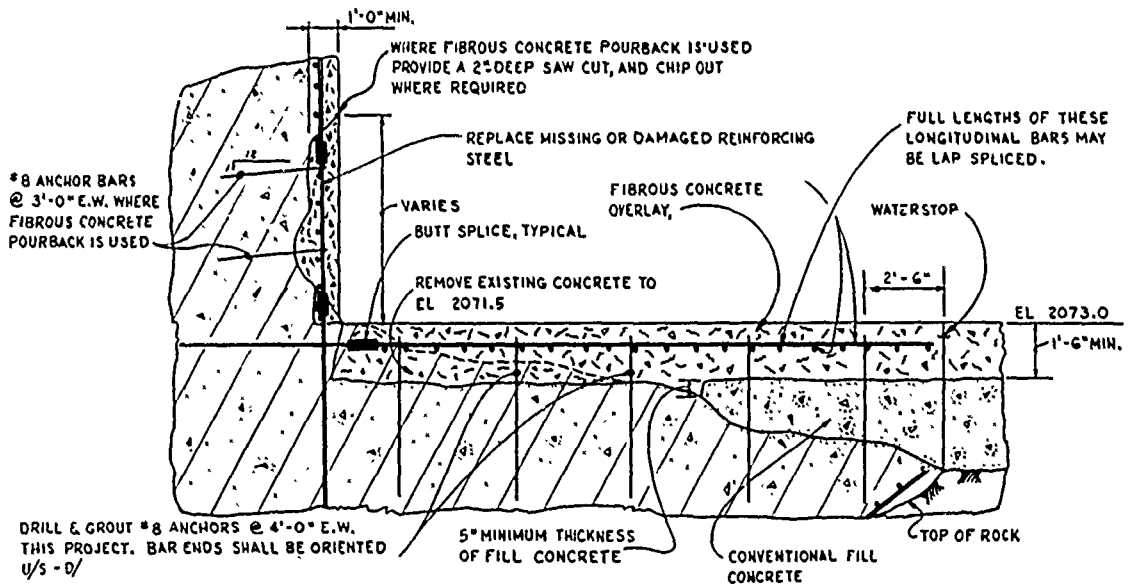
Figure 100. Repair detail at right training wall, Libby Dam

177. Erosion of the stilling basin training walls was such that only one monolith (see Figure 93) required repair. A fiber concrete pourback was used to repair this area (Figure 100). Erosion of the transition slab below the sluices was repaired by removal of concrete to a minimum depth of 12 in. and by placement of fiber concrete. Prior to placement of the concrete, No. 8 anchor bars were placed in holes drilled on 4-ft centers and grouted with a nonshrink grout. Also, a horizontal mat of No. 6 reinforcing bars on 12-in. centers was hooked to the anchor bars (Figure 101). The end sill was repaired using an 18-in. topping of fiber concrete anchored with No. 8 anchor bars to the existing concrete (Figures 102 and 103). On this sloping surface the fiber concrete was placed in 2-ft layers and vibrated internally prior to placement of another layer.

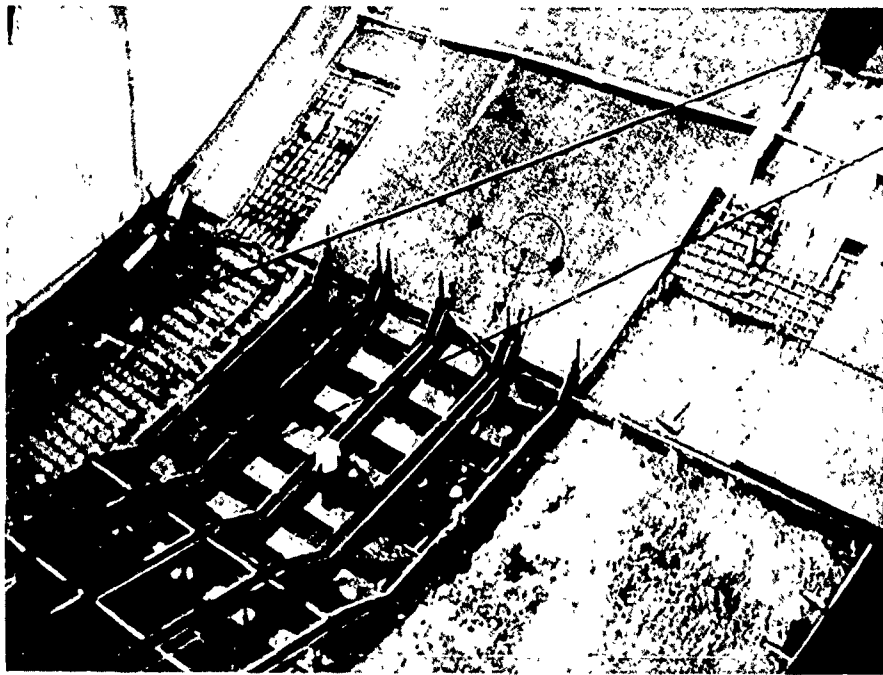
Figure 101. Repair of transition slab below sluices, Libby Dam

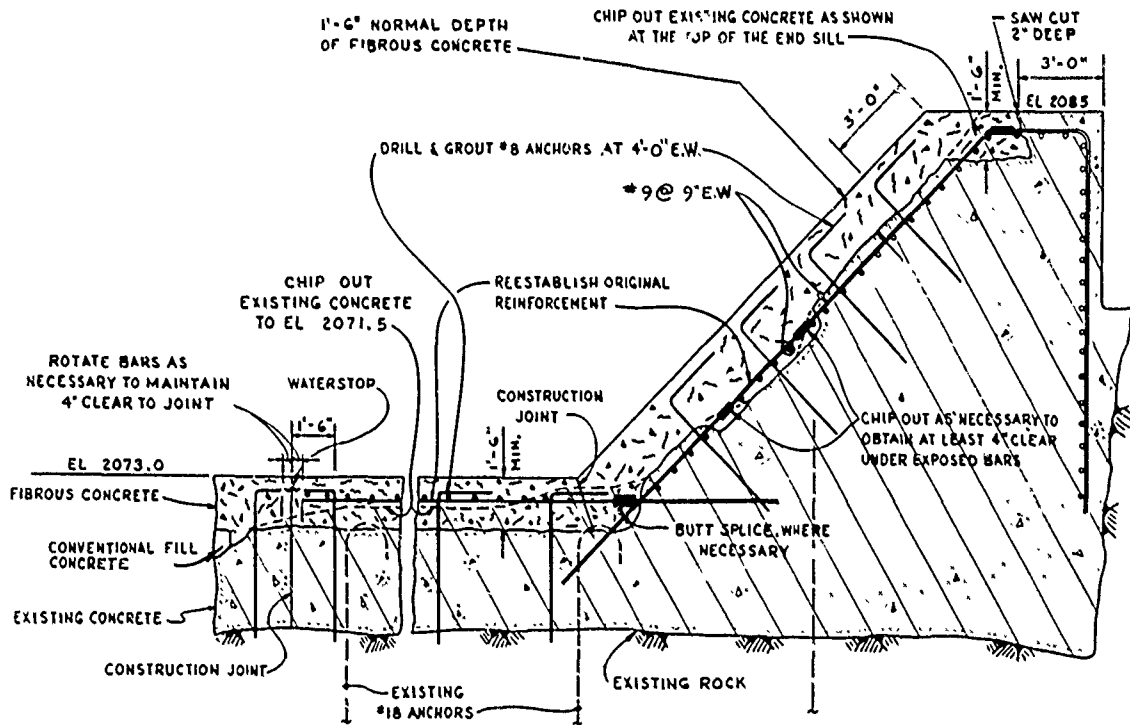
Figure 102. Repair detail at end sill, Libby Dam

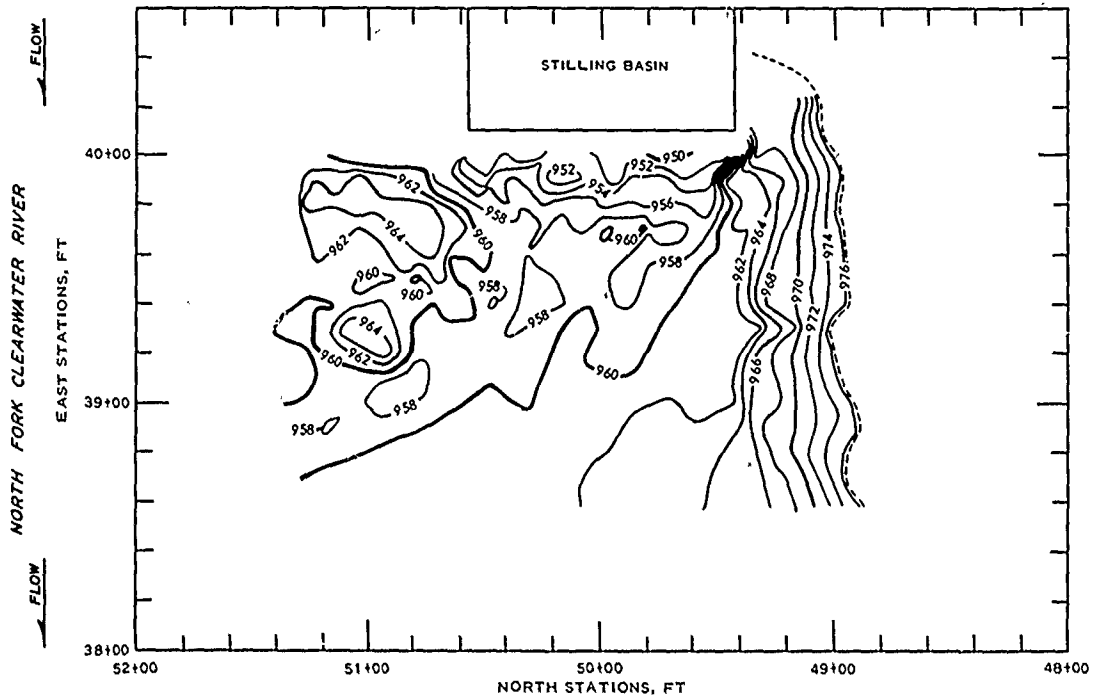
193. The fourth periodic inspection was conducted in June 1975 (Walla Walla District 1975a). At this point, the estimate of damage included erosion of 2000 cu yd of concrete with bedrock exposed in some areas. A topographic survey of the damaged floor was conducted (Figure 107), and soundings were made to determine the condition of the outlet channel downstream of the stilling basin (Figure 108).

Figure 108. Results of soundings downstream of the stilling basin, Dworshak Dam (from Walla Walla District 1975a)

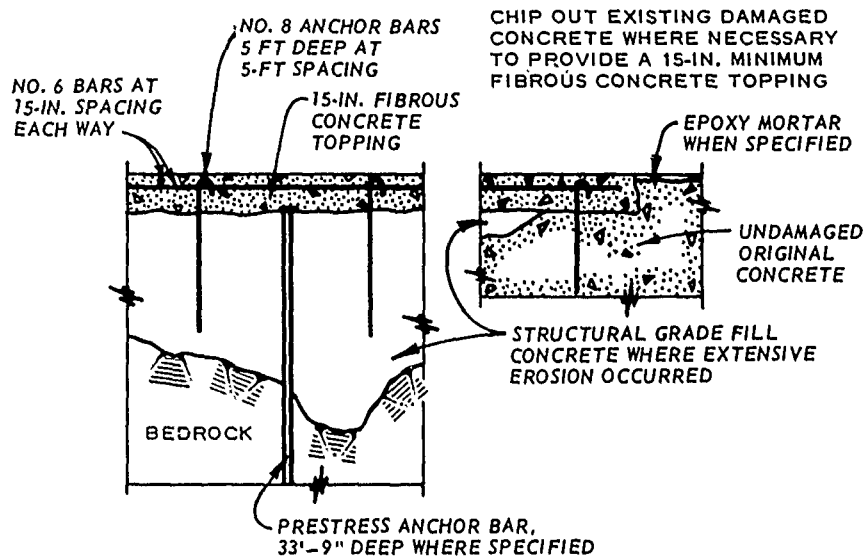
Figure 113. Repair details, Dworshak Dam (from Walla Walla District 1976)

200. Prior to the placement of fiber-reinforced concrete topping, No. 8 anchor bars were placed in rotary percussion holes on 5-ft centers and grouted with a nonshrink cement grout. A horizontal mat of No. 6 reinforcing bars on 15-in. centers was hooked to the anchor bars (Figure 113). The fiber concrete mixture proportions were as follows:

207. In areas where erosion of the original concrete had not progressed to the 15-in. minimum depth specified for the fibrous concrete topping, the design called for excavation of the remaining concrete to this depth (see Figure 113). However, one section of the stilling basin

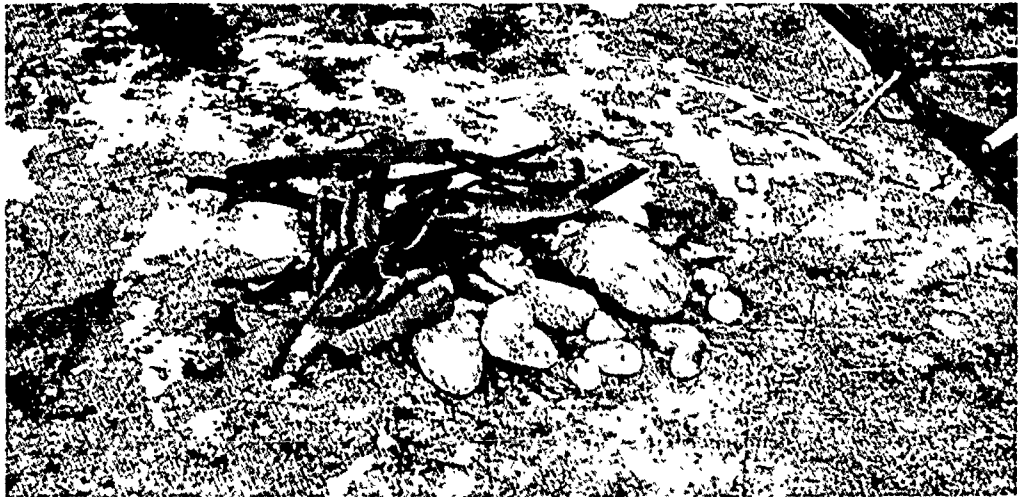
Figure 118. Typical debris removed from stilling basin during Nov 1976 cleaning, Dworshak Dam (from Walla Walla District 1977)

218. After some additional usage of the stilling basin, a diver was employed in November 1976 to clean the debris from the basin and provide more detailed information on the condition of the floor. Results of the diver inspection are shown in Figure 117. Photographs of the debris are shown in Figure 118. Significant comments resulting from the stilling basin inspection are as follows:

b. Metallic debris and cobbles

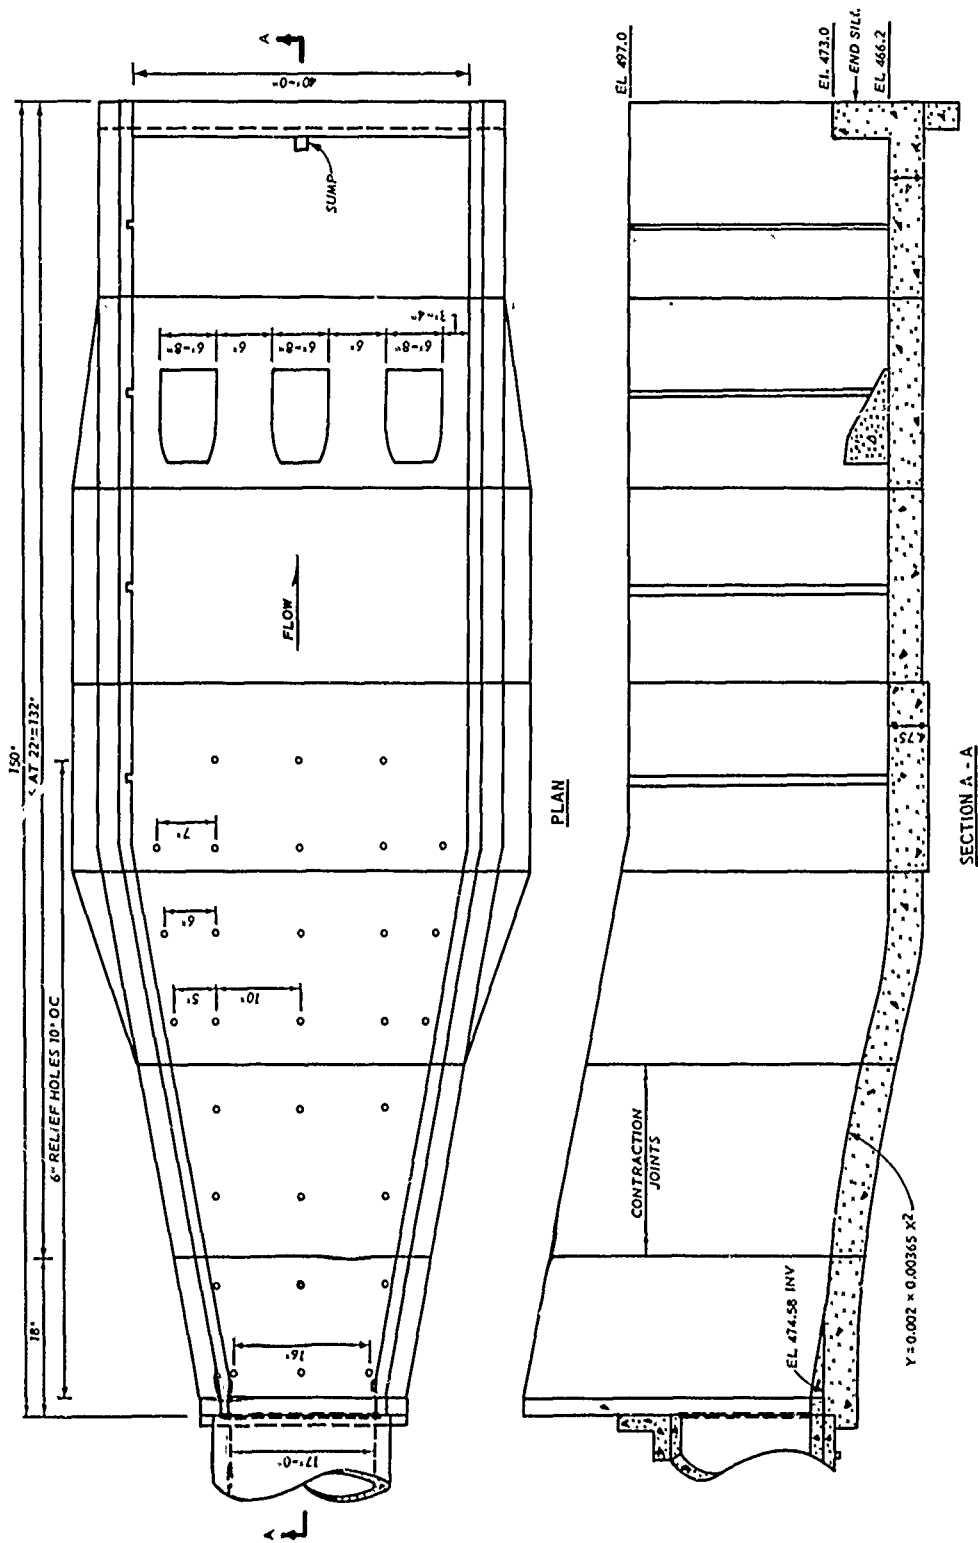
Figure 122. Stilling basin plan and section, Barren River Dam

223. Movement of rocks within the basin eroded approximately 80 percent of the basin floor to an average depth of 6-8 in. with a maximum depth of 10 in. The stilling basin was dewatered for repair by constructing a rock-fill cofferdam downstream in the outlet channel and by using a suction pump to remove the water. A bypass conduit was used to handle gate leakage. Water pressure under the basin floor was relieved with temporary pipes.

224. Edges of the eroded area were sawcut and the concrete was chipped to a minimum of 9 in. below finished grade. Existing reinforcement exposed was removed and the surface was cleaned by waterblasting. Dowels and reinforcing each way were added and an epoxy bonding agent was applied prior to the placement of conventional concrete (5000 psi). In an attempt to prevent future damage, the bottom of the retreat channel was paved and the riprap slopes were slush-grouted for 126 ft downstream of the stilling basin. Cost of the repair, completed in the fall of 1976, was \$104,000. The first inspection of the repair is scheduled for the summer of 1979.

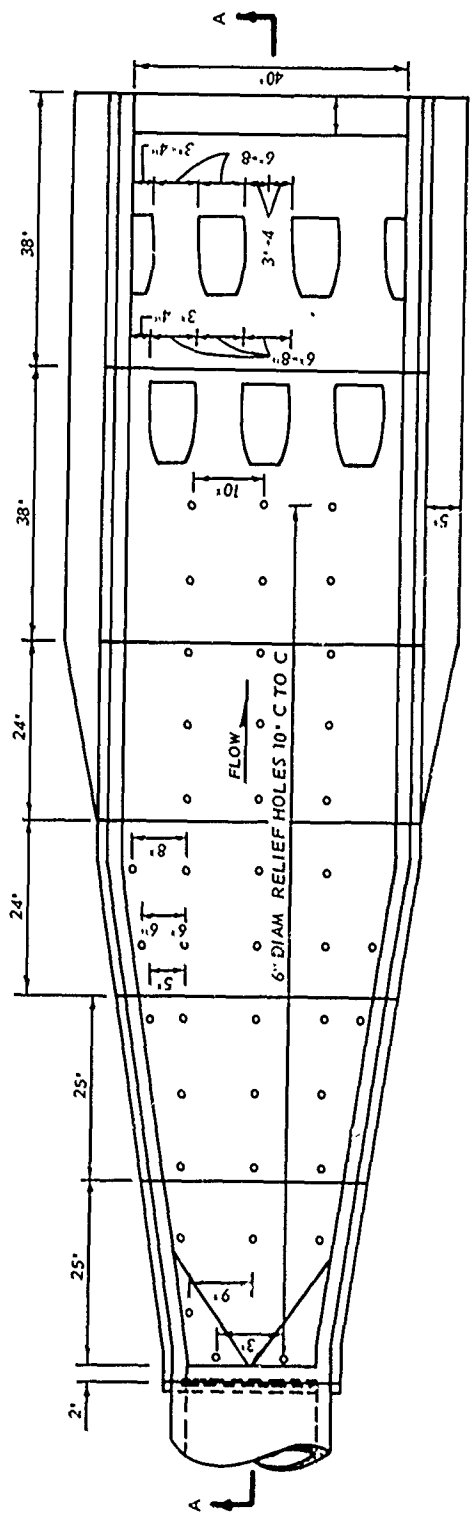
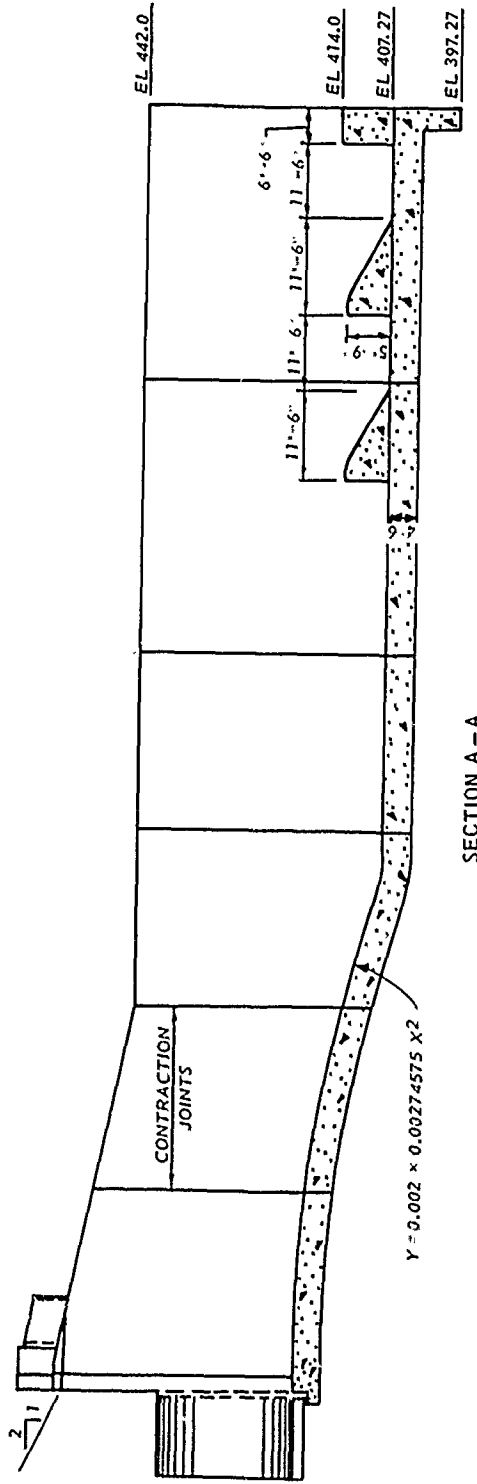
Figure 123. Stilling basin plan and section, Nolin Dam

226. During the September 1974 periodic inspection, a diver partially inspected the stilling basin and found rock, debris, and exposed reinforcement. The conduit and stilling basin were then dewatered and inspected in October 1974 to verify and determine the extent of damage. Erosion had occurred in the lower portion of the parabolic

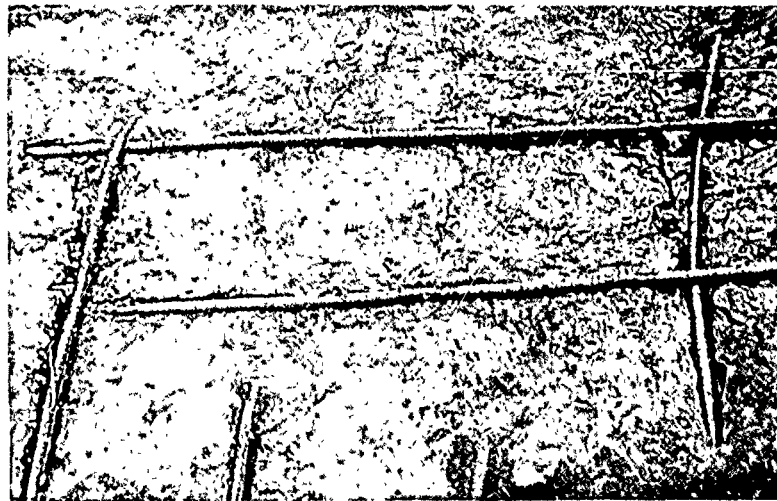
Figure 125. Typical erosion of parabolic section, Nolin Dam

227. The top layer of reinforcing steel was exposed on the lower portion of the parabolic section (Figure 125) and on the lower downstream portion of the baffles (Figure 124). The top reinforcement steel was missing in the middle portion of the stilling basin floor between the parabolic section and the baffles and also at the holes in the downstream corners of the stilling basin. Elsewhere, the stilling basin floor top reinforcement steel was in place, but exposed. At the end sill, the top reinforcement steel was either exposed or missing. Several feet of wall reinforcement steel were also exposed adjacent to the holes in the downstream corners of the stilling basin. After the inspection, Operations personnel removed the rocks and loose reinforcement (Figure 126) and returned the stilling basin to service until repair work could be scheduled.

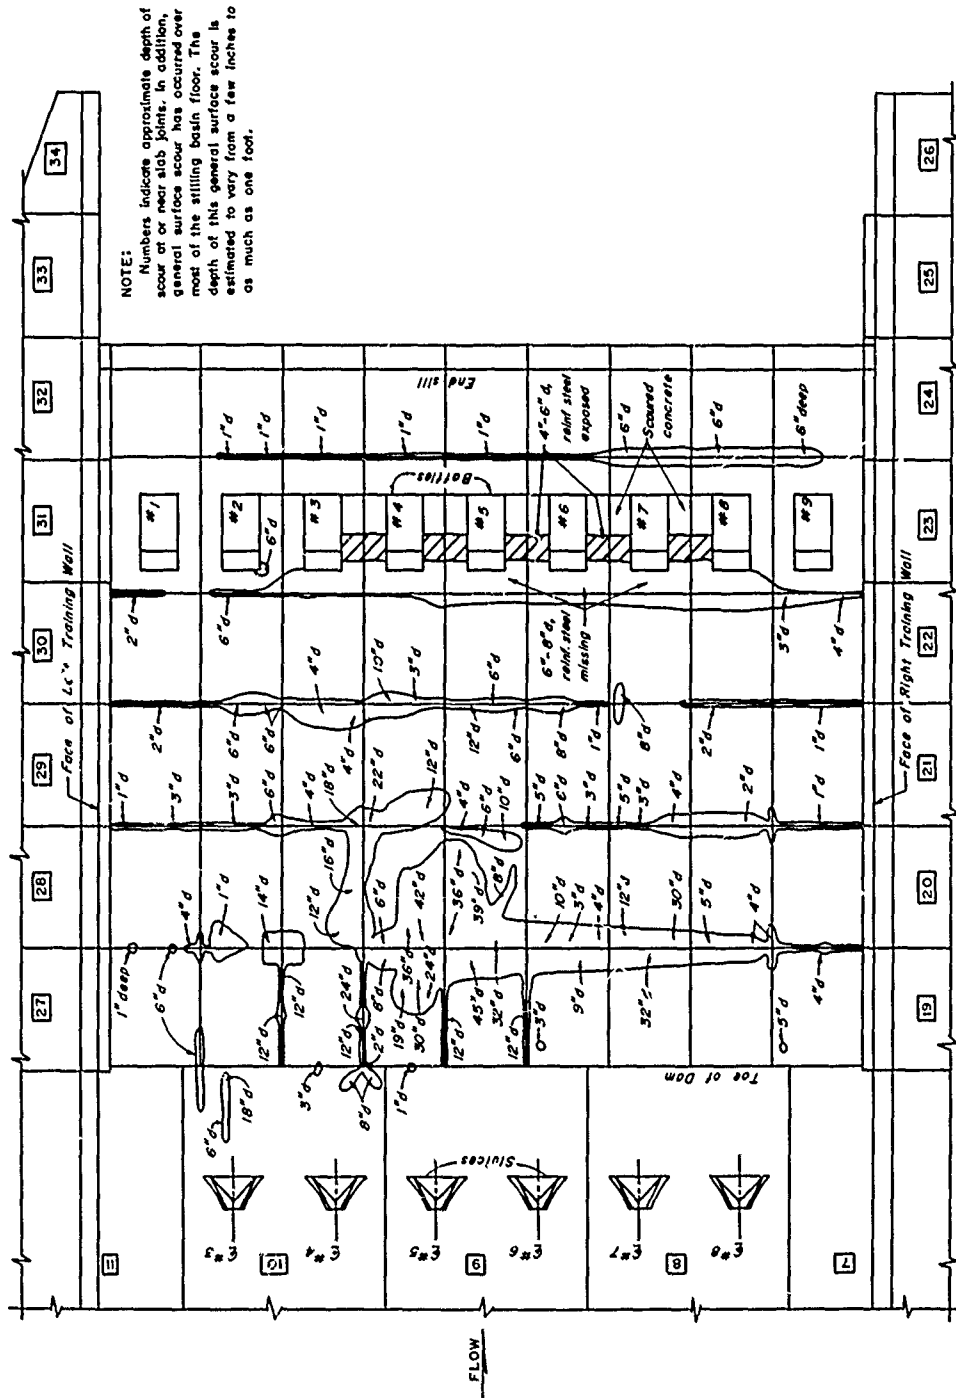
Figure 138. Erosion of stilling basin concrete, Kinzua Dam

253. Damage to the stilling basin floor was most noticeable in the area downstream of sluices 4 and 5 (Figure 138). The two rows of slabs adjacent to the left training wall had generally minor surface erosion with a maximum depth of approximately 6 in. A large, donut-shaped hole (Figure 139) extended over four slabs downstream of sluices 4 and 5 and had a maximum depth of about 42 in. Erosion was generally deeper at the joints. Damage to the baffles was generally confined to the baffles in the middle of the basin (3-7) with baffles 1, 2, 7, and 8 relatively undamaged. Reinforcing was exposed over approximately two thirds of the upstream face and partially around the corners of the baffles in the worst cases (Figure 140). All faces of the baffles had eroded to varying degrees. The toe of the spillway section was eroded to a maximum depth of 4 in. from the floor of the stilling basin up to approximately el 1192.5.

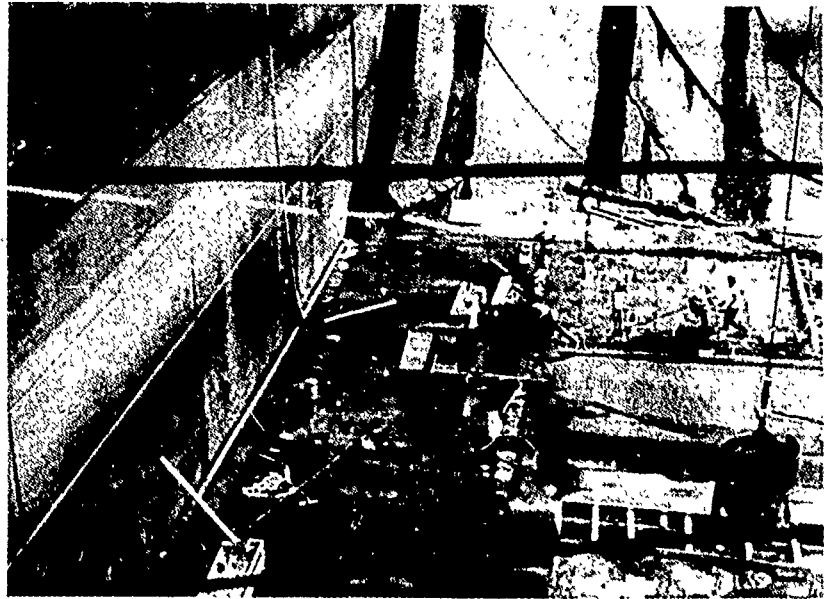
Figure 146. General view of repair operations,
Kinzua Dam

257. A high modulus epoxy bonding compound was placed on the stilling basin floor immediately prior to placement of the fibrous concrete overlay. The overlay was placed in slab sections (Figure 145) conforming to the original slabs. Slab placement was in alternate sections starting at the upstream end of the row adjacent to the left training wall (Figure 146) and proceeding in adjoining rows to the center of the stilling basin. Relief drains were extended through the overlay (Figure 144). Approximately 1400 cu yd of fiber concrete was required for the overlay, which was placed to el 1180.0, 1 ft higher than the original stilling basin floor from the toe of the dam to a point just short of the downstream end of the baffle piers.

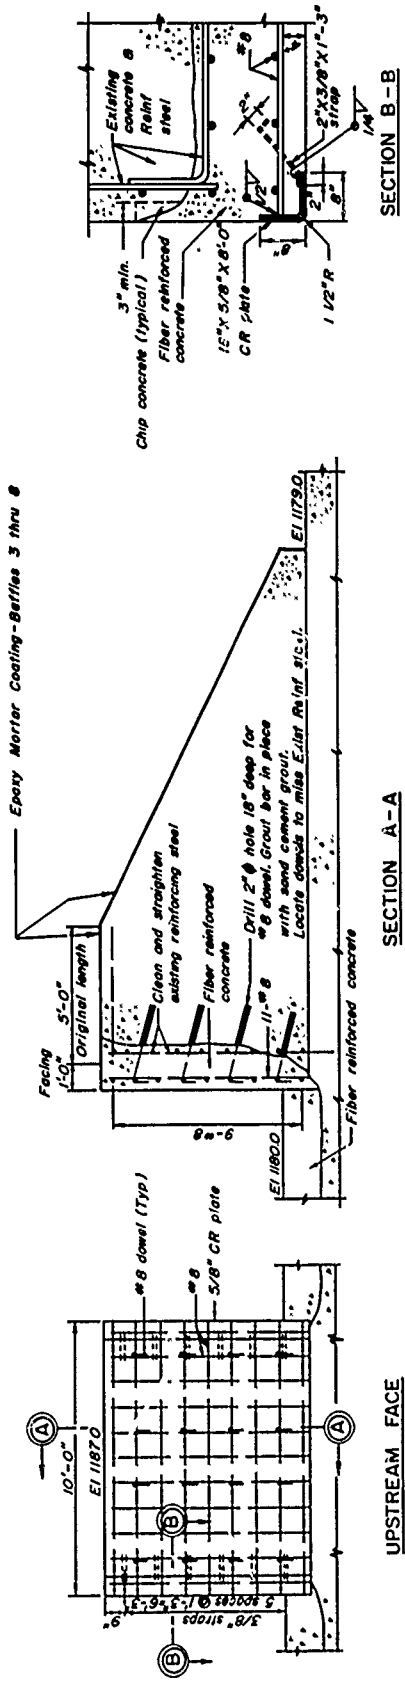
Figure 147. Baffle repair details, Kinzua Dam

258. The baffles were prepared for repair (Figures 147 and 148) in the same manner as the stilling basin slab. Dowels were installed and an epoxy bonding compound applied. The front of the baffles was resurfaced with fibrous concrete and reinforced with No. 8 steel bars. In addition, corner pieces of corrosion-resistant steel plate, 5/8 in. thick, were installed at the upstream corners of the baffles. Both sides, the top, and the back of damaged baffles were coated with an epoxy mortar. This same mortar, a 1 to 1 ratio of epoxy and silica sand, was used to coat the damaged spillway surface to a 1/2-in. average thickness.

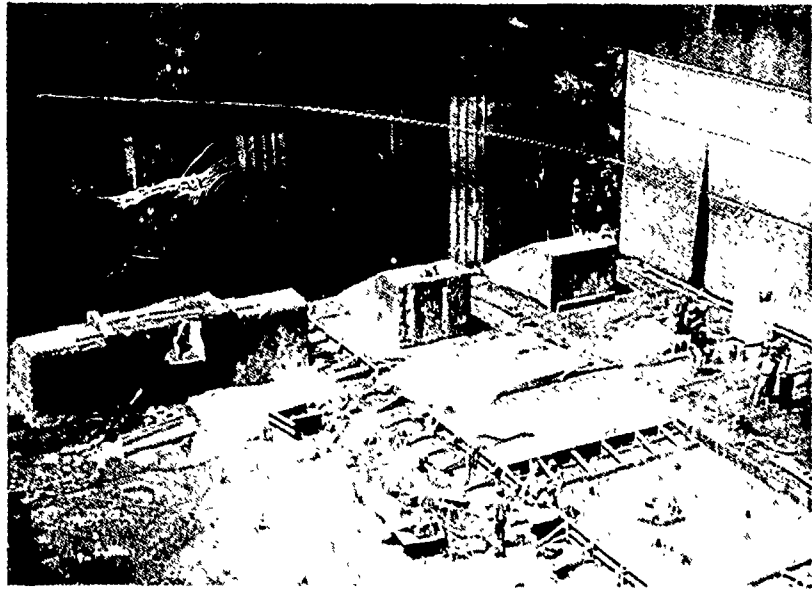
Figure 148. Baffle and basin slab repair,
Kinzua Dam

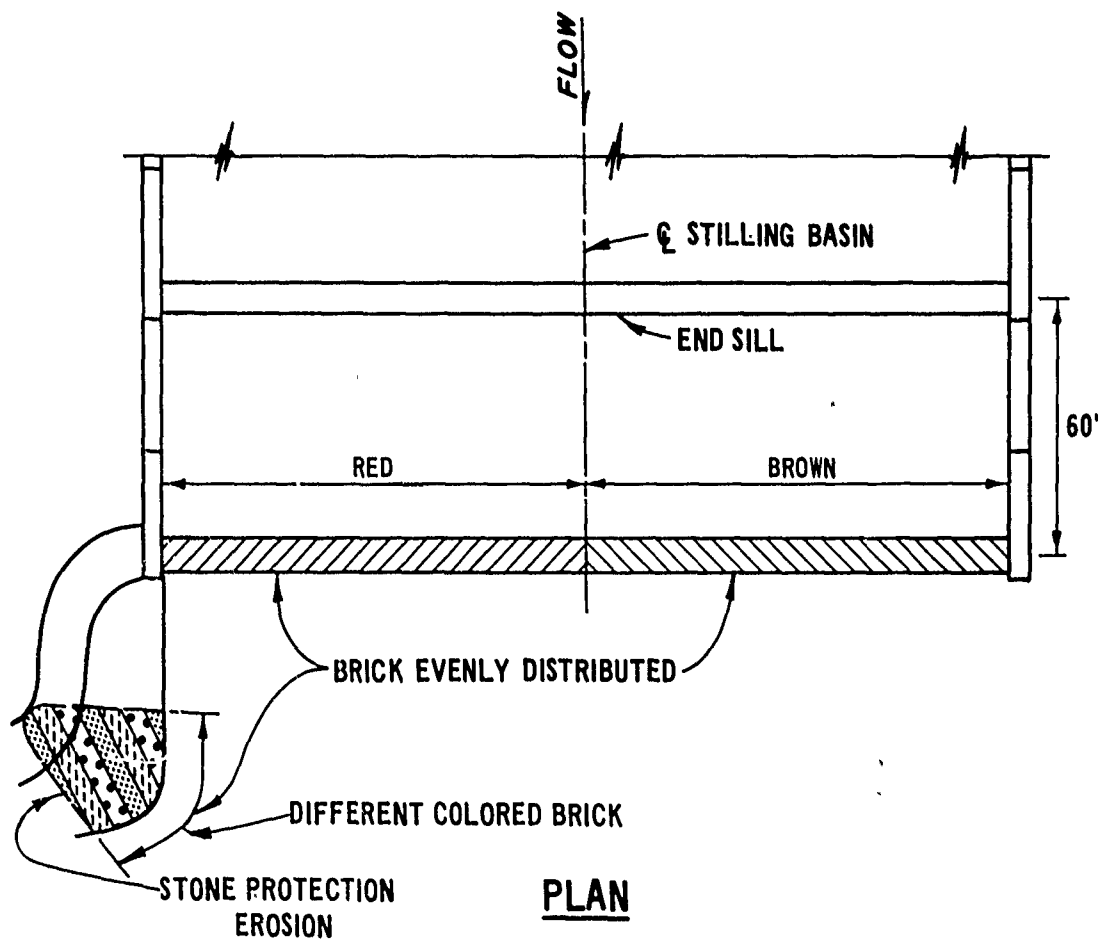
261. The initial diver inspection of the repair in November 1974 indicated minor concrete deterioration on some of the baffles and in the surrounding floor area. Two large areas of epoxy repairs at the base of the spillway were missing. An estimated 45 cu yd of debris was removed from the basin. At that time the District conducted an experiment to determine whether currents and eddies carried material back from the channel downstream of the stilling basin and over the end sill into the stilling basin. Approximately 5500 bricks of three different types were dropped from a boat into the river and were distributed downstream of the basin (Figure 149). Six days after the placement of the bricks, the

stilling basin was inspected by two Pittsburgh District scuba divers who found innumerable smooth pieces of all three types of brick in various sizes.

Figure 149. Experiment to determine source of stilling basin debris, Kinzua Dam

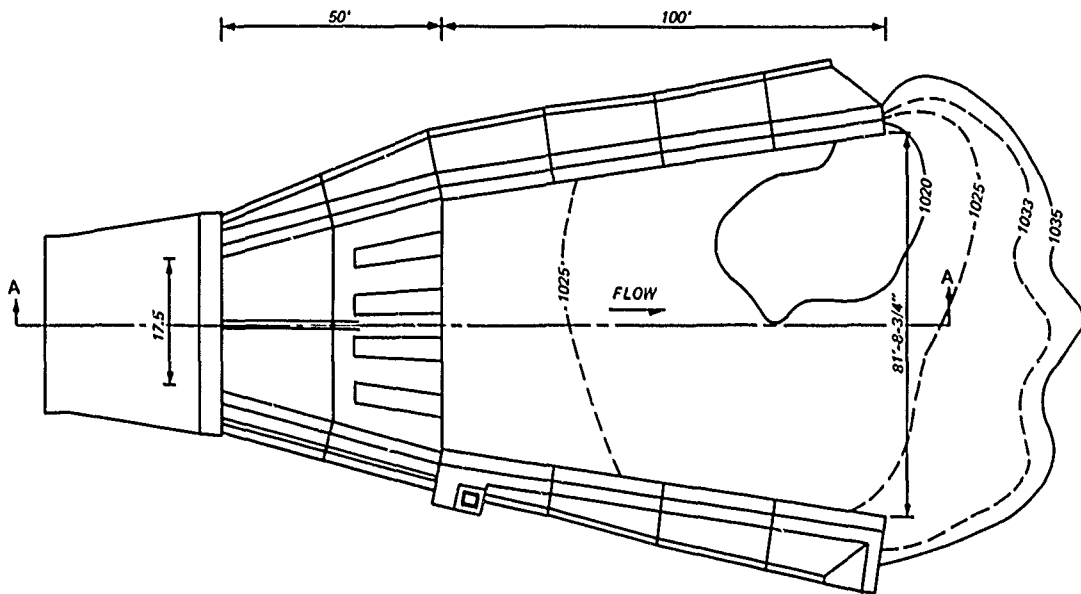
Figure 150. Stilling basin plan, Tionesta Dam

274. After nearly 30 years of service, large holes were observed in the stilling basin floor in the unpaved rock area. The eroded area varied from only about a foot (el 1034.0), a short distance downstream of the paving, to as much as 16 ft at the downstream end of the stilling basin (Figure 150). The erosion was a little more severe on the left side of the basin than on the right with undercutting of the sidewalls. A decision was made in March 1968 to restore the stilling basin floor as nearly as practicable to its original condition.

276. After all loose material was removed from the dewatered stilling basin by clamshell and the surface was cleaned, concrete and rock were placed in the eroded portion to el 1033.0. Finally, a 2-ft-thick concrete cap containing no large rock was placed over the stilling basin (Figure 152). This cap required four placements totaling

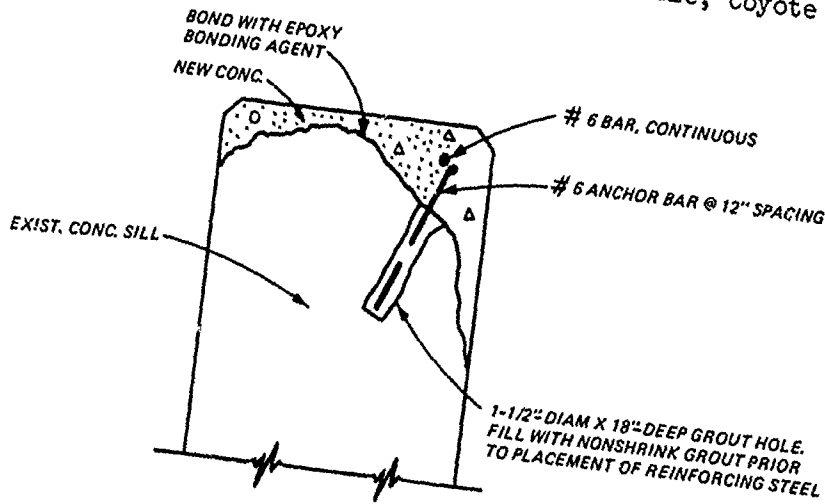
295. In 1969, erosion of the end sill was repaired using concrete proportioned for 4000 psi compressive strength at 28 days. The new concrete was bonded and anchored to the existing sill (Figure 159). In an effort to prevent future erosion and loss of downstream riprap, an additional row of baffles was constructed (Figure 158). A 2-in. saw cut was made in the basin slab to outline the new baffles and the inscribed concrete was chipped out to a depth of 2 in. Anchor bars were embedded in the existing concrete with a nonshrink grout and the baffles were reinforced (Figure 160). During the repair work the contractor diverted a flow of 300 cfs around the site and kept the basin dry by pumping.

Figure 159. End sill repair, Coyote Dam

NOTE: NEW REINFORCING STEEL PLACED ONLY IN AREAS WHERE EXISTING STEEL IS EXPOSED BY EROSION.

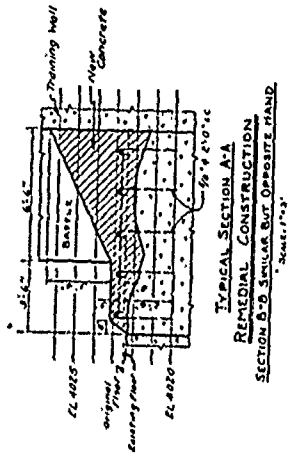
298. When the basin was dewatered in September 1944, pronounced erosion was noticeable in only four areas on the floor of the stilling basin (Figure 163). The most noticeable erosion, designated Area 1, occurred between the end sill and the baffle adjacent to the north training wall. The maximum depth of erosion in this area was 1 ft 6 in. at one point on the north side where the floor mat of reinforcing steel was exposed for about a 1-ft length. In general, however, the depth of erosion was from 9 to 12 in. in a roughly elliptical-shaped trough bounded by the baffle, training wall, and end sill, and extended about 18 in. south of a line extending from the south side of the baffle. The wear in this area also extended into the downstream face of the baffle and into the training wall as much as 6 in., exposing the vertical reinforcing

Figure 163. Stilling basin inspection and repair, Conchas Dam

bars in the baffle. Area 2, between the end sill and the baffle adjacent to the south training wall, had a maximum depth of wear of about 12 in. and was eroded in a manner very similar to but less extensive than the first area described above.

302. The major portion of the stilling basin was virtually free of sedimentation. Two piles of gravel and rock were found between the baffles and the end sill (see Figure 163). The largest pile, containing approximately 60 cu yd of material, was located directly downstream from monolith 13 and covered almost the entire area between the monolith joints and between the baffles and the end sill. The other pile,

306. Inasmuch as the operation of both the spillway and the conduits was to be minimized upon completion of the irrigation facilities being constructed at the time, the only remedial action deemed practical was removal of the rock and gravel deposits and renovation of the areas between the end baffles and the end sill. The latter was accomplished by placing concrete between each end baffle and the end sill (see Figure 163).

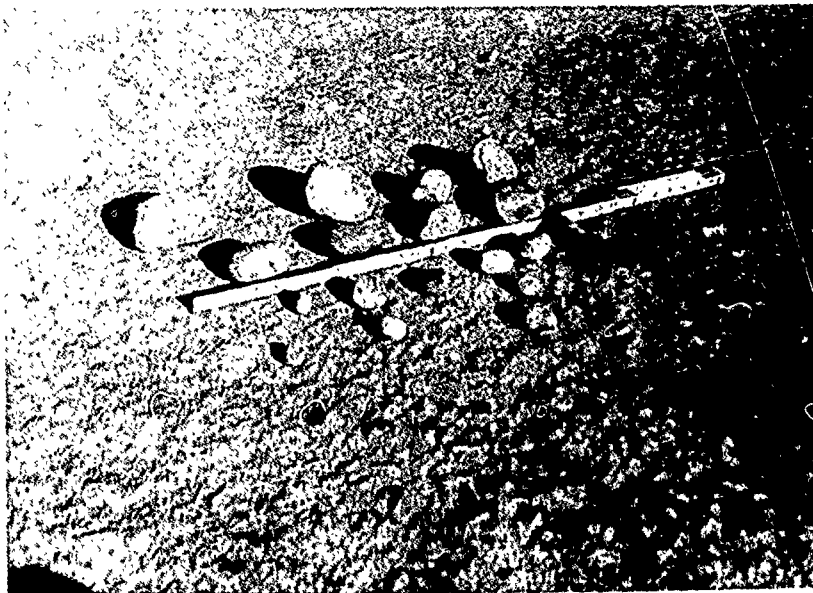
319. Inspections of the unwatered stilling basin in October and November 1952 revealed deposits of sand, gravel, timber, and miscellaneous scrap steel. The largest deposit (Figure 169) was in monolith 21, and most of the pieces of rock and steel deposited in the basin were rounded by abrasion (Figure 170). Areas of eroded concrete and exposed reinforcing steel were present on or immediately downstream from the first elliptical step below 12 of the 16 conduit outlets and on or immediately downstream from the second step below 6 of the conduit outlets. Locations of the eroded areas are shown in Figure 171 and typical examples are shown in Figures 172 and 173.

Figure 170. Typical abraded aggregate from debris deposits, Bull Shoals Dam (from Little Rock District 1953)
