MAINTENANCE AND PRESERVATION OF CONCRETE STRUCTURES

REPAIR OF EROSION-DAMAGED STRUCTURES

James E. McDonald

April 1980

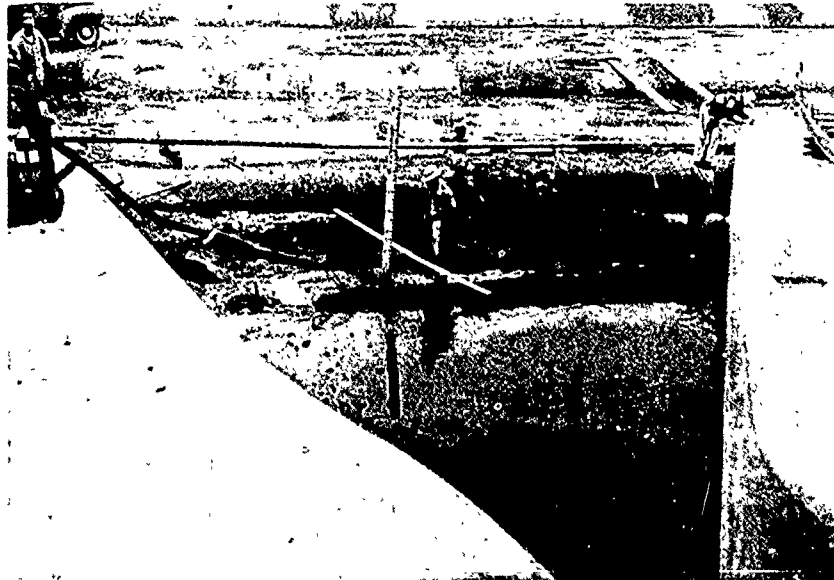
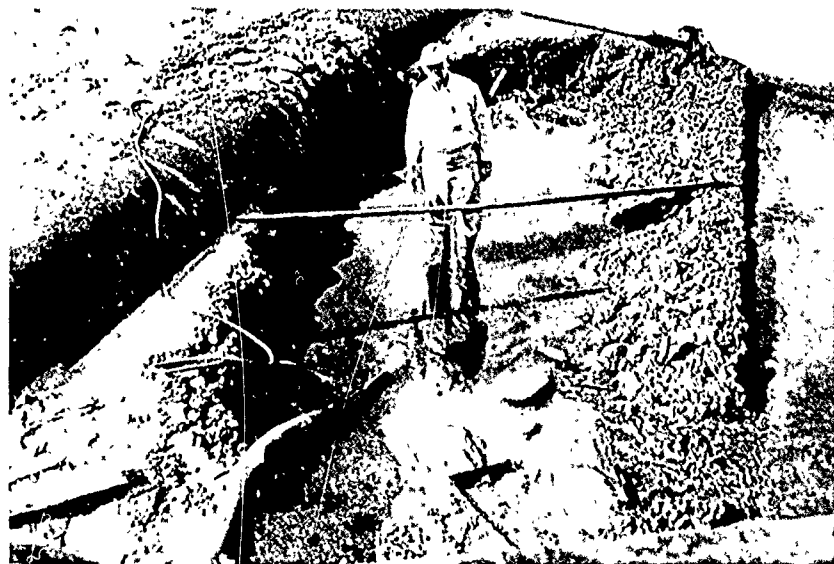
321. Damage occurred downstream from only those conduits which had been operated during this period, but only a very general relationship was found between the eroded volume and the flow data (Figure 174). The erosion on the first steps ranged in depth to a maximum of about 3.5 ft. The exposed reinforcing steel appeared to have failed because of bending fatigue as there were no "necks" characteristic of tension failures. The downstream ends of many longitudinal reinforcing bars appeared to have been "peeled" out of the 3-in. concrete cover, leaving rough grooves about 2 in. wide, 4 in. deep, and 1 ft long. On the top

Figure 172. Erosion of first step and face of second step downstream from monolith 22, Bull Shoals Dam (from Little Rock District 1953)

322. A temporary repair of the basin while it was dewatered included cutting back the damaged steps and replacing them with smooth, upward sloping slabs. The slabs replaced the two upstream steps at conduit outlets 22 and 24-36 and all four steps at conduit outlet 21 (Figure 175). The undamaged steps at conduit outlet 23 were to be retained for testing purposes.

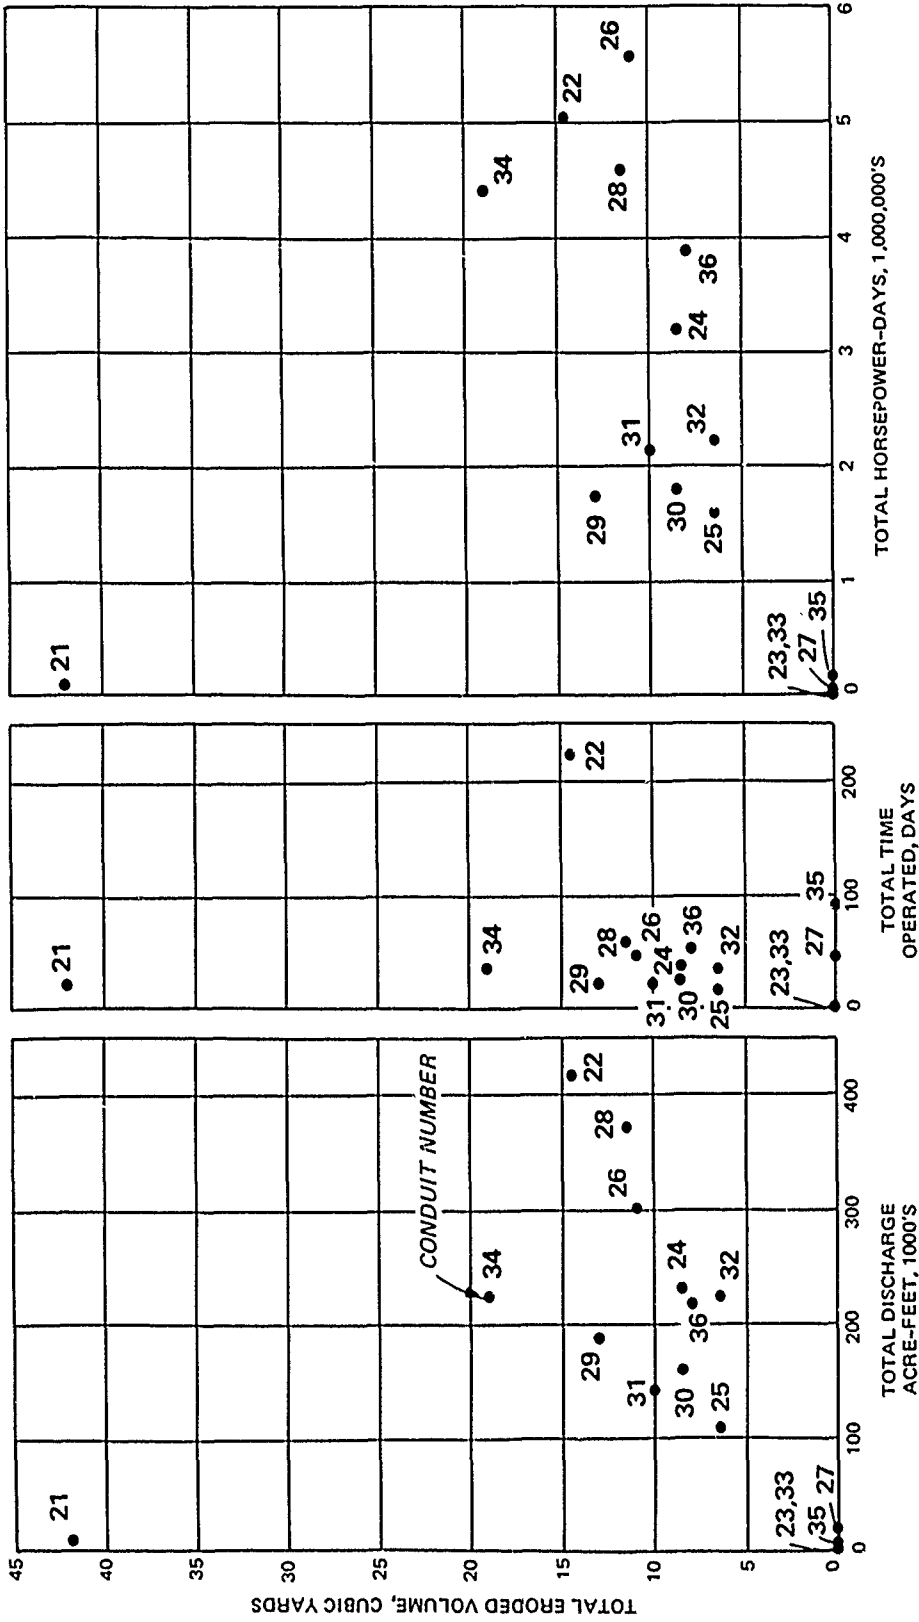
Figure 174. Relationships between erosion and flow, Bull Shoals Dam
(from Little Rock District 1953)

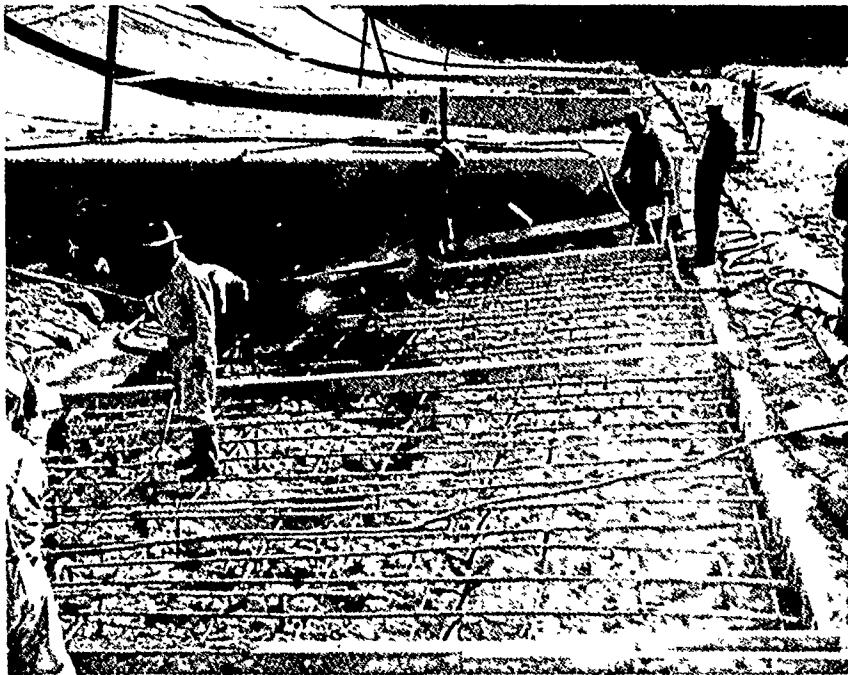
a. Concrete removal

b. Immediately prior to placing new concrete

Figure 177. Repair operations downstream of monolith 26, Bull Shoals Dam (from Little Rock District 1953)

323. Concrete in the stepped areas was broken with paving breakers and was excavated by hand. Anchors were grouted into holes drilled on 4-ft centers each way and reinforcing mats were welded to the anchors (Figures 176 and 177).

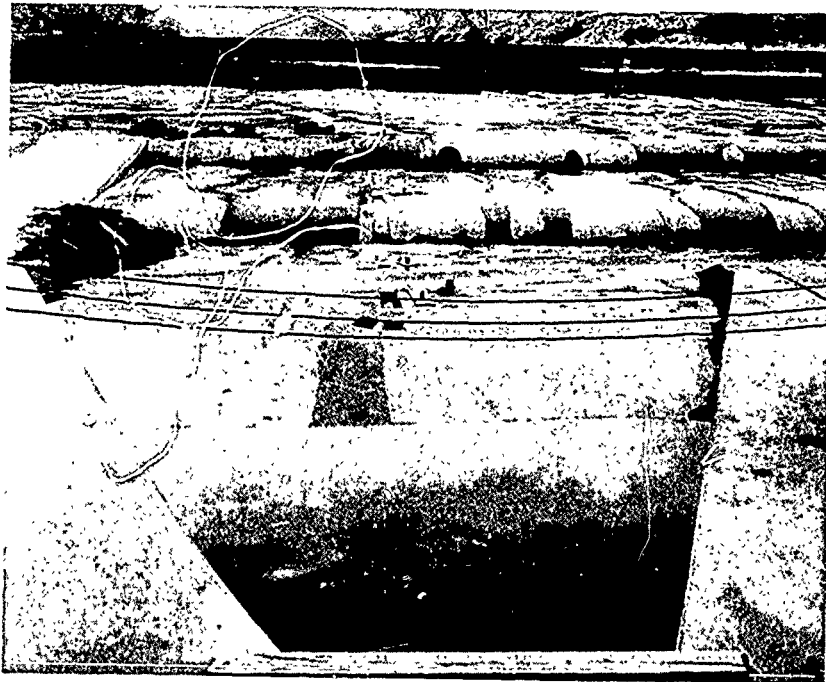
a. Slab replacement of first and second steps, monolith 22

b. Slab replacement of four steps downstream from monolith 21

Figure 178. Completed repairs, Bull Shoals Dam
(from Little Rock District 1953)

No air entraining admixture was used. Average compressive strengths at 7 and 28 days were 3630 and 5820 psi, respectively. All concrete surfaces were given a hard troweled finish. Typical completed repairs are shown in Figure 178. The repairs were made by contract from November 1952 to January 1953 at a cost of \$67,689, excluding dewatering, which was accomplished by hired labor at a cost of \$11,947.

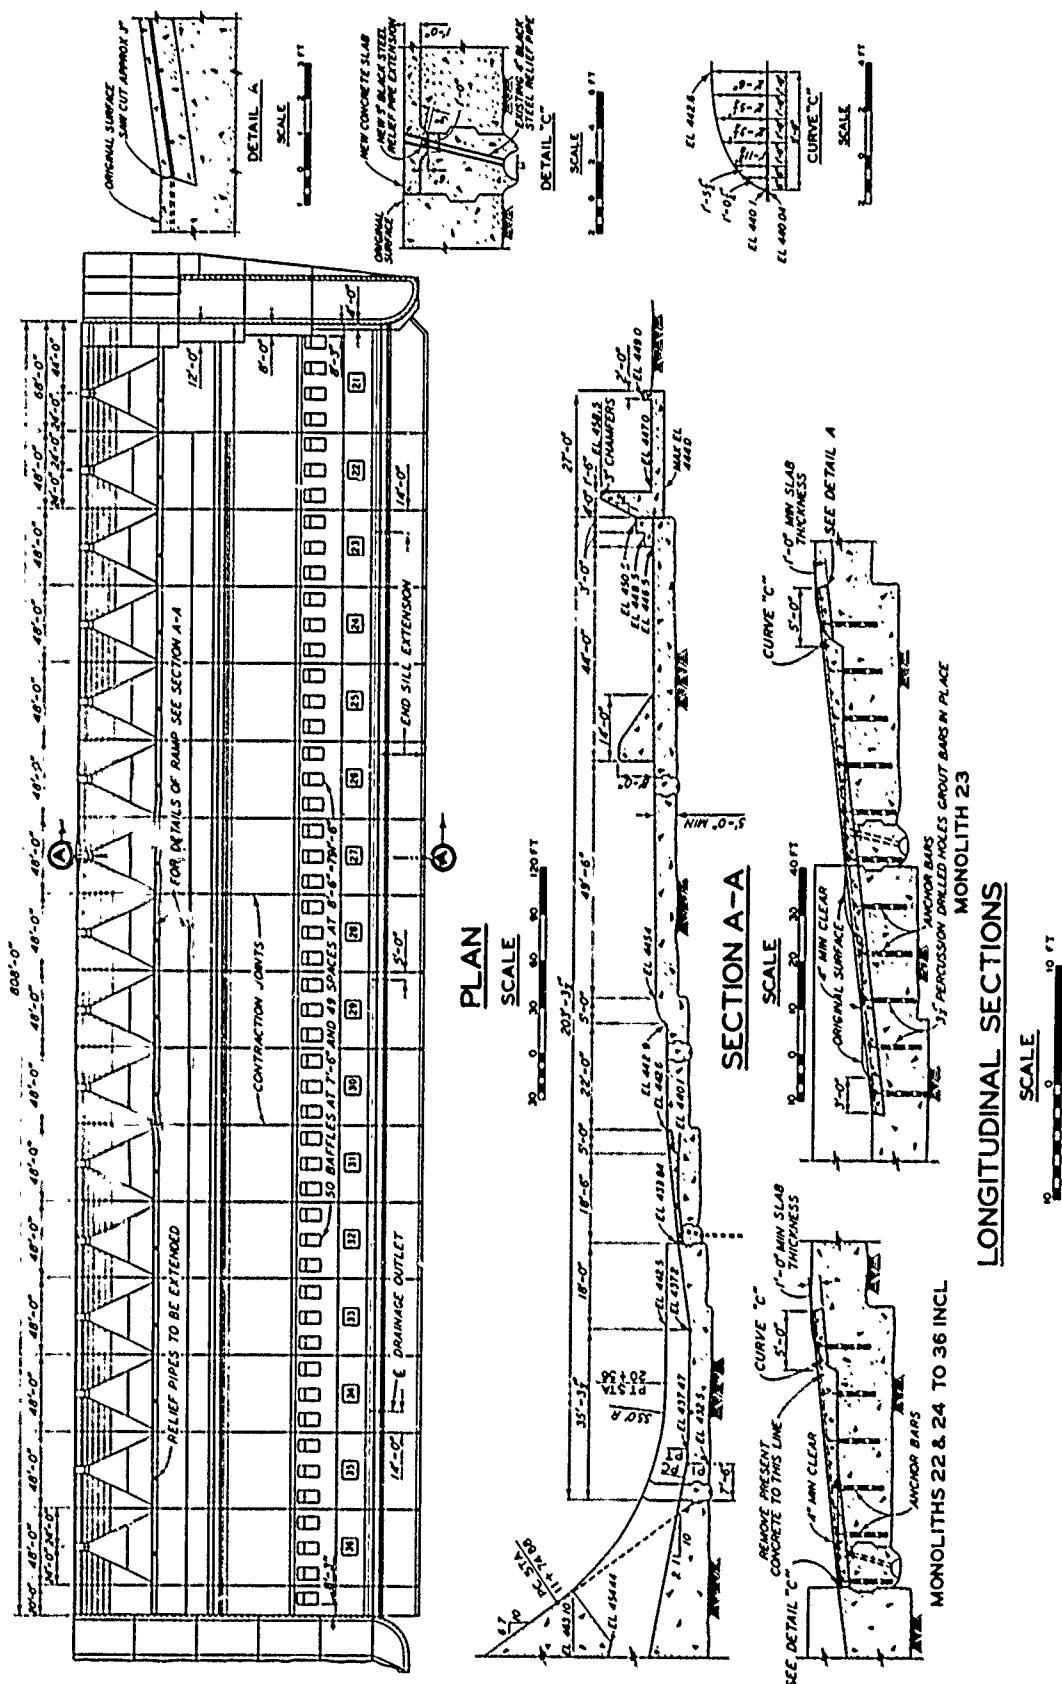
Figure 179. Modifications to stilling basin, Bull Shoals Dam (from WES 1958)

329. Based on the results of these tests, a contract was awarded in June 1954 for construction of one row of vertically faced baffles, 8 ft in height (Figure 179). Also, the end sill was increased in height to 12 ft, and a 19.5-ft-long horizontal apron terminated by another 2-ft-high sill was provided downstream for protection of the exit area during periods of low flow. Total cost of the contract was \$294,350.

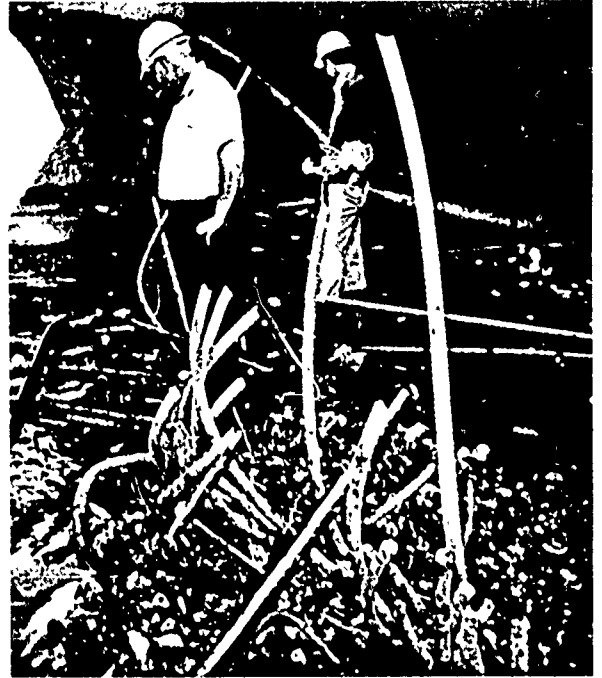
1970, revealed only minor areas of scour on the floor and three baffles with cavities deep enough to require repair. Repair were made by installing anchor bolts and filling the cavities with epoxy mortar. The second inspection of the basin in September 1975 revealed that a large amount of damage had occurred since the first inspection and presumably since the pool was raised in 1972. In the right basin, the erosion of the floor was deep enough (17-in. maximum) to expose and remove reinforcing steel from two separate layers (Figure 185). In comparison, the left basin lost very little reinforcement but most of the top layer was exposed (Figure 186). Most of the baffles had exposed reinforcing but the erosion was generally confined to about 18 in. at the base (Figure 186). It was concluded that erosion of the stilling basin concrete resulted from debris trapped in the basin.

a. Loose reinforcement removed from right basin

b. Stilling basin after removal of loose reinforcement

c. Floor of right basin. Note broken rebars

Figure 185. Right stilling basin damage, Oologah Dam

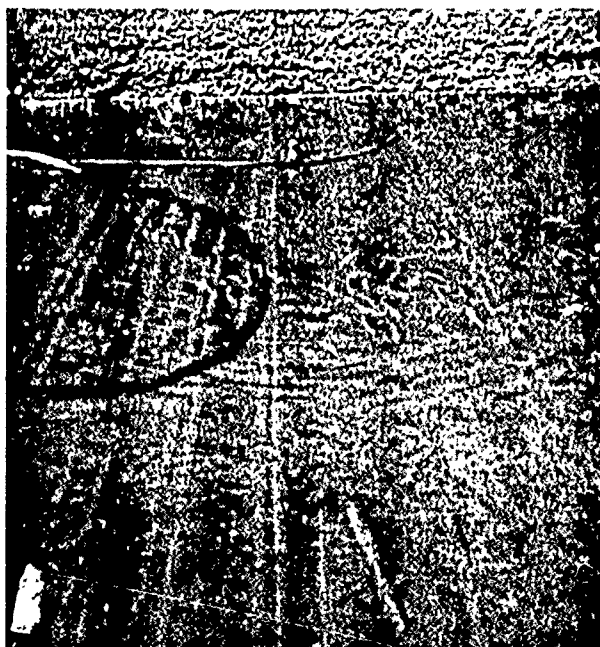
a. Typical baffle damage

b. Severe baffle damage

c. Floor of left basin. Note exposed rebar

Figure 186. Left stilling basin damage, Oologah Dam

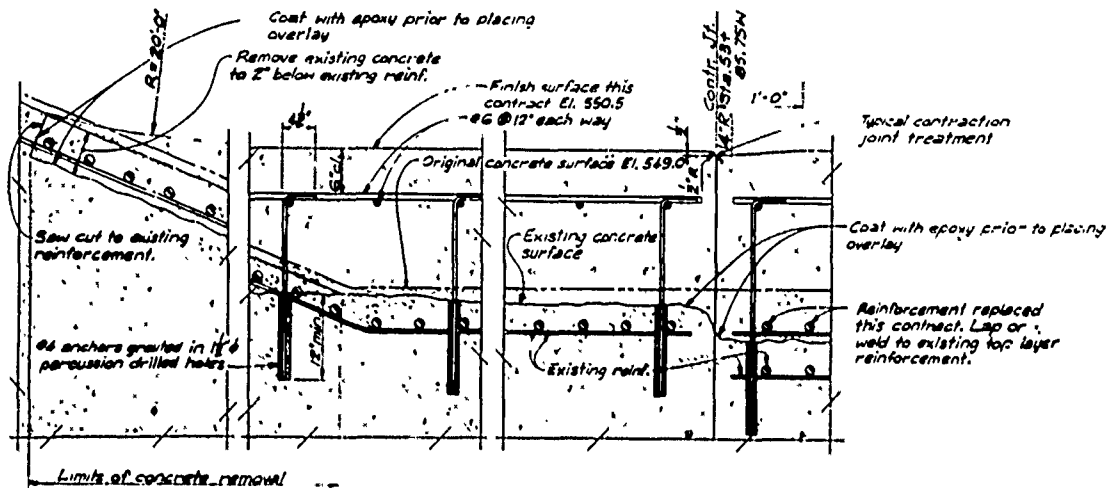
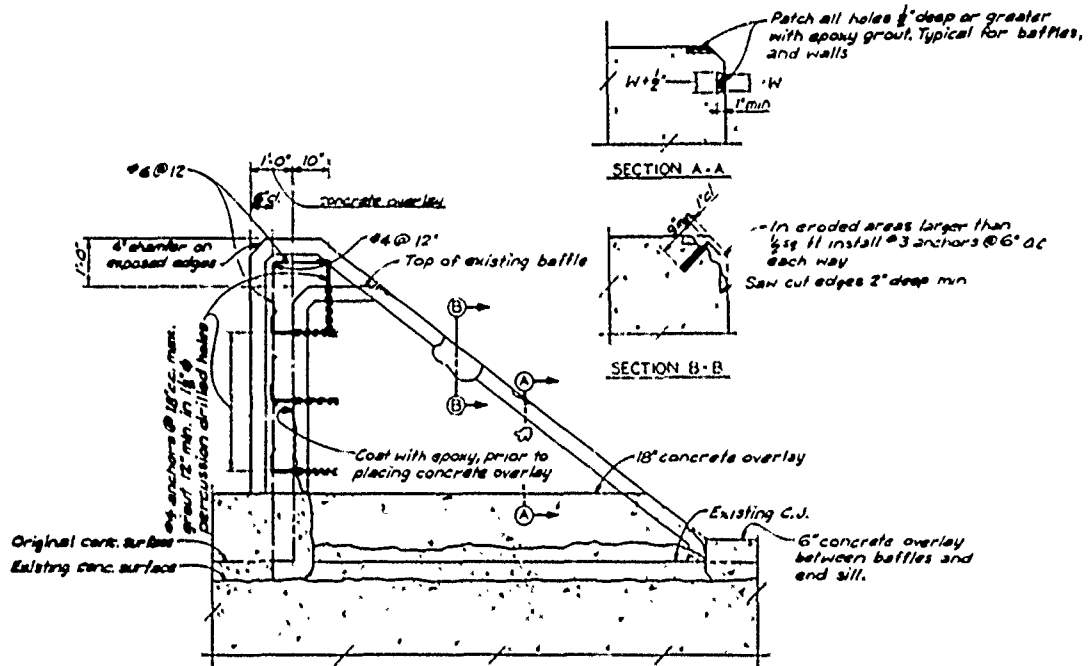
a. Slab repair detail

b. Baffle repair detail

Figure 188. Repair details, Oologah Dam

356. An 18-in.-thick concrete overlay was added on the basin floor between the toe of the parabolic drop and the downstream edge of the baffles (Figure 188). From that point to the end sill the thickness of the overlay was reduced to 6 in. This provided adequate depth for the formation of the hydraulic jump and provided a collection basin for debris. A 45-deg batter was added on the upstream face of the end sill (Figure 188) in order to facilitate removal of debris by higher discharges. The baffles received a 1-ft overlay on the upstream face and top (Figure 189). All overlays were anchored to the old concrete with both steel anchors and with epoxy grout. A concrete slab was added around the outside of the stilling basin walls to prevent the rock fill from being washed into the basin by high discharges.

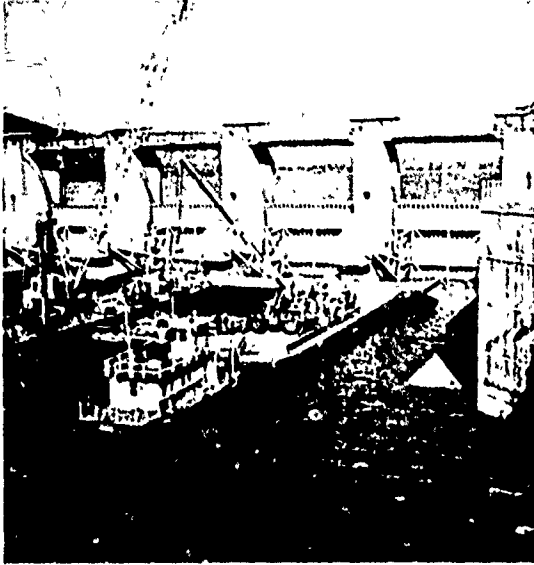
a. Work area showing equipment arrangement

b. Transit mixers carried to work site by barge

Figure 195. Repair operations, Webbers Falls Dam

373. Several barges lashed together formed a work platform over the area to be repaired. Prior to the placement of concrete, the damaged area was air cleaned of silt and debris. The concrete was conveyed to the area by loading the transit mix trucks on a barge (Figure 195) at a point about half a mile below the dam. Because of the length of time required to get from the batch plant to the work site, the cement and some water were withheld from the mix until the trucks had been loaded on the barge and were approaching the work area. A placement was made by transferring the concrete from the truck into a 1-cu-yd capacity bucket. The bucket was positioned by crane over a 1-cu-yd-capacity hopper attached to a 10-in. ID tremie pipe. A "rabbit," composed of a greased polyethylene bag filled with burlap bags, was placed in the top of the tremie prior to placing concrete in the hopper (Figure 196). The bottom of the tremie pipe was positioned by divers and rested on the surface of the existing concrete in the hole. When the fresh concrete forced the rabbit to the bottom of the pipe, the pipe was raised approximately 1 ft to eject the rabbit and permit the flow of concrete. This process was repeated each time it was necessary to move the tremie pipe. The depth of the water in the stilling basin during the repair was about 40 ft. The water velocity was 3 or 4 fpm due to releases through the adjacent power plant. No releases were made through the spillway for 7 days following the concrete placement. A total of 43 cu yd was placed during two different periods. Twenty-one cu yd was placed in March 1975: 7 cu yd in slabs D-5 and D-6 and 14 cu yd in slabs D-7 through D-10. After this repair proved resistant to heavy flows, an additional 22 cu yd was placed in October 1975. Seven cu yd was placed on the D-6 and D-7 slabs and 15 cu yd in the D-4, D-5 area.

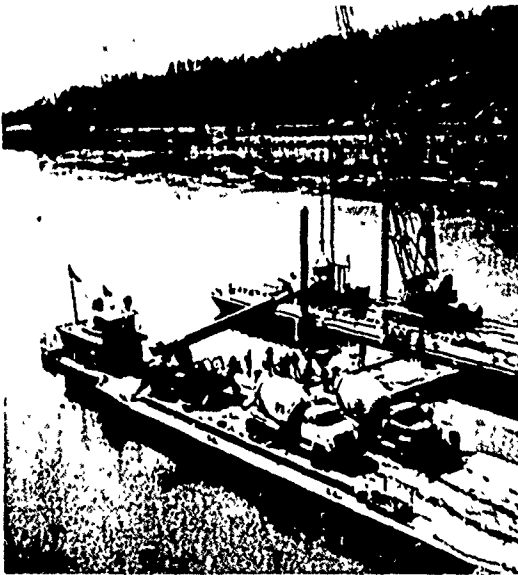
c. Placement in progress

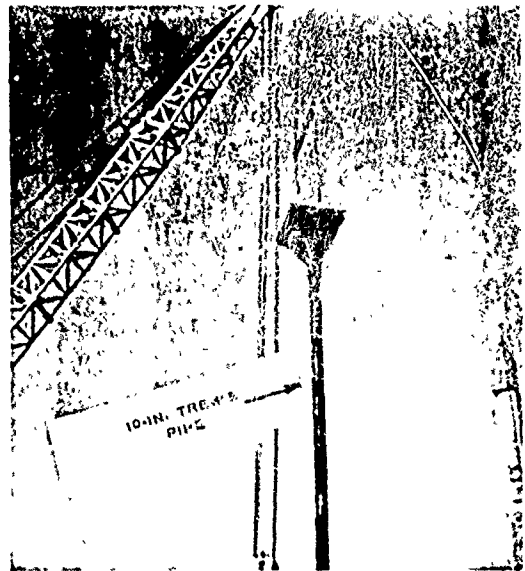
d. Hopper and tremie pipe handled by crane

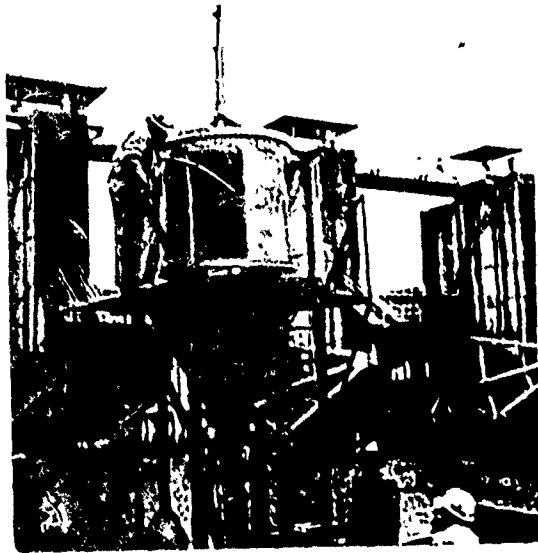
a. Concrete being discharged into hopper

372. Conventional concrete placed with a 10-in.-diameter tremie pipe was used to fill the eroded areas. The concrete was designed for a cement content of 752 lb/cu yd and a water content as required to obtain a 5- to 8-in. slump with a maximum water-cement ratio of 0.45. During the placing operation, a 5-1/2- to 7-1/2-in. slump was found to be best for this type operation. The mixing water was heated to about 150°F to offset the effect of the cold river water. Mixture proportions for 1 cu yd were as follows:

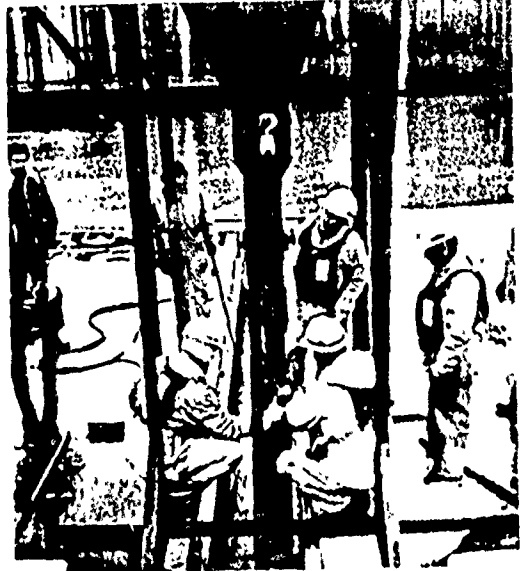
b. Workmen adjusting tremie pipe

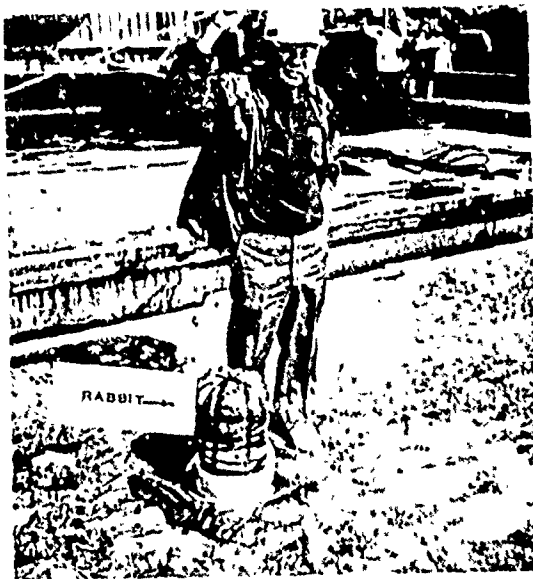
c. A "rabbit" forced the water out of the tremie pipe ahead of the concrete
