NEW YORK STATE DEPT OF ENVIRONMENTAL CONSERVATION ALBANY F/6 13/13  
NATIONAL DAM SAFETY PROGRAM. WARNER DAM, CHAUTAUGUA LAKE OUTLET--ETC(U)  
SEP 80 B L THOMSEN, G L WOOD DACW51-79-C-0001

REPORT DOCUMENTATION PAGE		READ INSTRUCTIONS BEFORE COMPLETING FORM
1. REPORT NUMBER	2. GOVT ACCESSION NO. AD-A090 937	3. RECIPIENT'S CATALOG NUMBER
4. TITLE (and Subtitle) Phase I Inspection Report Warrer Dam-Chautauqua Lake Outlet Allegheny River Basin, Chautauqua County, New York Inventory No. 750		5. TYPE OF REPORT & PERIOD COVERED Phase I Inspection Report National Dam Safety Program

PHASE I INSPECTION REPORT  
NATIONAL DAM SAFETY PROGRAM  
WARNER DAM  
I.D. NO. N.Y. 750  
ALLEGHENY RIVER BASIN  
CHAUTAUQUA COUNTY, NEW YORK

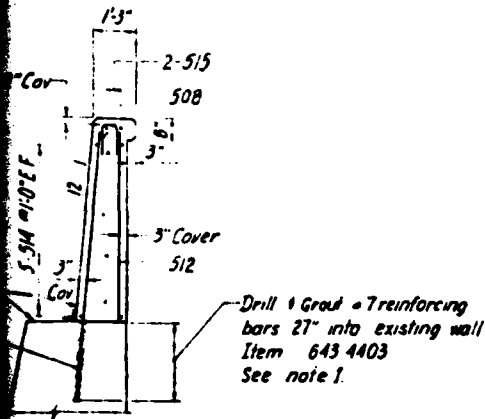
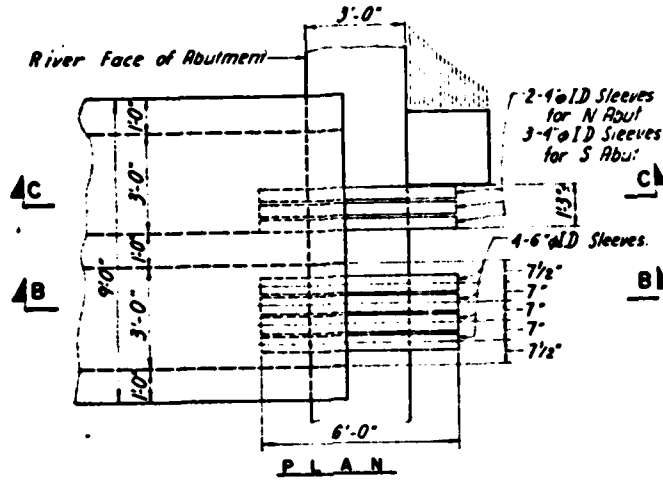
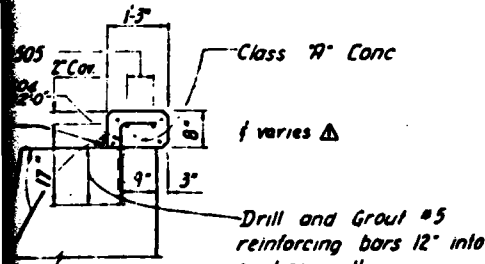
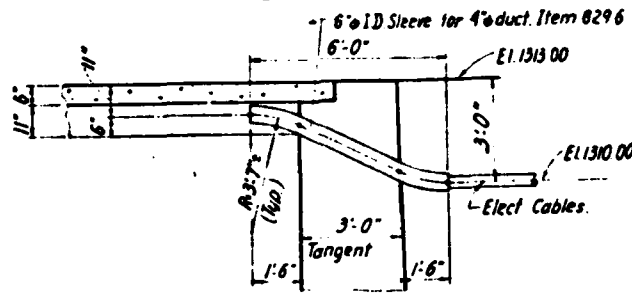
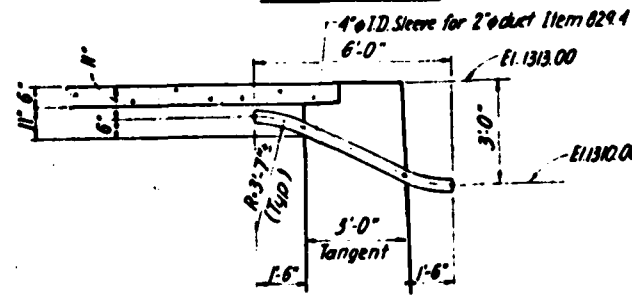
DRAWING TITLE  
**CONCRETE WALL  
REPAIR DETAILS**

- Contractor shall remove unsound concrete from top of existing wall before adding cap
- Dimensions & elevations of existing structure shall be verified in the field by the contractor.
