NEW YORK STATE DEPT OF ENVIRONMENTAL CONSERVATION ALBANY F/G 13/13  
NATIONAL DAM SAFETY PROGRAM, CLARKS MILLS DAM, (INVENTORY NUMBE--ETC(U)  
AUG 80 J B STETSON DACW51-79-C-0001

REPORT DOCUMENTATION PAGE		READ INSTRUCTIONS BEFORE COMPLETING FORM
1. REPORT NUMBER	2. GOVT ACCESSION NO. AD-A091130	3. RECIPIENT'S CATALOG NUMBER 130
4. TITLE (and Subtitle) Phase I Inspection Report Clarks Mills Dam Upper Hudson River Basin, Washington County, NY Inventory No. 120		5. TYPE OF REPORT & PERIOD COVERED Phase I Inspection Report National Dam Safety Program

PHASE I INSPECTION REPORT  
NATIONAL DAM SAFETY PROGRAM  
NAME OF DAM - CLARKS MILLS DAM ID# - NY 120

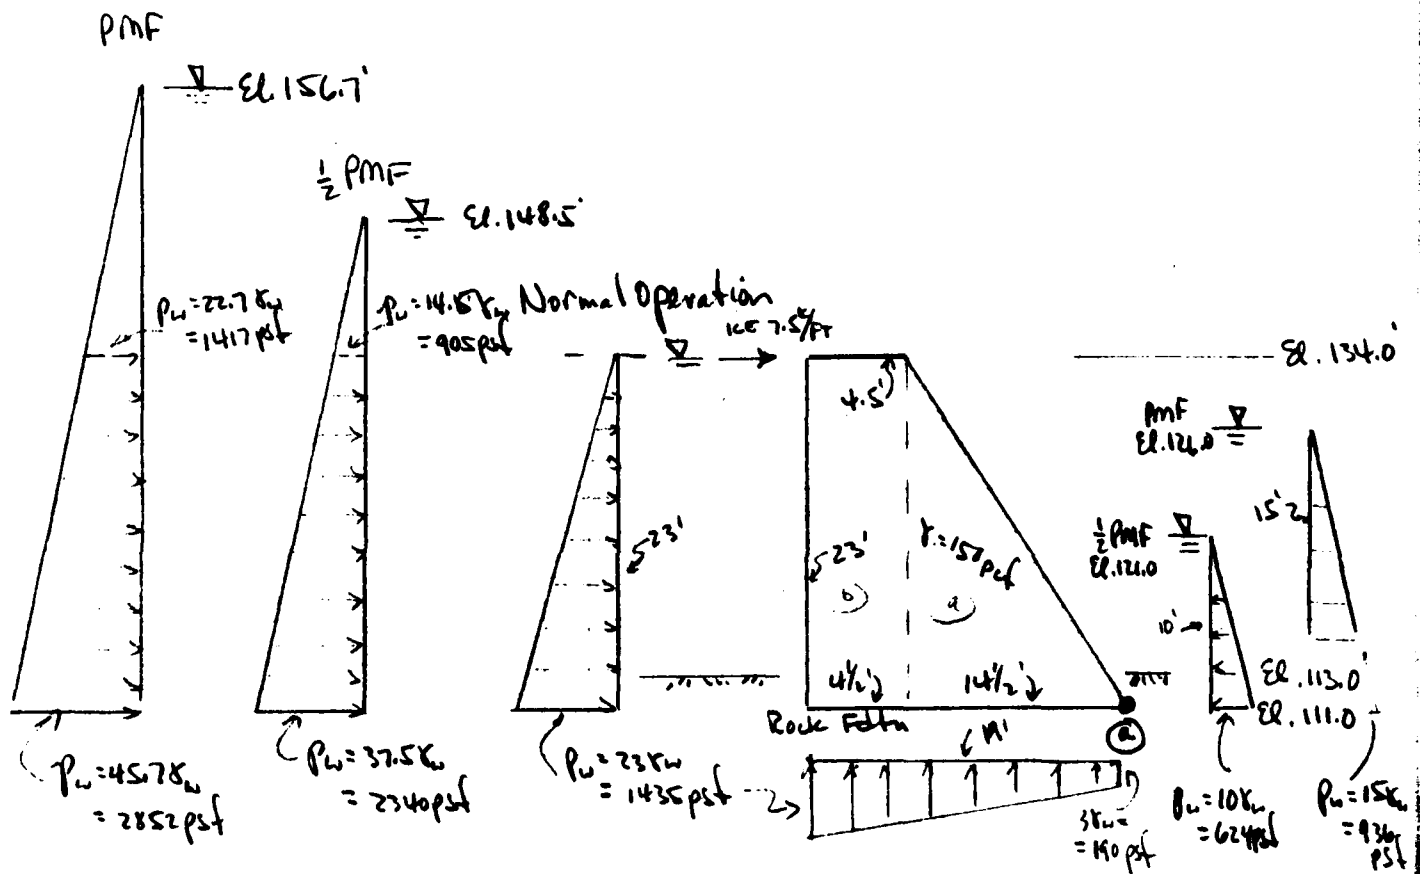
### Assumed Dam Section and Loading Conditions

$$\text{Wt. of Dam Section} = \left( \frac{1}{2} \times 23 \times 14.5 \times 15 \right) + \left( 23 \times 4.5 \times 15 \right) = \underline{40.6^k}$$

$$\begin{aligned} M_a \text{ due to weight of dam} &= \left( \frac{1}{2} \times 23 \times 14.5 \left( \frac{2 \times 14.5}{3} \right) \right) + \left( 23 \times 4.5 \times 15 \left( \frac{4.5}{2} + 14.5 \right) \right) \\ &= 242 + 260 = \underline{502^{\text{ft-k}}} \end{aligned}$$

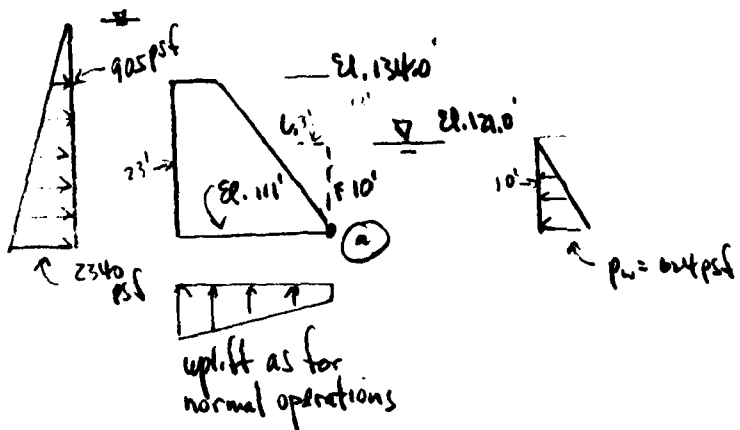
Case III. WL @ 1/2 PMF Levels

Overturning

M<sub>a</sub> causing overturning due to upstream H<sub>2</sub>O, uplift

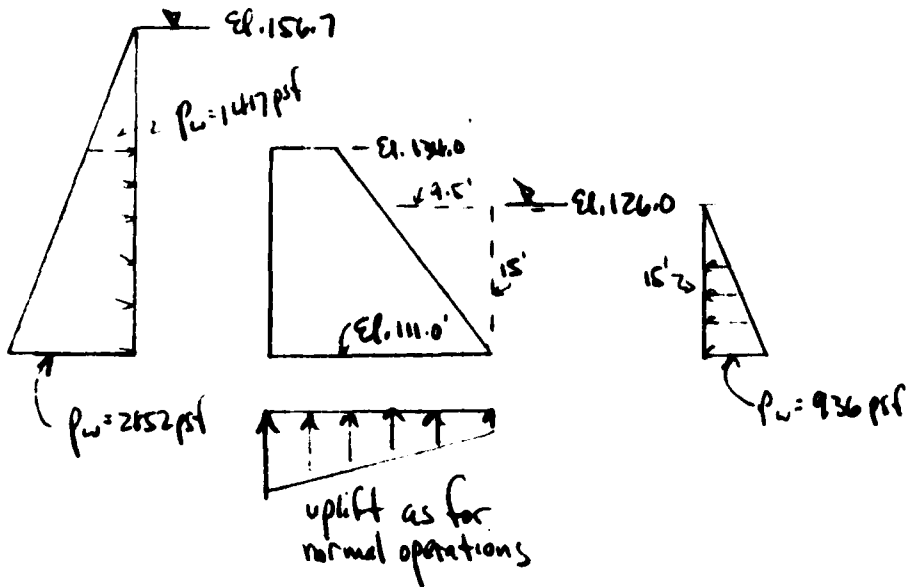
Case II - WL @ PMF Levels

Overturning

M<sub>a</sub> causing overturning due to lateral H<sub>2</sub>O upstream, uplift
