PANAMA DAM

CHAUTAUQUA COUNTY NEW YORK
INVENTORY NO. N.Y. 784

**PHASE I INSPECTION REPORT
NATIONAL DAM SAFETY PROGRAM**

Name of Dam: Panama Dam I.D. No. NY 784
State Located: New York
County: Chautauqua
Watershed: Allegheny River Basin
Stream: Little Brokenstraw Creek
Dates of Inspection: October 3 and November 9, 1979

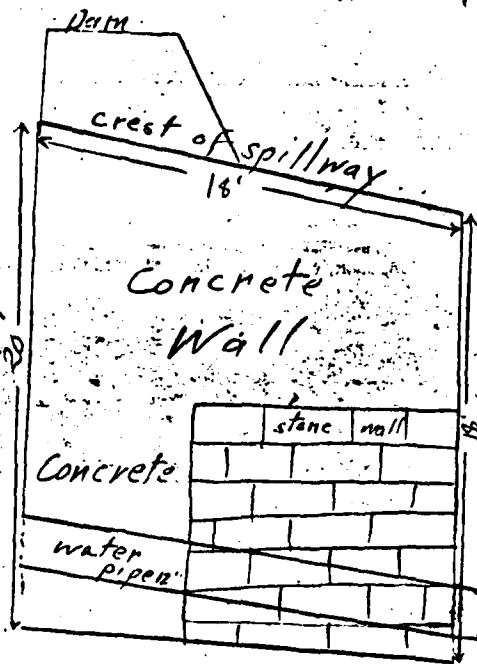
Cross-Section of Spillway

The total length of this dam is 160 feet. The spillway or waste-weir portion, is about 50 feet long, and the crest of the spillway is about 2 1/2 feet below the top of the dam.
