DRUID HILL LAKE

NDI ID NO. MD-109

PHASE I INSPECTION REPORT  
NATIONAL DAM INSPECTION PROGRAM

JULY 1980

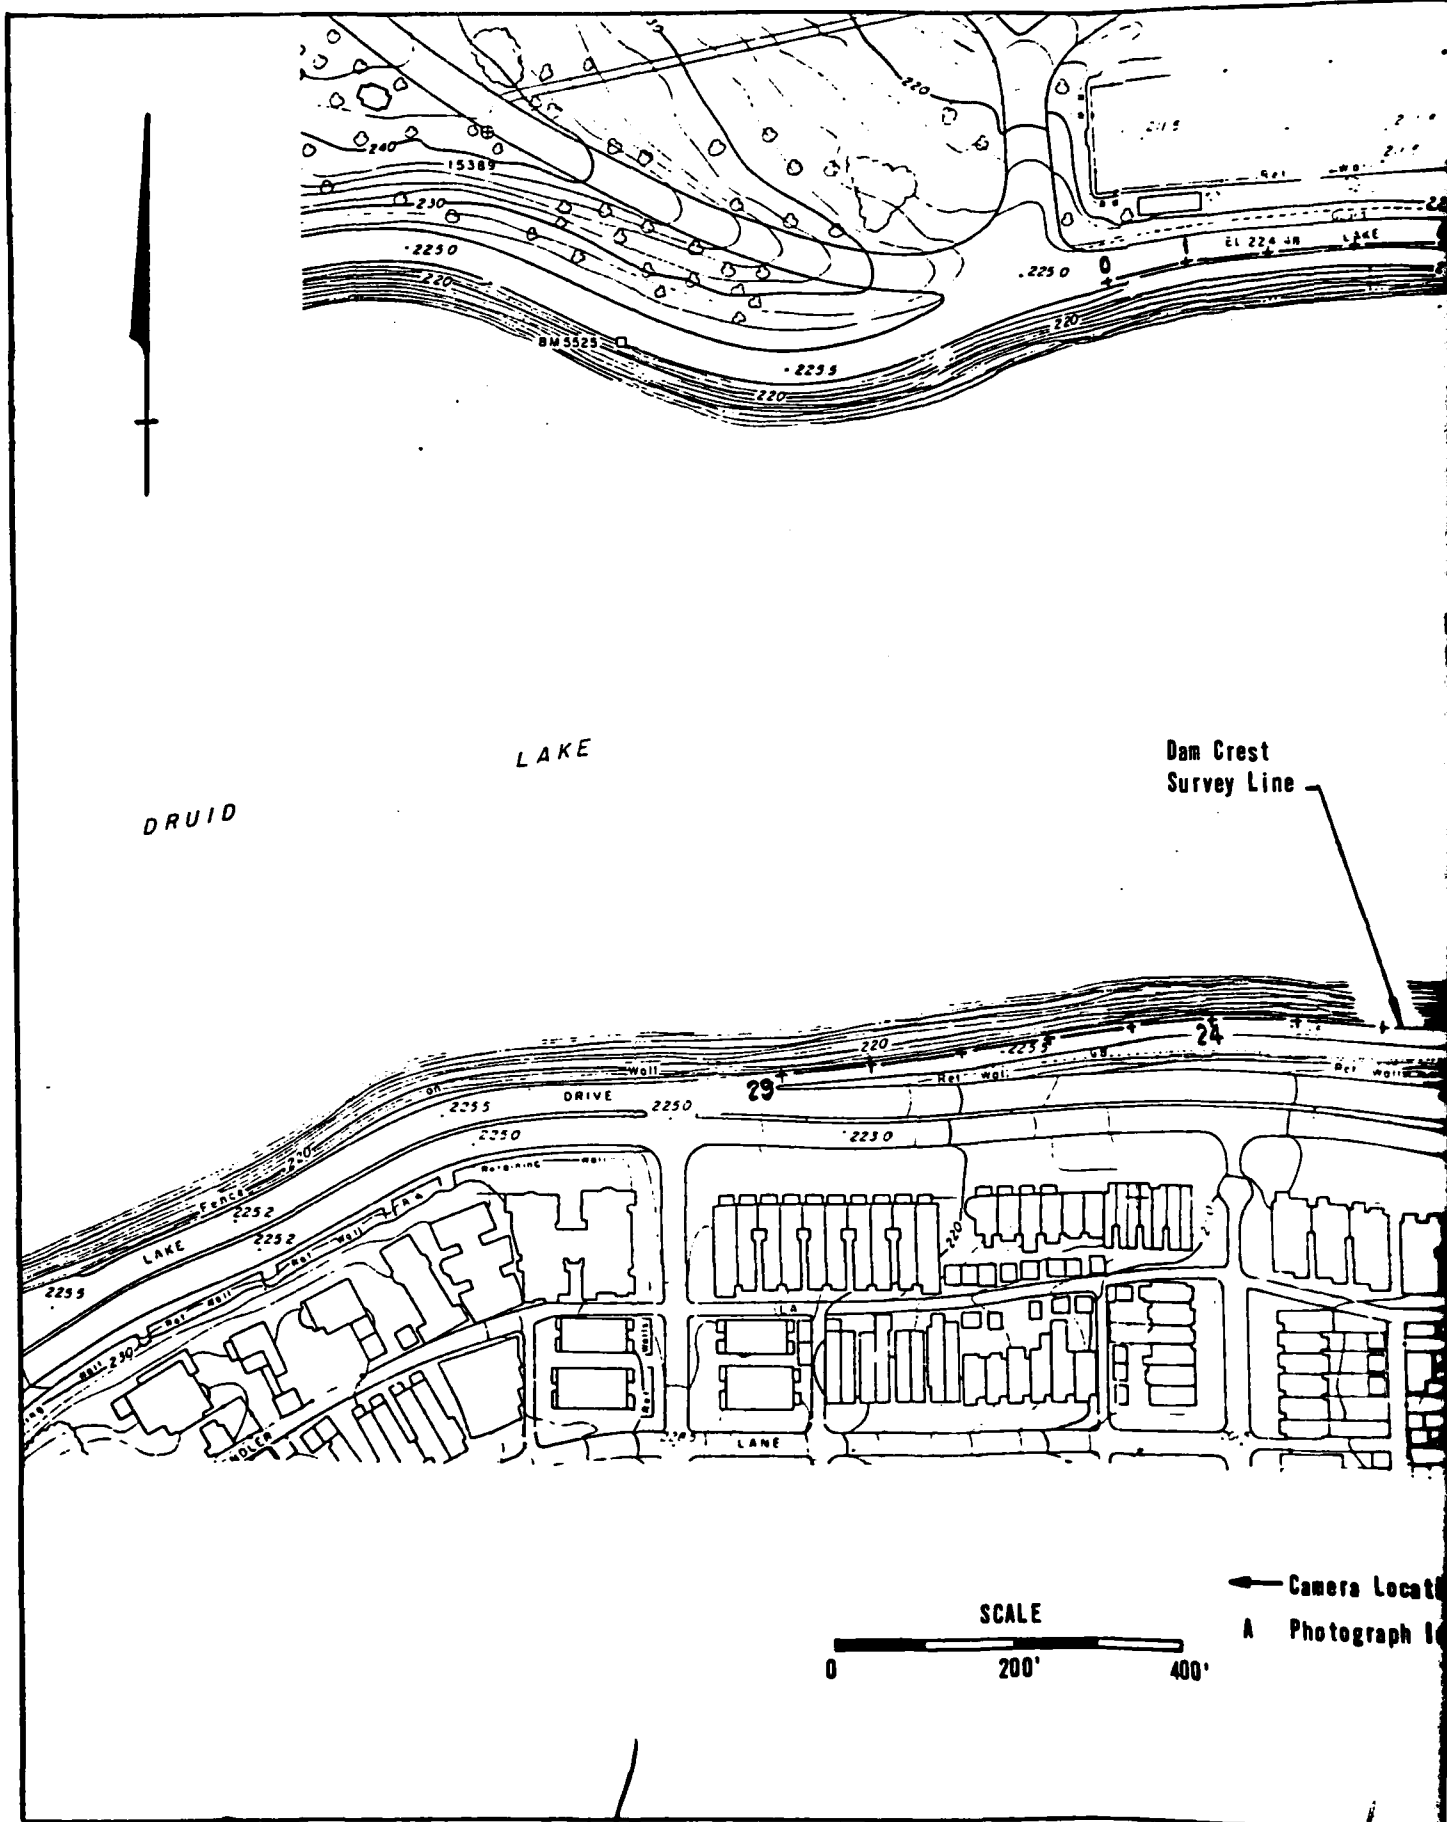
H. Erosion has exposed soil at the top  
of the eastern embankment

3. Retain the services of a Registered Professional Engineer experienced in the design and construction of embankment dams to: a) re-inspect the eastern embankment after the vegetation has been removed to determine the total extent of slumping; b) investigate the cause of the existing earth slumps; and c) recommend remedial measures for repairing the slope.
