JOHNSON'S POND

NDI ID NO. MD-11

PHASE I INSPECTION REPORT
NATIONAL DAM INSPECTION PROGRAM

JULY 1980

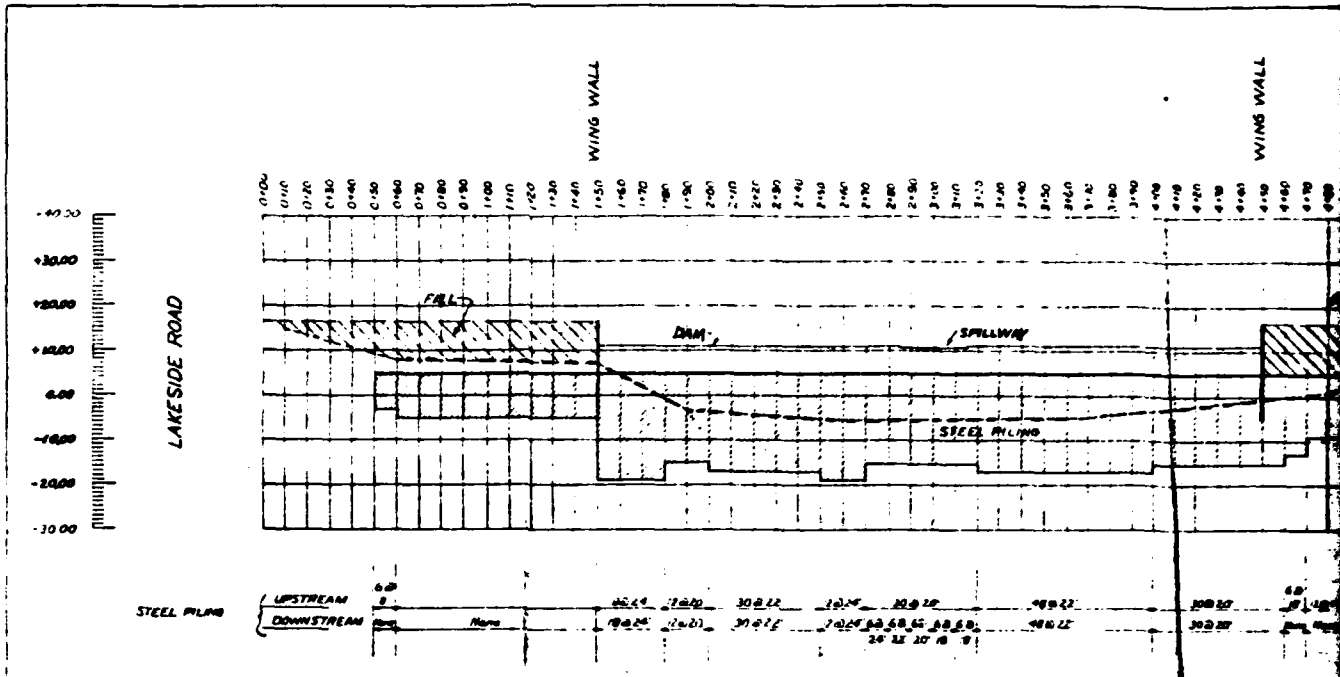
PLATE E-2

PROPOSED STEEL & CONCRETE DAM AT JOHNSON'S POND	SHEET NO. 1 OF 2	SCALE AS SHOWN	14 (B-36-2) 8

PROFILE OF DAM STANDING ABOVE DAM & LOOKING DOWNSTREAM
 VERTICAL SCALE 1" = 20.0'
 HORIZONTAL SCALE 1/4" = 10.0'
